Durham E-Theses

*The detection of hydrogen induced cracking in welded
and seamless steel pipes using acoustic emission and
ultrasonic techniques*

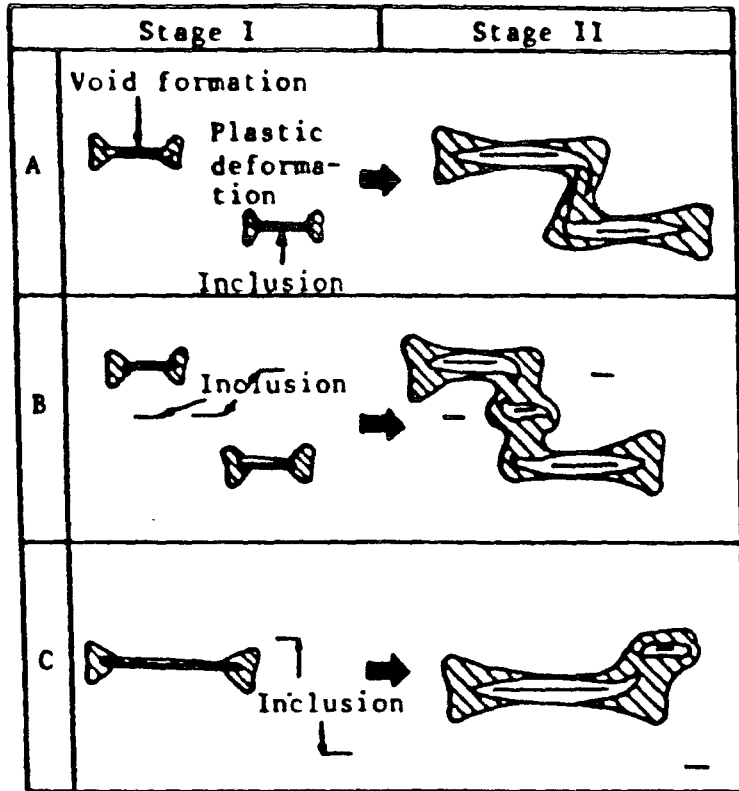
- A The case of direct linkage between closely spaced crack sites.
- B Creation of small cracks by the interaction of two main cracks. Joining between main crack and a small crack takes place by Mechanism A.
- C Creation of small crack in front of main crack.

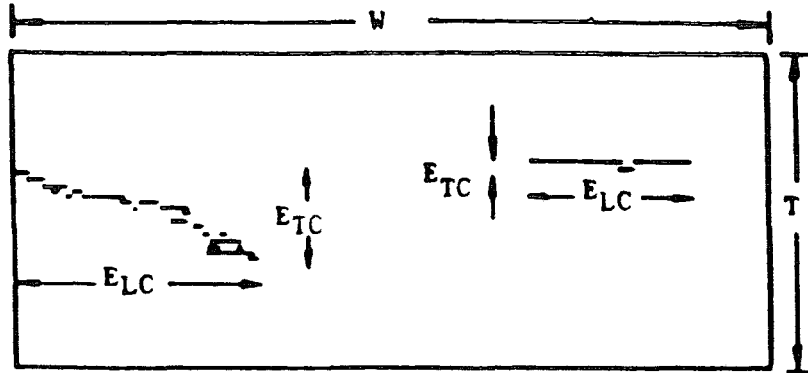
$$\text{Crack length ratio (CLR)} = \left[\frac{\Sigma E_{LC}}{W} \times 100 \right] \%$$

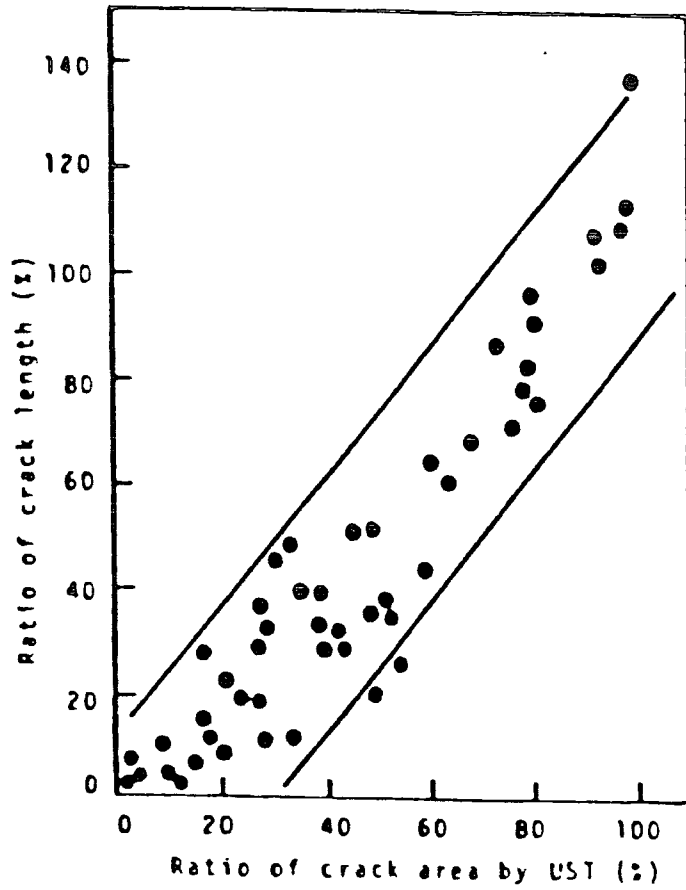
RELATIONSHIP BETWEEN RATIO OF CRACK LENGTH AND
RATIO OF CRACK AREA BY UST
AFTER NAKAI ET AL 17

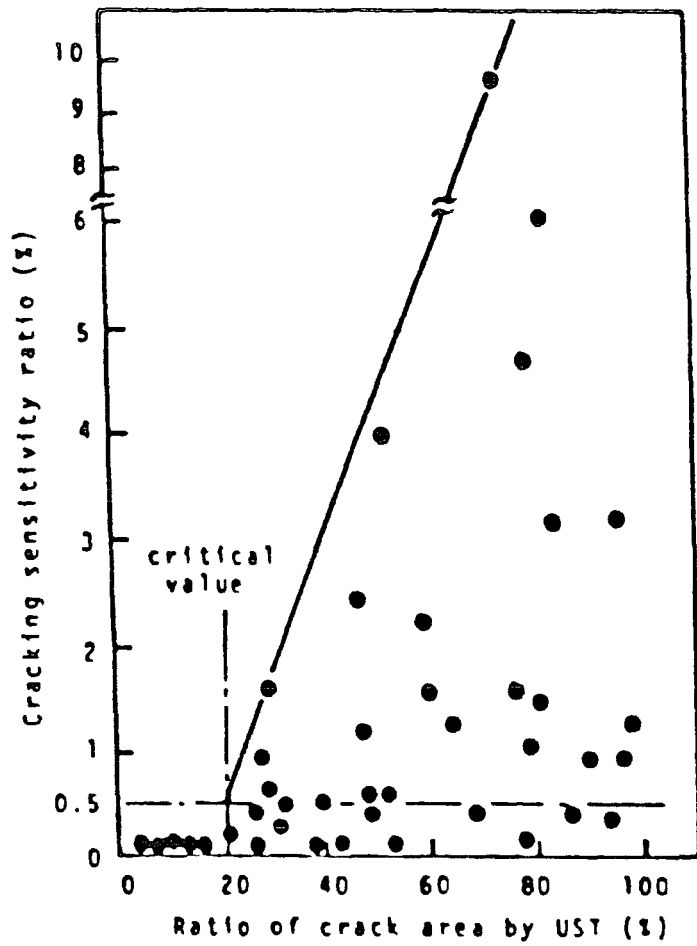
RELATIONSHIP BETWEEN CRACKING SENSITIVITY RATIO
AND RATIO OF CRACK AREA BY UST
AFTER NAKAI ET AL 17

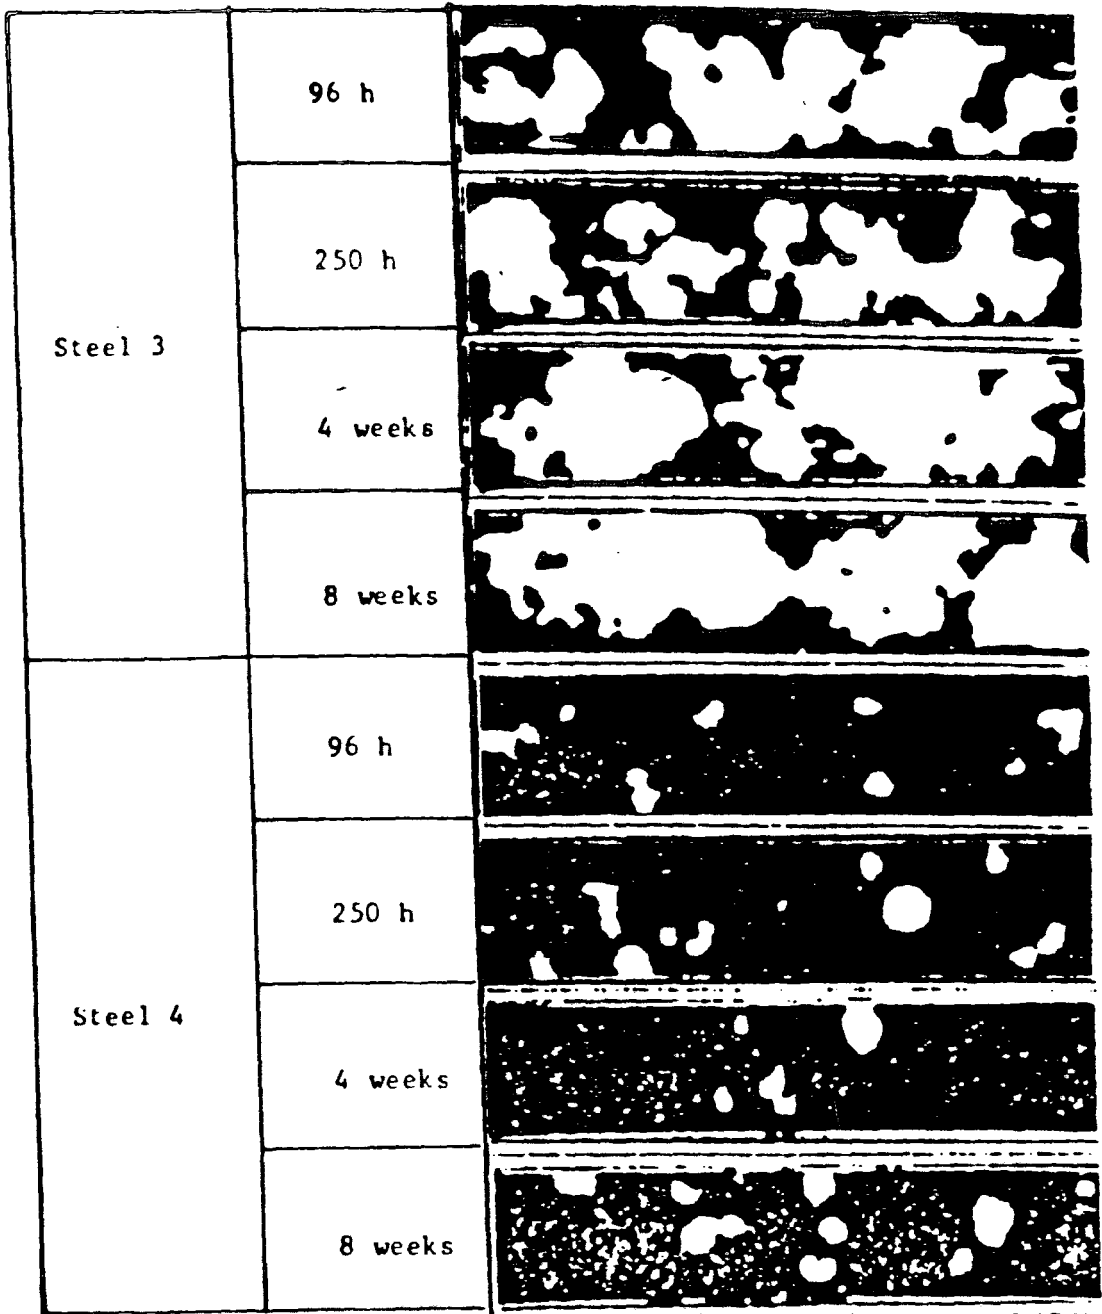
TYPICAL DISPLAY OBTAINED USING ULTRASONIC SCANNING

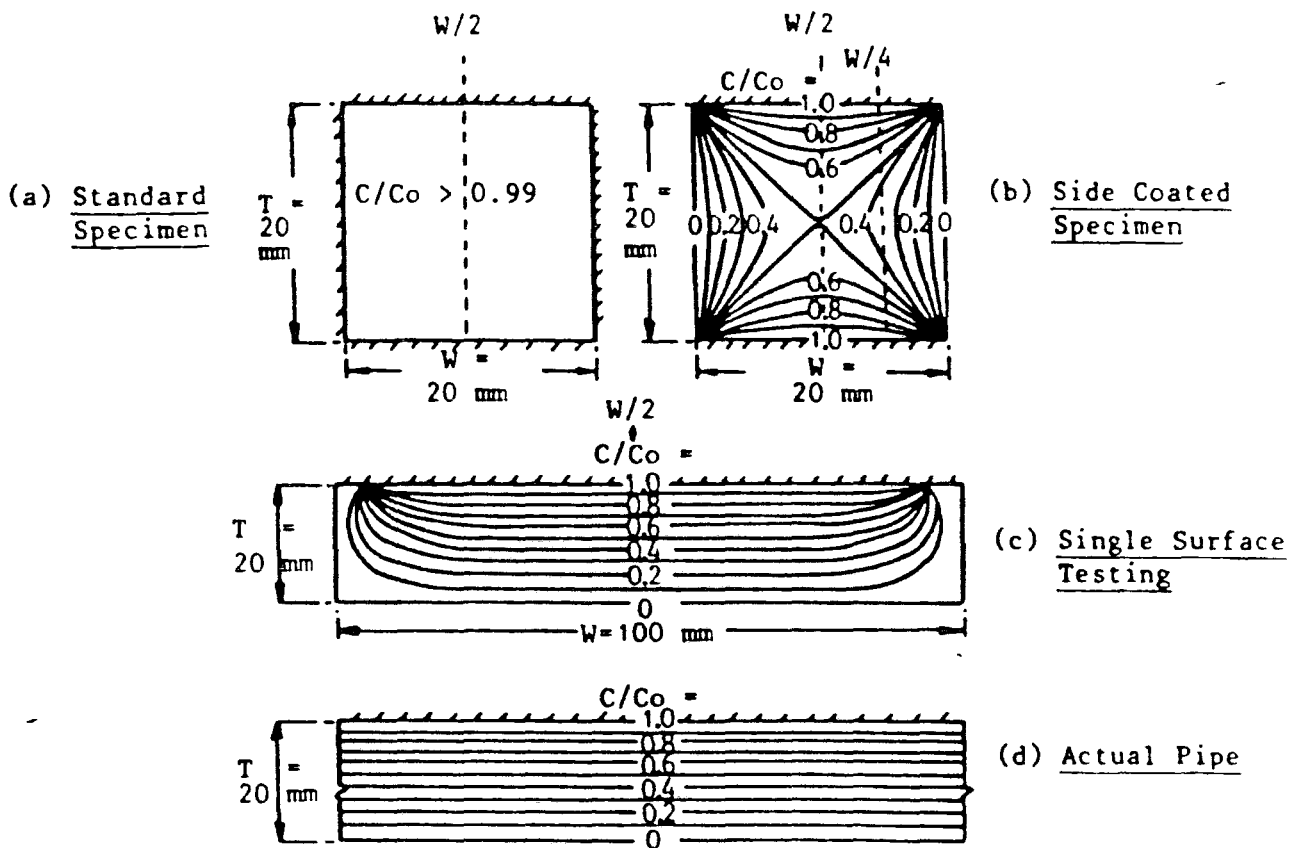
Assumed diffusion coefficient = 3.13×10^{-7} cm²/s
Test duration 96 h

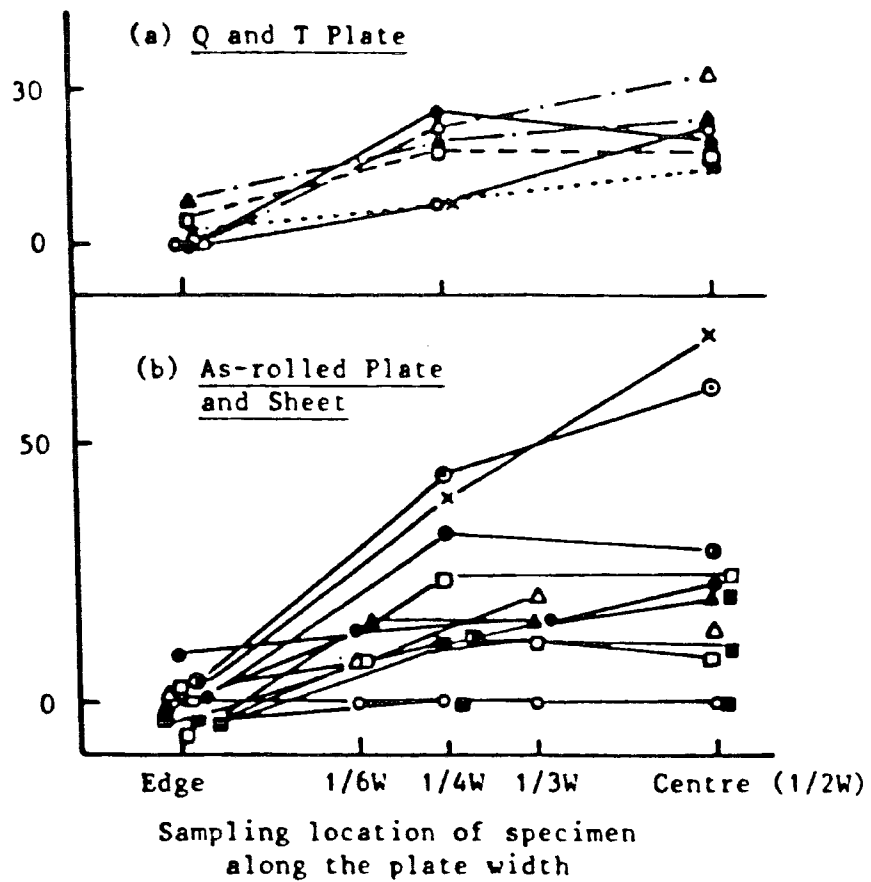
(Symbols refer to different steels)

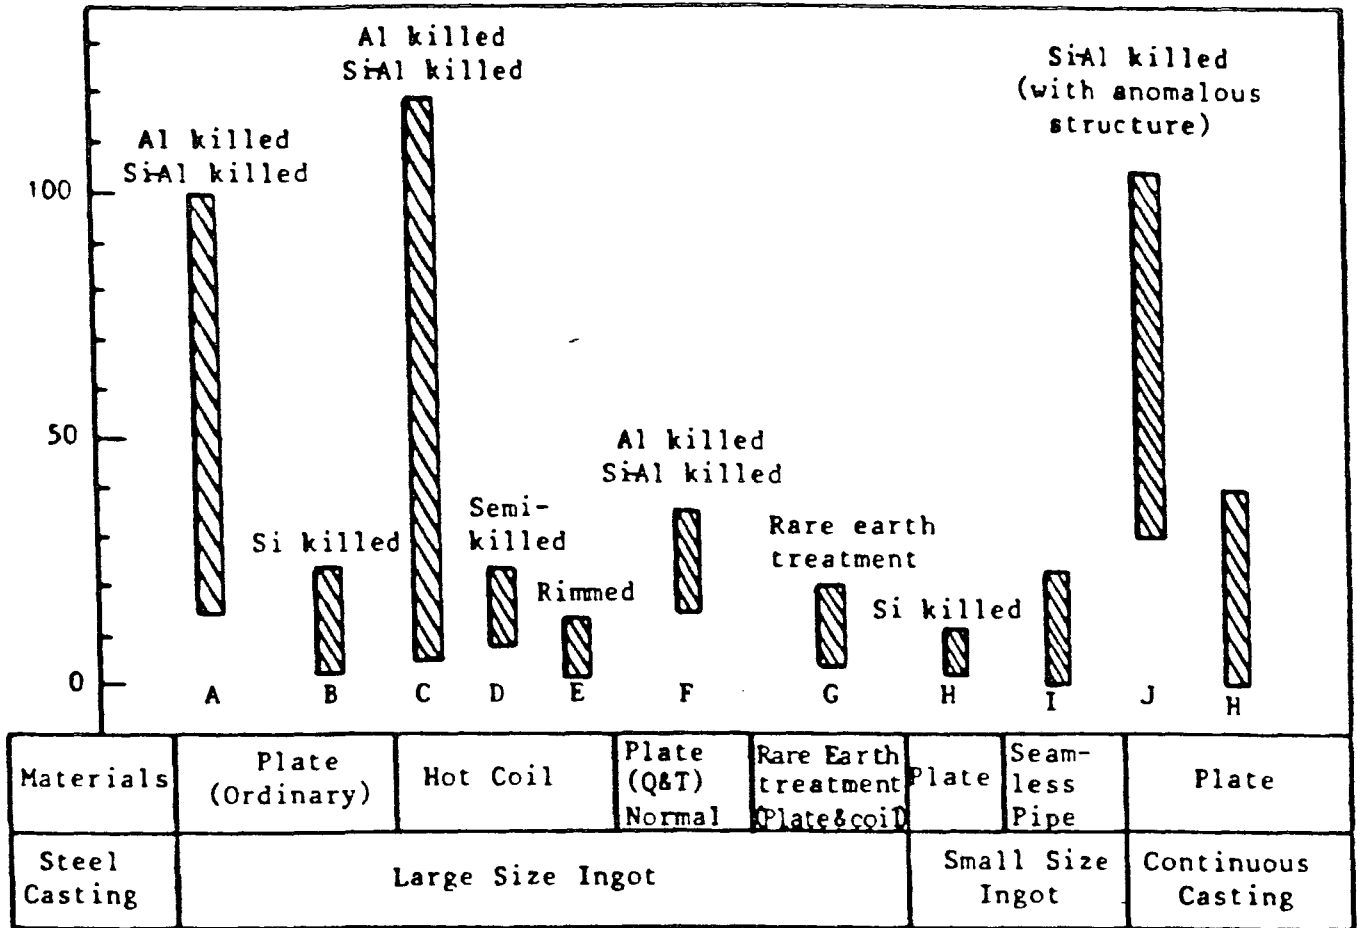
SUMMARY OF HIC SUSCEPTIBILITIES OF
COMMERCIAL HOT ROLLED STEEL MATERIALS
AFTER IKEDA ET AL 23

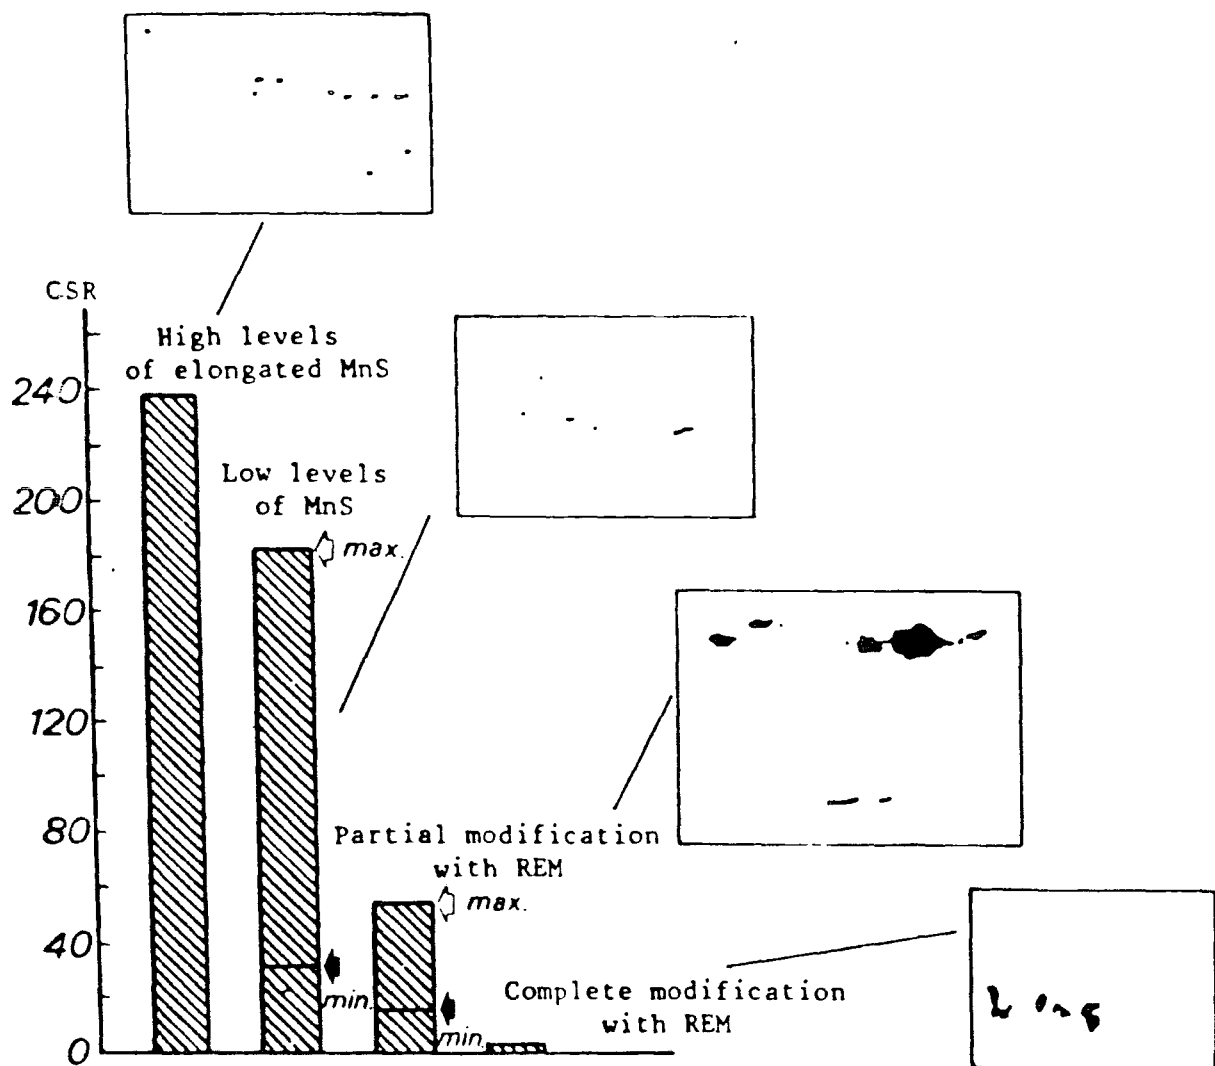
EFFECT OF SULPHIDE INCLUSION SHAPE ON CRACKING BEHAVIOUR
AFTER PARRINI AND De VITO '38

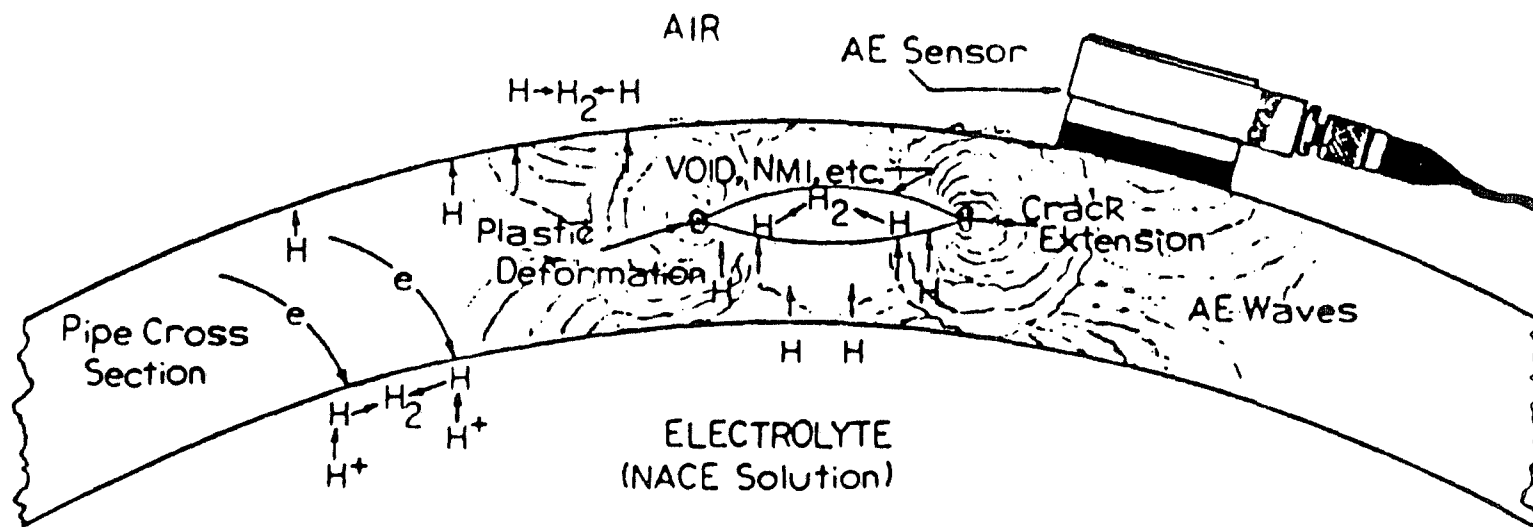
The Mechanism of Sulfide Corrosion Cracking (SCC):

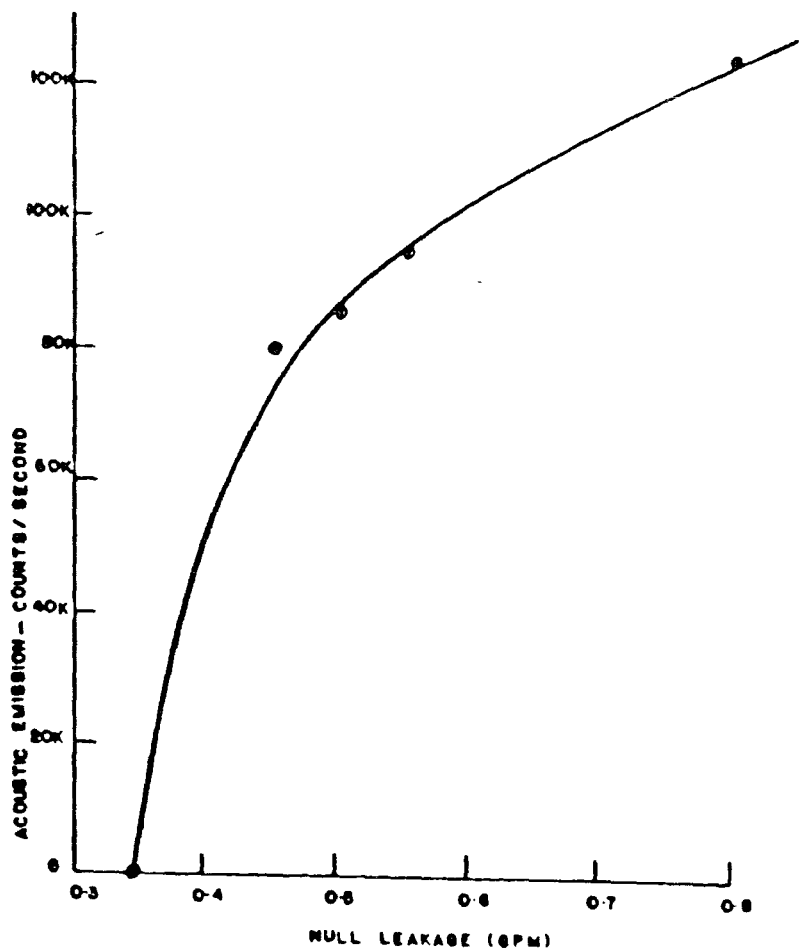
FIG. 23 Acoustic emission versus leak rate.

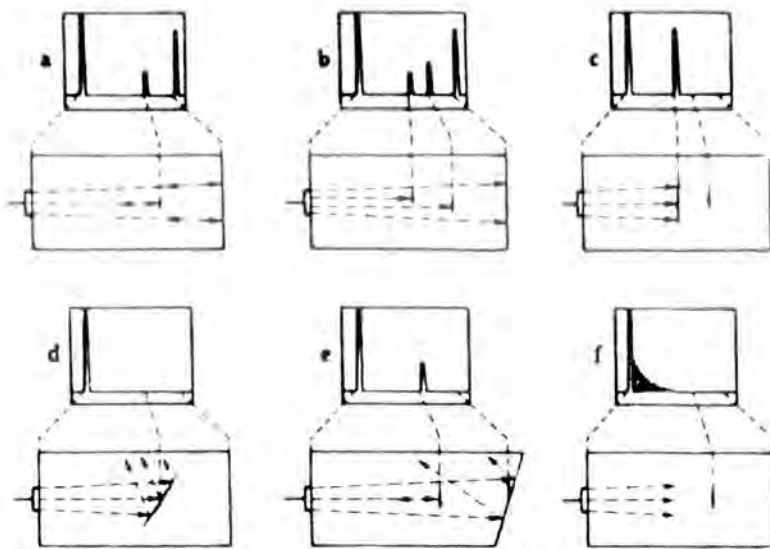
Fig. 24 Schematic screen pictures obtained by the pulse echo method. a) Small flaw in sound beam. b) Two small flaws in sound beam. c) large flaw in sound beam, smaller second flaw and backwall masked. d) large, obliquely orientated flaw, backwall masked. e) small flaw but no backwall echo because the axis of the beam is not incident at right angles on back wall. f) strong attenuation of sound beam due to scattering, no echo from flaw or backwall, only grass.

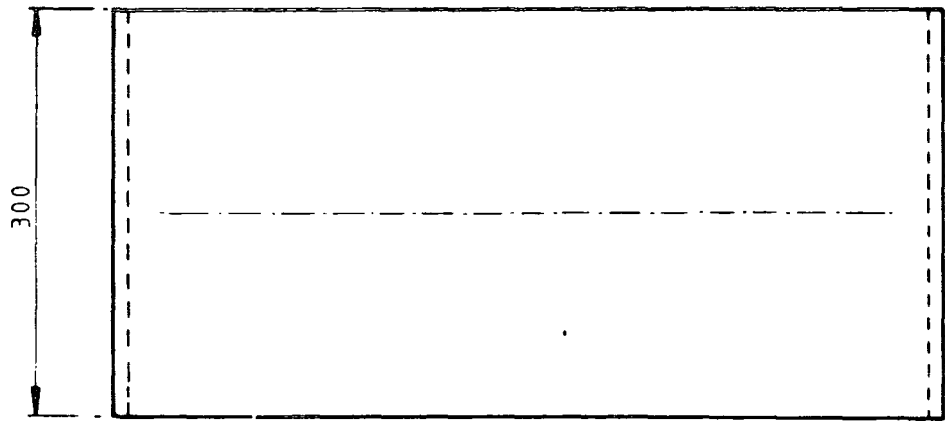
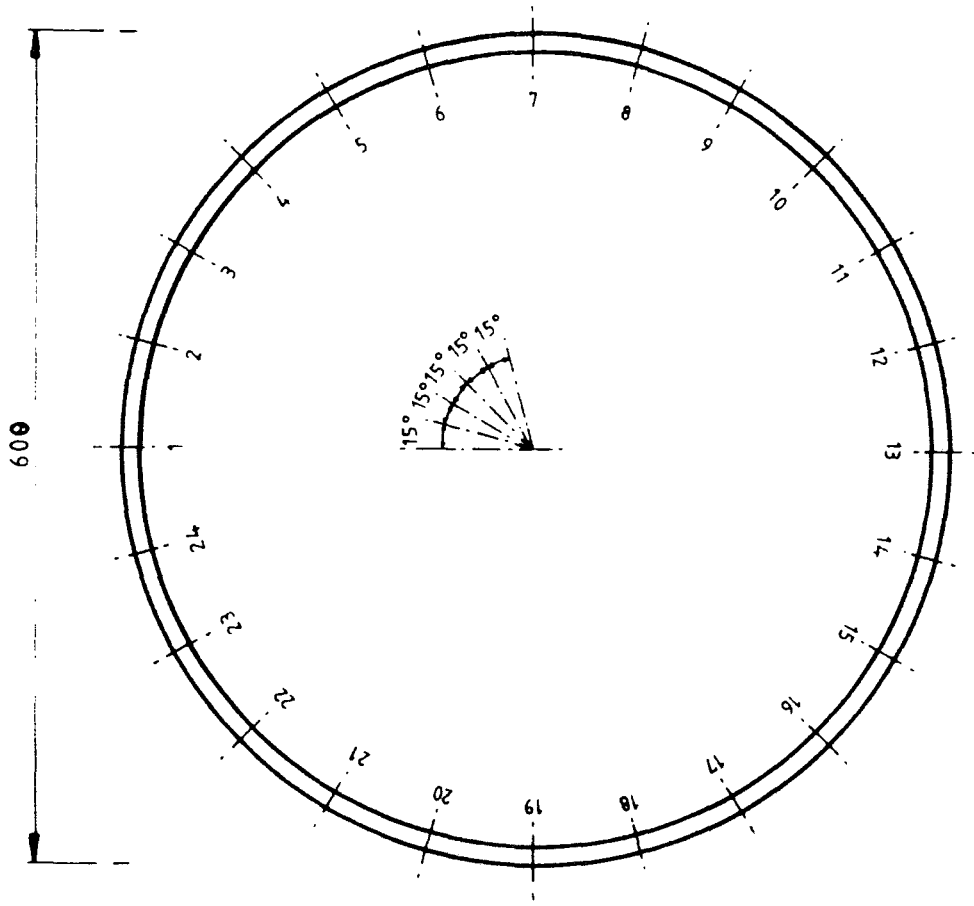
All Defects are Located at the Innerside and on the Centreline as Indicated

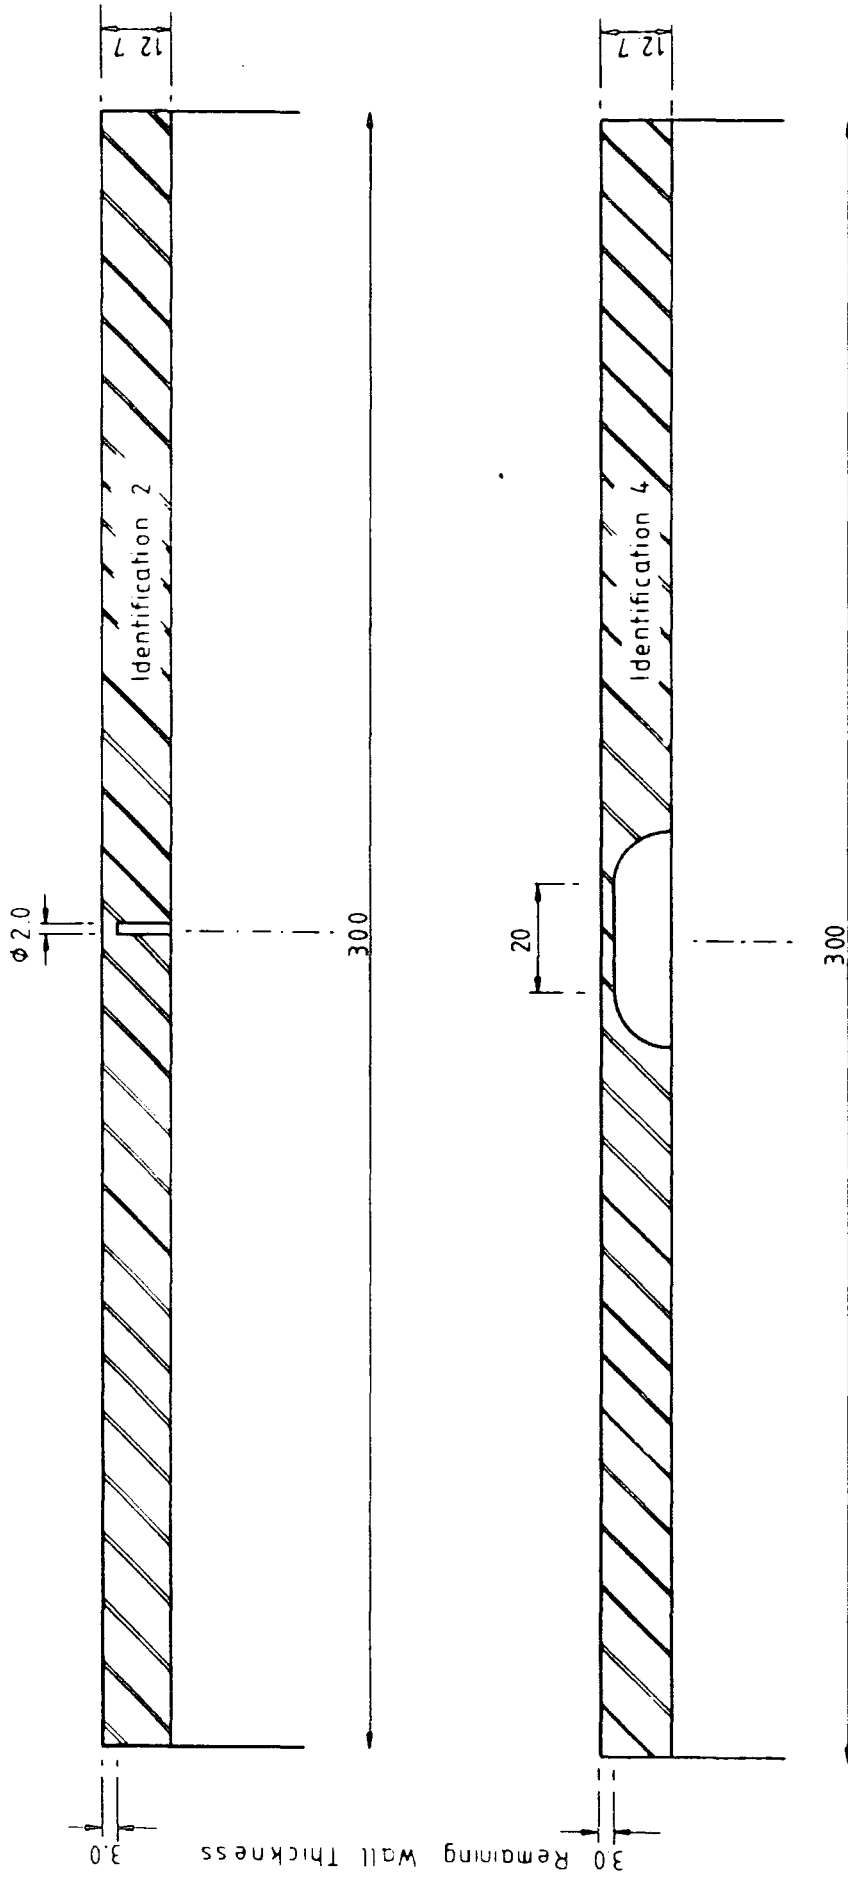
Fig. 4.5: Test Sample with Artificial Defects

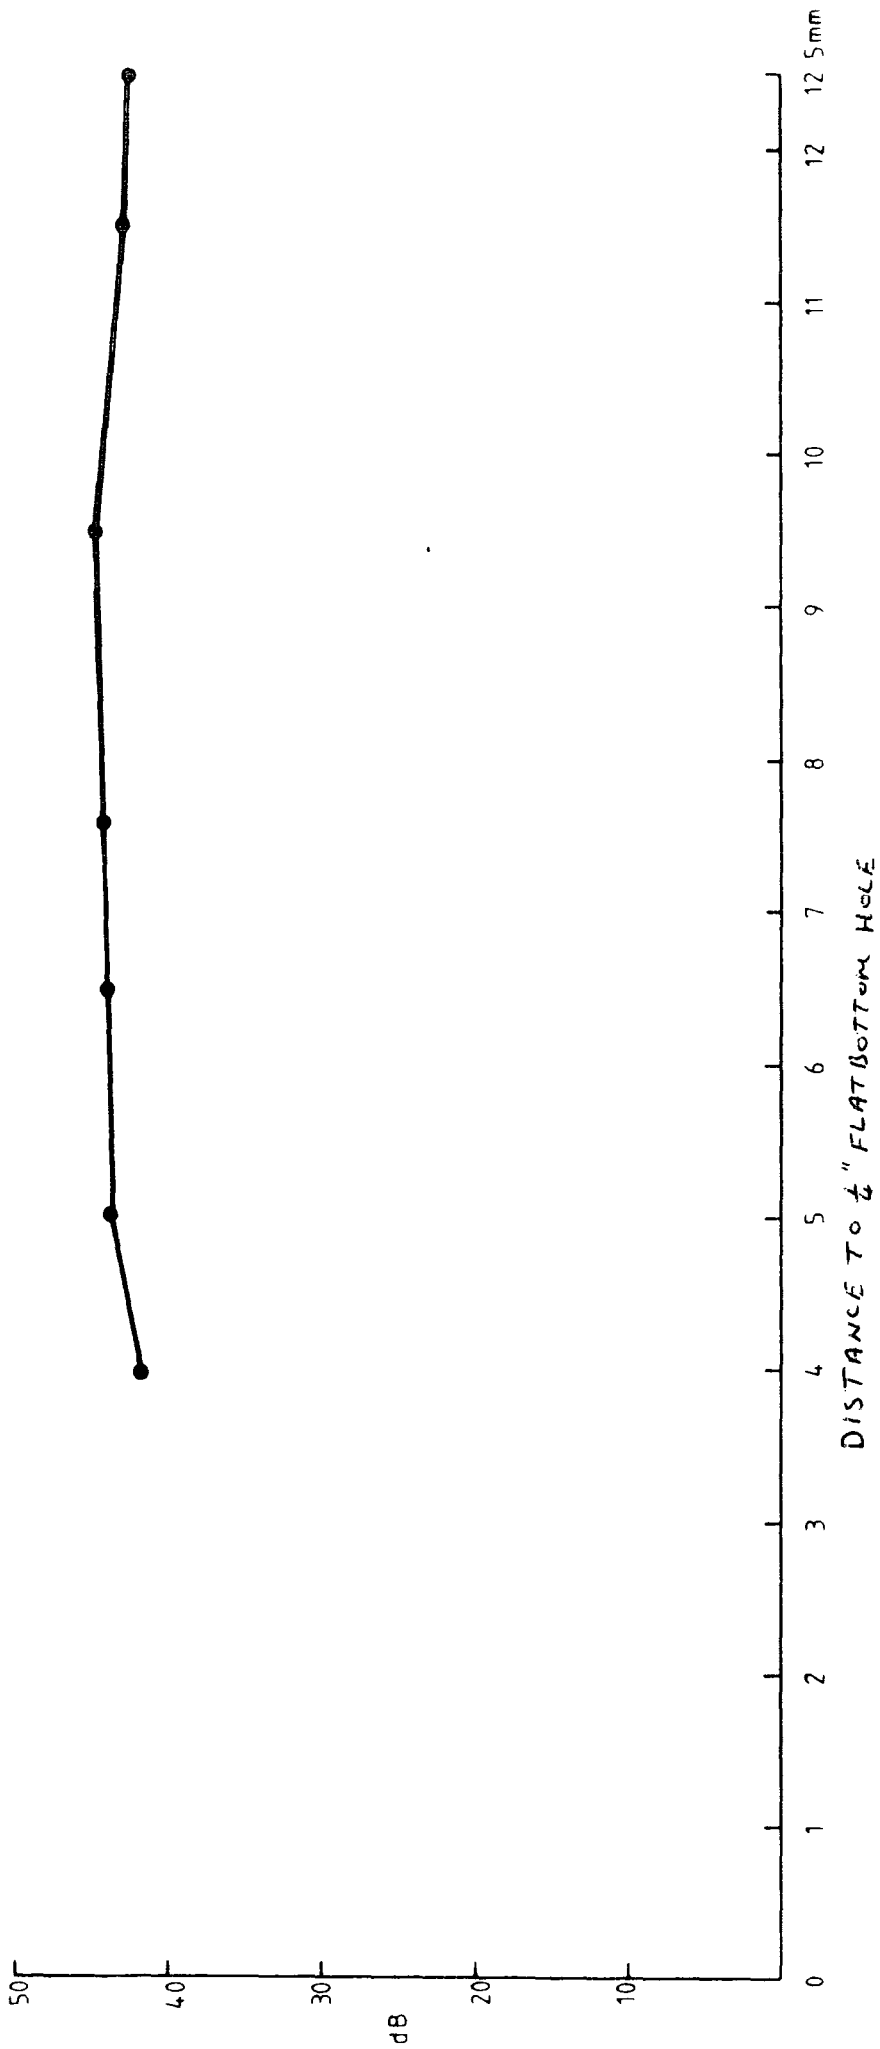
Fig. 63 : Characteristic Curve for the Ultra Image 8MHz Transducer

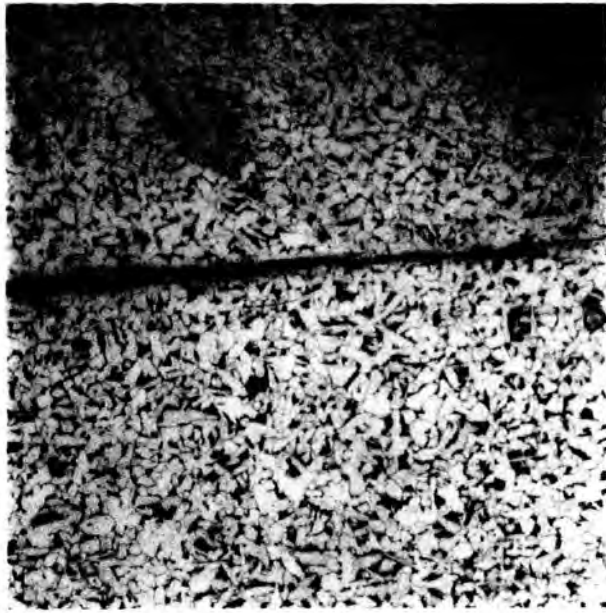
Figure 86
Laminar hydrogen induced crack detected in
area S0 x 100

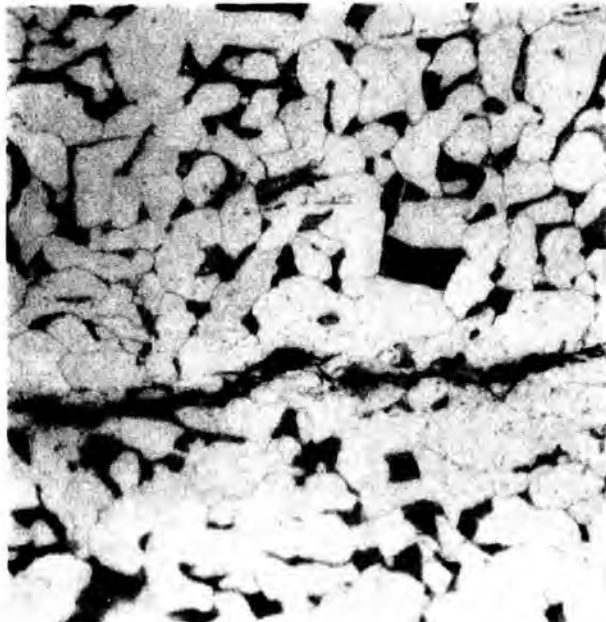
Figure 87
Non metallic inclusions associated with the
crack x 400

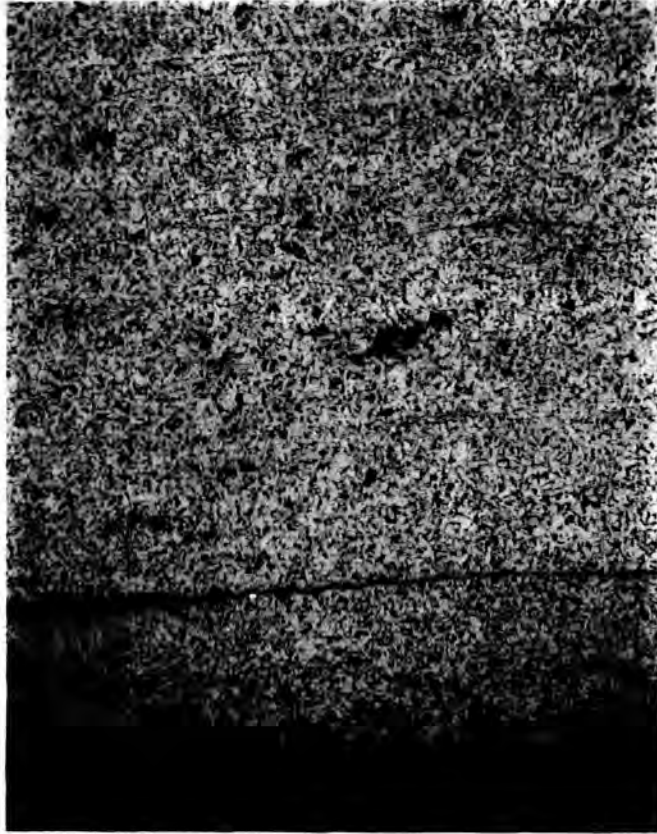
Figure 88
Near surface crack located within 1 mm of the
inner surface. x 10

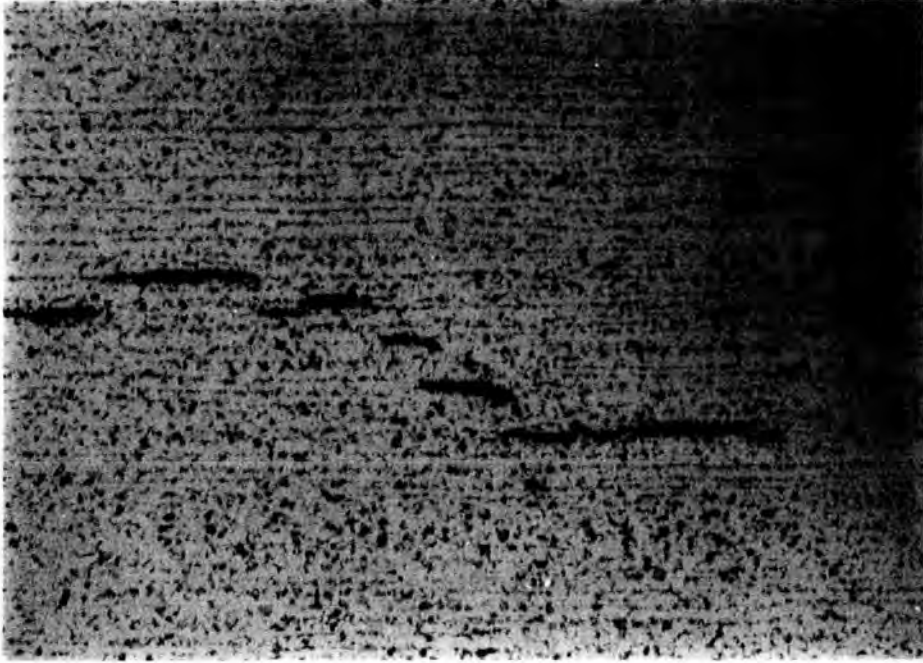
Figure 89
Classical step wise hydrogen induced crack revealed
near to the surface x 100 showing extreme banding.

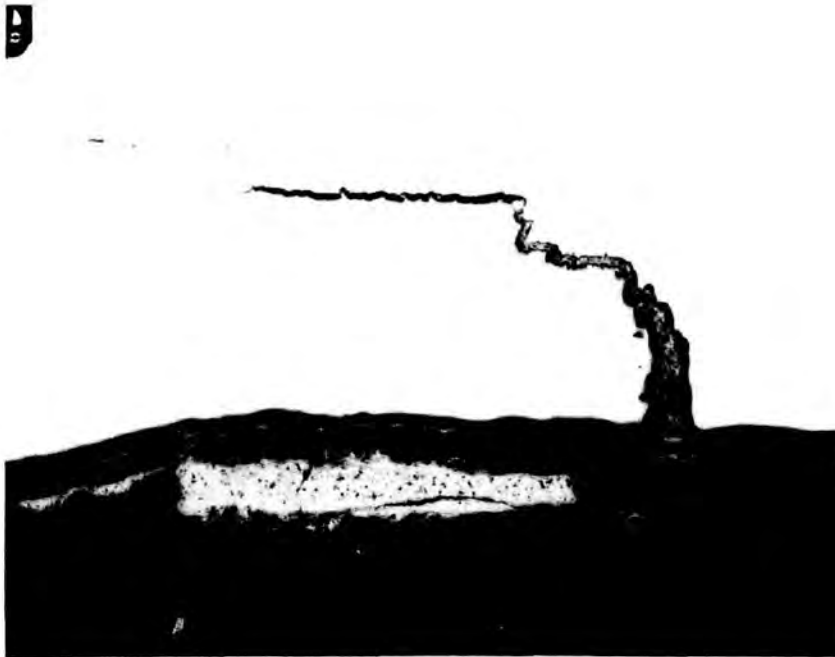
Figure 90
Hydrogen induced crack located in area S1 x 10

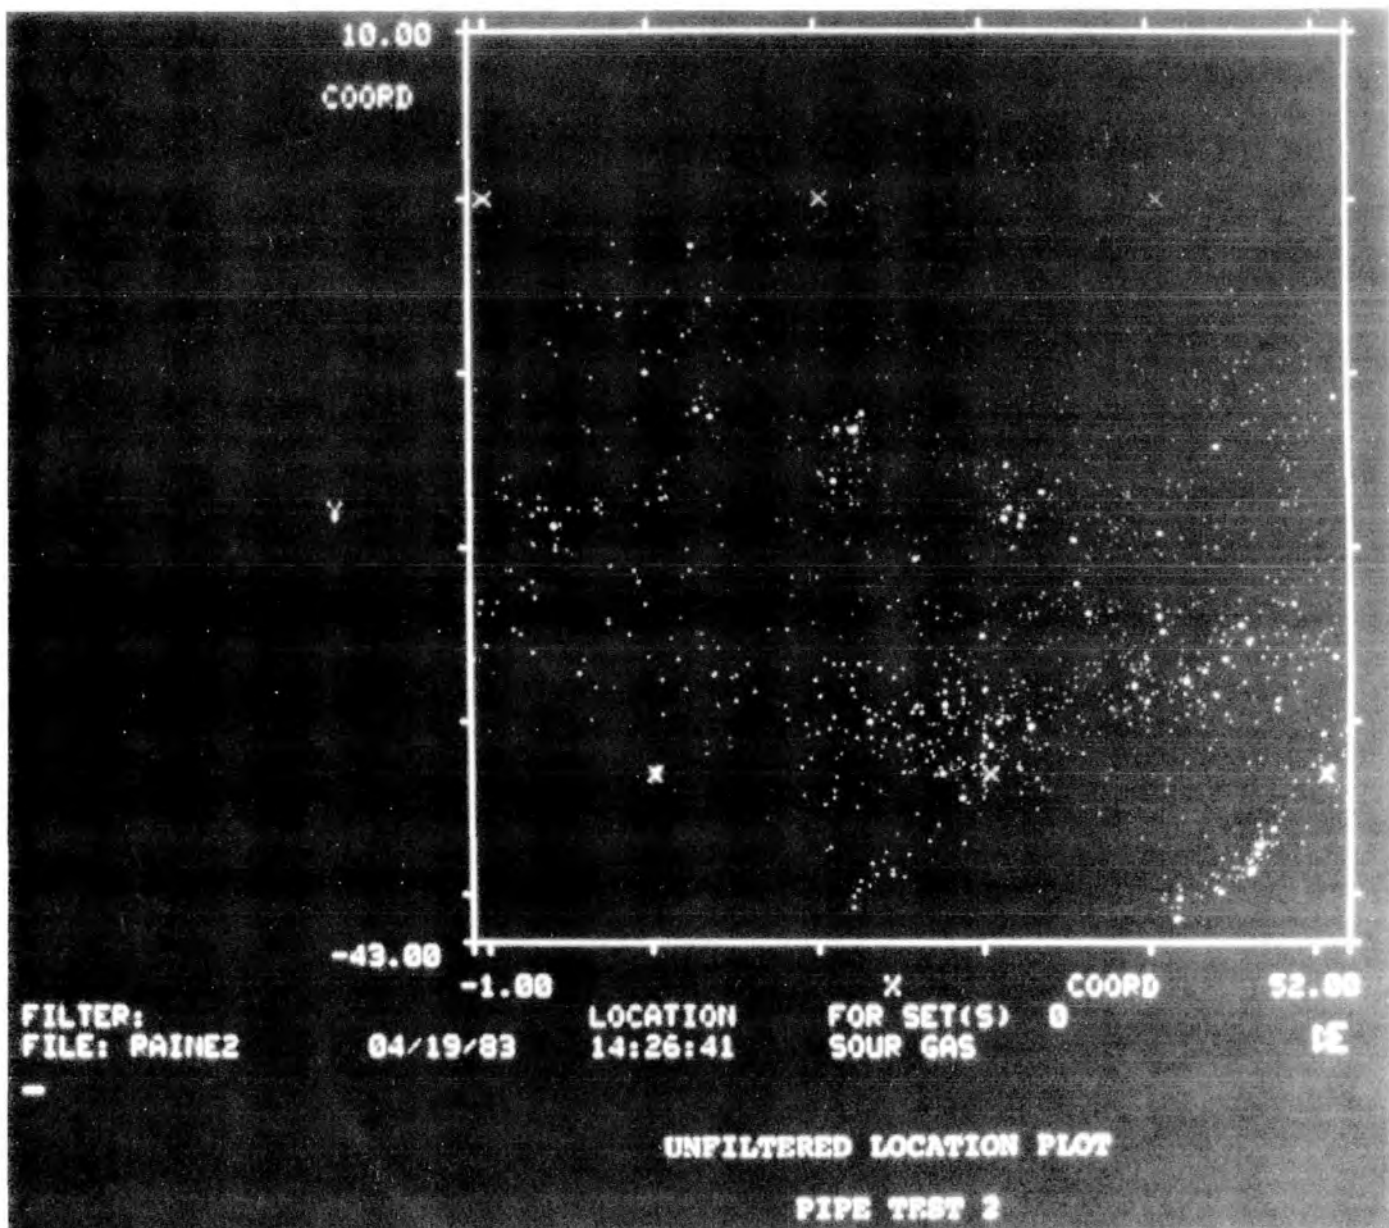
Figure 91
 Multi Triplet Location Plot of Pipe Section 2,
 Unfiltered

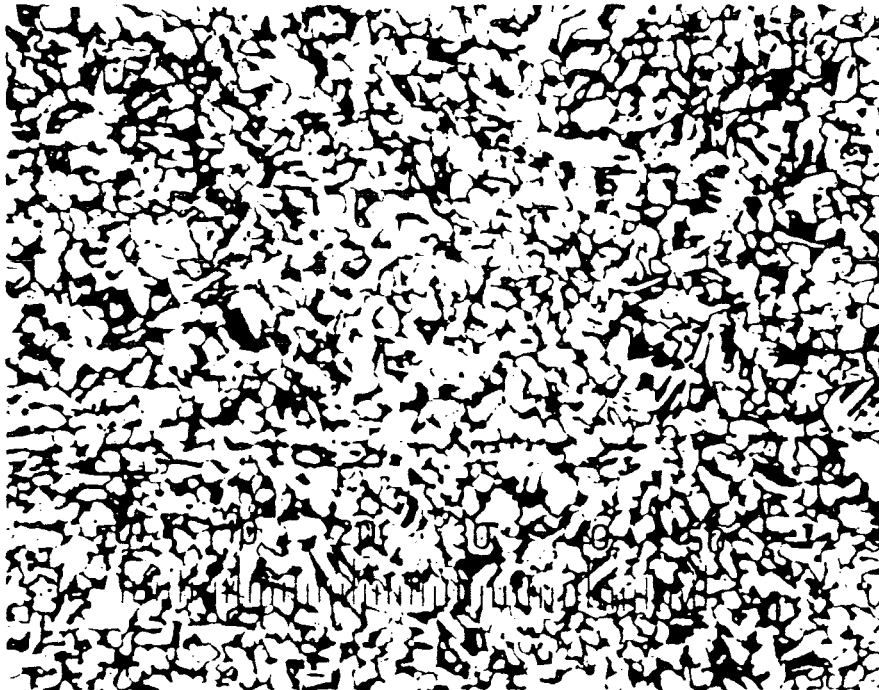
Figure 94 Microphotograph of Banded Microstructure
as Seen in Pipe Test Section 1.

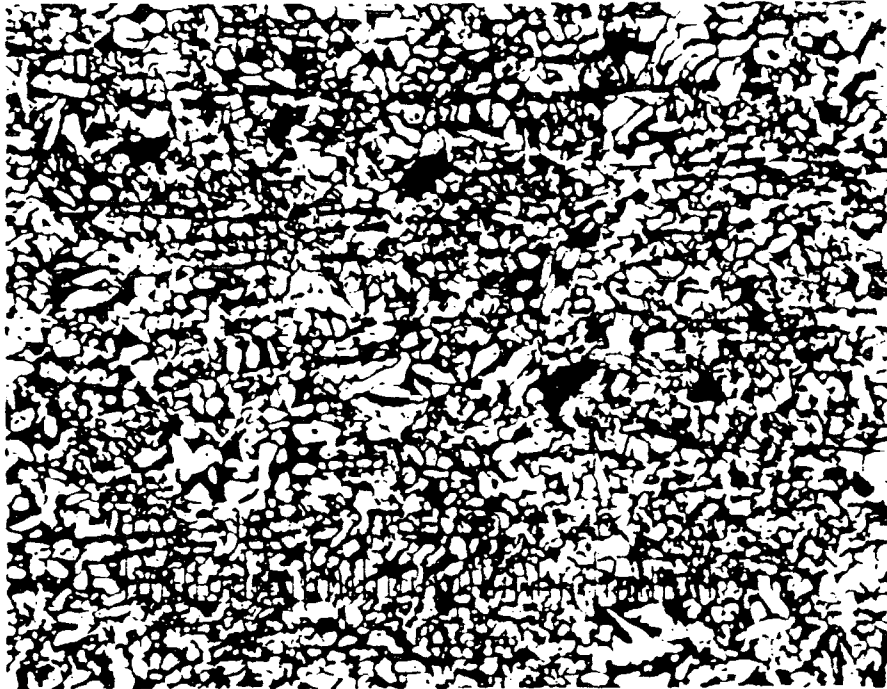
Figure 95 Microphotograph of Banded Microstructure Present in Pipe Test Section 2. Although the Banded Microstructure Was Present, the Elongated, Stringer-Like Inclusions Were Not
150x, 2% Nital.

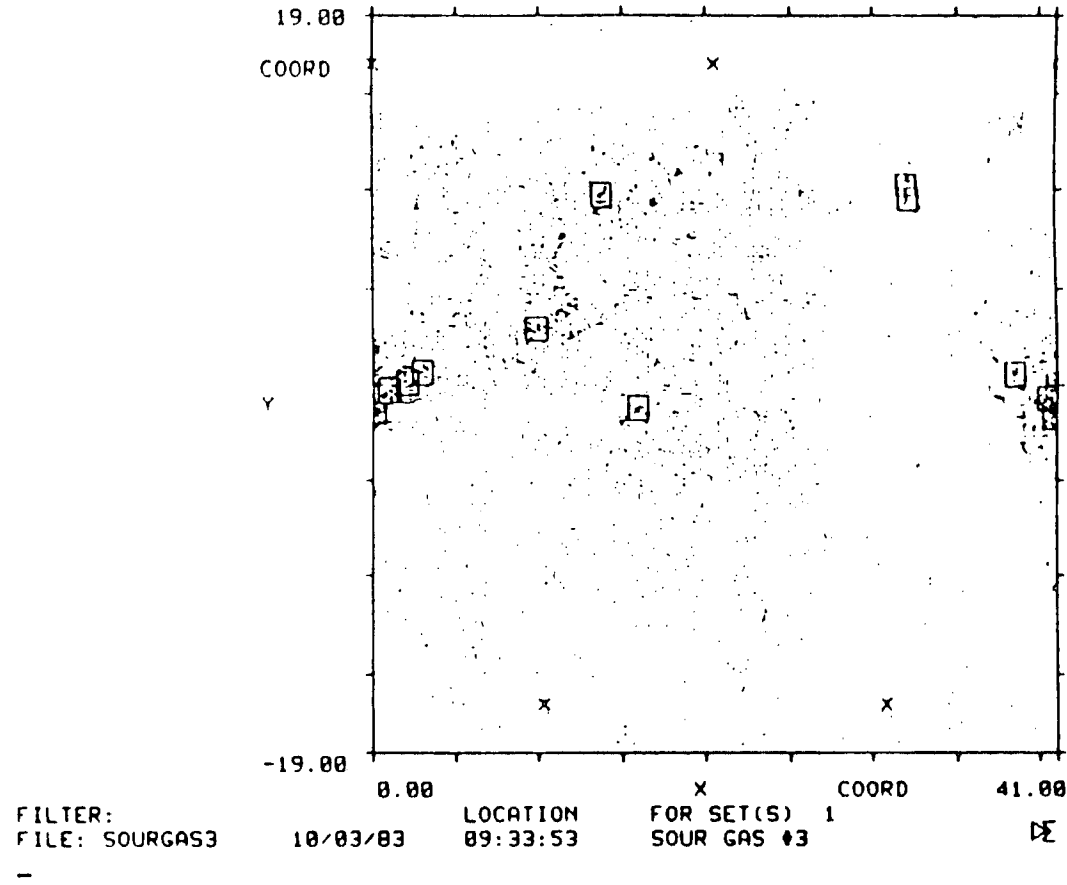
Figure 96 Cylindrical Location Plot of Pipe Test Section 3, Unfiltered. (Dimensions: Inches)

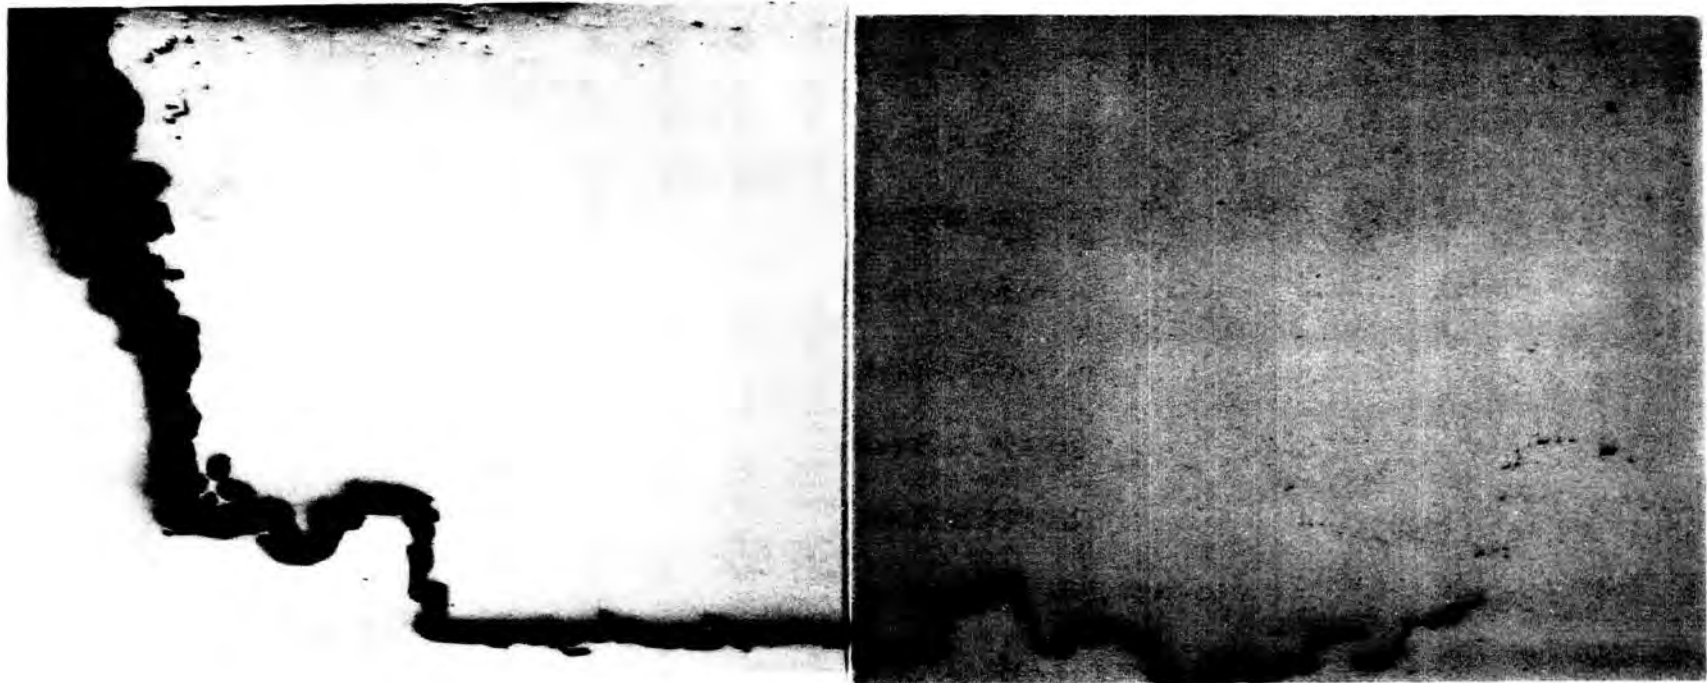
Figure 103
Micrograph of near surface defect located near to the
inner wall of the pipe x 100.
