Durham E-Theses

*The detection of hydrogen induced cracking in welded
and seamless steel pipes using acoustic emission and
ultrasonic techniques*

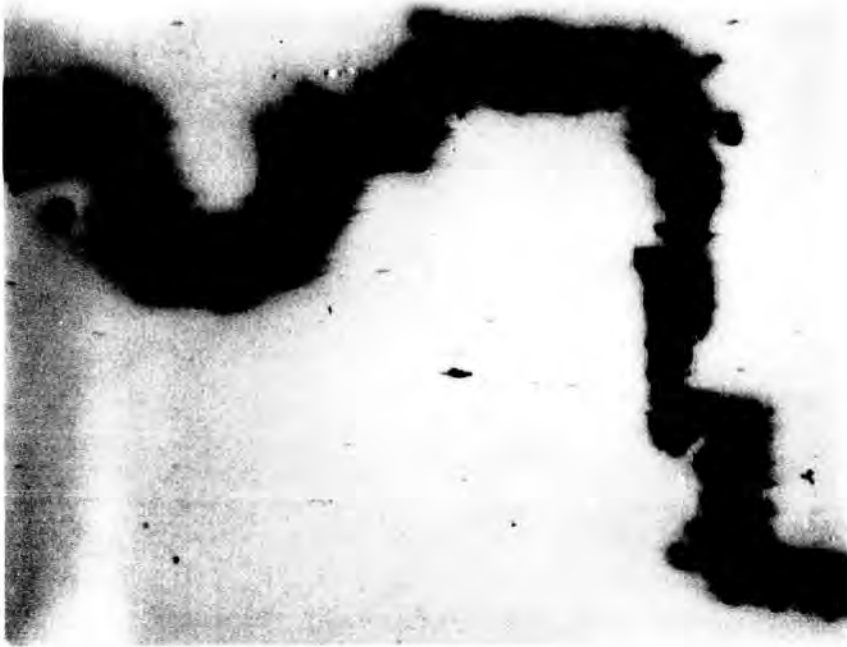
Figure 104
Non metallic inclusions associated with the step wise
section of the crack x 200.

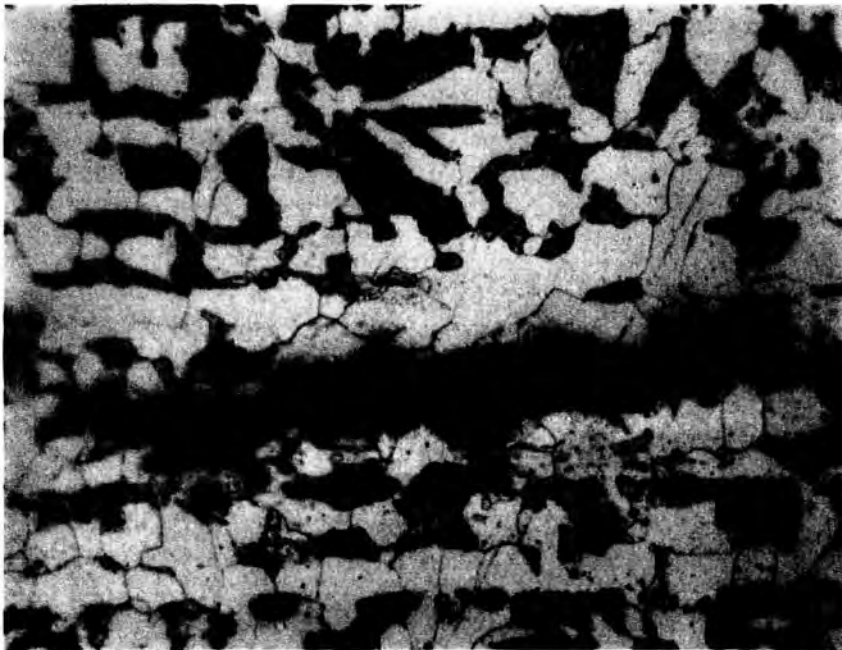
Figure 105
Fine cracking revealed of the extremity of
the crack x 500

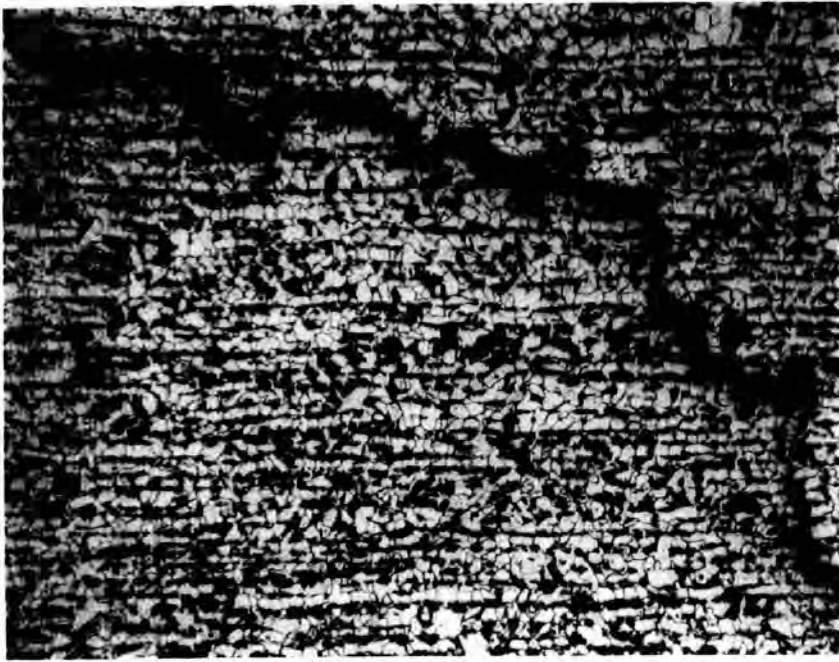
Figure 106
Metallographic section of pipe section 3 showing
extent of banding x 200

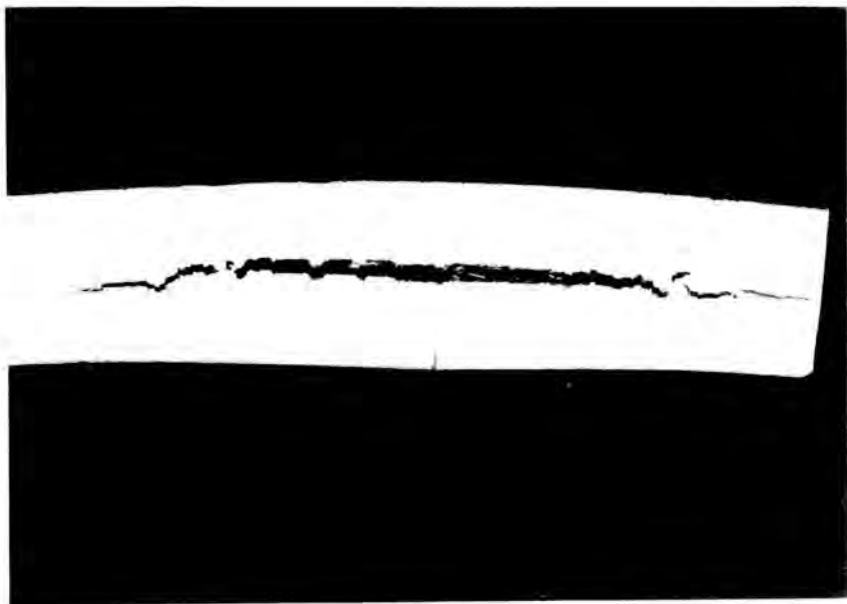
Figure 121
Delamination of the pipe wall and stress corrosion
cracking detected in the pipe section 4.
