Durham E-Theses

Luminescence Dating of Medieval and Early Modern Brickwork

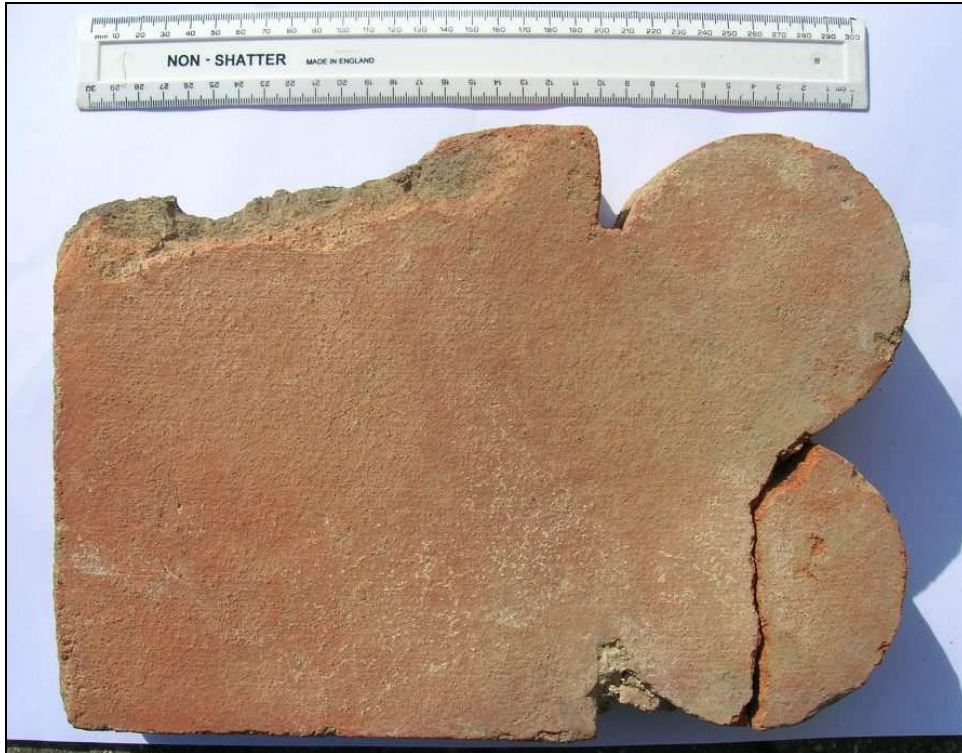
Fig. 2.2: Example of a moulded brick form used at Coggeshall Abbey (Pat Ryan, 2007).

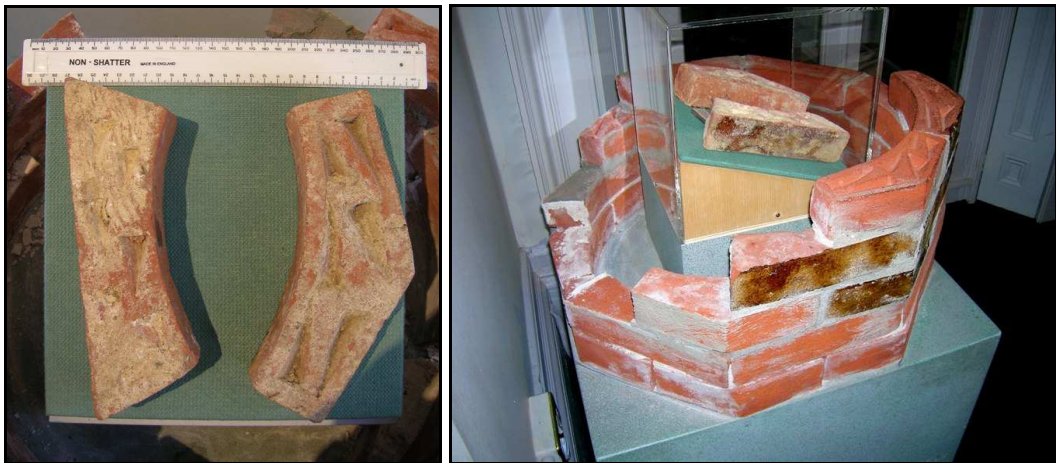
Fig. 2.14: Medieval chimney bricks. The left image shows the two different forms of brick needed to produce a chimney (the left brick is a ‘Type B’ brick whilst the right brick is a ‘Type A’ brick. Note the keying holes in the Type A brick). The image on the right demonstrates how alternating courses of the two types of brick produce a cylindrical shaft with an octagonal exterior.

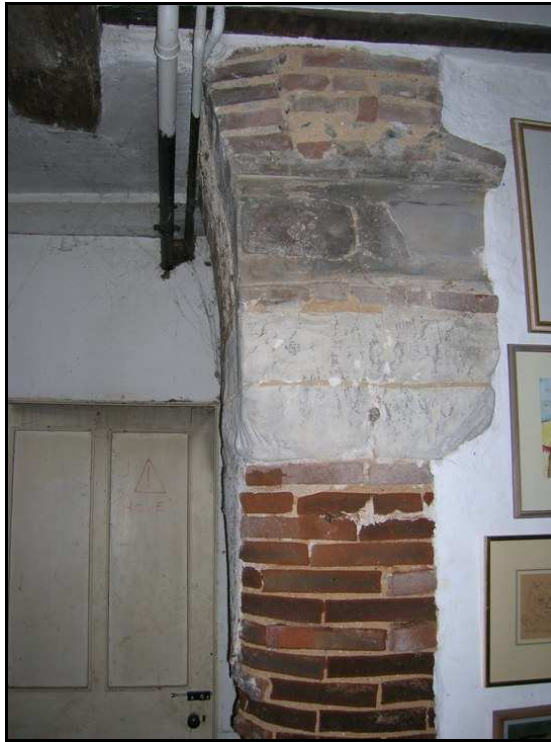
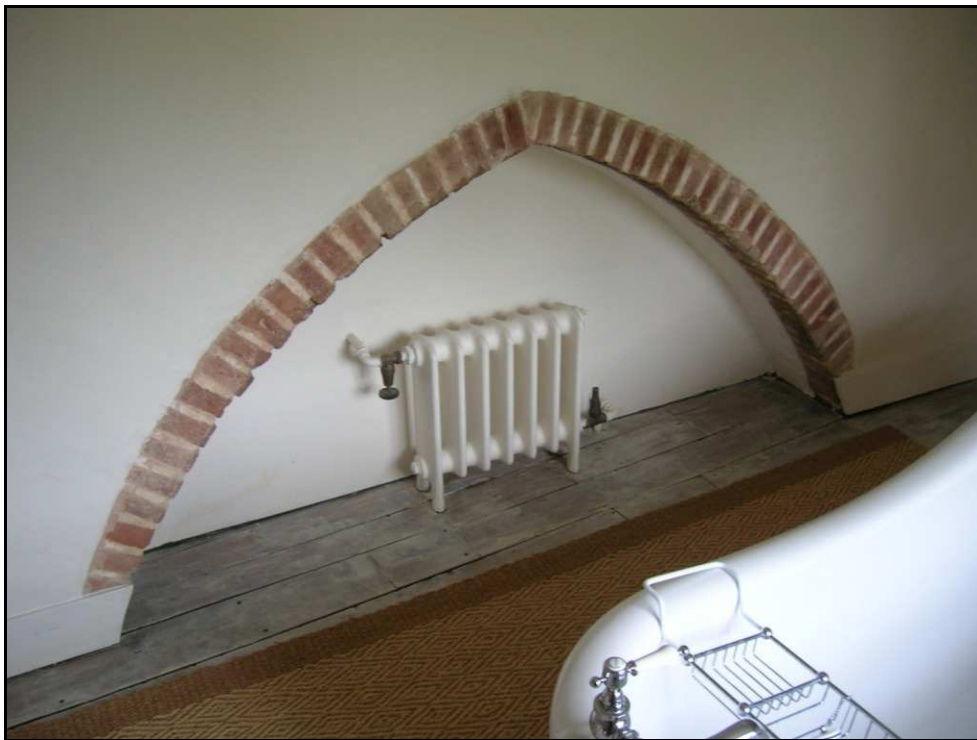
Fig. 3.8: The top image shows the Infirmary column with scalloped capital, now highly worn. The springing for the lancet arch can be seen above the capital whilst the crown of the arch is seen in the bottom image.

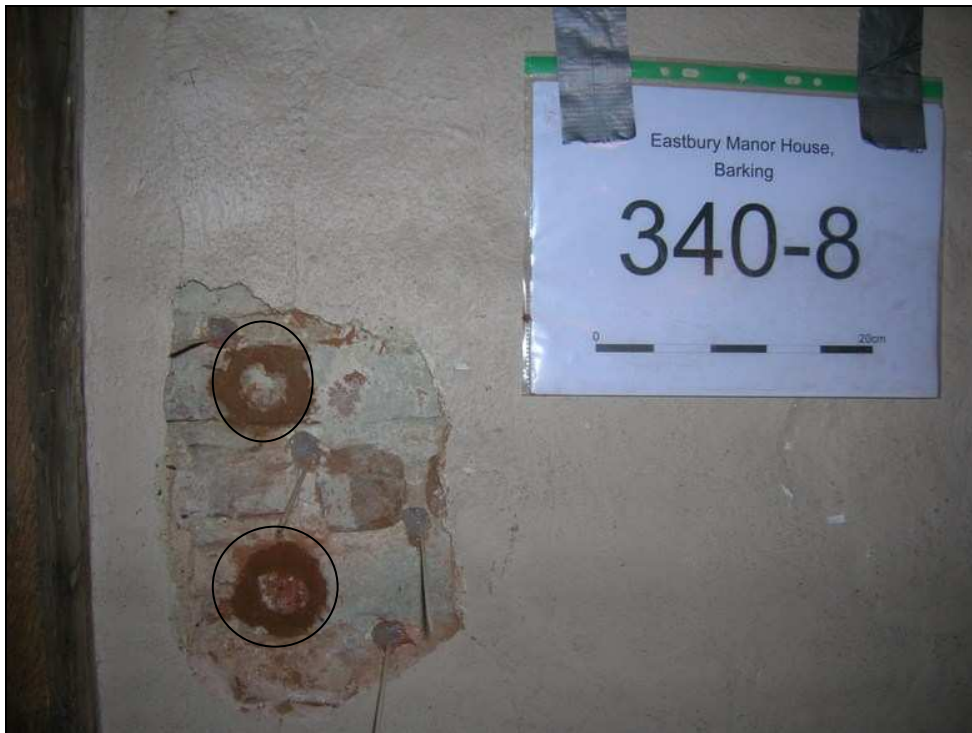
Fig. 3.22: The south western corner of the attic space where two samples were collected. The sample points have been circled. The scale bar is 20 cm in length. The image shows the wet mortar repair work shortly after sampling had taken place.

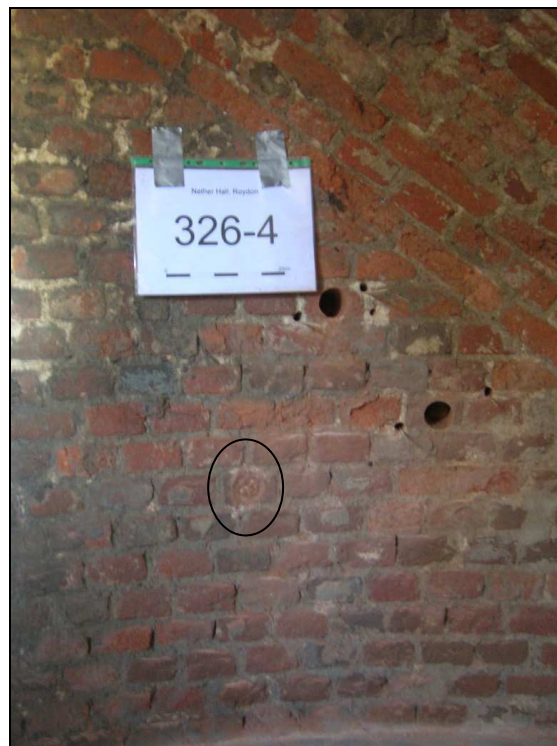
Fig. 3.48: The sampling points at the base of the brick newel stair. Note the change in the bonding pattern in the top right corner of the image. This change signifies the springing of the spiralling barrel vault upon which the lower part of the staircase sits. The scale in the image is 20 cm in length. There are three sampling points, two of which are shown open. The other sampling point is circled. This point was repaired and allowed to dry over the course of several months, illustrating the aesthetic effectiveness of the repair work undertaken.

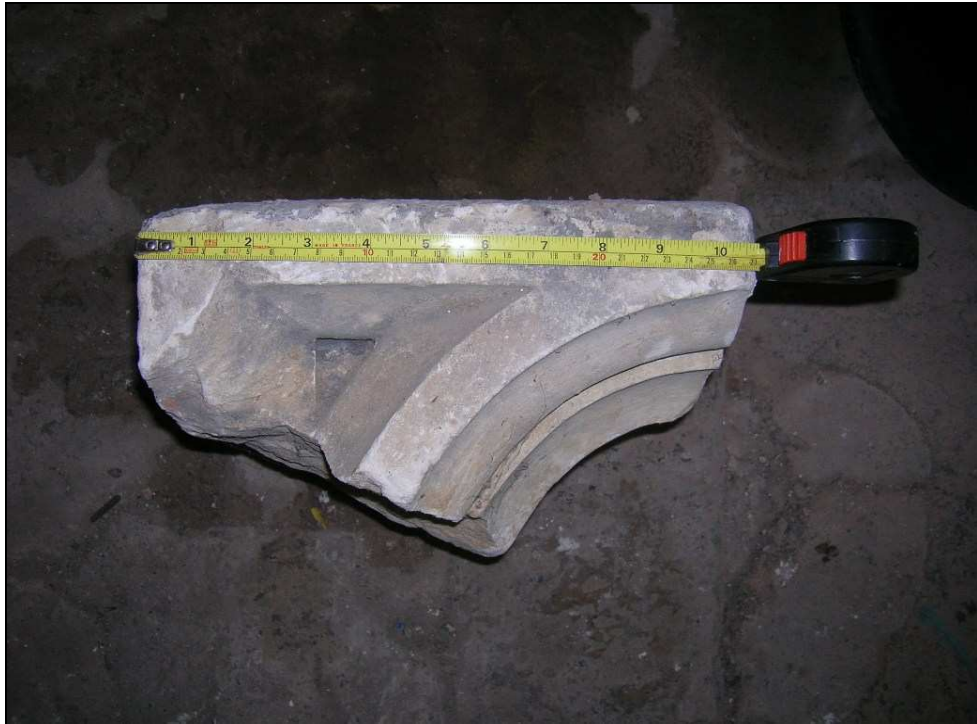
Fig. 3.59: Part of a window spandrel that had been re-used as a flag in the cellar floor. The top image shows the ogee and quarter circle moulding beneath the spandrel whilst the bottom image shows the cross sectional profile.

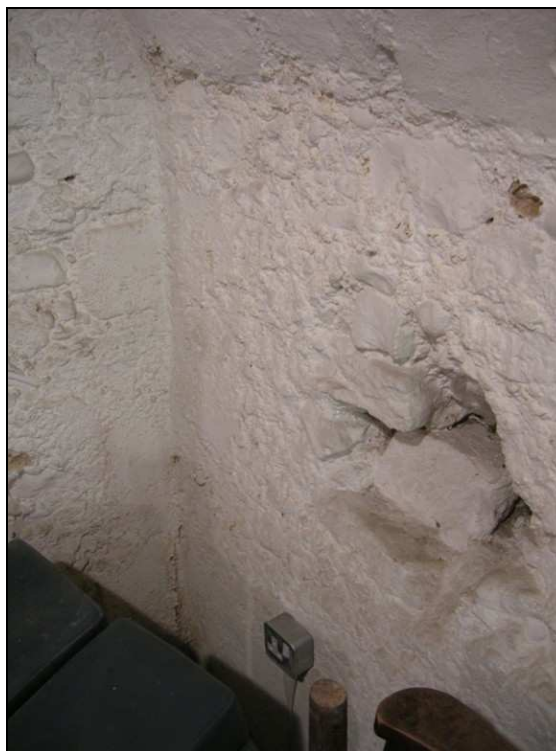
Fig. 3.95: Blocked indent at the eastern end of the southern wall of the sunken chamber. This feature might have been a piscina originally intended to serve an altar located at the east end of the chamber.

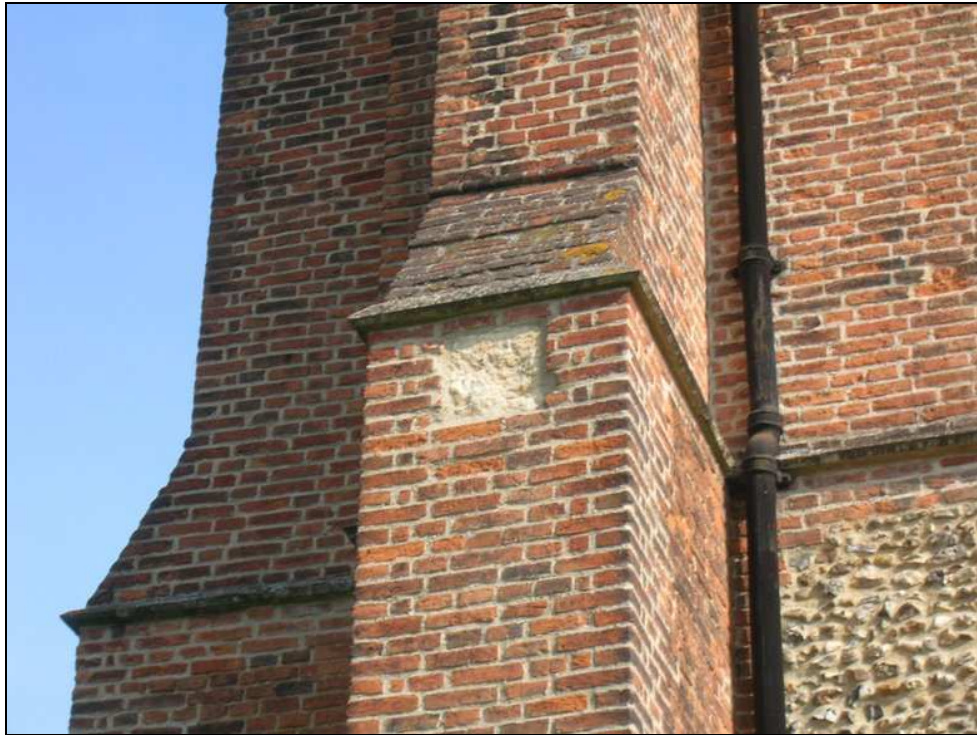
Fig. 3.100: Stone inset into the brick buttress on the southern face of the tower at the top of the first stage. Antiquarian accounts record that the Mildmay family arms and the date 1586 were originally inscribed in the stone.

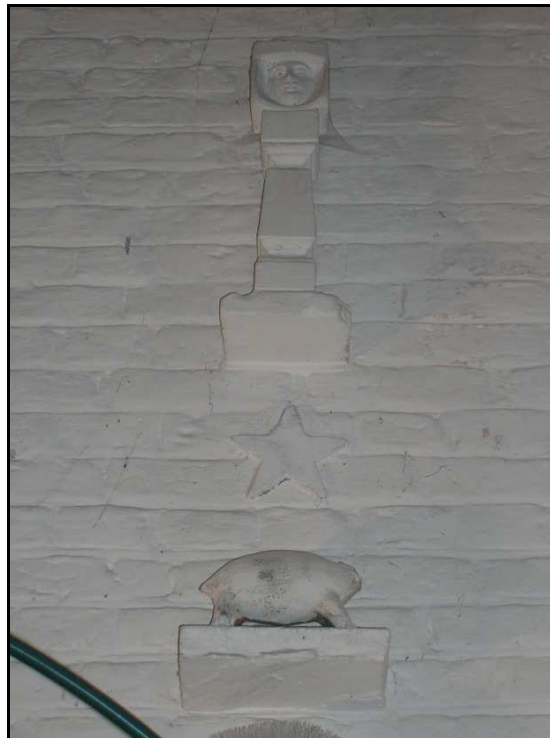
Fig. 3.112: Decorative fittings inside the church tower, probably added by Margaret Anna Brett. The lower two (the five pointed star and the headless boar) are emblems of the de Vere family.

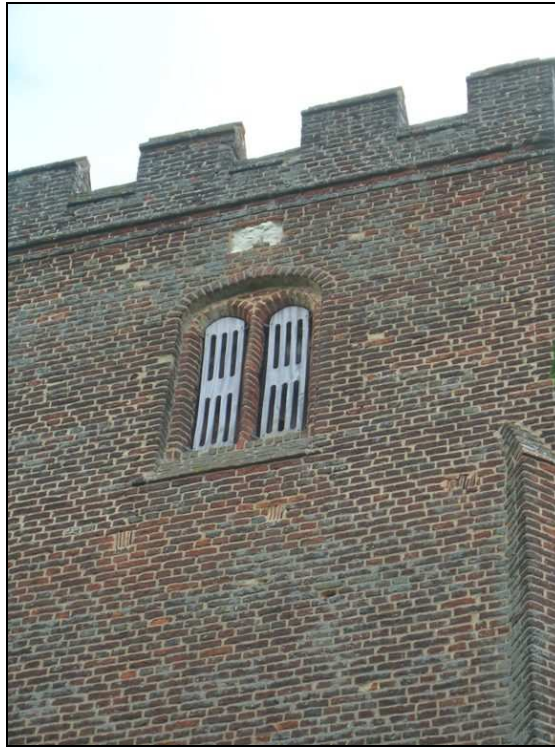
Fig. 3.114: The western face of the third stage of the tower. Note the weathered stone panel set immediately above the belfry window.

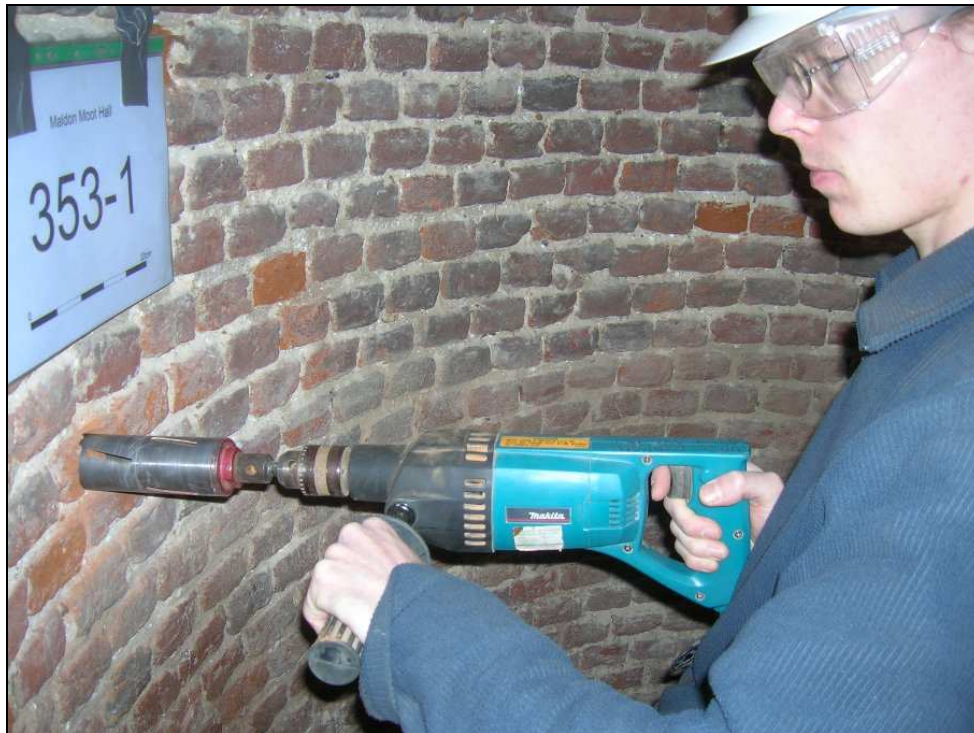
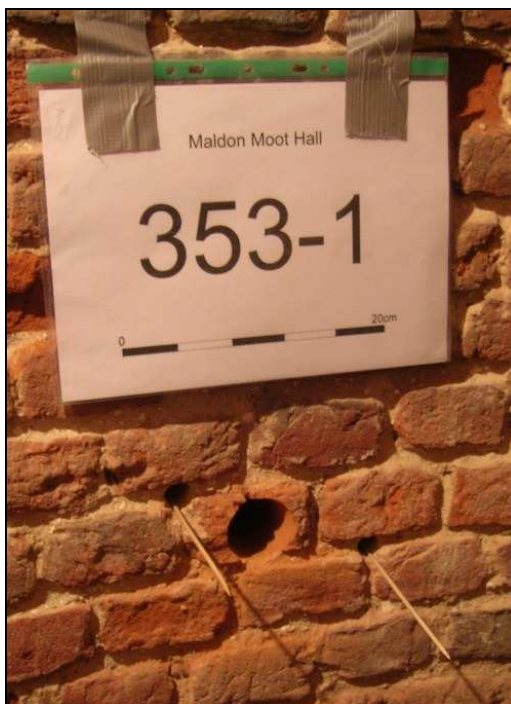
Fig. 4.4: Images illustrating the different stages in collecting a sample. The top image shows the brick selected for sampling being sampled with the electric core drill. The bottom left image shows the resulting hole after the core had been removed and the smaller holes in the mortar into which dose capsules have been inserted (the sticks to which the capsules are attached protrude from the wall face). The bottom right image shows the repair work done to the brick (circled) after sampling had been completed (the protruding parts of the dose capsule sticks were snapped off to prevent further disturbance to the capsules). The scale in the images is 20 cm in length.

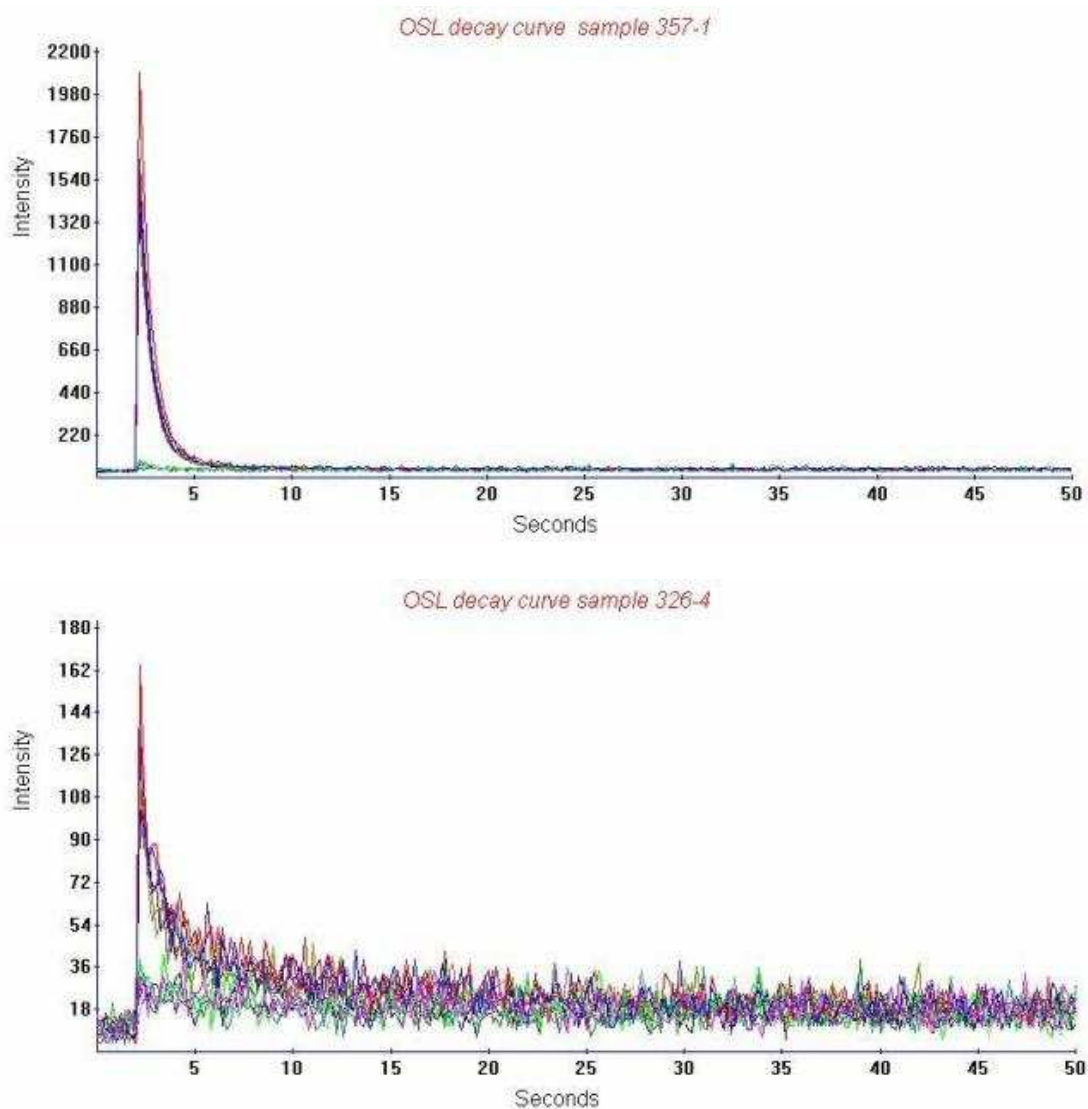
Fig. 4.7: OSL decay curves for two different samples. The top curve was for quartz extracted from sample 357-1 (Bradwell-juxta-Coggeshall) whilst the bottom curve was for quartz extracted from sample 326-4 (Nether Hall). Note the difference in the scale of signal intensity between the samples.

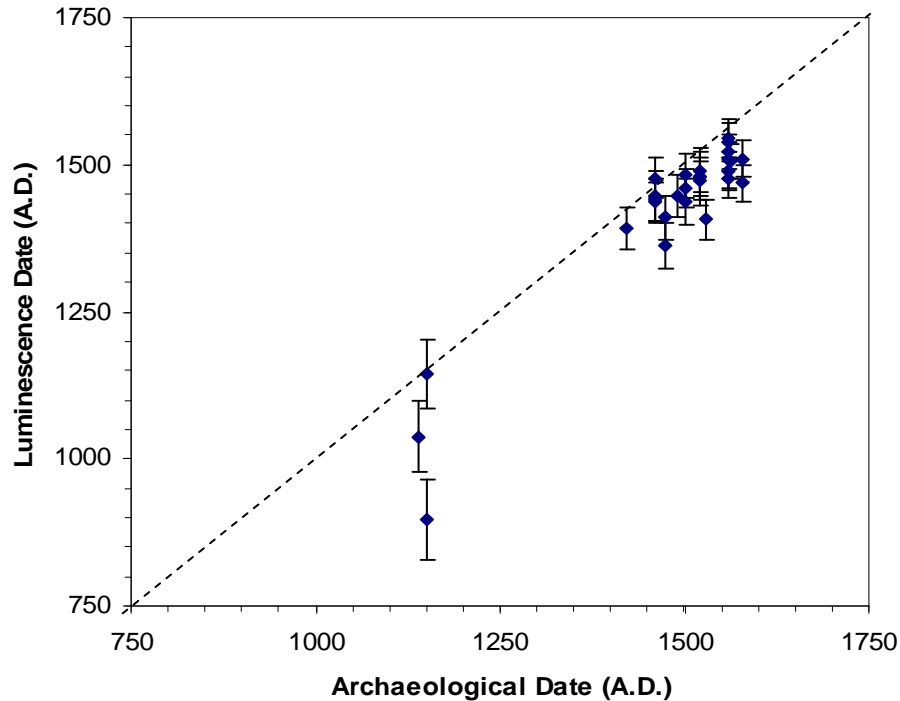
Fig. 4.12: Plot of the luminescence dates against the archaeological dates assigned for the sampled buildings. The error bars relate to the σ_B errors associated with the luminescence dates.

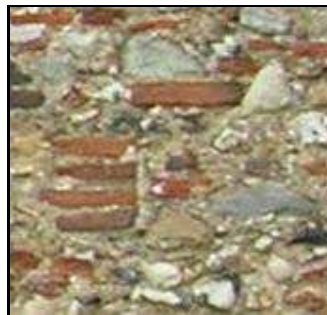
Fig. 6.1: Fairstead church chancel. The current chancel end is thought to have been extended in the 13th century, possibly replacing an earlier structure. The quoins that identify the eastern extent of the earlier structure are preserved in the wall fabric and are circled in the main image. Coggleshall type brick occurs randomly among the flint rubble walling of the 13th century square eastern end, an example of which is shown in the bottom image where Coggleshall type bricks have been used to form part of a put log hole. The occurrence of Coggleshall type bricks in the later 13th century chancel suggests re-use from an earlier context.
