Assessing the importance of river bank erosion for fine sediment delivery to Bassenthwaite Lake

Thesis for M. Sc. (by research)

Durham University, Department of Geography

2007

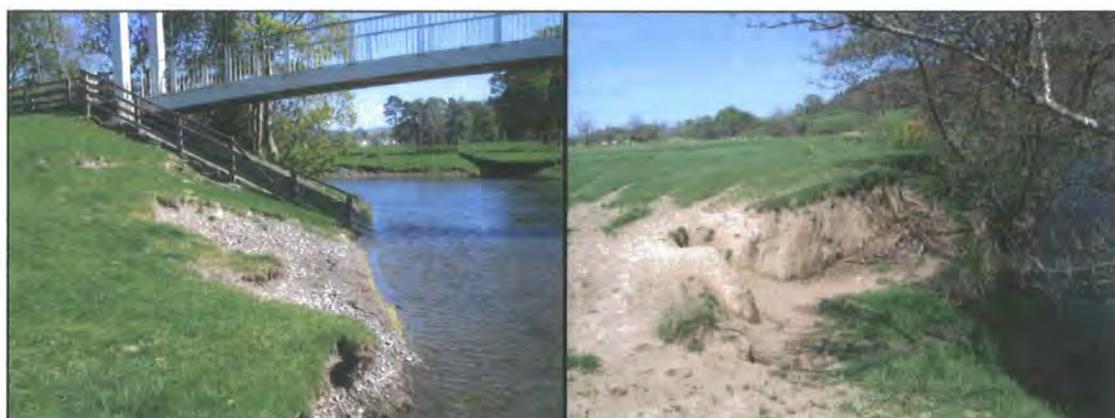
Figure 2.3: Poaching scars at Portinscale (left) and Low Stock Bridge on the River Derwent, Cumbria (right) showing trampled, disturbed fine sediment in areas of grazing.

and Radford 1994). Such scars frequently form on river banks where agricultural land borders the channel (Figure 2.3), and loosened material can be easily entrained by high flows. In some upland grazing areas, including the northern slopes of Skiddaw (Figure 1.3), the installation of networks of drainage channels known as grips has taken place (Figure 2.4) in order to increase the area of grazing land. The erosion of such grips has the potential to contribute fine sediment to the lowland catchment, with additional increases in peak flows following the installation of upland drainage networks (e.g. Conway and Millar 1960, Knighton 1973).

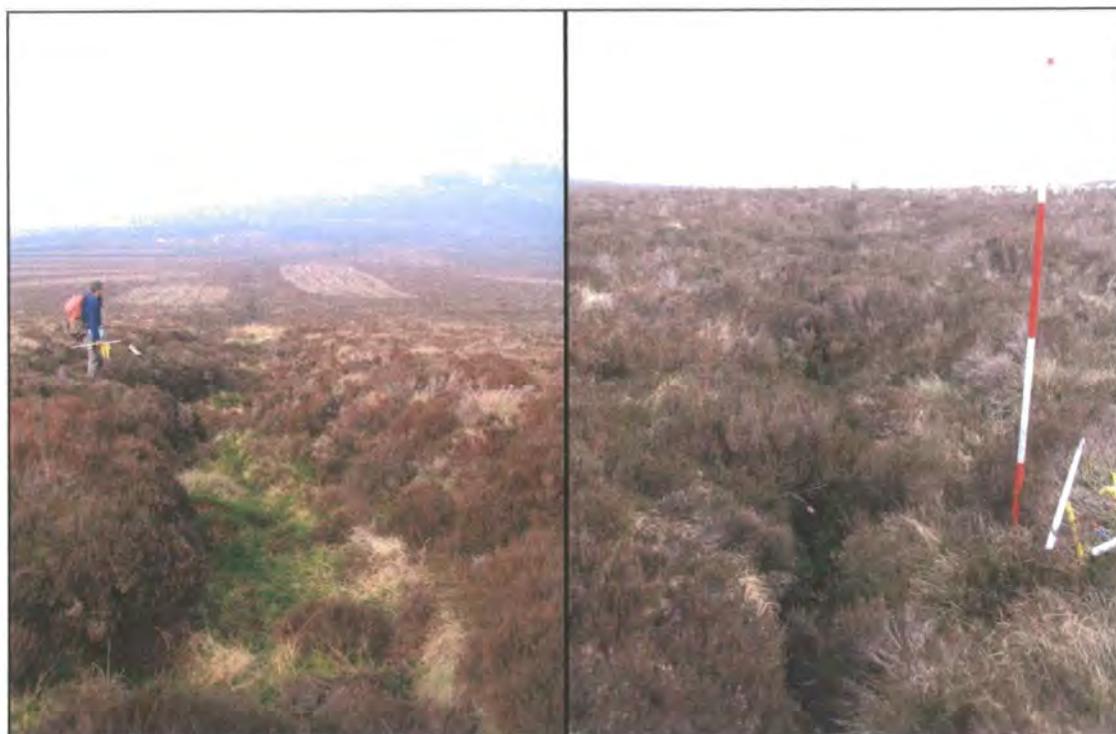
Figure 2.4: Grips at Candleseaves Bog (NY 277 304) near Skiddaw House, showing parts of the network of narrow and deep (maximum depth c. 1m) drainage channels cut into the peat bogs on heather moorland close to the Derwent/Eden watershed.

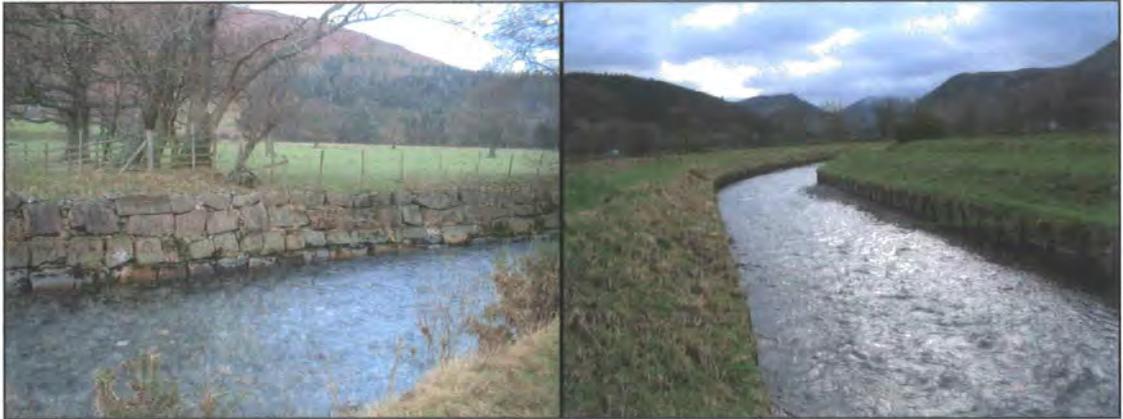
Figure 2.5: Channel regulation on Newlands Beck, showing channel straightening and bank heightening and reinforcement using (left) boulder revetments (NY 238 221) and (right) wooden revetments at Newlands Bridge (NY 240 263).

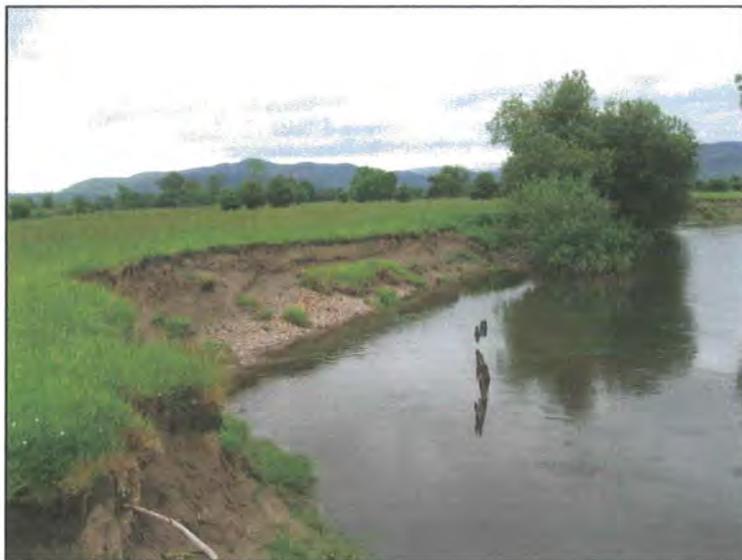
Figure 2.6: A line of ruinous wooden revetments in the River Derwent's channel at erosion study bank 2 near Low Stock Bridge (NY 237 266), showing obvious retreat and erosion of the bank back from the revetments.

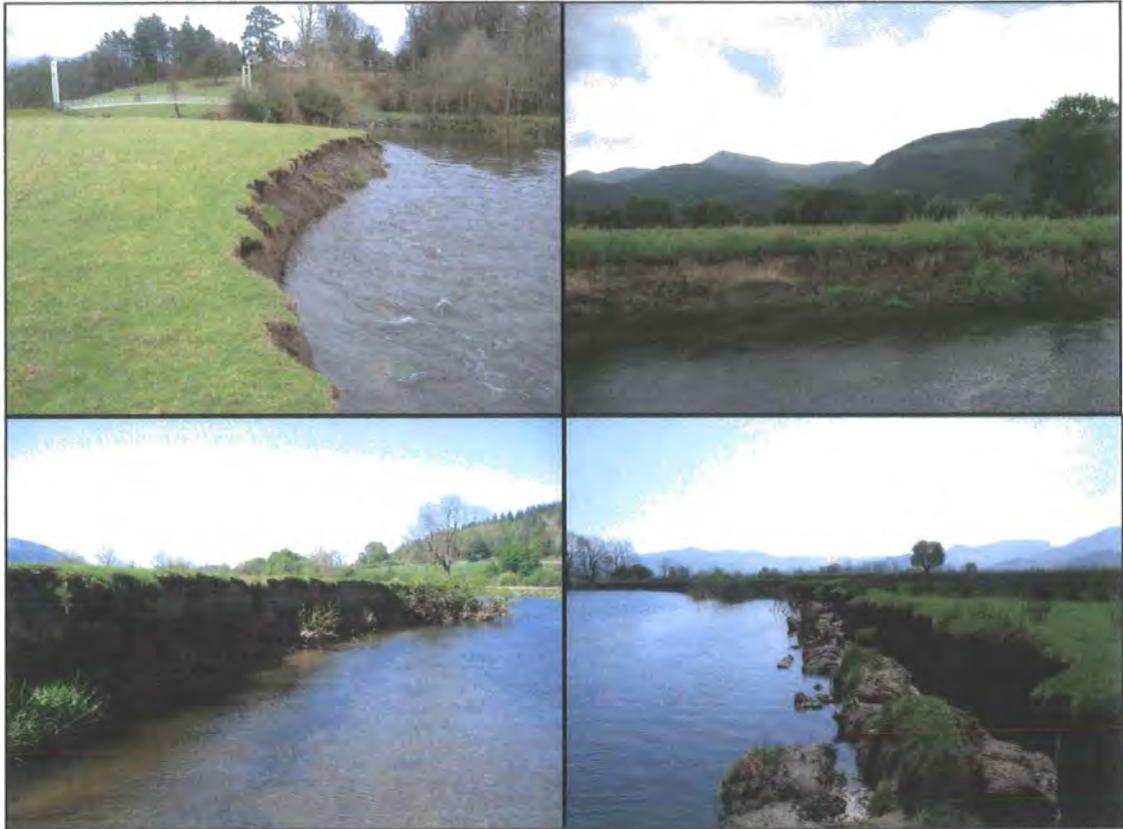
Figure 2.7: Examples of eroded banks on the River Derwent. Top row: at Portinscale (left), upstream of Low Stock Bridge (right). Bottom row: eroded river banks downstream of Low Stock Bridge.

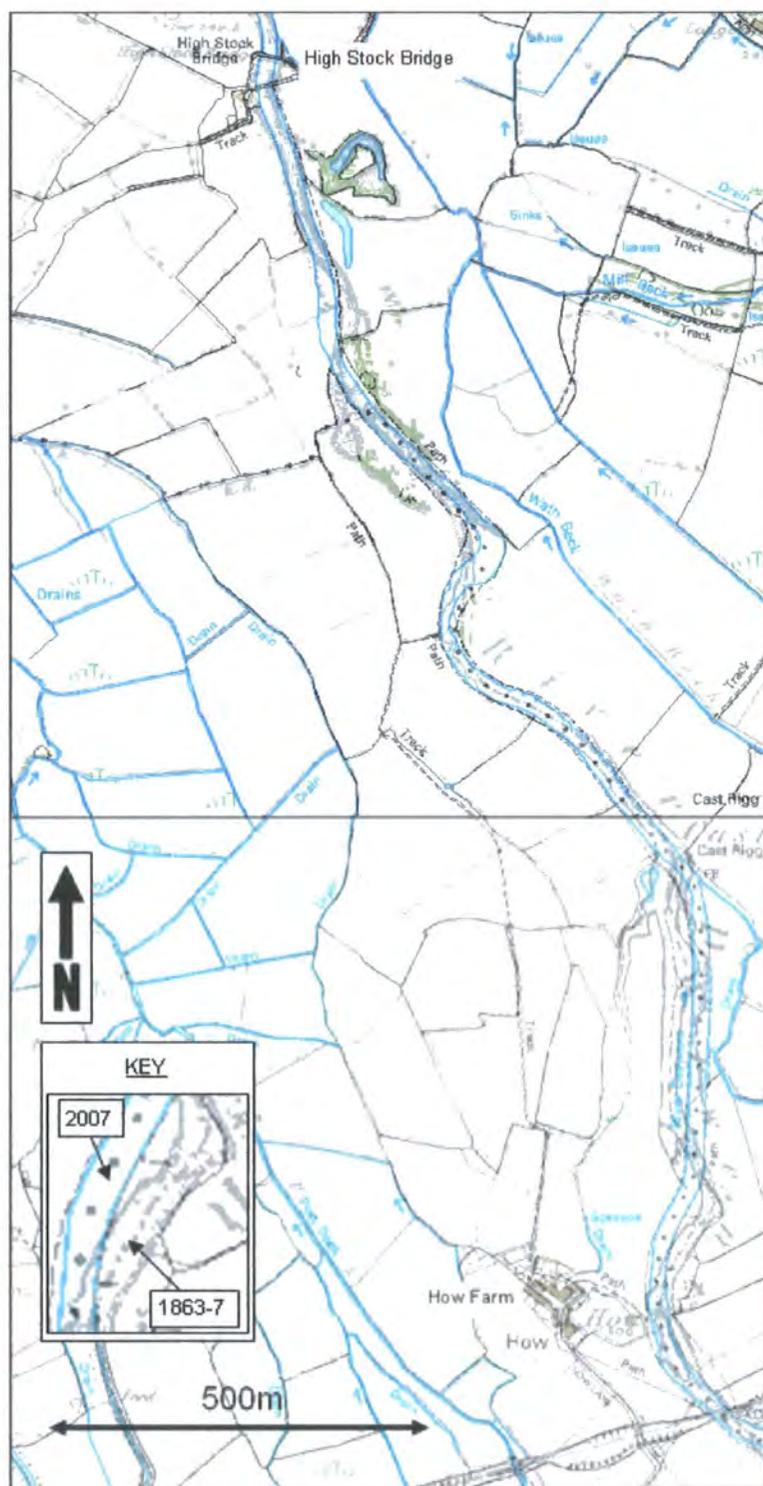
Figure 2.9: Channel changes on the River Derwent between How Farm and High Stock Bridge, indicated by an ArcMap overlay of County Series First Edition mapping (1863-7) and a modern National Grid map (2007).

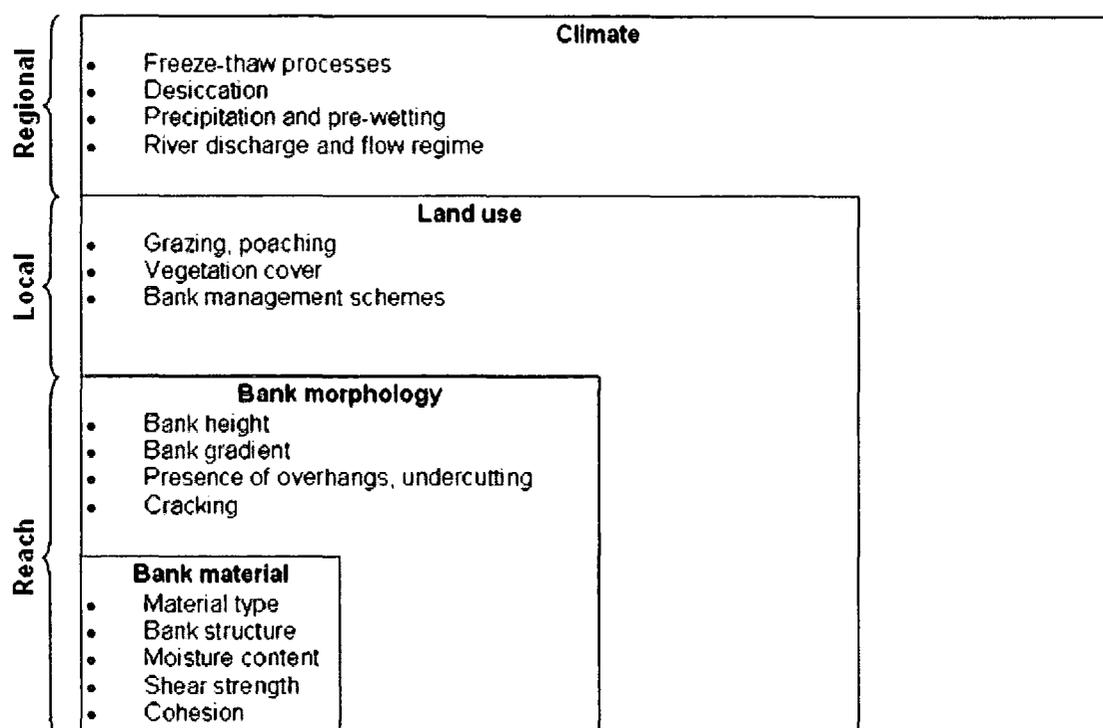
Figure 2.12: General factors affecting river bank stability. These operate at a range of scales, from the bank reach (bank material and morphology) to local and regional scales (land use and climate).

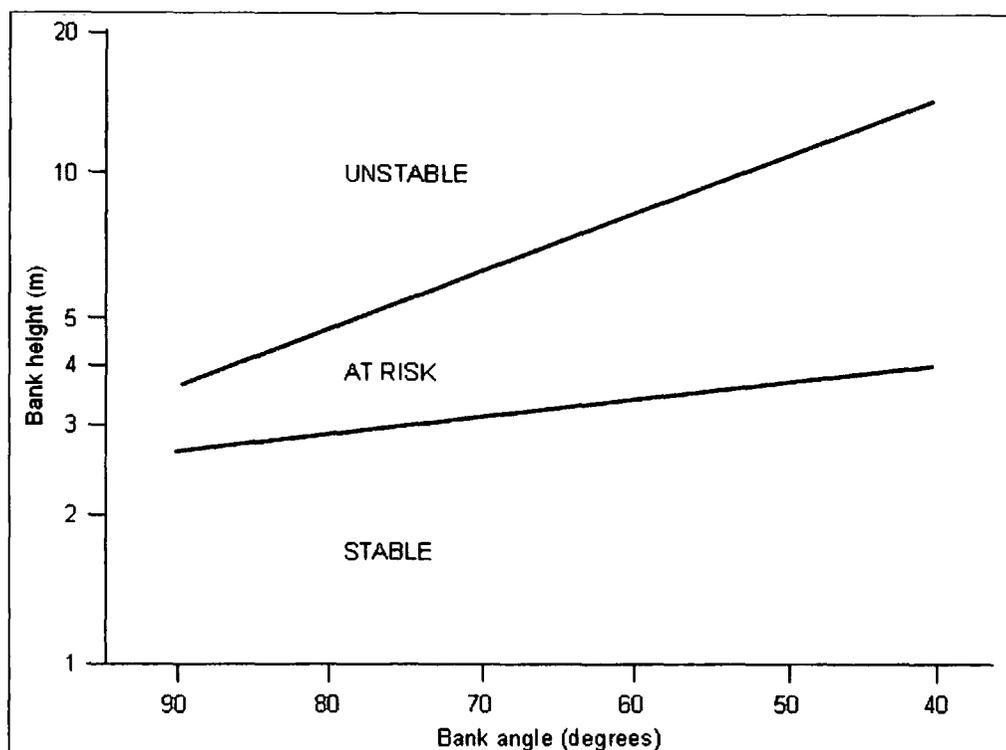
Figure 2.13: An example of slope-stability analyses, suggesting critical bank heights for river banks at certain angles. Adapted from Simon and Hupp (1987).

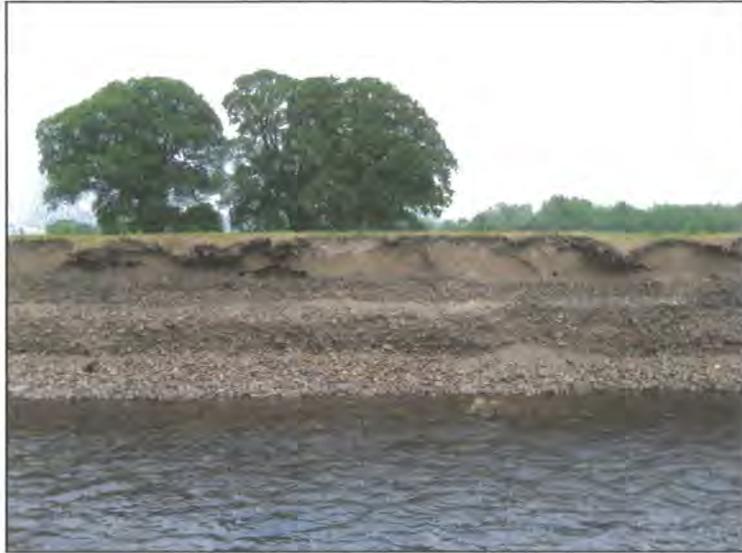
Figure 2.14: A well-developed, eroding composite river bank near Portinscale Bridge (height c. 2.5 m). Note the cohesive upper layer of fine-grained sandy material overlaying a non-cohesive lower layer of coarse pebbles and gravel. The turf slippage and slight overhang development at the bank top, and the steepened profile of the lower bank suggest recent active erosion of this bank.

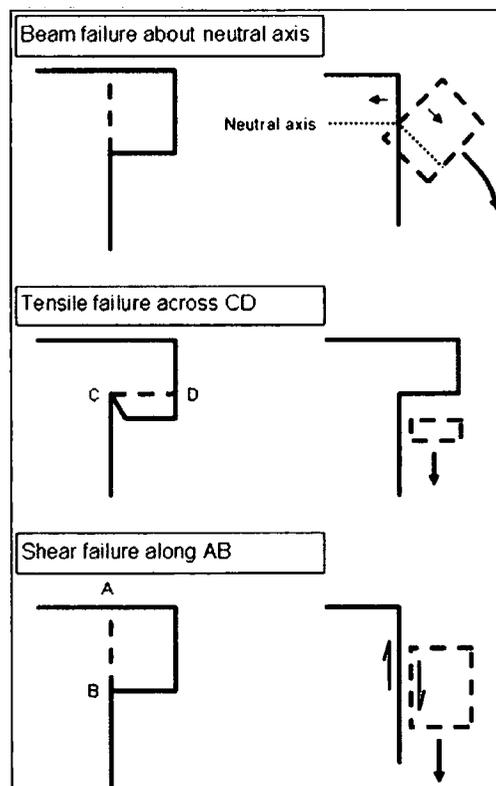
Figure 2.15: Mechanisms of cantilever failure: beam failure, tensile failure and shear failure. Adapted from Thorne and Tovey (1981).

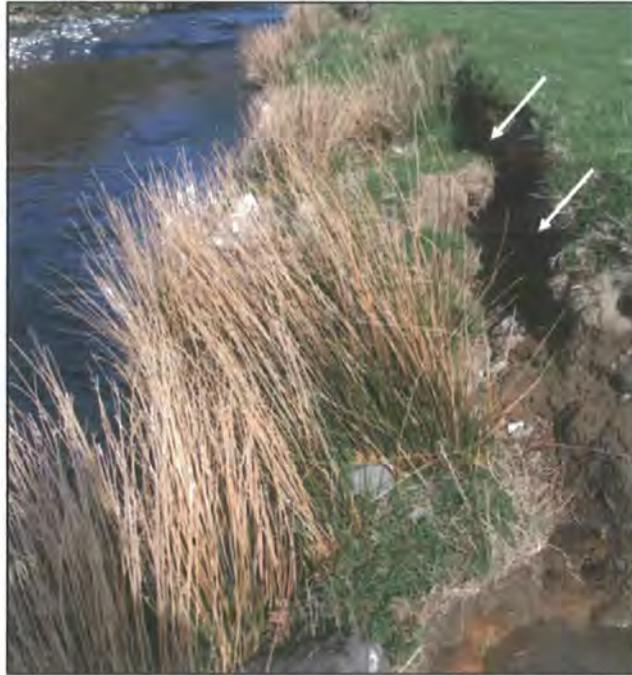
Figure 2.16: Shallow slip failure on the river bank of St. John's Beck, St. John's-in-the-Vale, Cumbria. The failed block has not been further eroded and it remains well vegetated. An obvious tension crack (indicated by the white arrows) is situated between the failed block and the retreated bank face.

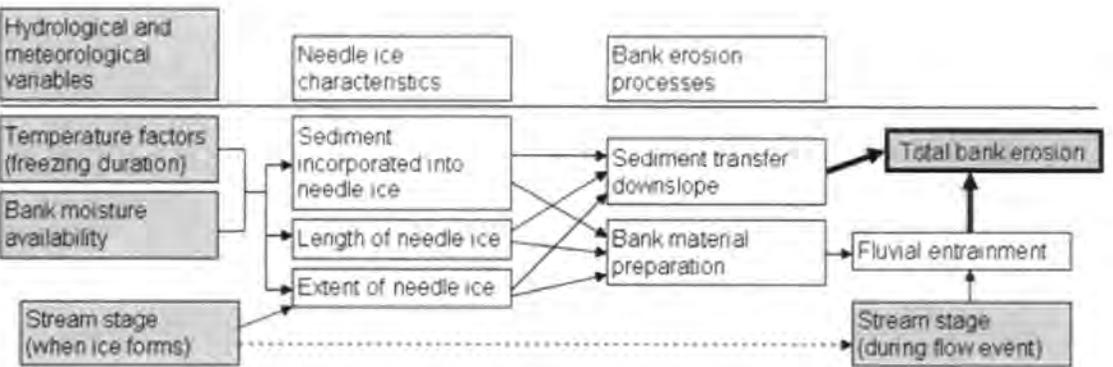
Figure 2.17: A flow diagram showing the role of needle ice in producing bank erosion, emphasising the importance of hydrological and meteorological variables in needle ice formation and subsequent bank erosion processes. Adapted from Lawler (1987).

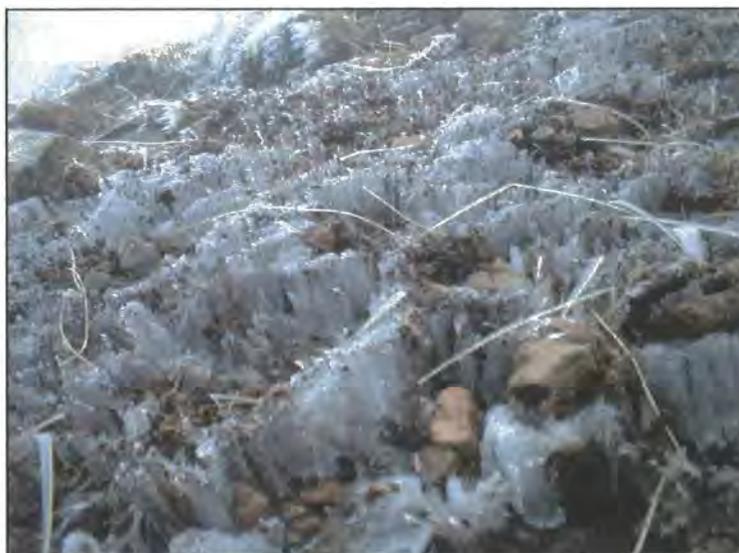
Figure 2.18: Needle ice observed on bare in the upland Bassenthwaite catchment on 26th December 2006. The crystals in the photograph were around 50 mm in length.

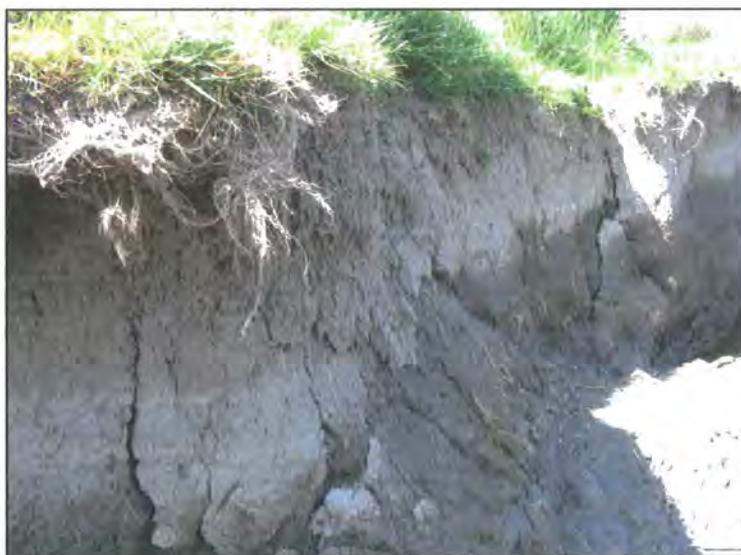
Figure 2.19: A desiccated river bank on the River Derwent near Bassenthwaite Lake, showing a dry and crumbly upper bank with deep cracks in the upper bank surface.

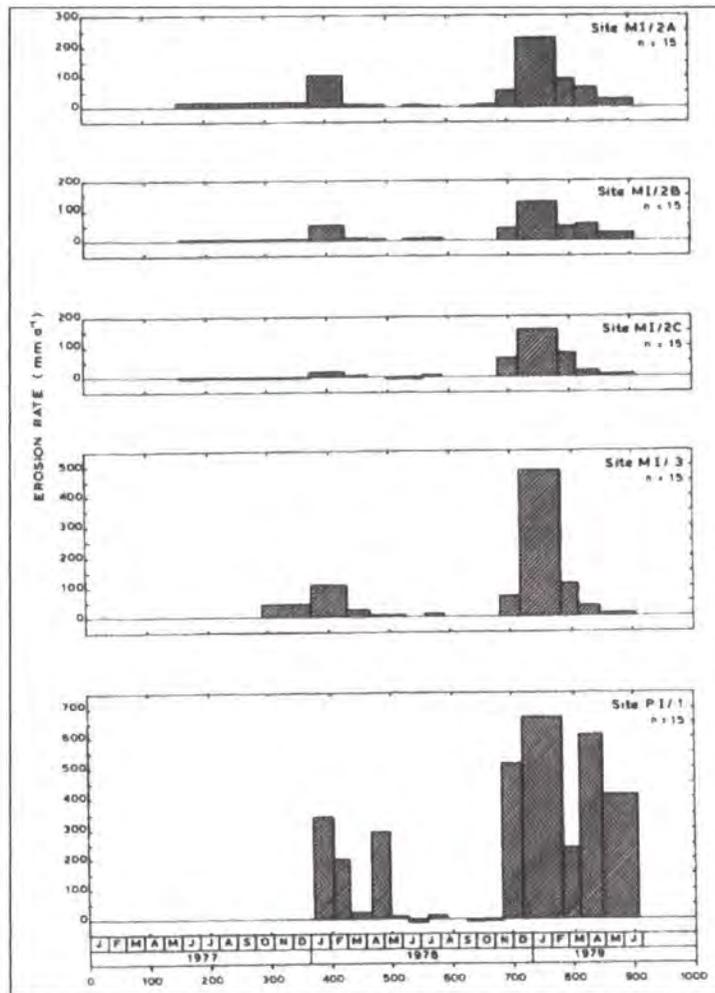
Figure 2.20: Bank erosion rates on river banks on sites in South Wales in a study period from 1977-1979, showing a strong seasonality of erosion rates. Diagram from Lawler (1985).

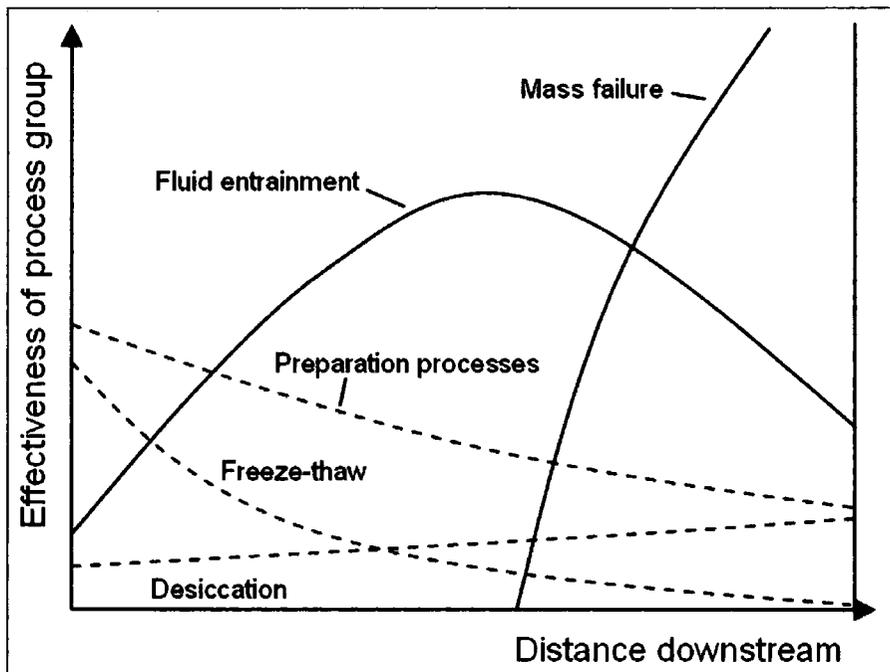
Figure 2.21: The distribution of dominant bank erosion processes along a hypothetical river system, showing a transition from the dominance of preparation processes (especially freeze-thaw) in the uplands of a catchment to fluid entrainment processes and mass bank failures at lower river reaches. Adapted from Kirkby (1980).

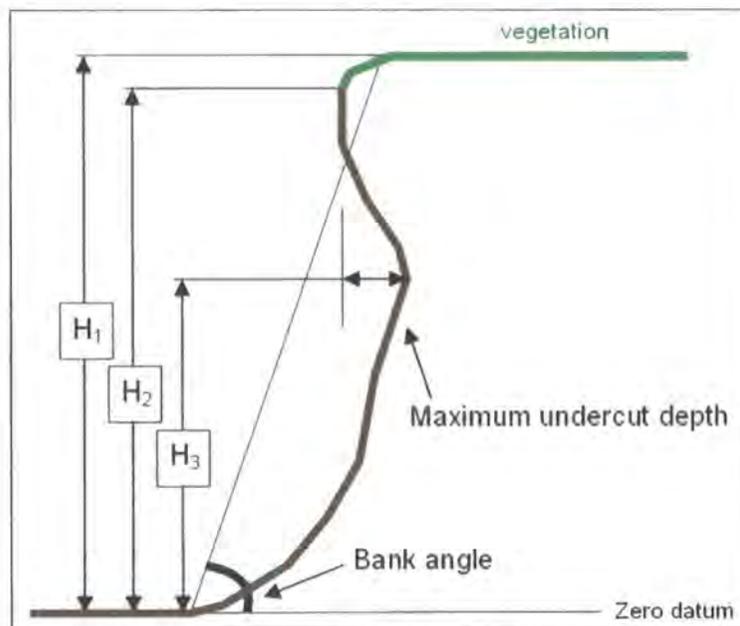
Figure 3.6: Bank profile measurements collected during mapping. H_1 = maximum bank height, H_2 = height of eroded part of bank, H_3 = height of bank to maximum undercut depth.

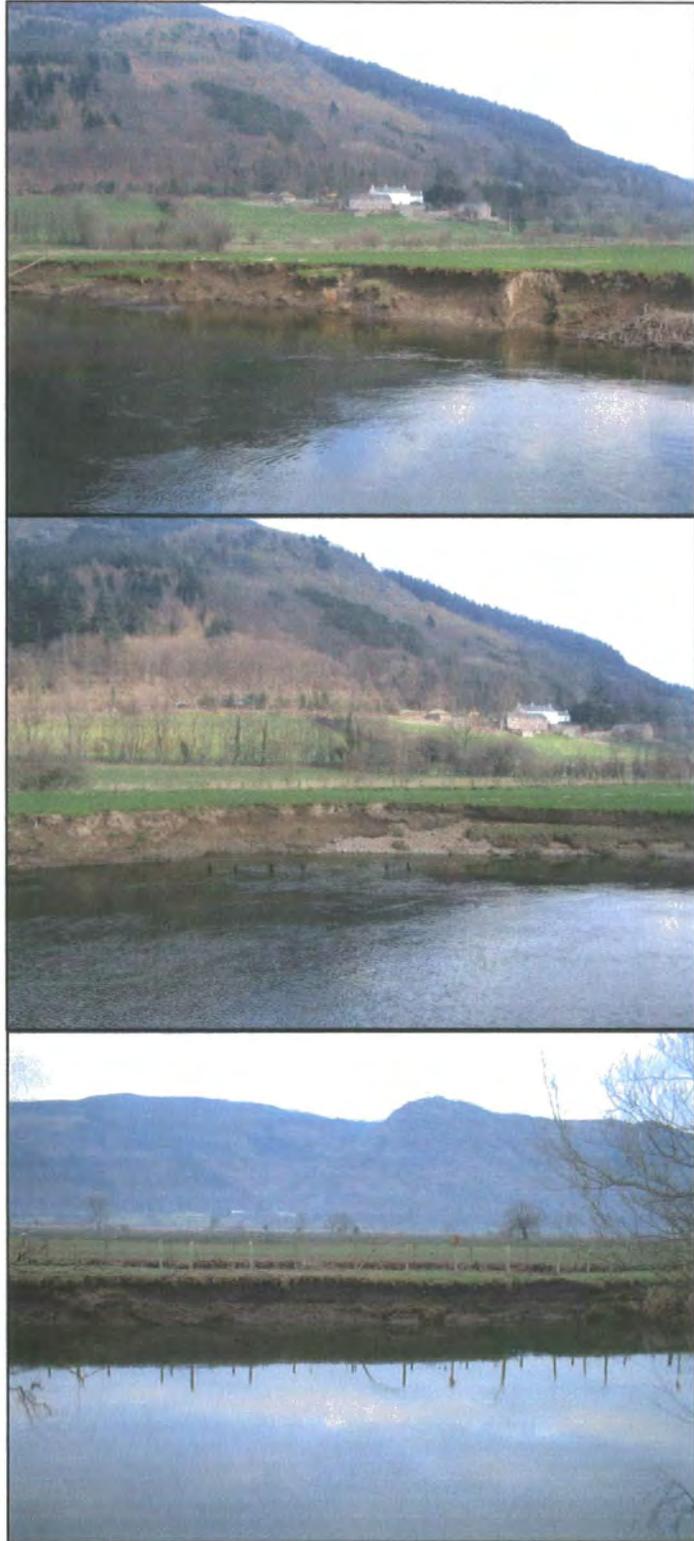
Figure 3.7: The three river bank sections analysed in the river bank erosion study in this project, showing bank 1 (top), bank 2 (middle) and bank 3 (bottom).

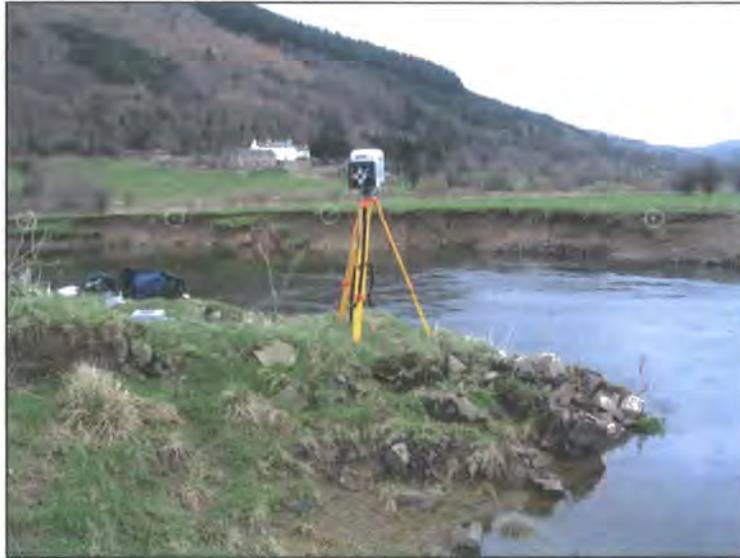
Figure 3.8: The laser scanner taking the first base scan of river bank 1, 13th March 2007. The laser scanner is mounted on the yellow tripod. The scan targets used for referencing the scans are indicated (circled).

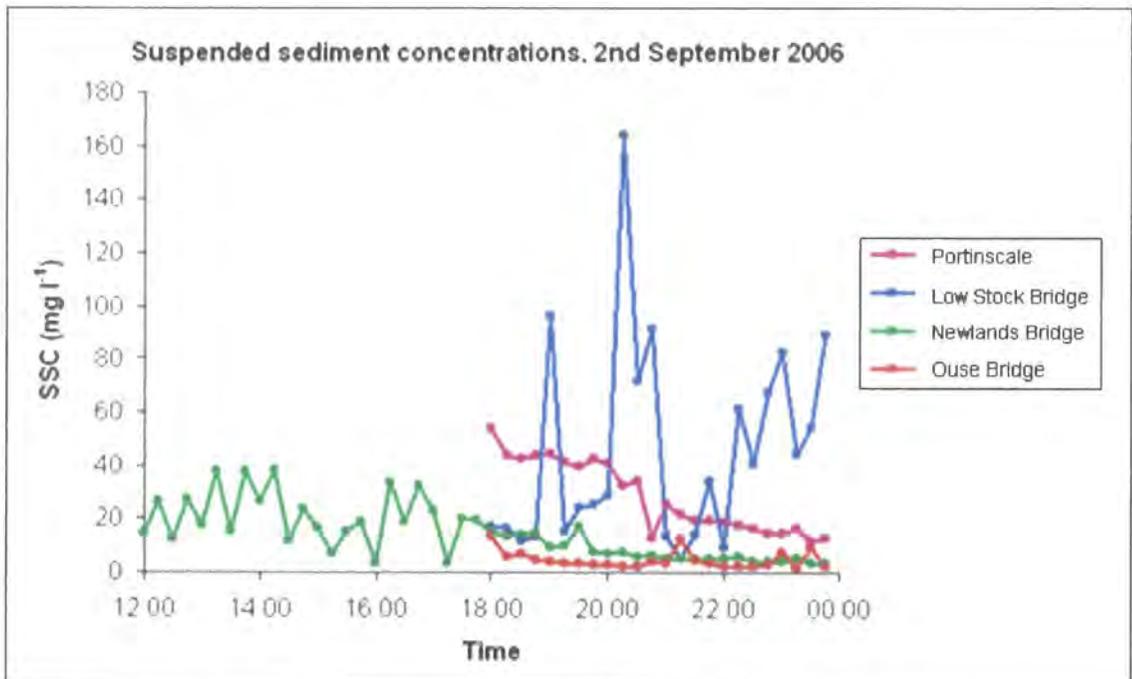
Figure 4.3: Graph showing variations in suspended sediment concentrations recorded at the four monitoring stations during sampling on the 2nd September 2006. Note that the second half of the Newlands Bridge record (18:00-23:45) was retrieved from the turbidity data rather than from water samples.

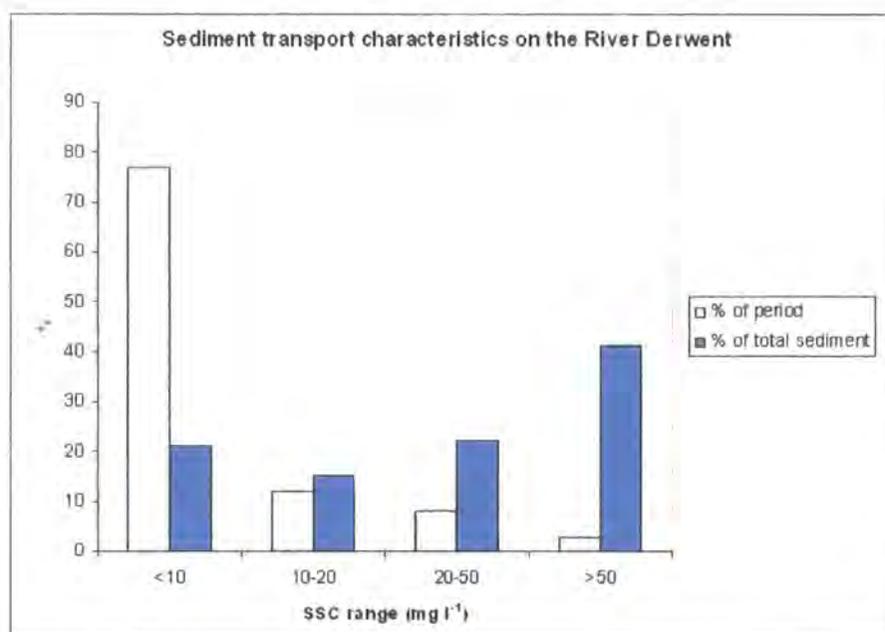
Figure 4.5: Sediment transfer characteristics on the River Derwent between April and November 2006, showing the importance of high concentrations in overall sediment transfers.

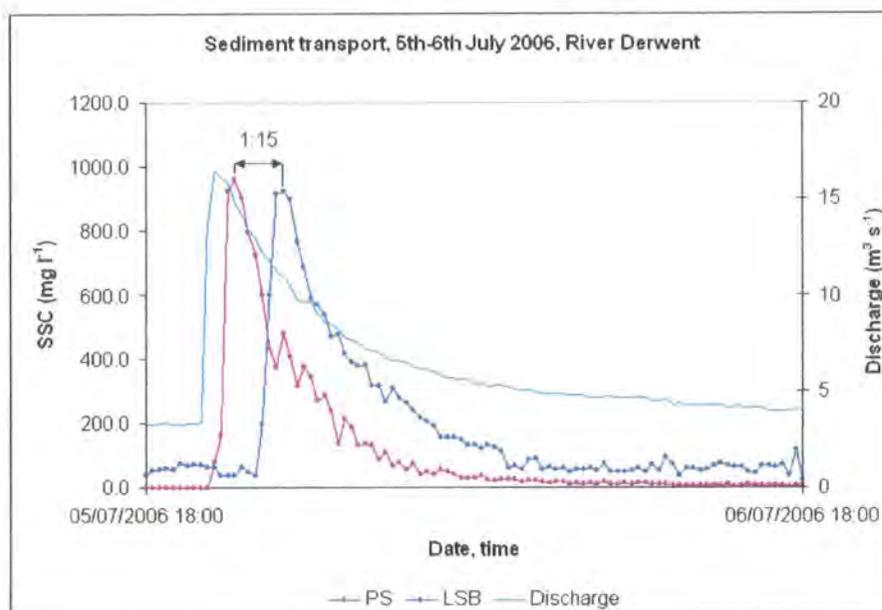
Figure 4.7: A large suspended sediment pulse observed between the 5th and 6th July 2006 at Portinscale and Low Stock Bridge. The discharge values (peak: $16.4 \text{ m}^3 \text{ s}^{-1}$) and sediment transport peaks at Portinscale and Low Stock Bridge are shown, as is the lag time (1 hour 15 minutes) between the peak sediment transport at the monitoring stations.

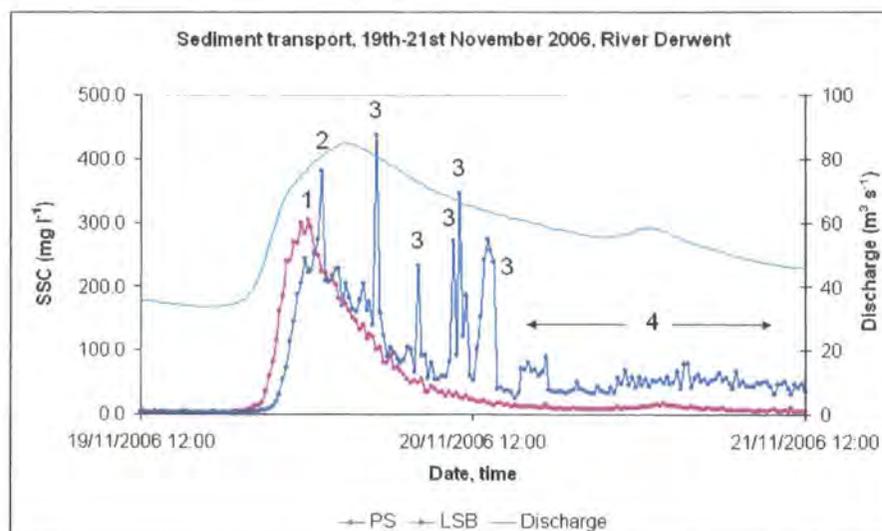
Figure 4.8: Suspended sediment transfers on the River Derwent at Portinscale and Low Stock Bridge, 19th-21st November 2006. As with Figures 4.9 and 4.10 below, numbers on the graph are referred to in the text in Section 4.1.3.4.

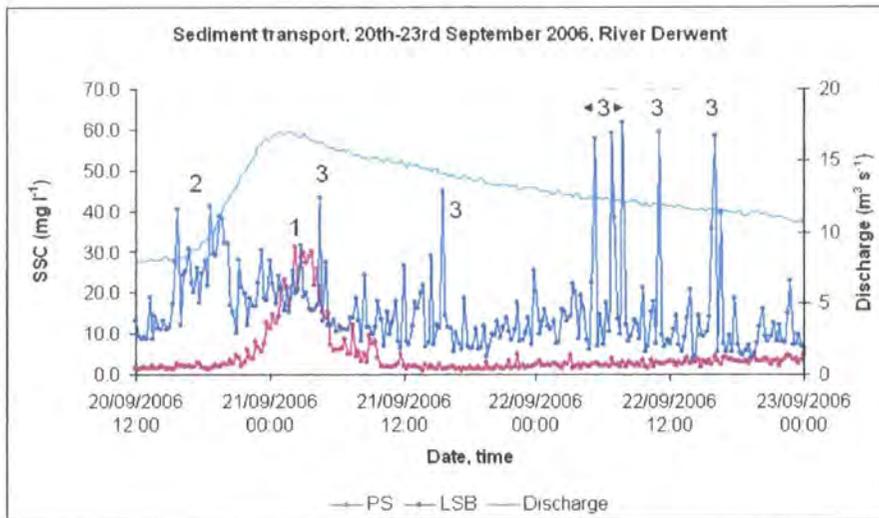
Figure 4.9: Suspended sediment transfers on the River Derwent at Portinscale and Low Stock Bridge, 20th-23rd September 2006.

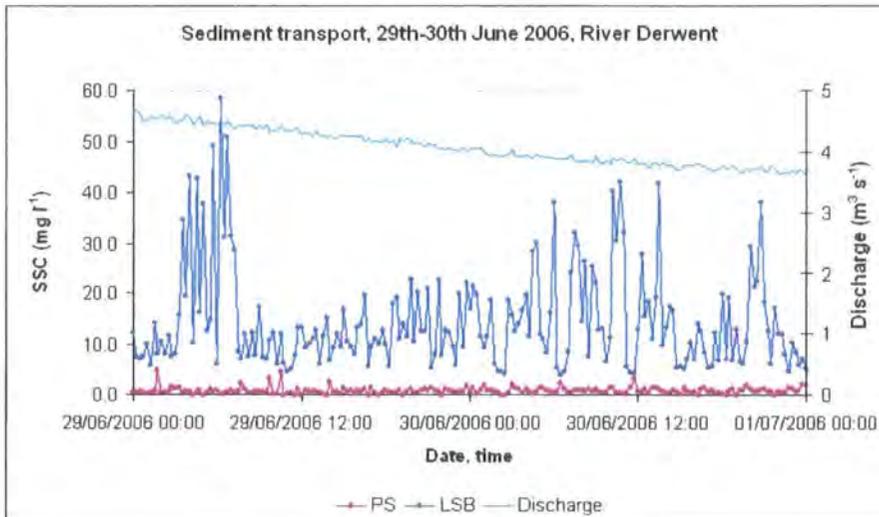
Figure 4.10: Suspended sediment transfers on the River Derwent at Portinscale and Low Stock Bridge, 29th-30th June 2006.

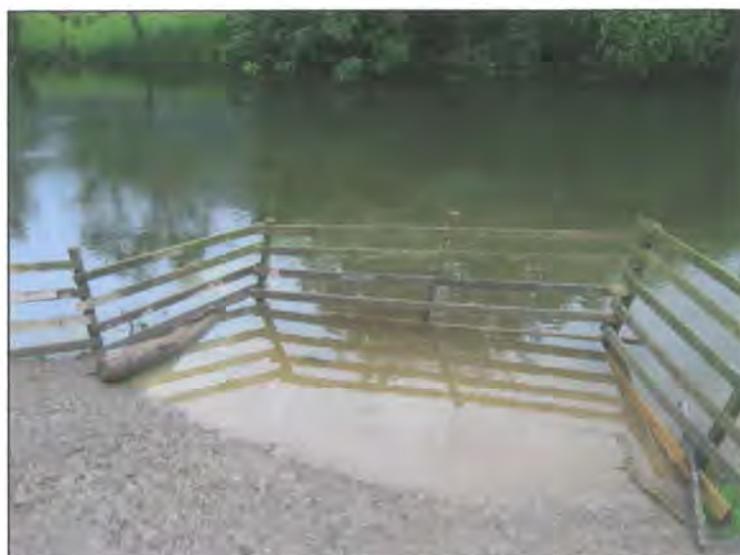
Figure 4.11: Suspended sediment addition to the River Derwent from an area of bare soil in the large poaching scar c. 150 m upstream of Low Stock Bridge (NY 244 257) following heavy rain, 22nd June 2007.

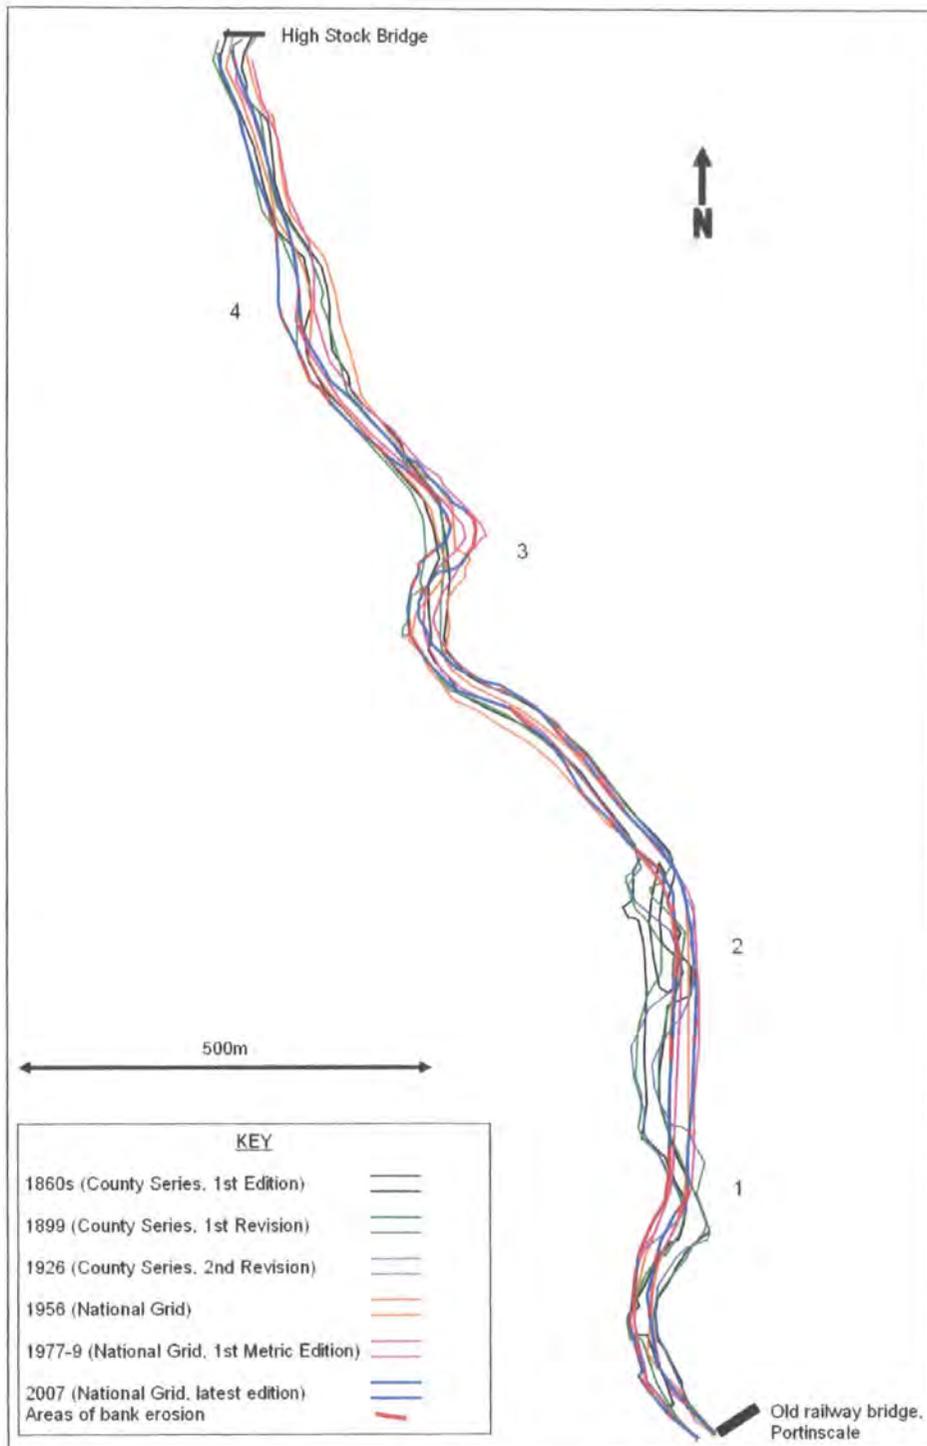
Figure 4.14: The relationship between modern-day river bank erosion and areas of significant river channel migration, on a reach of the River Derwent between Portinscale and High Stock Bridge. Numbering corresponds to bank areas referred to in the text (Section 4.2.3).

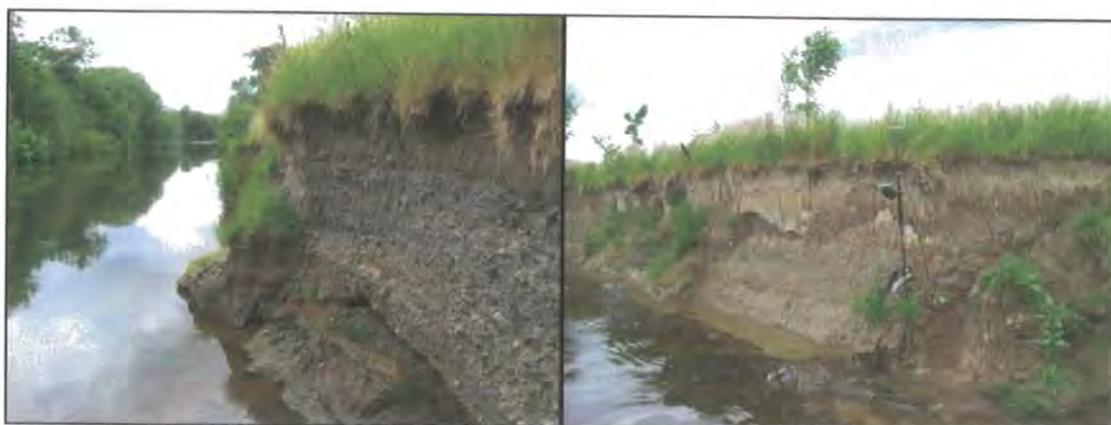
Figure 4.15: Comparison of river bank composition between High and Low Stock Bridges: a composite bank with a thick non-cohesive layer (left), and an almost completely cohesive bank (right).

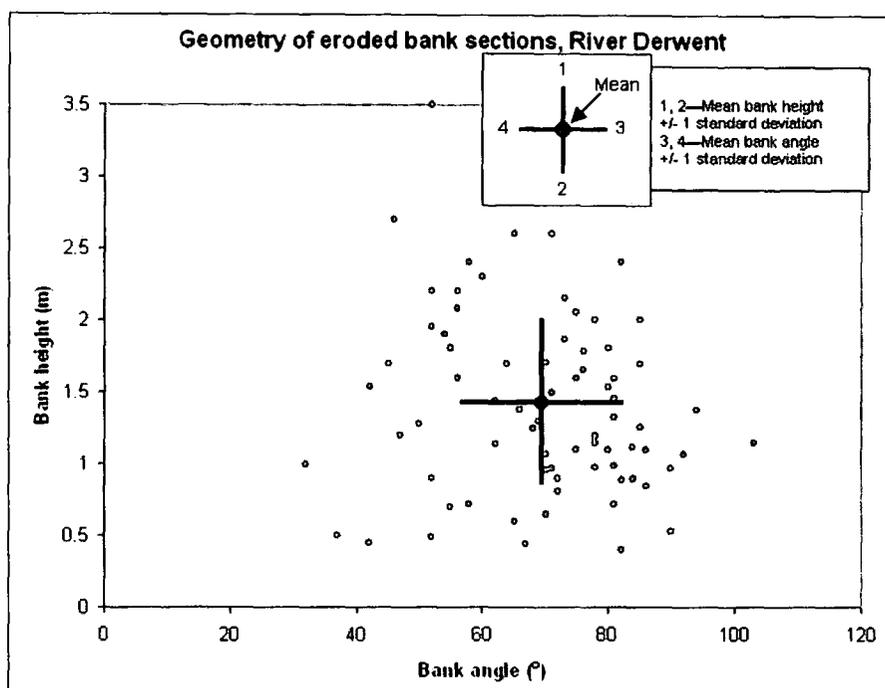
Figure 4.16: The geometry of eroded bank sections measured on the River Derwent, showing average geometry and centroids.

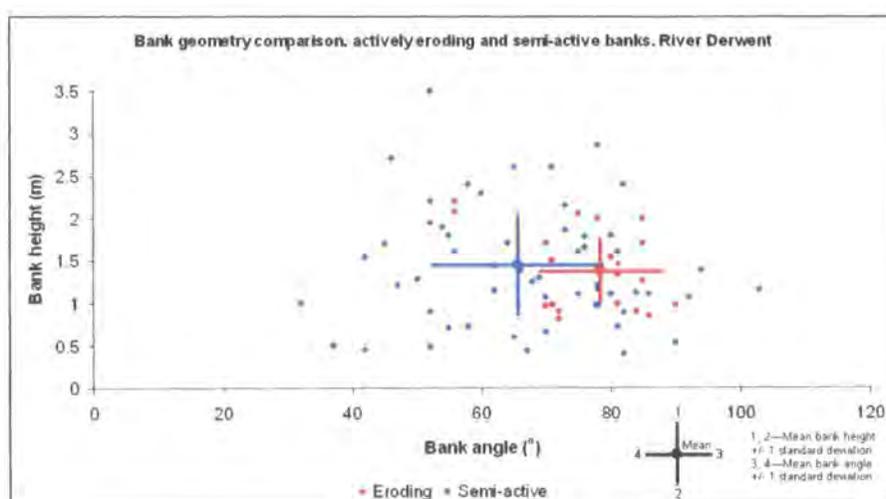
Figure 4.17: Geometry comparison of presently actively eroding and semi-active banks profiles showing average geometry with centroids for both categories.

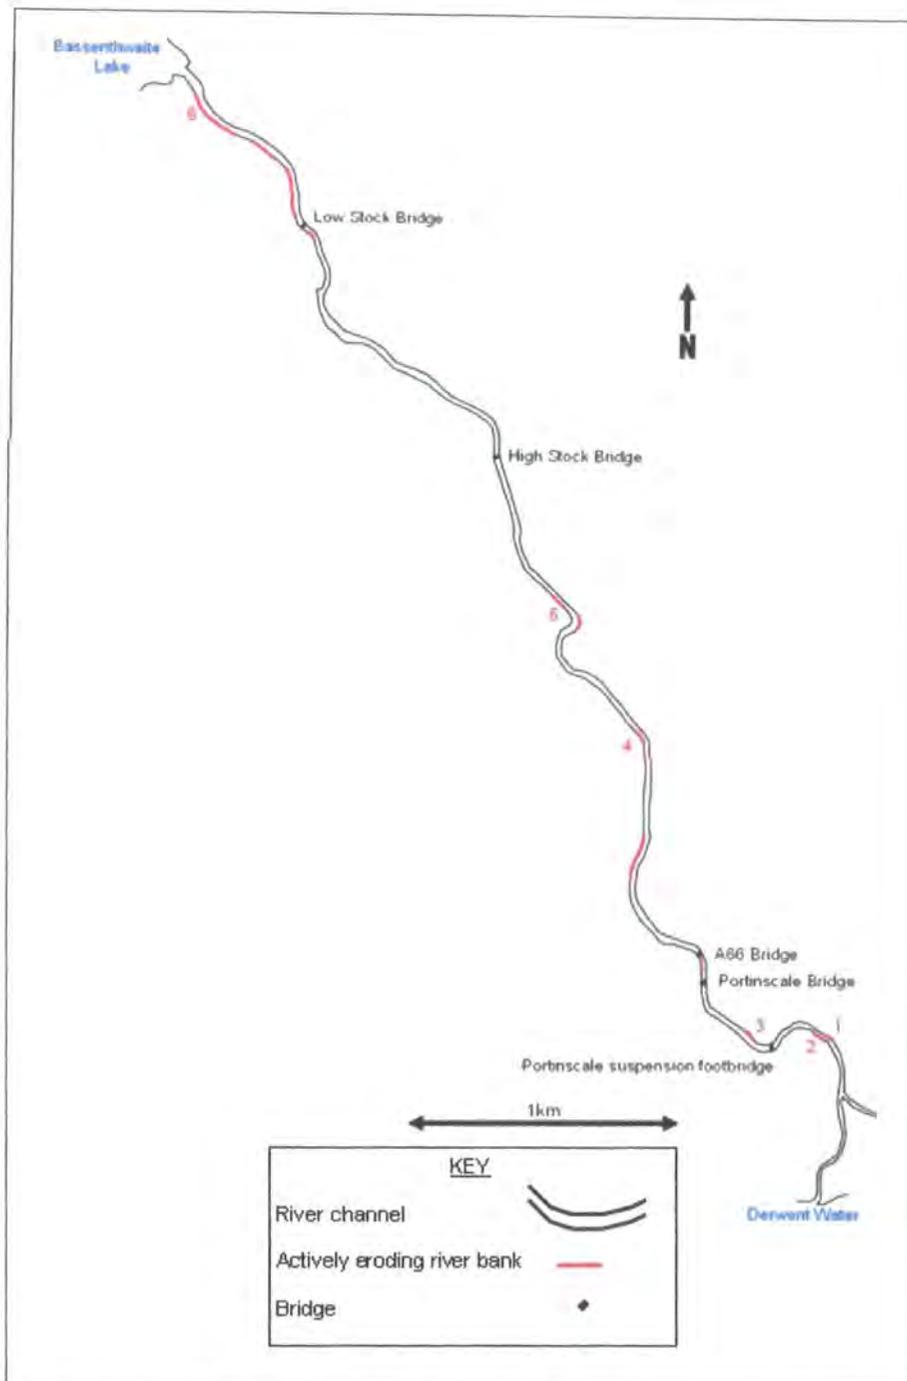
Figure 4.18: Map of the River Derwent channel between Derwent Water and Bassenthwaite Lake, highlighting the bank lengths currently in the process of active erosion (block failures). Numbered bank reaches are used as examples in the text below.

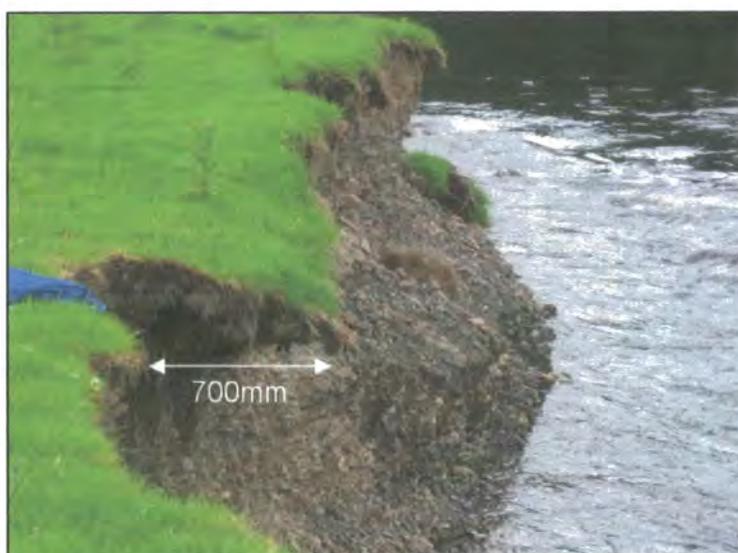
Figure 4.22: Considerable undercutting (indicated) at bank 3 following a rise in river levels, also note the oversteepened profile of the lower bank.

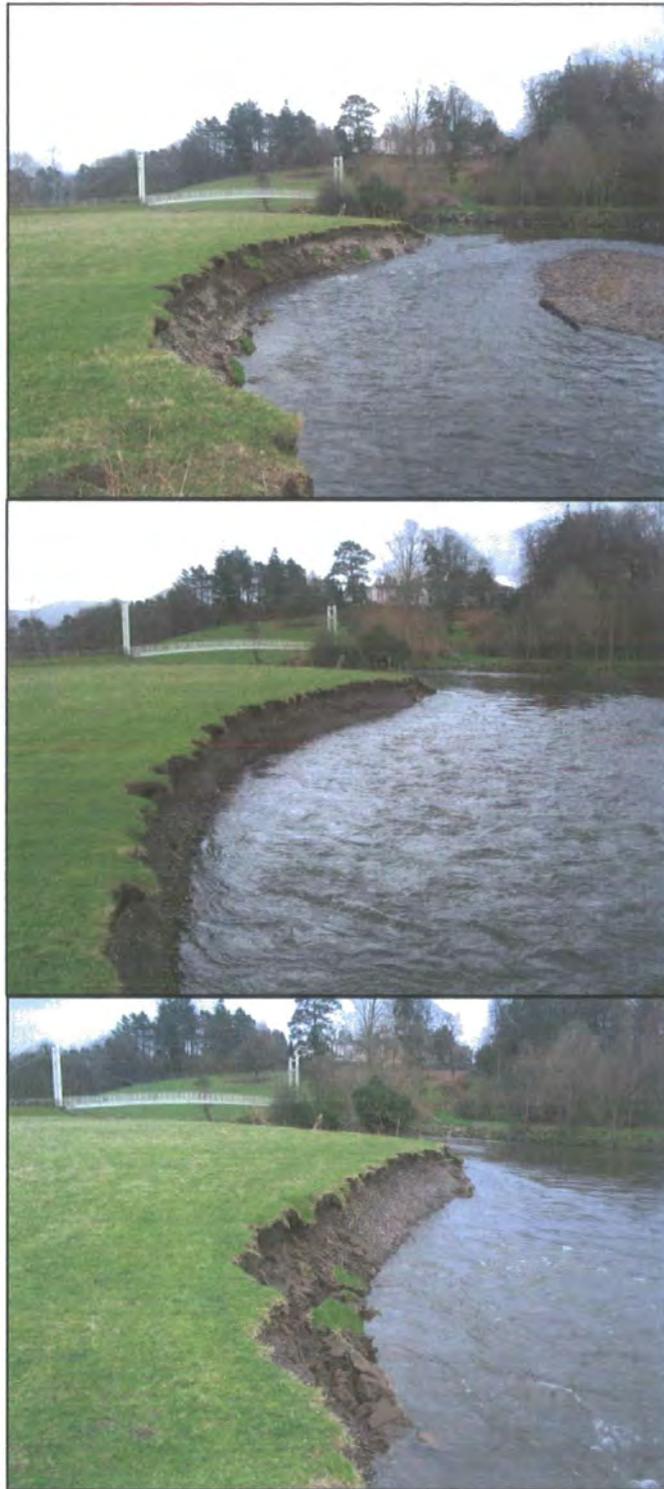
Figure 4.23: Block failure events and material removal from bank 3 near Portinscale suspension footbridge (looking upstream). Photograph dates: Top - 19th February 2007, middle – 5th March 2007, bottom – 11th March 2007.
