Assessing the importance of river bank erosion for fine sediment delivery to Bassenthwaite Lake

Thesis for M. Sc. (by research)

Durham University, Department of Geography

2007

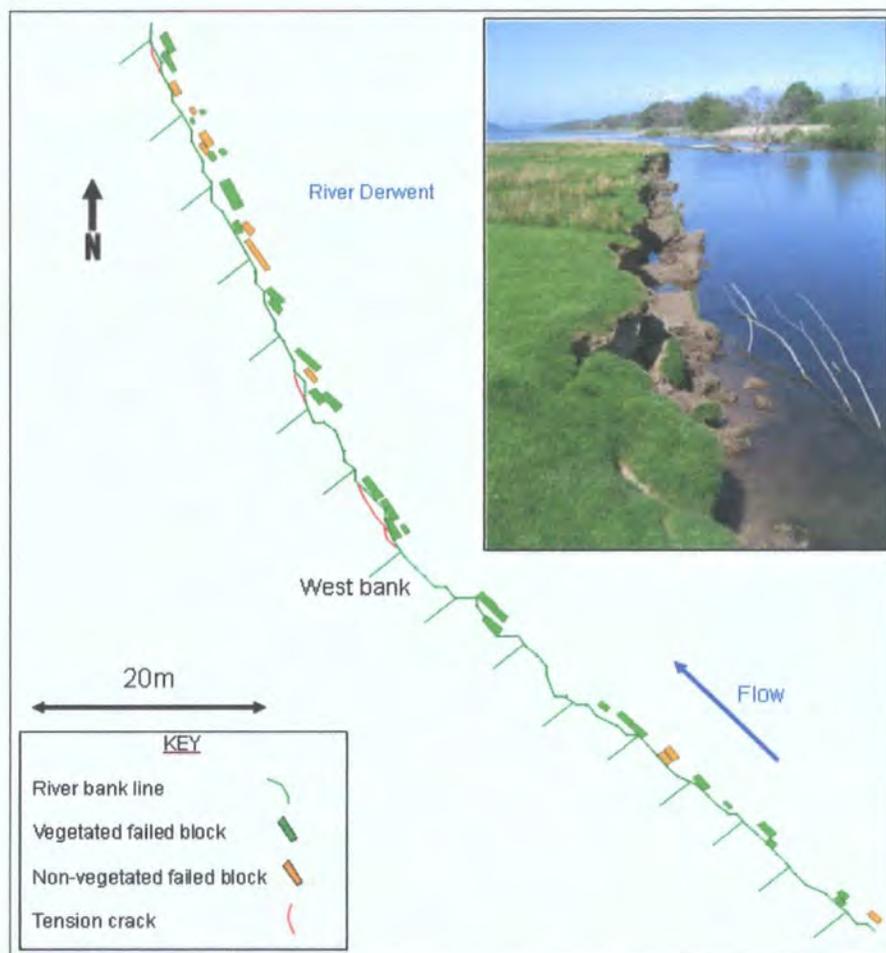
Figure 4.27: Map of the extensive block (cantilever) failures on the west bank of the River Derwent at Derwent Foot (bank 6), also showing photograph of the failures (looking downriver to Bassenthwaite Lake). Tension cracks at the bank top in the foreground suggest a very high likelihood of block failures following further erosion. Flow direction is away from photograph towards the lake.

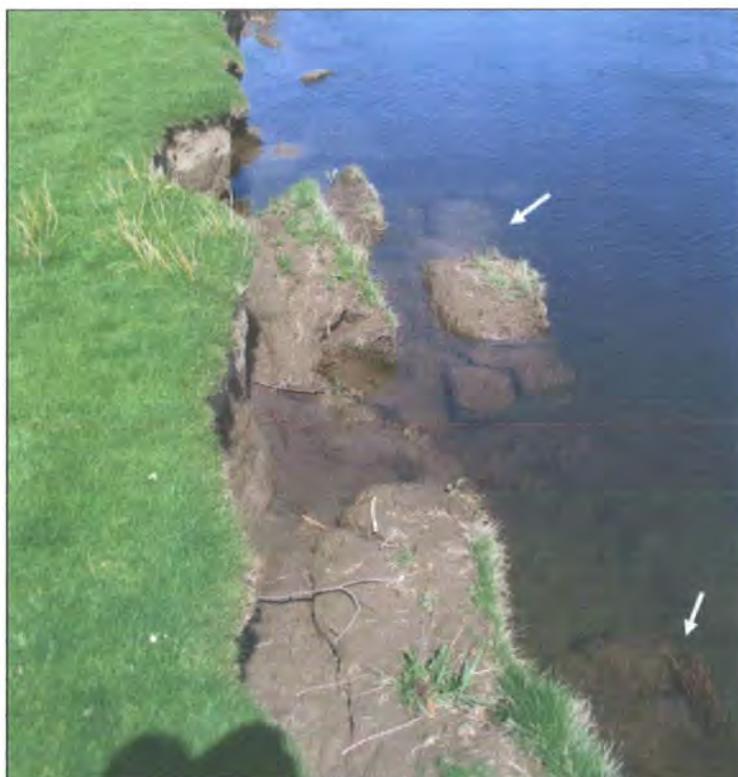
Figure 4.28: Unvegetated, intact blocks (indicated by white arrows) lying in the river channel below more recent failures at bank 6 (flow direction: away from photograph).

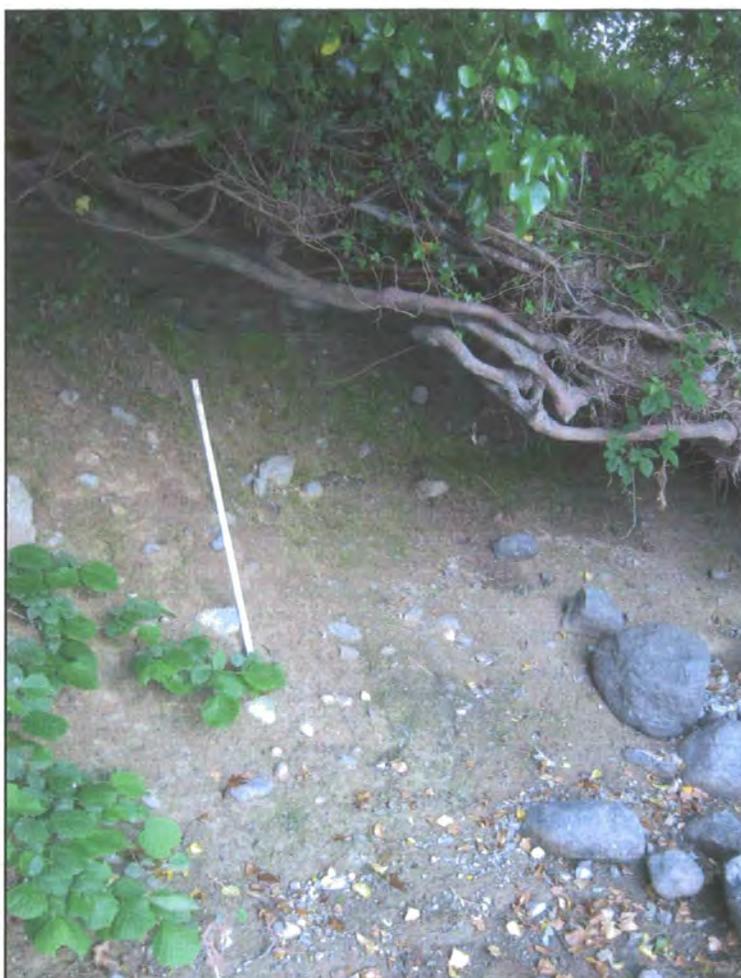
Figure 4.29: High (3.5 m) but presently stable river bank near Portinscale (NY 252 238), with metre ruler for scale. The dense vegetation roots at the overhang and the highly cohesive till on the lower, exposed bank face have prevented active erosion of this bank.

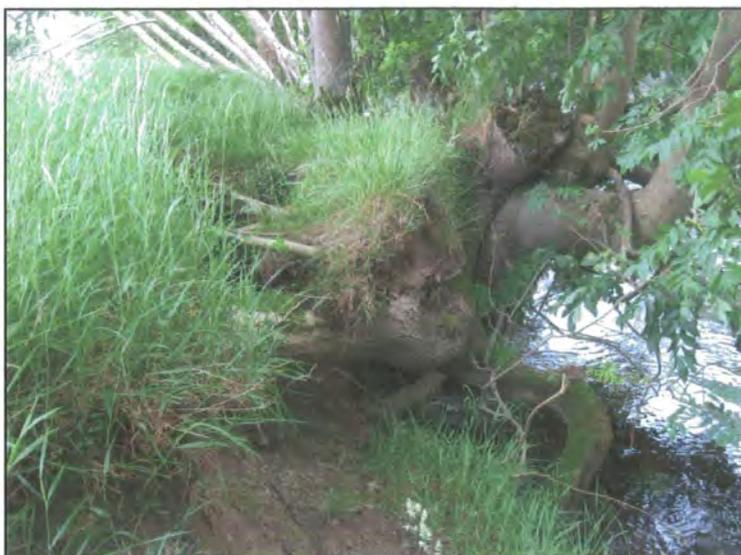
Figure 4.30: Semi-active exposed bank face between Portinscale and High Stock Bridge at NY 248 250, showing the influence of tree roots on river bank form and upper bank stability. The tree is however extremely undermined.

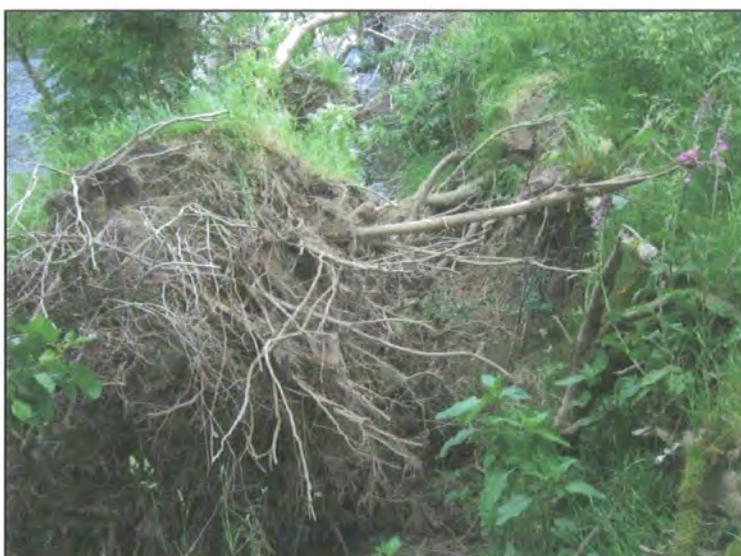
Figure 4.31: Collapsed bank-top tree at NY 247 251, showing a considerable amount of material removed from the bank attached to the roots, and a steep bank face left exposed by the removal of the material.

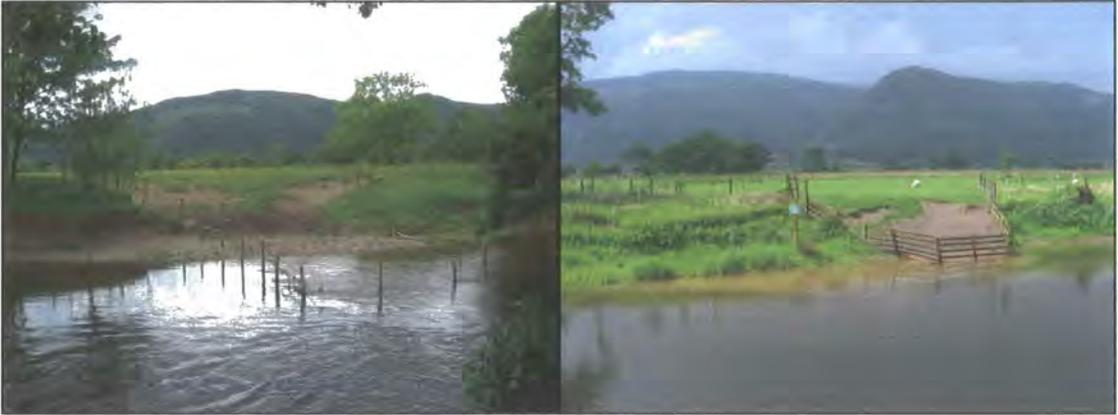
Figure 4.32: Large poaching scars: (left) near High Stock Bridge (NY 244 257), (right) near Low Stock Bridge (NY 244 257). Note the diversion of fencing into the river channel to allow grazing animals access to the water.

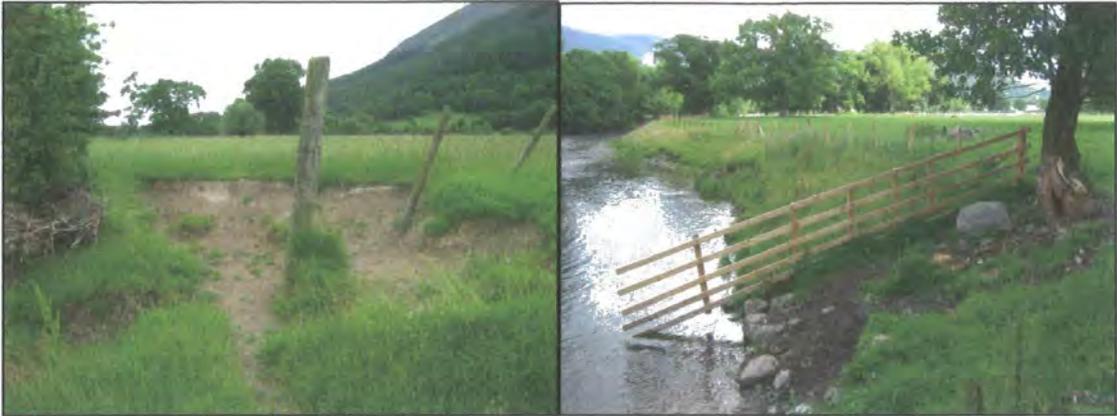
Figure 4.33: Examples of poaching scars formed near to fences in areas of channelled grazing: upstream of Low Stock Bridge (NY 237 264) (left) and near Portinscale (NY 253 237) (right).

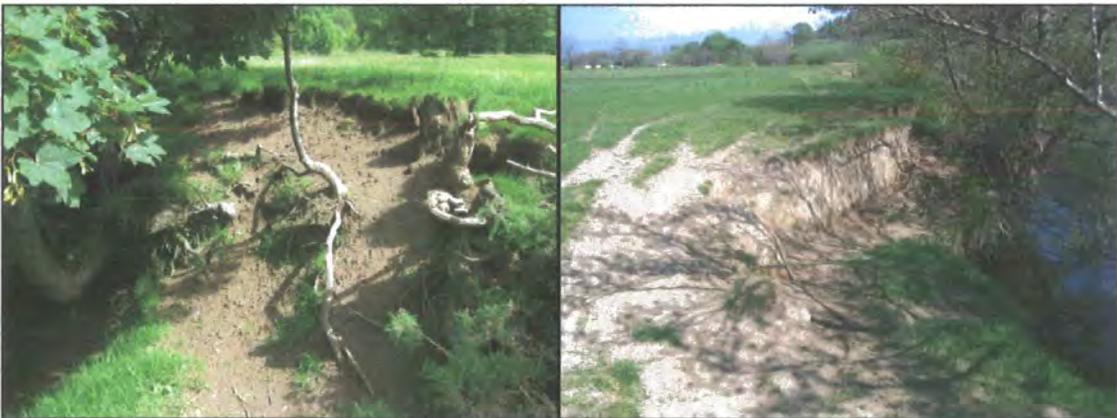
Figure 4.34: Examples of poaching scars that have formed in sheltered areas of river bank: under trees near Portinscale (NY 251 240) (left), and below a steep bank face downstream of Low Stock Bridge (NY 236 268) (right).

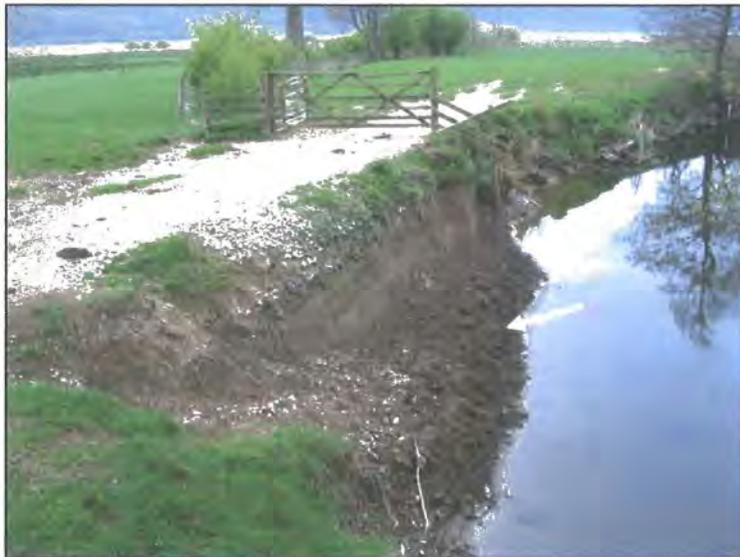
Figure 4.35: Poaching scar at Low Stock Bridge (NY 236 268) showing hoofmarks and loosened soil at the lower part of the scar (indicated by arrow). Photograph looking downstream.
