The Progressive Development and Post-failure Behaviour of Deep-seated Landslide Complexes

JONATHAN MARTIN CAREY

PhD thesis

This thesis is submitted in accordance with the regulations for the degree of Doctor of Philosophy in Durham University, Department of Geography, 2011

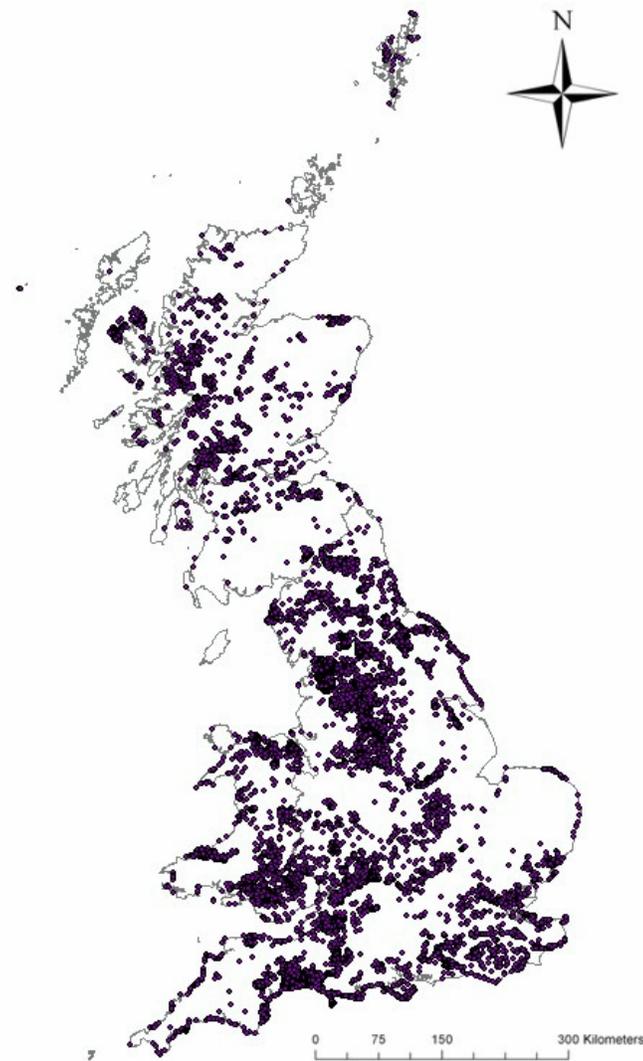
*Figure 1.3 Distribution of landslides in the BGS National Landslide Database
(from Foster et al., 2008; after GSL, 1986/87)*

mapping undertaken by GSL (1986/87) that currently records over 14,000 landslides across the UK (Fig 1.3). Many UK landslides are slow moving (mm / year) (e.g. Ventnor; Folkestone Warren; Lyme Regis), which can often disguise their effects and the potential hazard. In some cases rapid movement events do occur in the UK, such as the 1966 Aberfan landslide and the 1993 Holbeck Hall event, both of which had catastrophic consequences. The impacts of landslides in the UK are particularly apparent along the coastline where, in many locations, a combination of weak and/or unfavourably dipping geology, coastal erosion and the potential high groundwater levels are commonly observed.

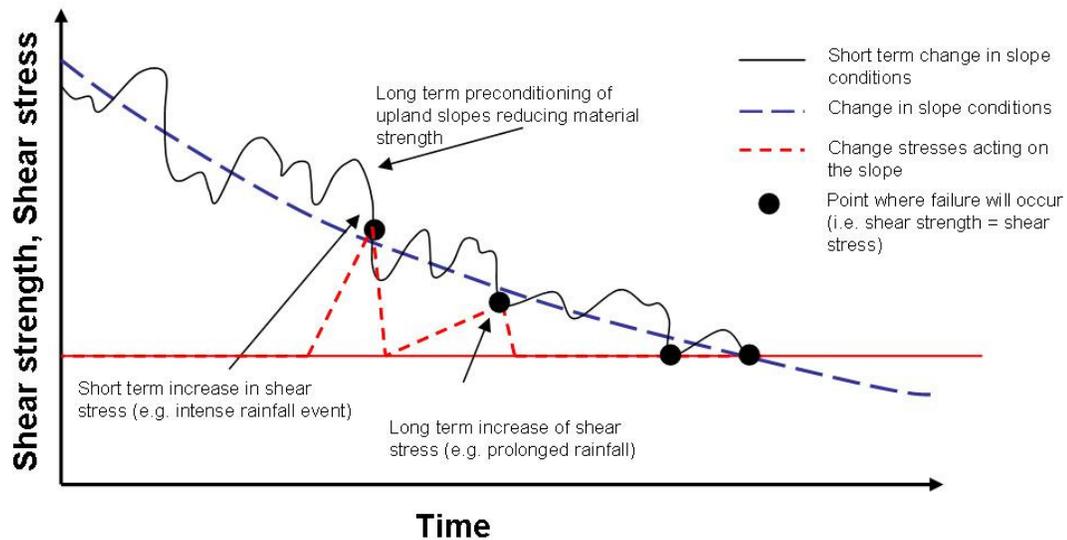
Figure 2.4 Model showing relative time frame of landslide development and significance of slope ripening and landslide triggering factors, adapted from Julian and Anthony (1996).

This concept of long-term slope soil strength reduction (Fig 2.4), with corresponding fluctuations in shear stress, has been discussed by numerous authors (e.g. Allison, 1996; Julian and Anthony, 1996).

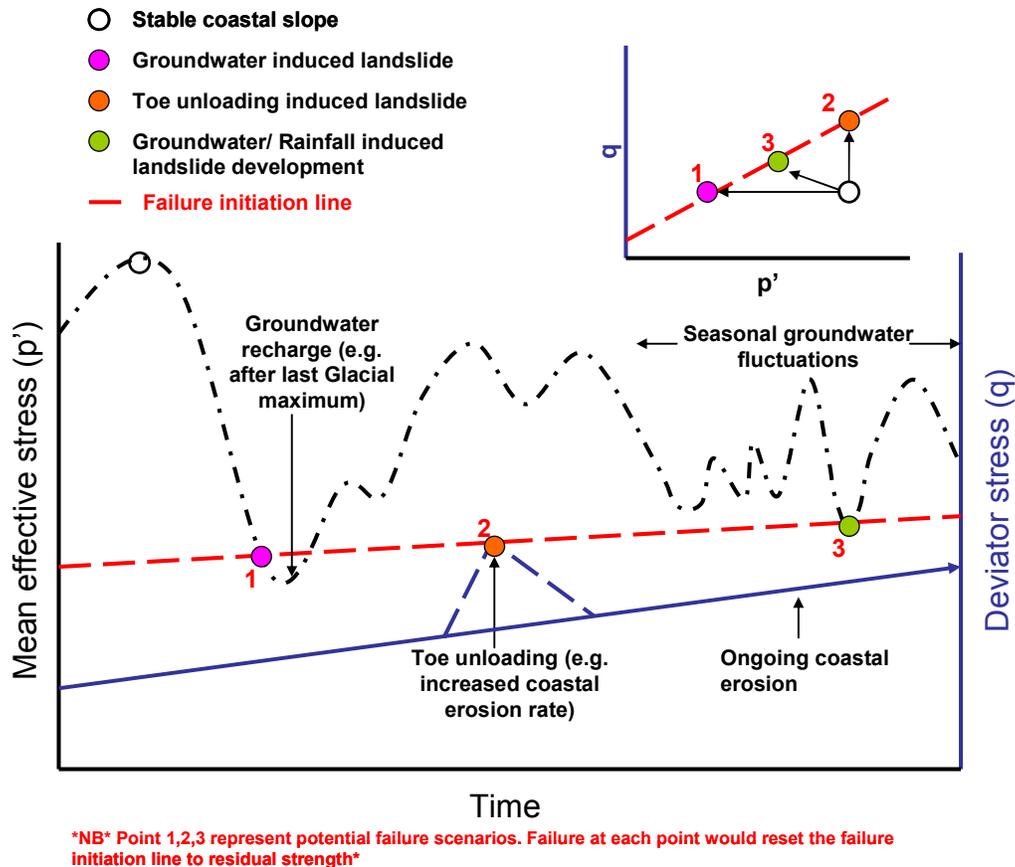
Figure 2.5 Conceptual model of coastal landslide development

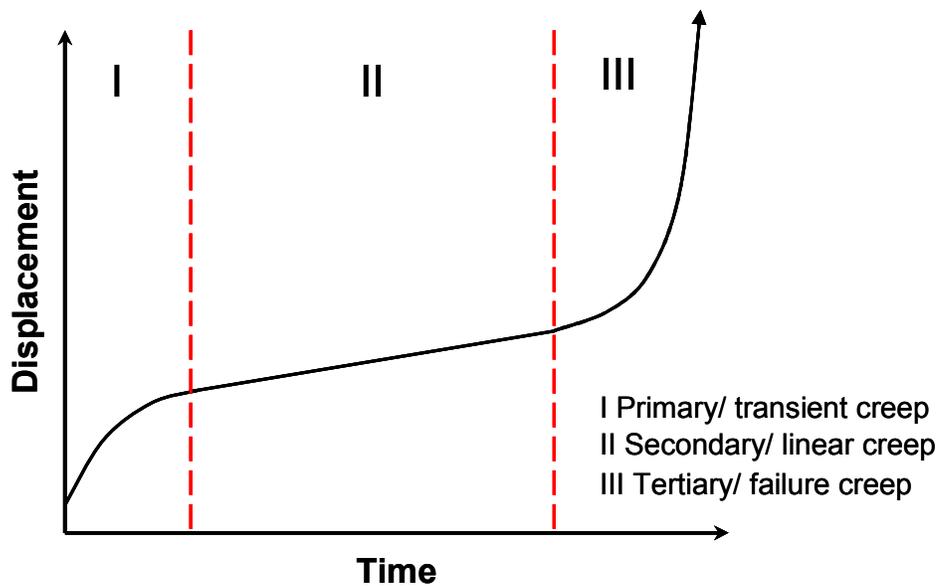
Figure 2.7 Idealised pattern of material deformation through time proposed by Varnes (1983)

dilatancy hardening. During 'Secondary creep', strain hardening and weakening forces are both occurring almost in balance and therefore the rate of deformation is slower and almost constant. The relationship between these forces slowly transfers during this stage toward the dominance of strain weakening forces. As a consequence, deformation begins to increase, which may explain the inflection point often observed in many creep deformation patterns. During the Tertiary phase the weakening forces clearly dominate deformation and eventually local softening feedback mechanisms cause the run-away to final failure along a singular shear surface.

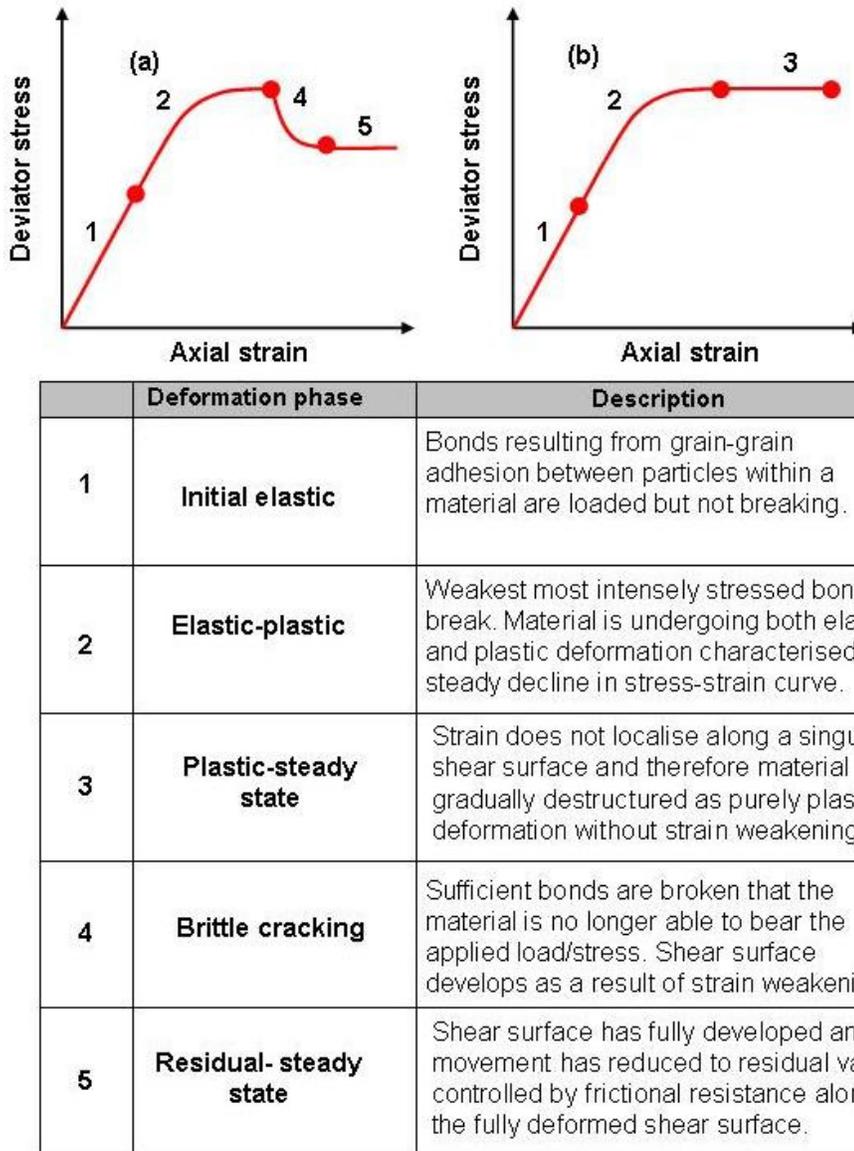
Figure 2.9 Idealised deformation patterns (a) Ductile deformation (b) Brittle deformation

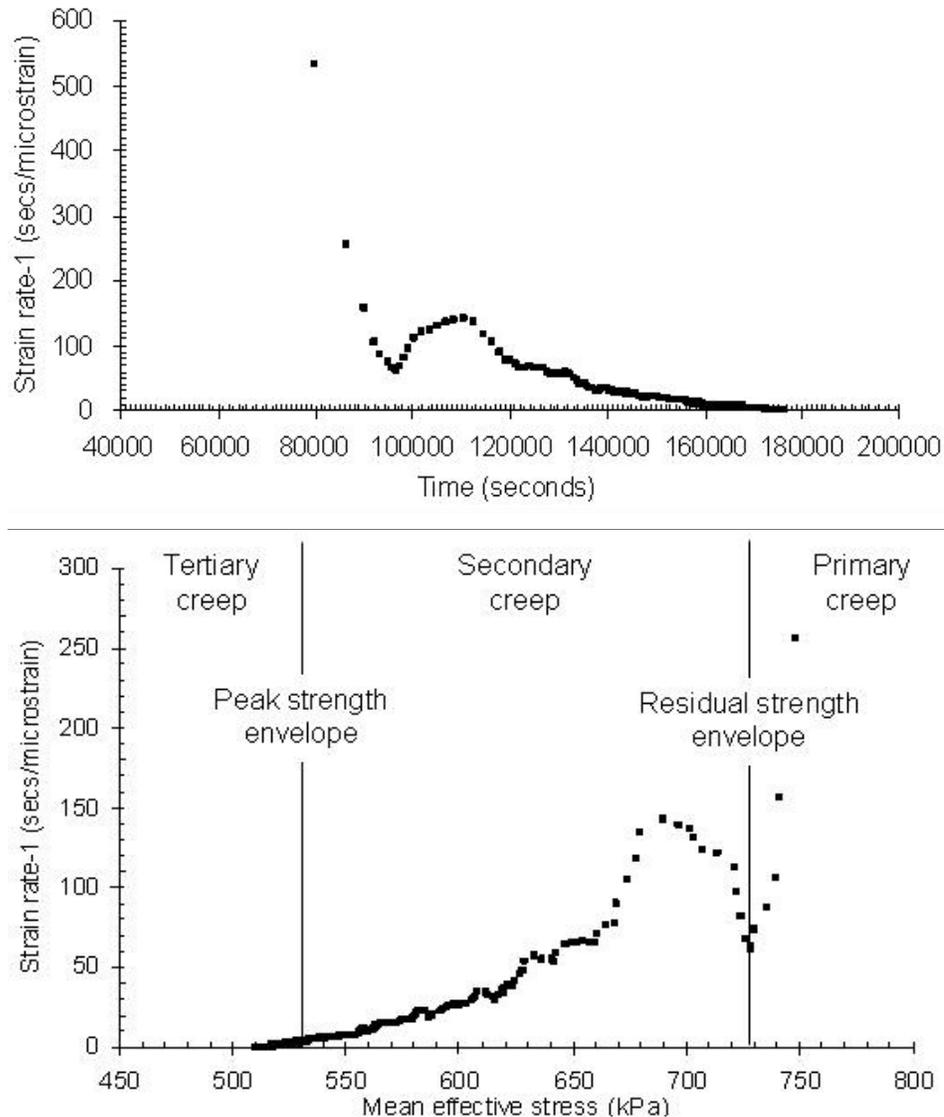
Figure 2.13(a) $1/v - t$ space plot of sample tested at 1000 kPa (b)

When the same dataset was plotted against mean effective stress (Fig 2.13b) measurable deformation began shortly after the residual strength failure envelope. After the residual strength had been surpassed a continual increase in strain rate was recorded but the pattern was not linear until the peak strength envelope had been reached (Petley and Allison, 2006). This linearity was then maintained to final failure but with cyclical fluctuations in strain rate.

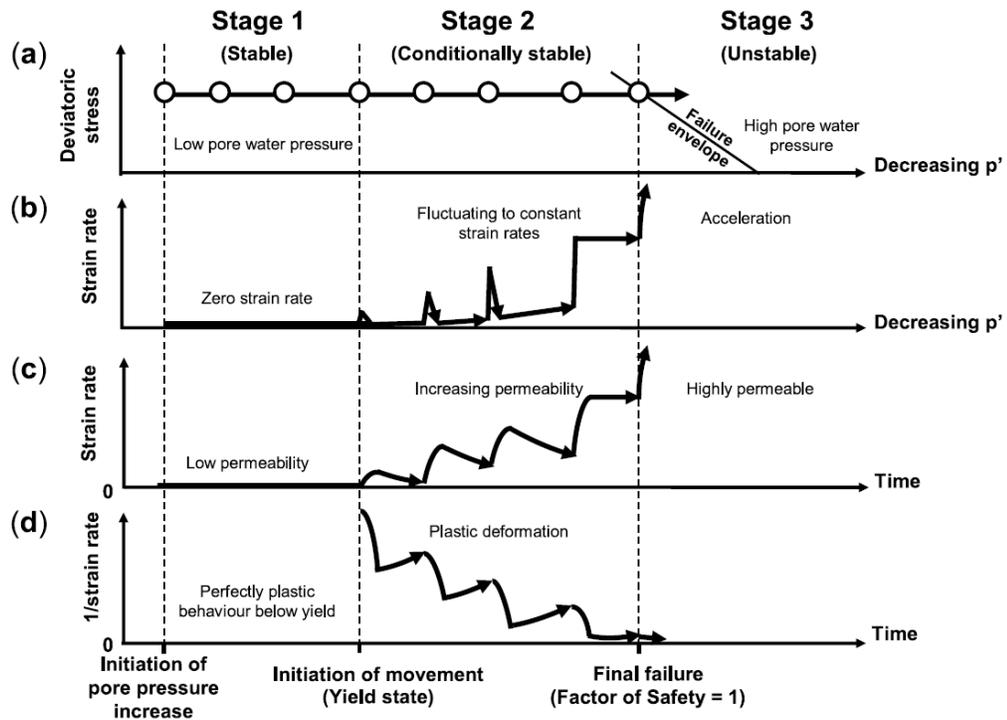
Figure 2.14 Schematic diagrams illustrating 3 stages of landslide movement in residual soils (after Ng and Petley, 2009)

1. Stage 1 is characterised by very low strain rates when the mean effective stresses are still high.
2. Stage 2 occurs as the mean effective stress decreases and associated strain increases. During this phase non-linear pulses in pore pressure increase lead to the development of measureable but significantly variable strain rates are observed.
3. Stage 3 occurs where porewater pressures are increased to a sufficient level that the landslide accelerates to final failure. This phase is believed to be associated with the restructuring of material within the landslide shear zone towards the critical state.

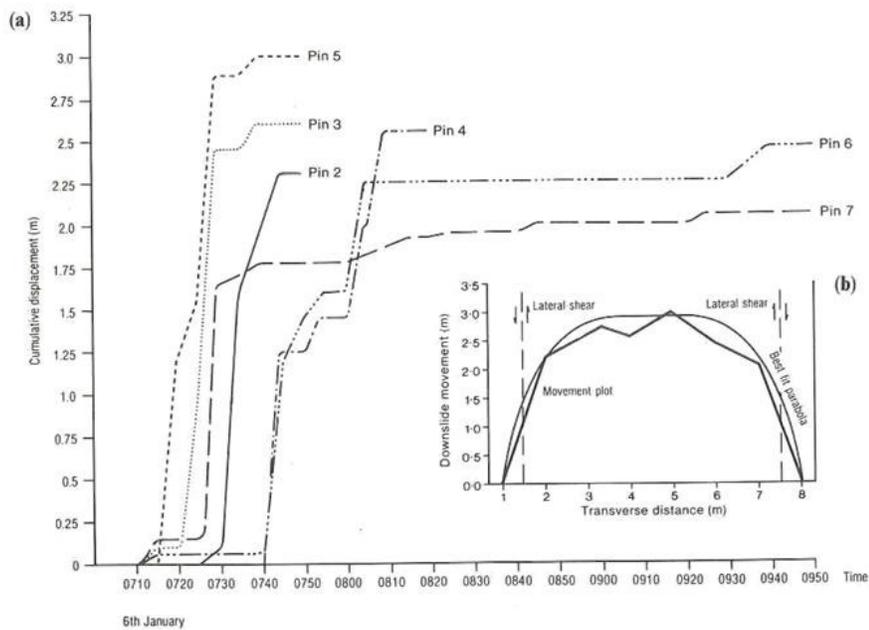
Figure 2.20 (a) A surge movement plot; (b) a horizontal velocity plot of surge movement (after Allison and Brunsden, 1990)

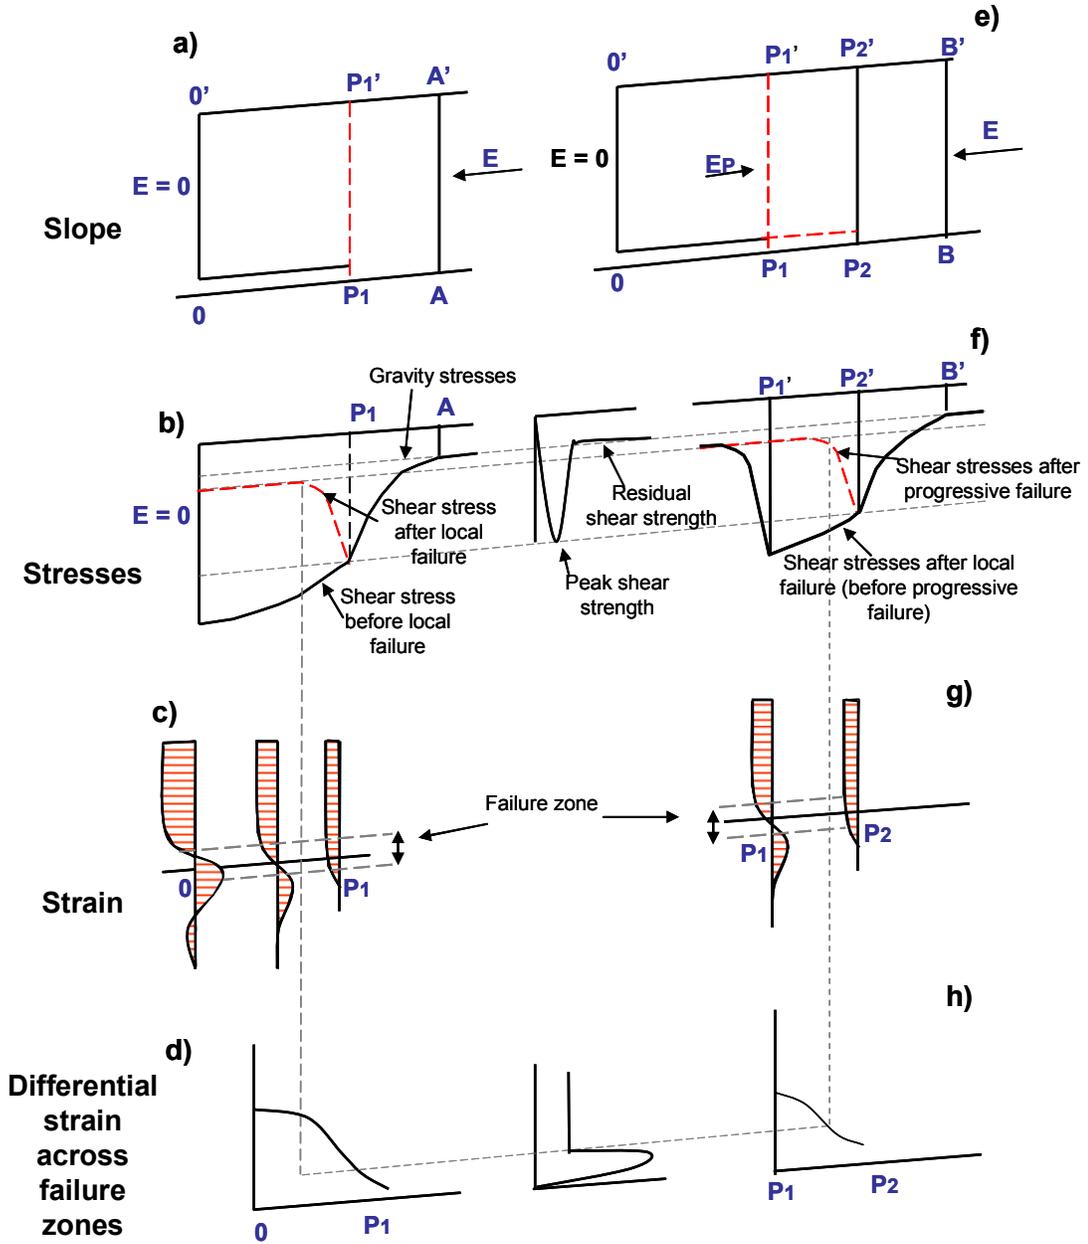
Figure 2.21 Principle of development of a continual sliding surface by progressive failure (after Bjerrum, 1967)

progressing. Prior to the excavation E_p would have been equal to E . The local unloading caused by the excavation and the reduction in shear stresses along OP1 when the initial failure occurred resulted in a reduction of E_p .

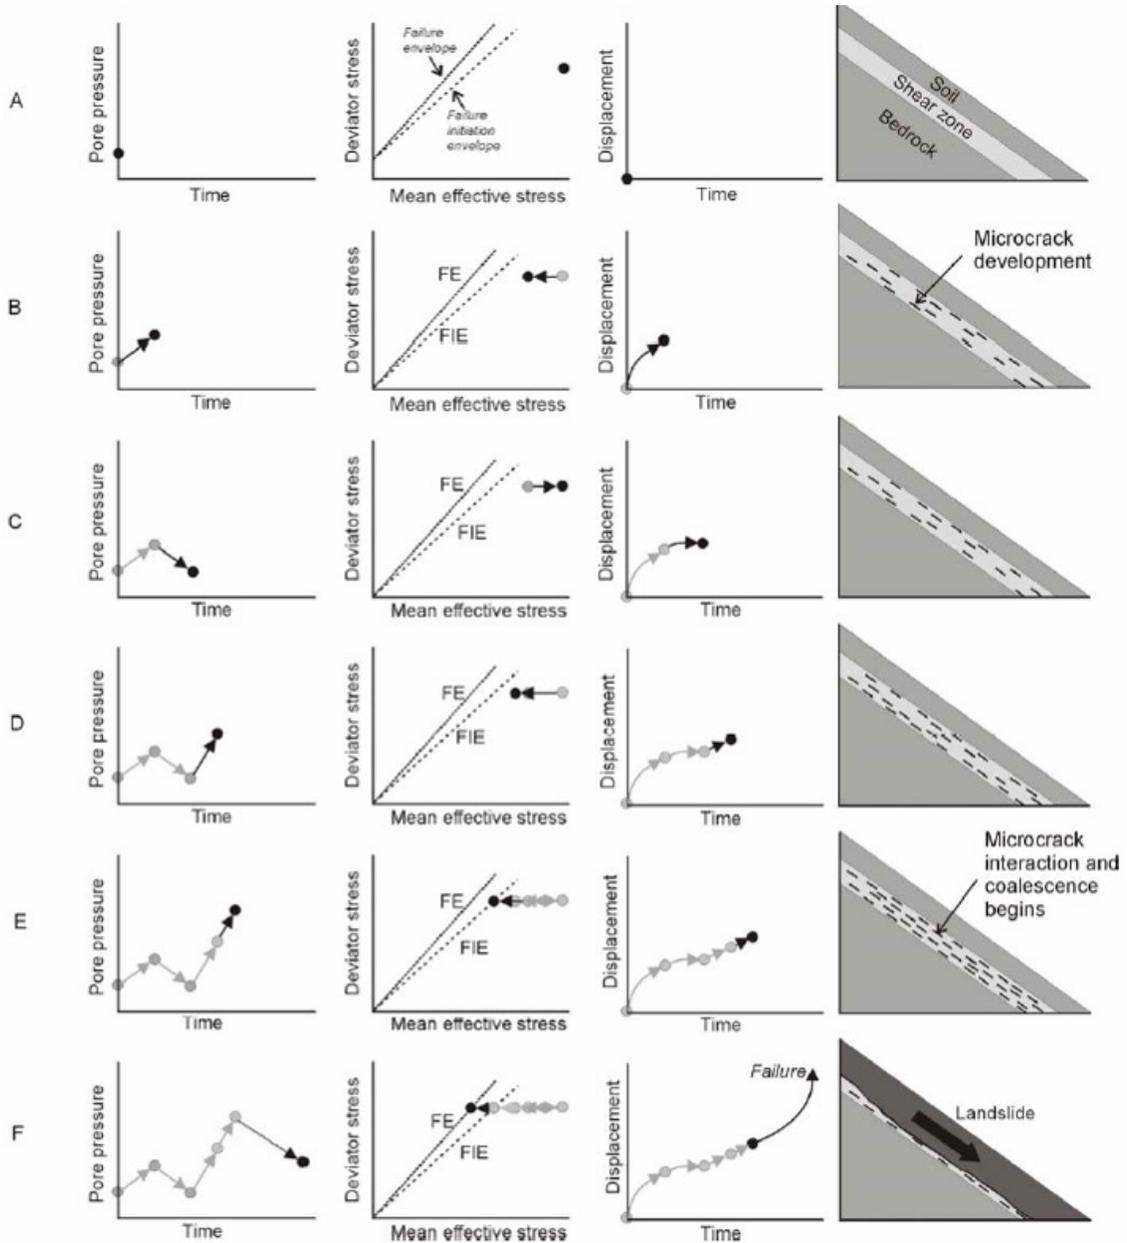
Figure 2.23 New model for the progressive development of a shear surface after Petley et al. (2005b)

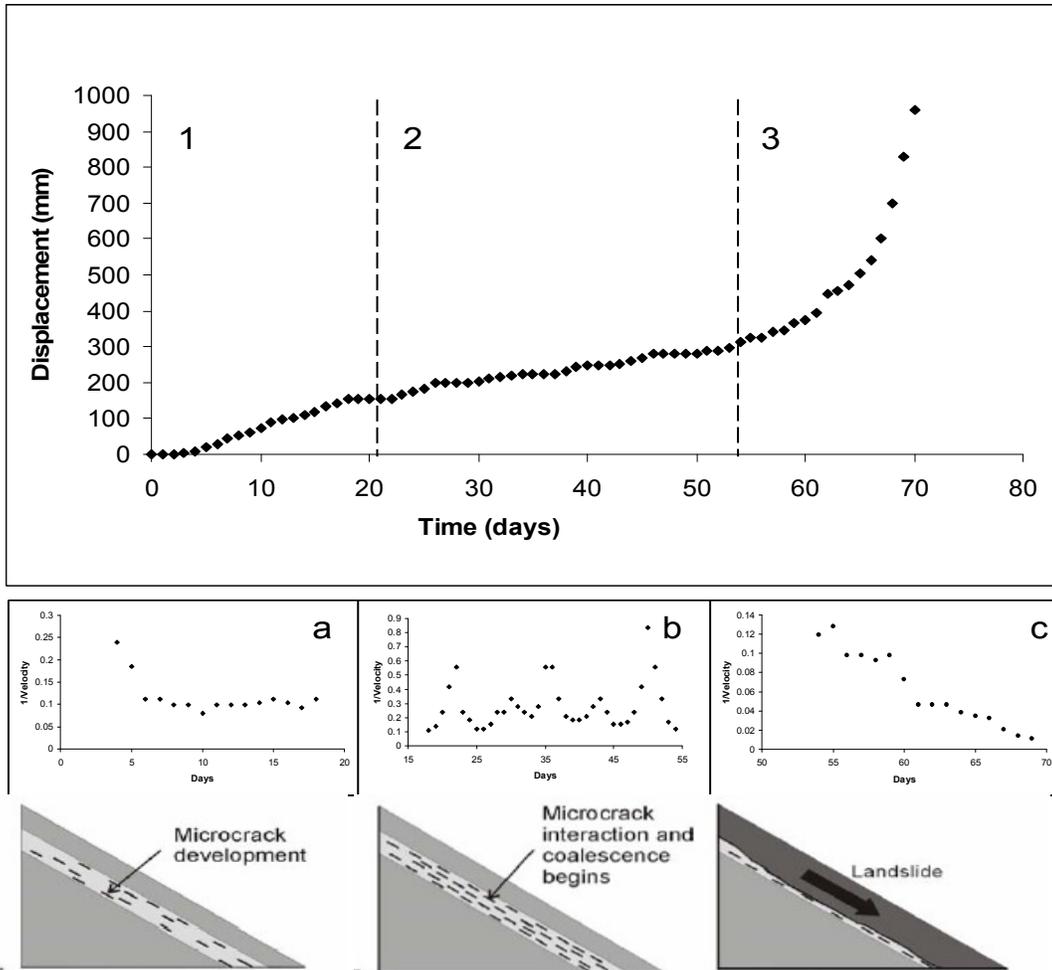
Figure 2.25 Landslide movement, New Tredegar (after Carey et al., 2007).

The 1930 New Tredegar landslide event supports the proposed models of progressive development of landslide failure proposed by Petley *et al.* (2005a; 2005b). The data supports the recent analysis of the Vaiont dam landslide (Petley and Petley, 2006), illustrating the early ductile movement patterns followed by a transitional trend from pure ductile deformation to brittle deformation. It further supports the existence of 'Saito' linearity during the final phase of failure (Fukuzono, 1990). The development of the linear trend in $1/v - t$ is recognisable at approximately day 56, which further highlights the potential use of this method as an effective forecasting and landslide hazard warning system

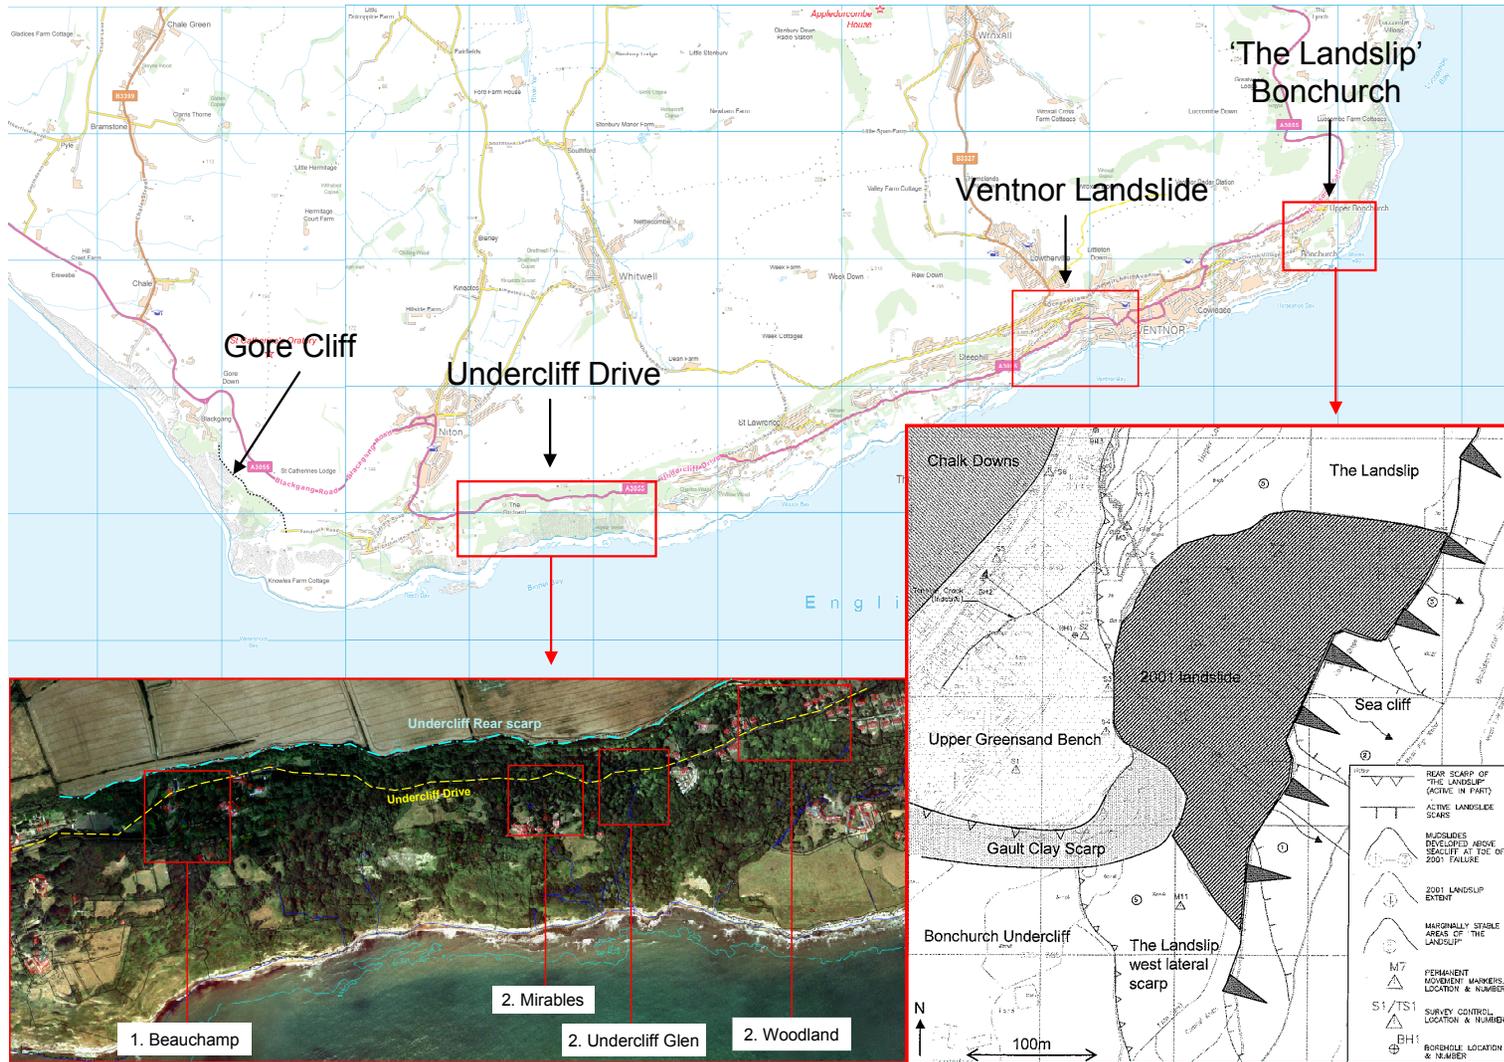
Figure 3.3 Previous investigations sites along the Undercliff

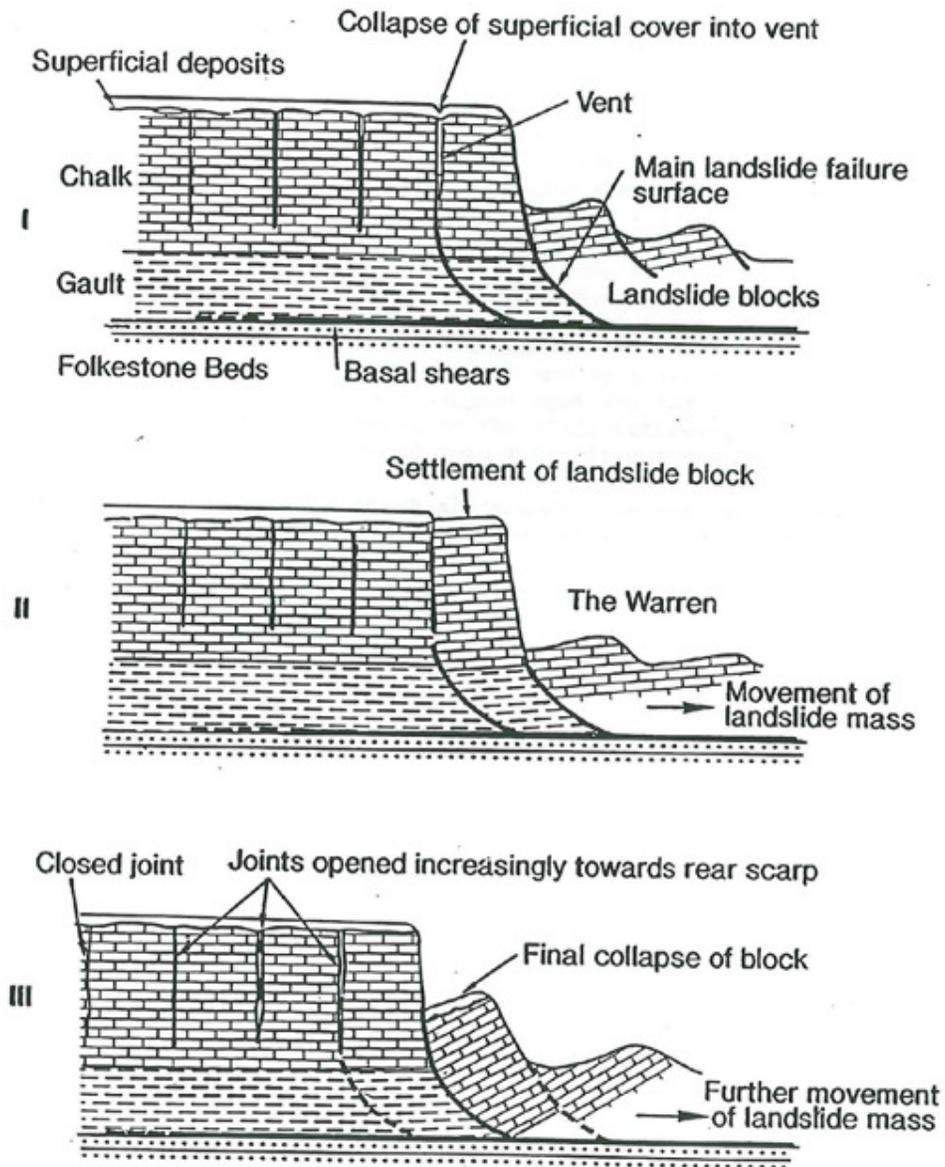
Figure 3.16 Proposed landslide development model, Folkestone Warren,
(after Hutchinson, 1969)

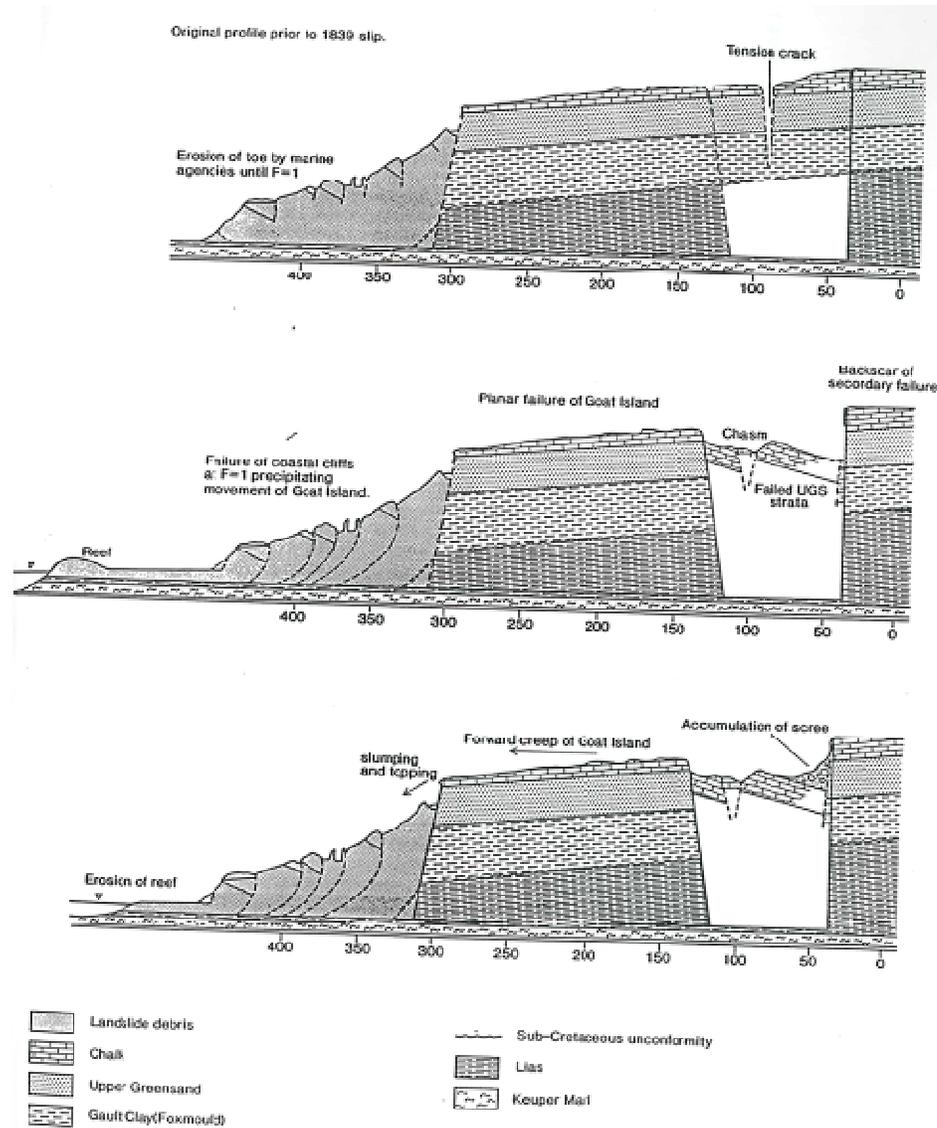
Figure 3.17 Proposed landslide model for the Bindon, Dorset (after Pitts and Brunsden, 1982)

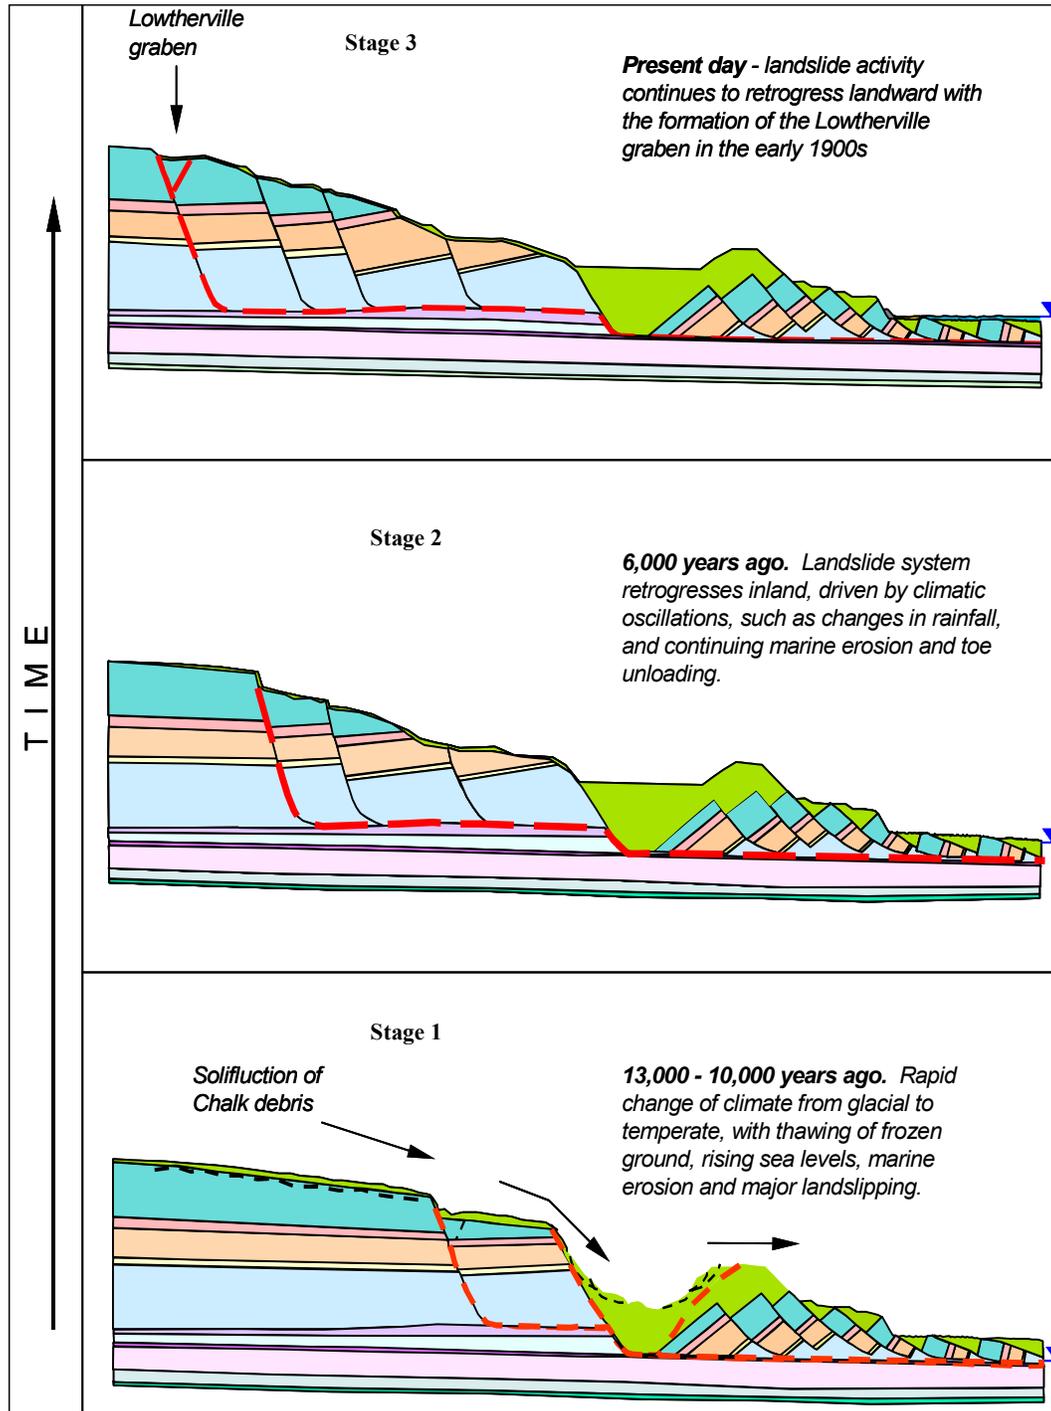
Figure 3.19 Proposed evolution of the Ventnor Undercliff Landslide (after Moore et al., 2007b)

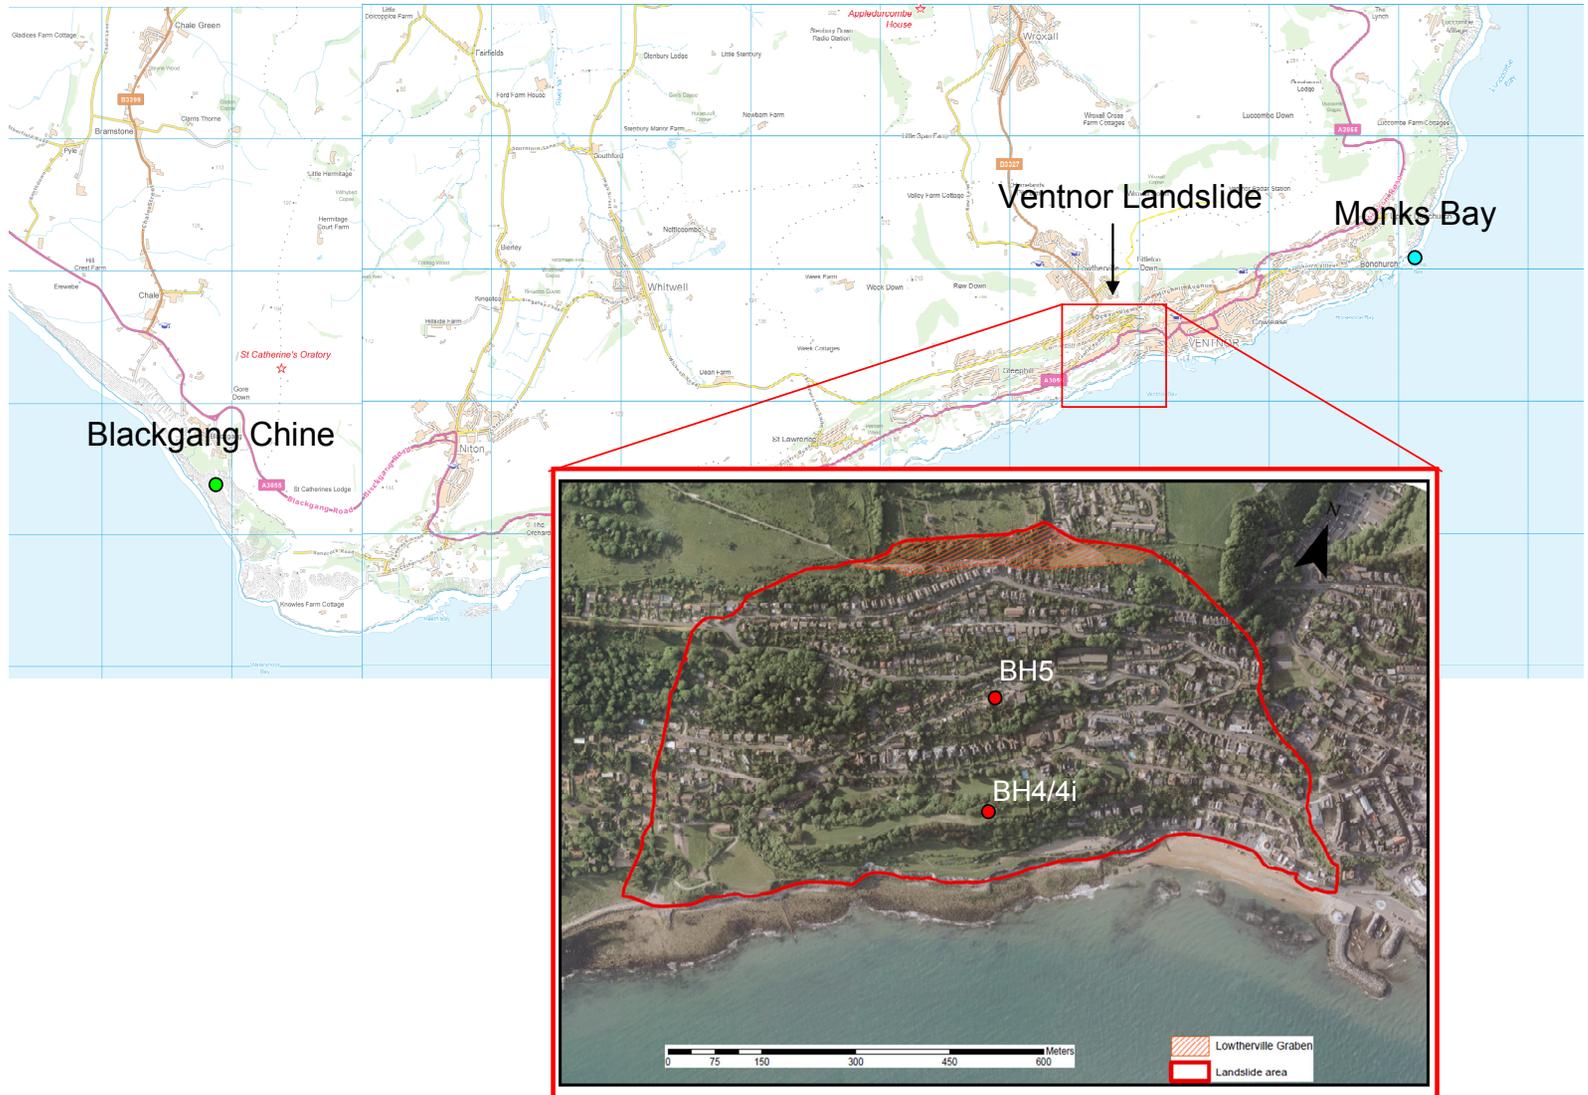
Figure 4.1 Sampling locations along the Undercliff

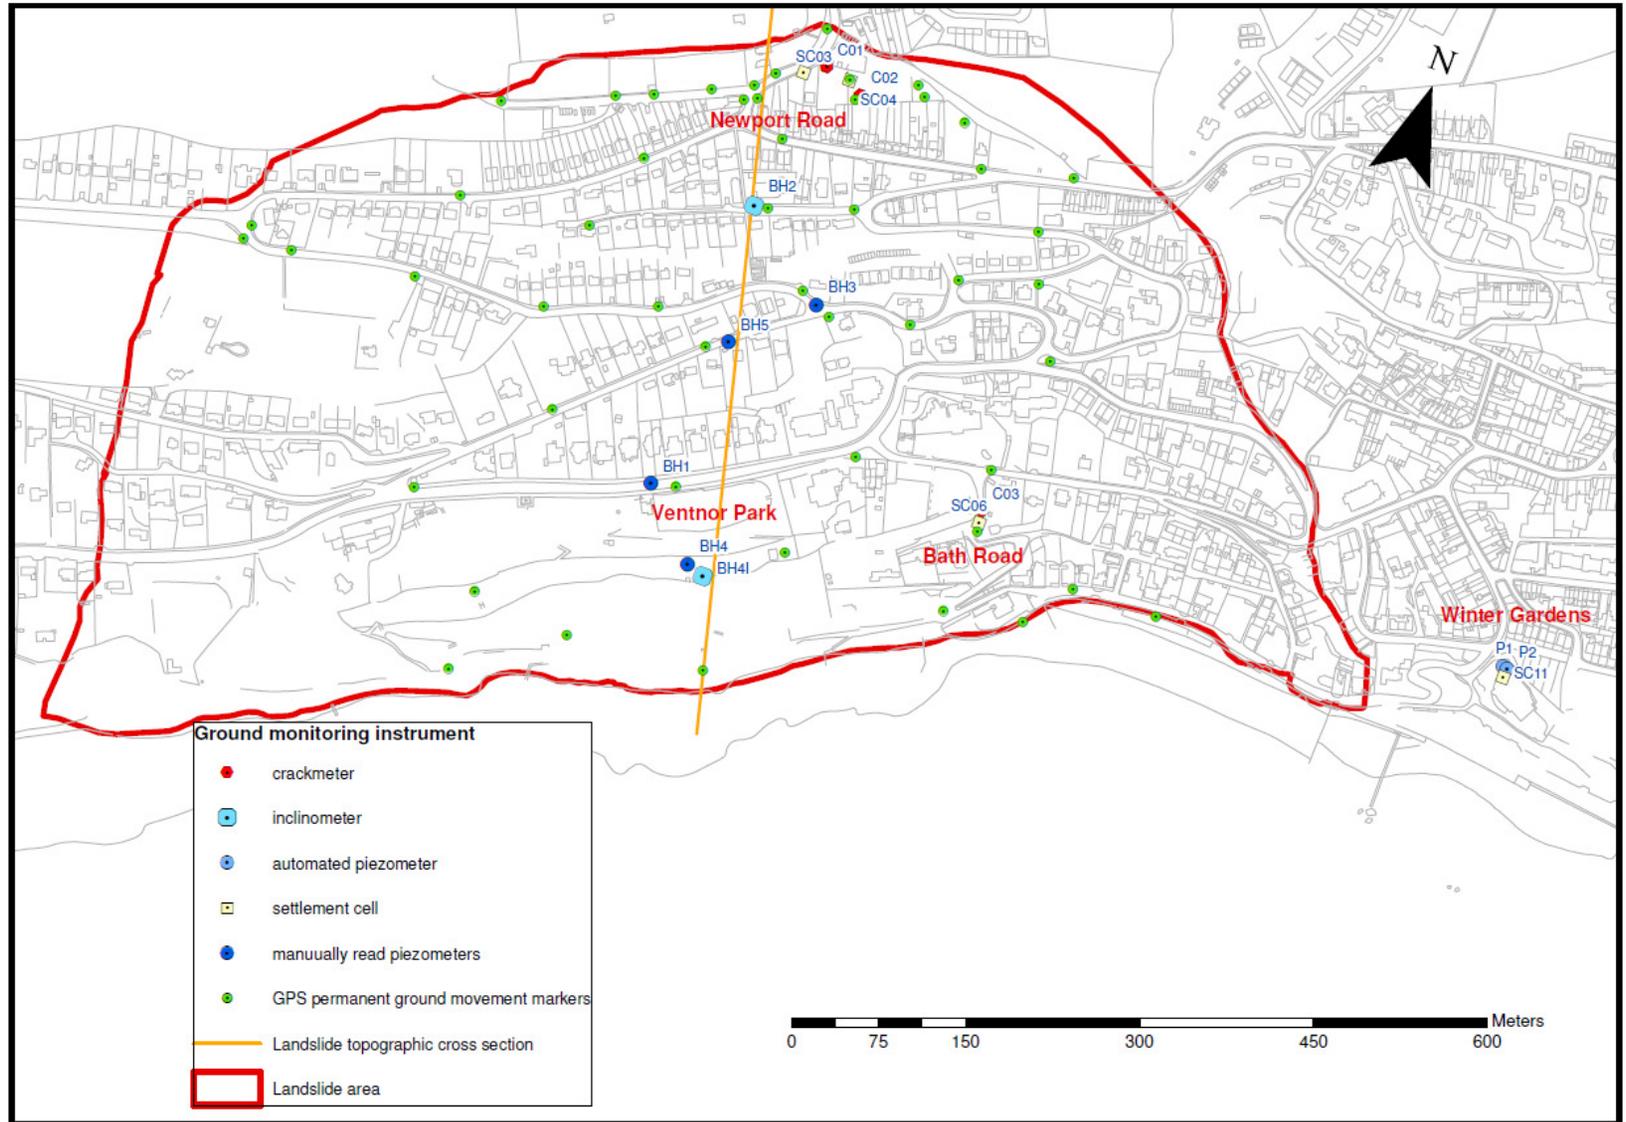
Figure 4.2 Site monitoring sites and instrument location plan, Ventnor Town
