The Progressive Development and Post-failure Behaviour of Deep-seated Landslide Complexes

JONATHAN MARTIN CAREY

PhD thesis

This thesis is submitted in accordance with the regulations for the degree of Doctor of Philosophy in Durham University, Department of Geography, 2011

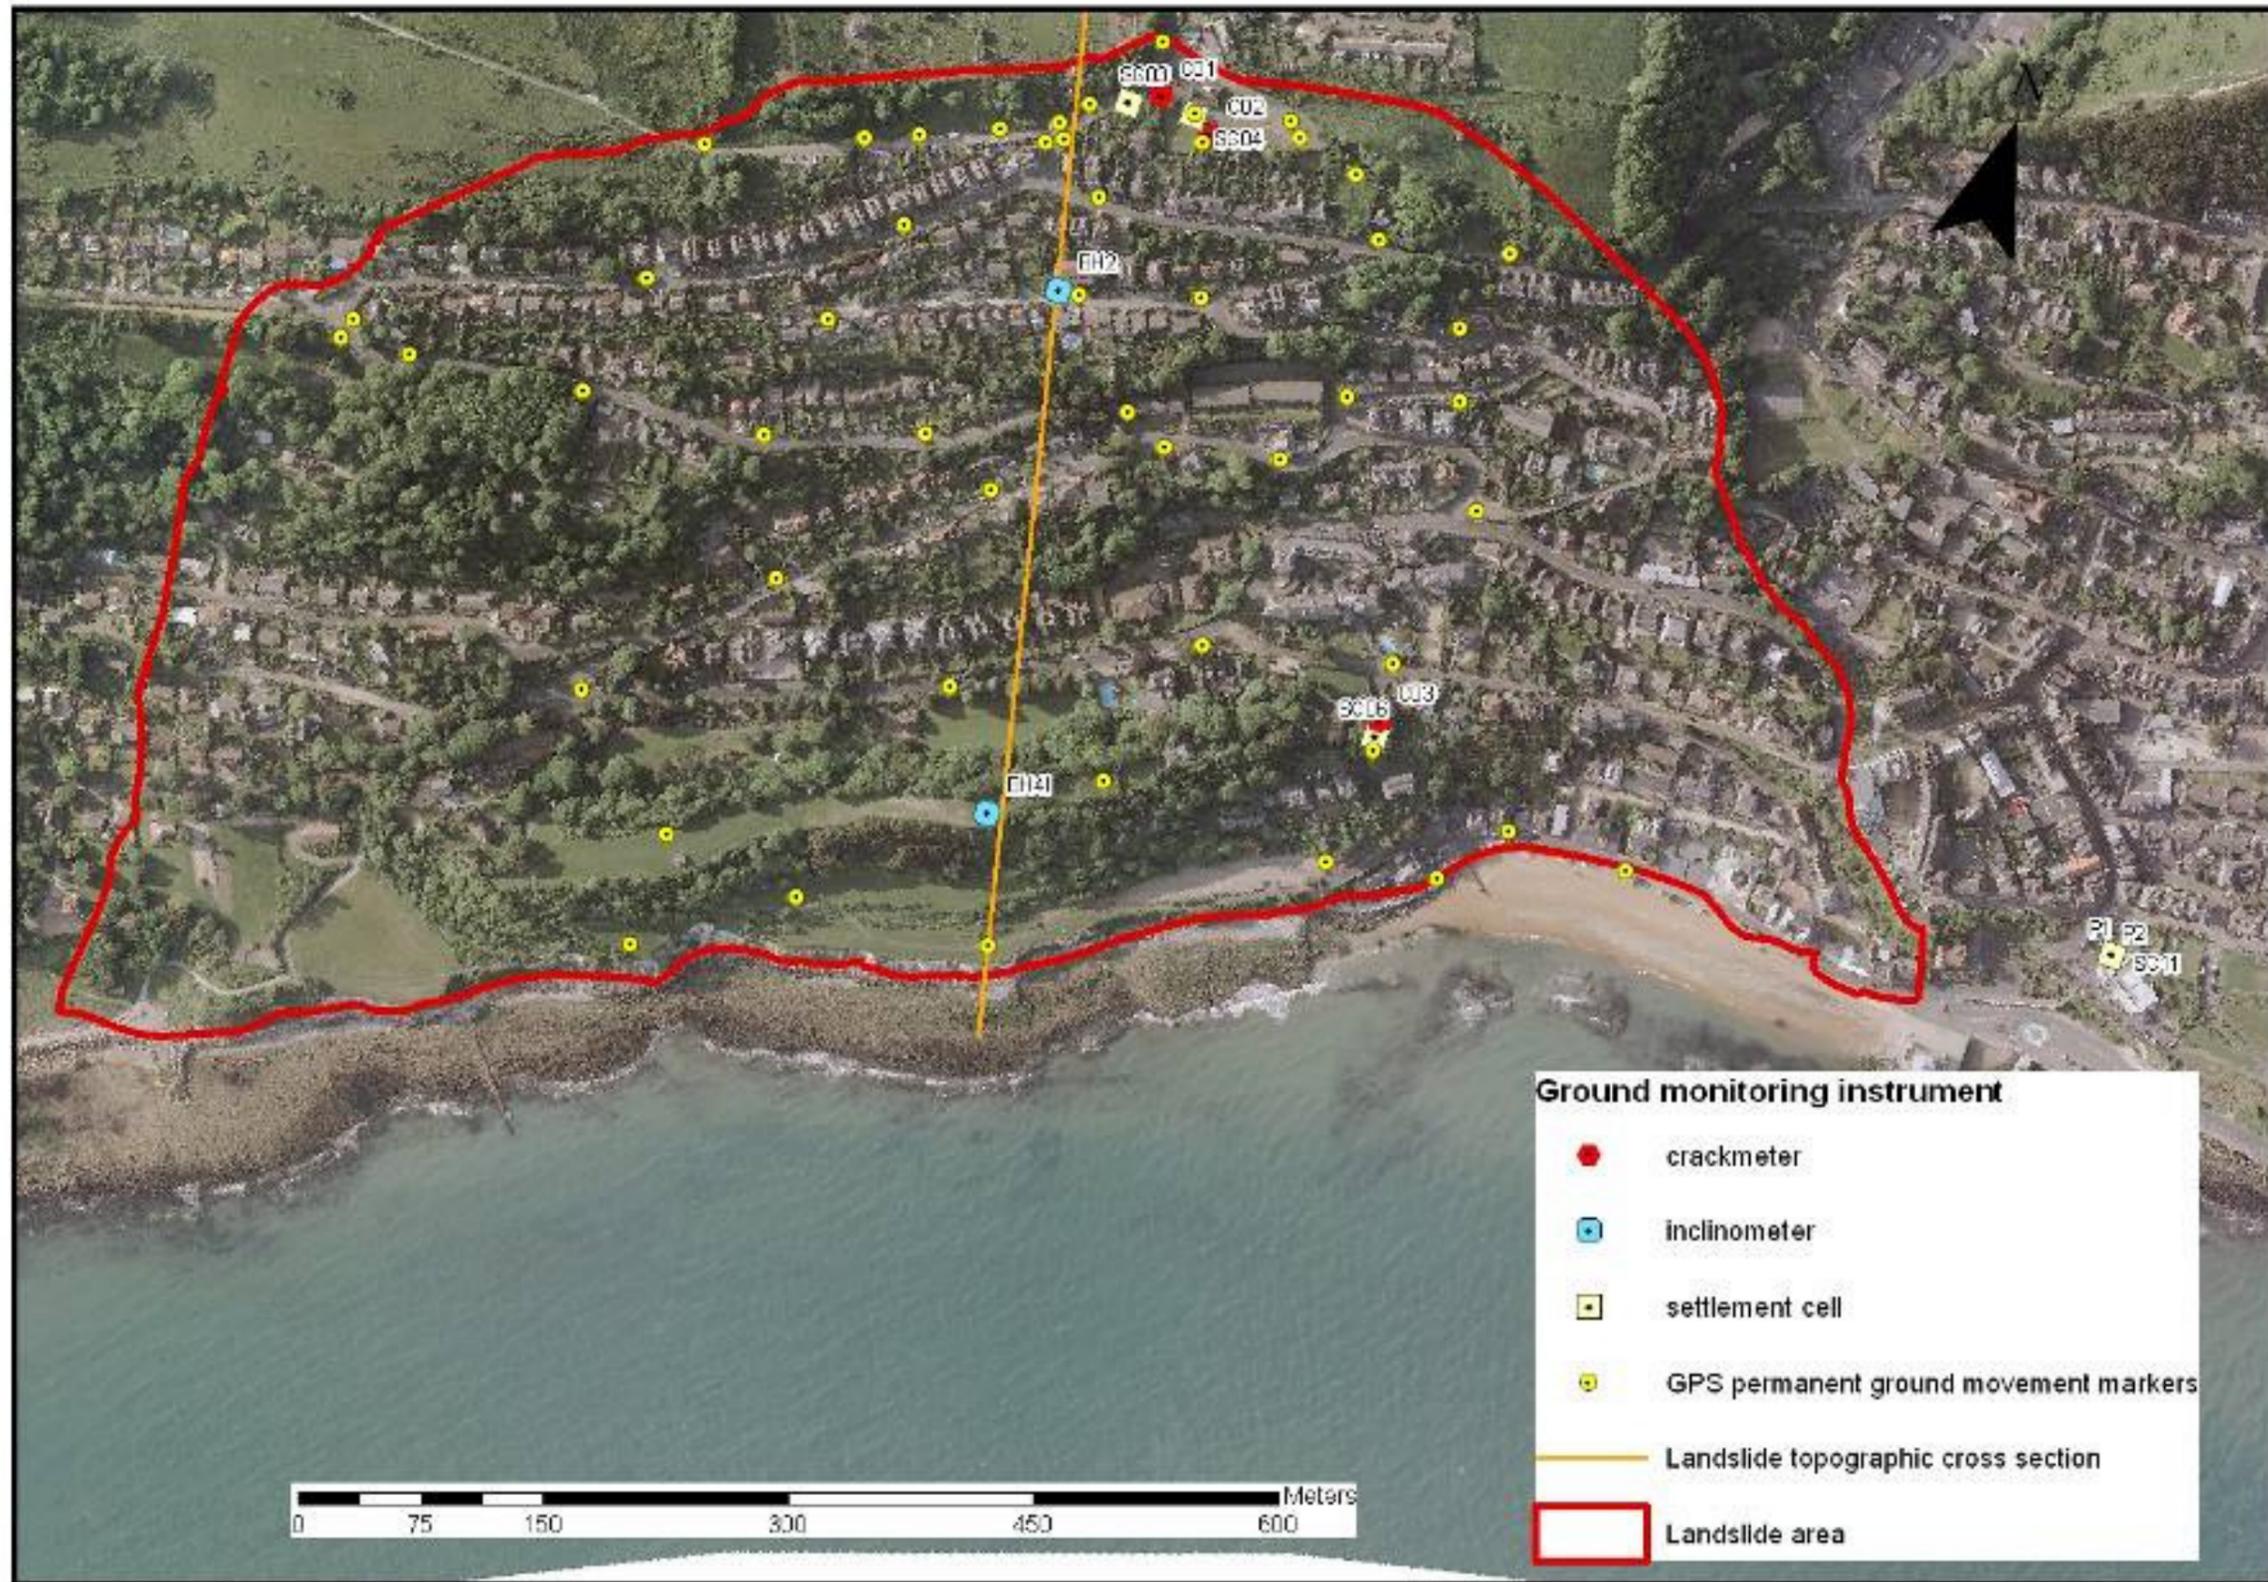
Figure 5.1 Location of the Ventnor ground monitoring instruments

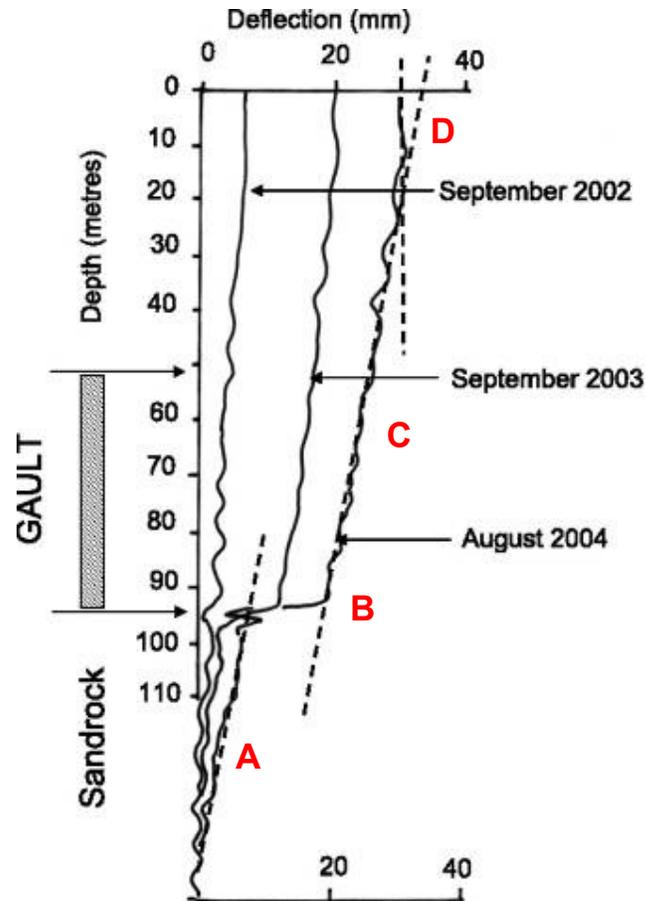
Figure 5.3 Inclinometer movement recorded at BH2 between 2002 and 2004
(after de Freitas, 2009)

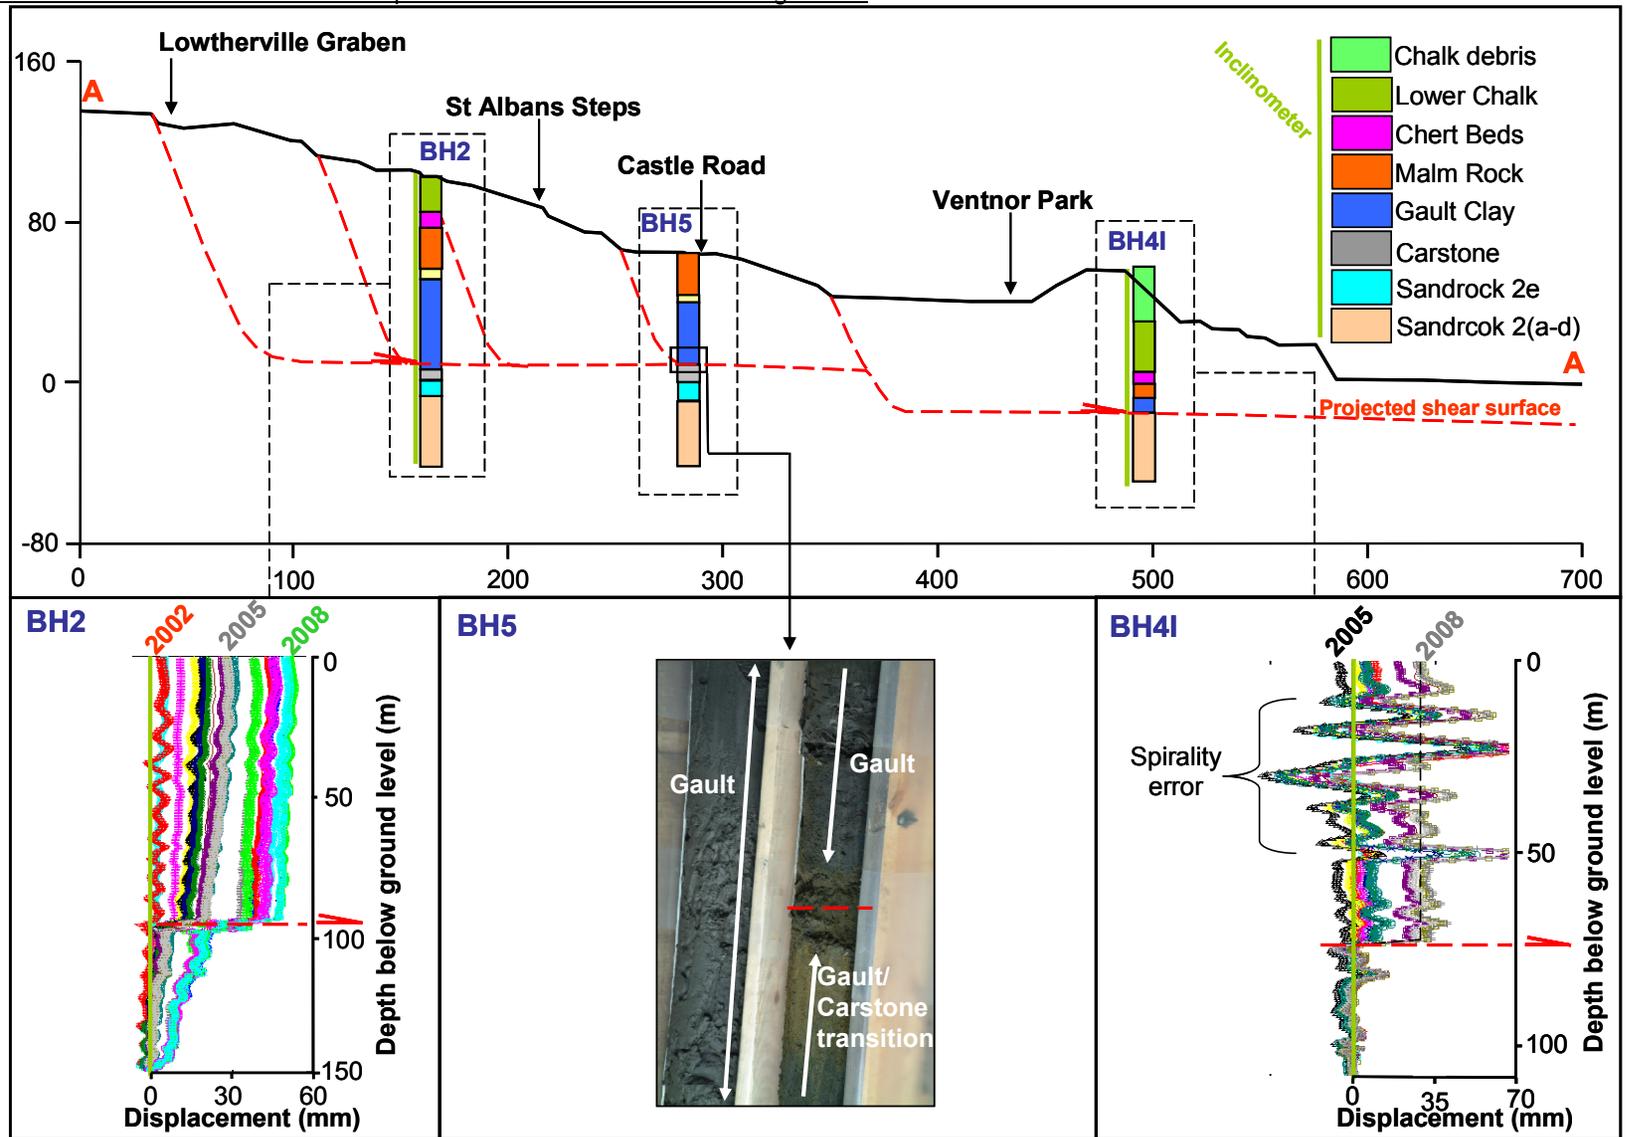
Figure 5.4 Cross section of landslide ground movement within the Ventnor landslide complex

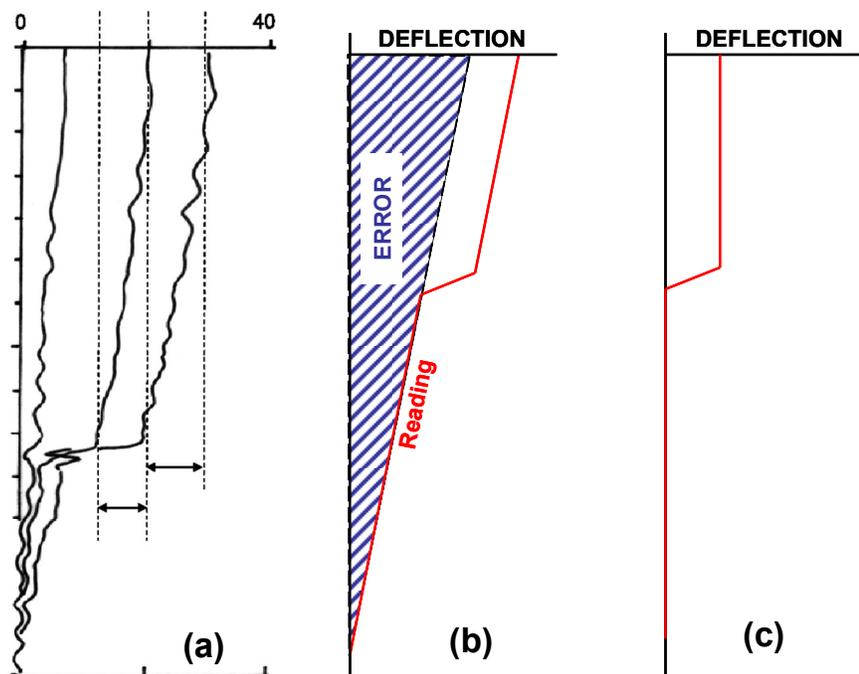
Figure 5.5 Potential travel error within the borehole measurements at BH2 (a) Ventnor inclinometer record (after de Freitas, 2009) (b) bias shift error (c) bias shift correction (adapted from Mikkelsen, 2003)

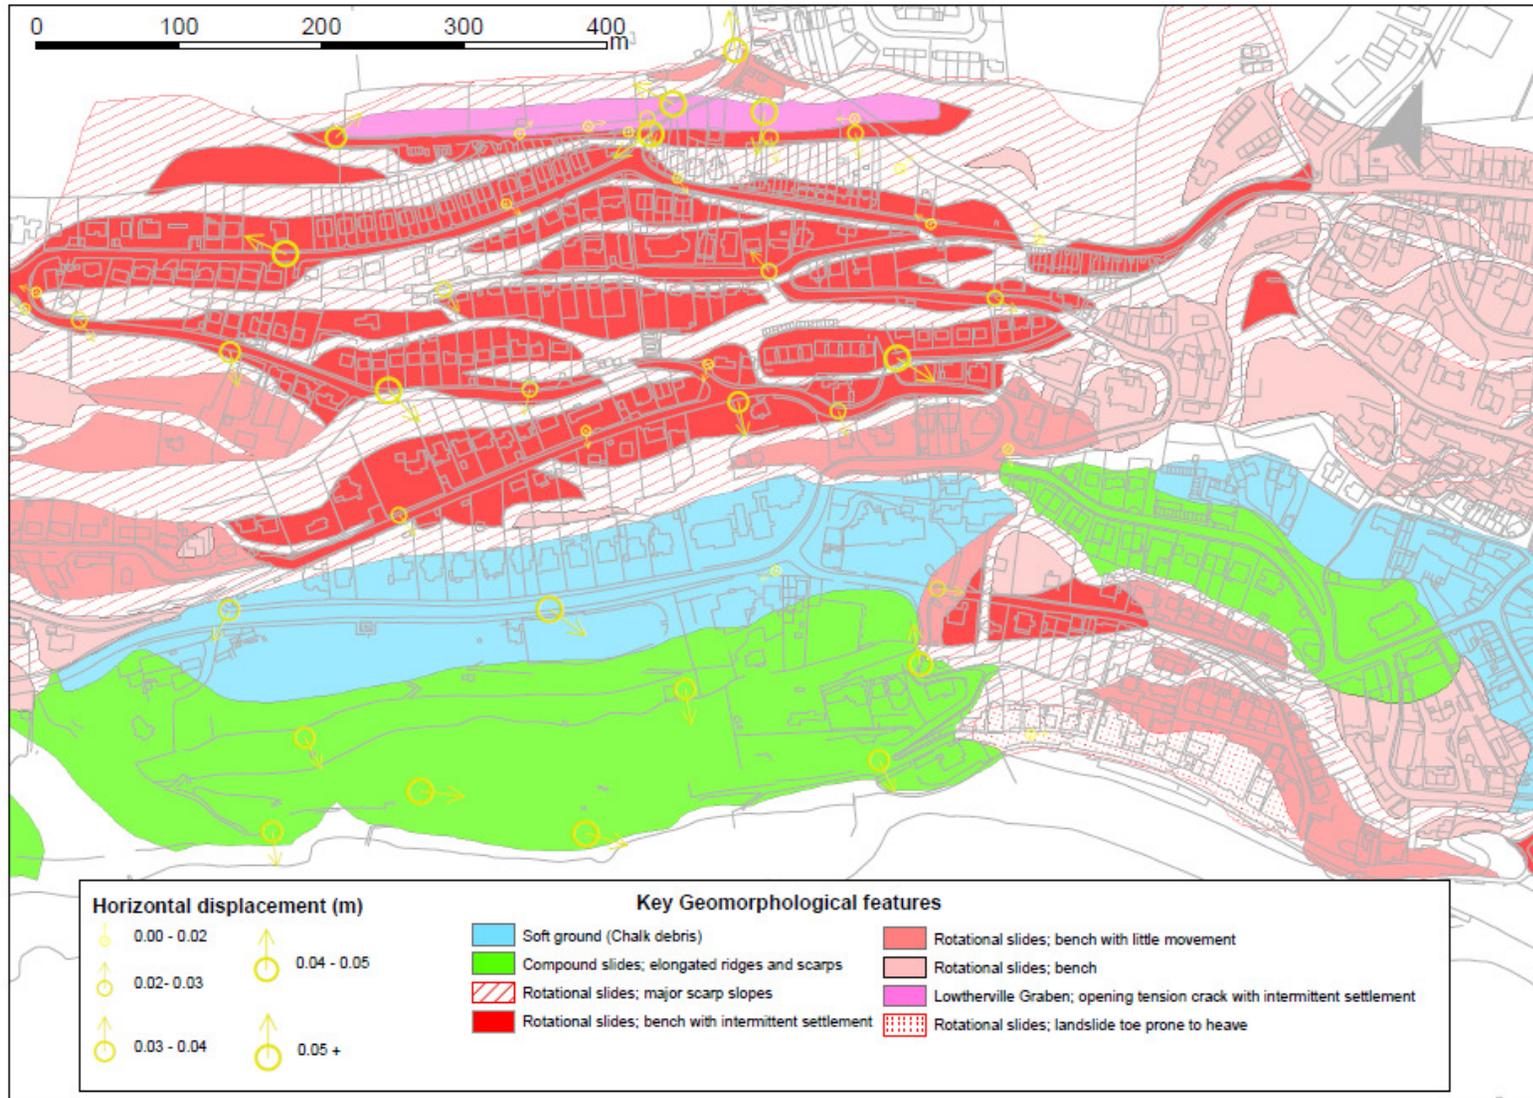
Figure 5.7 Comparison of the differential GPS survey data collect by IWC (2005-2008) and site geomorphological mapping undertaken by GSL, (1991)

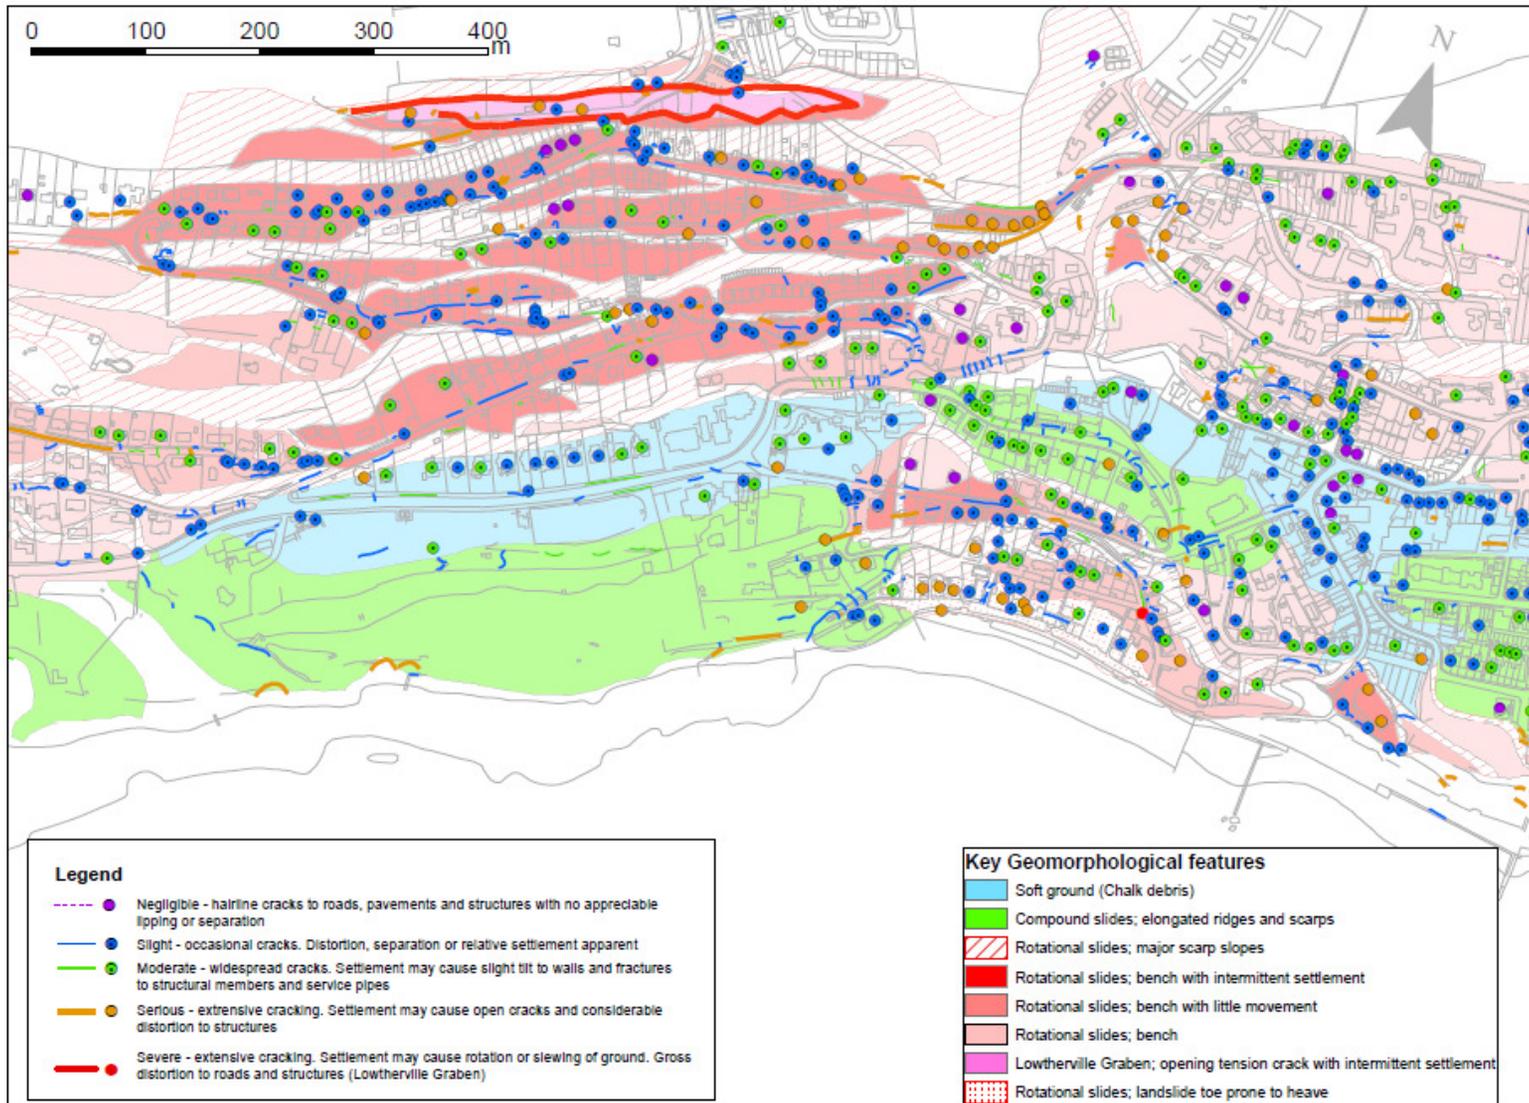
Figure 5.8 The spatial distribution of damage in relation to site geomorphological mapping undertaken by GSL (1991)

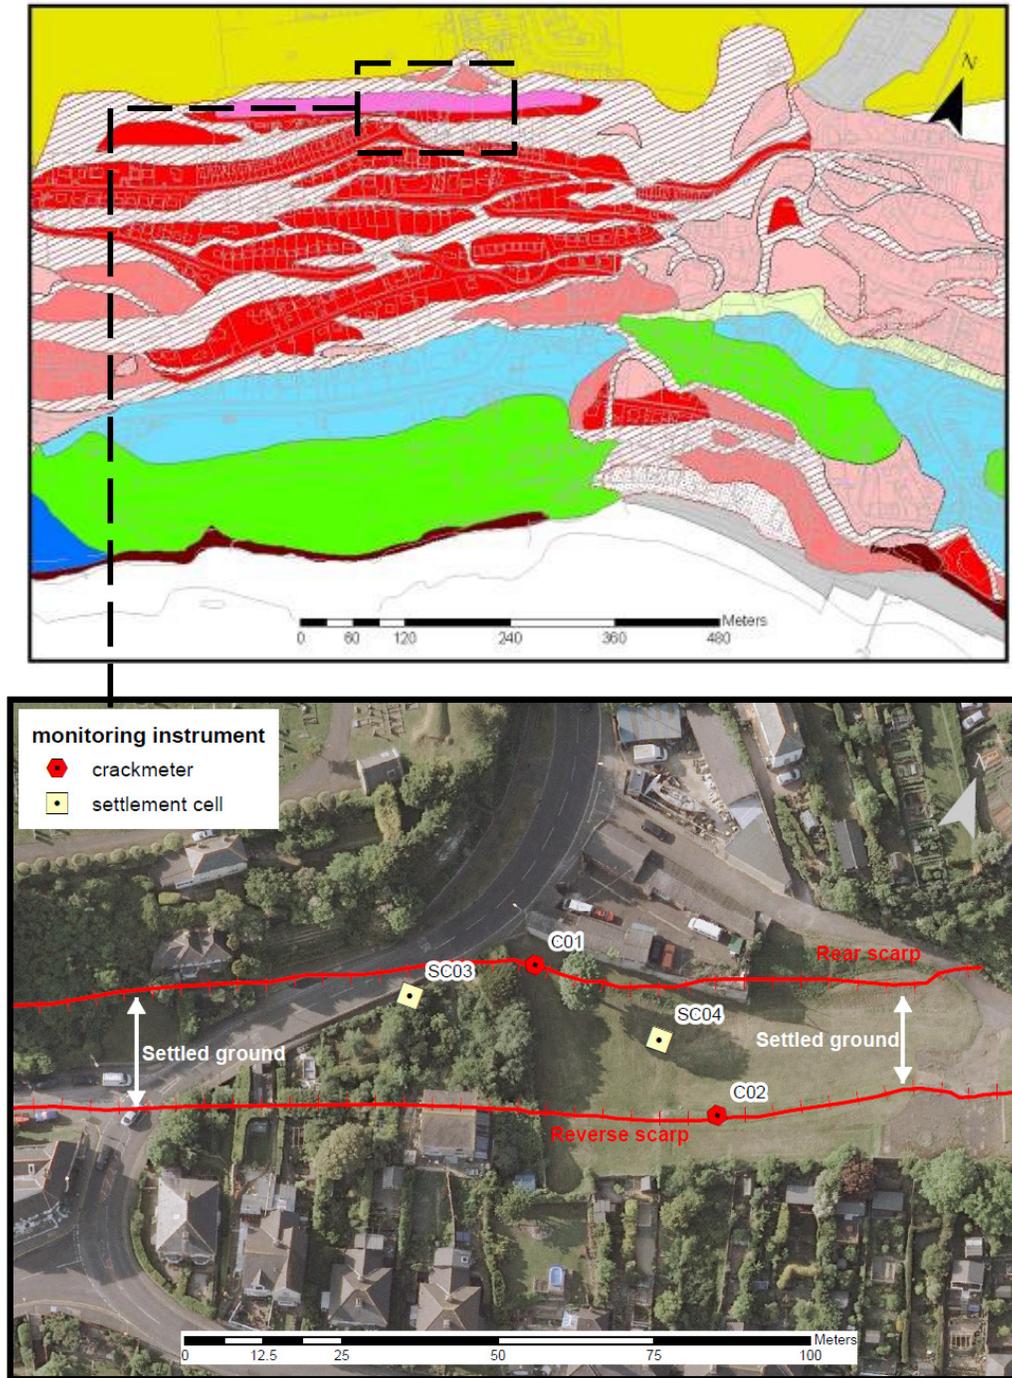
Figure 5.9 Monitoring instruments installed at Newport Road (Lowtherville Graben) in relation to the site geomorphology mapped by GSL (1991)

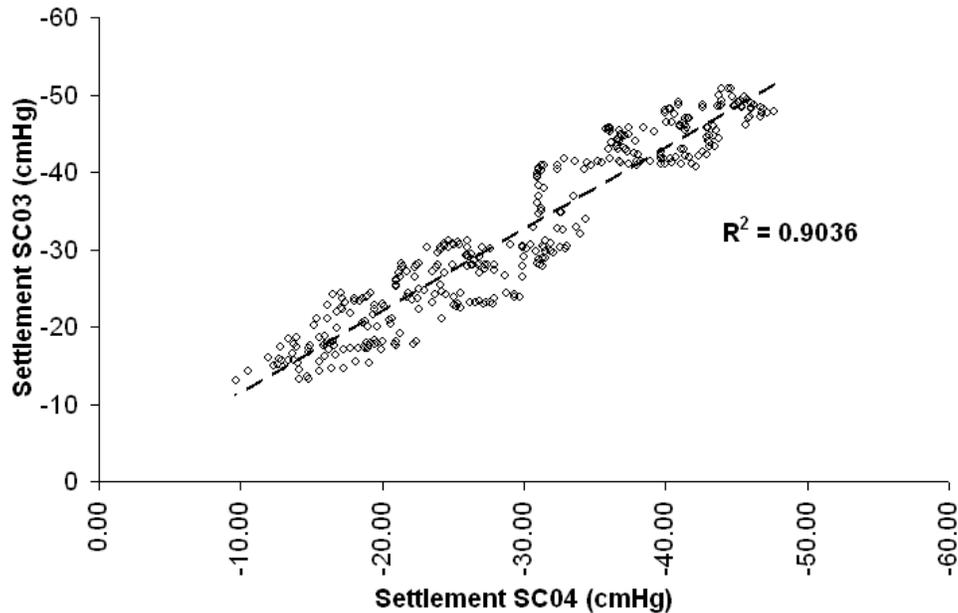
Figure 5.12 Correlation of settlement measurements at the Newport Road between 1995 and 2004

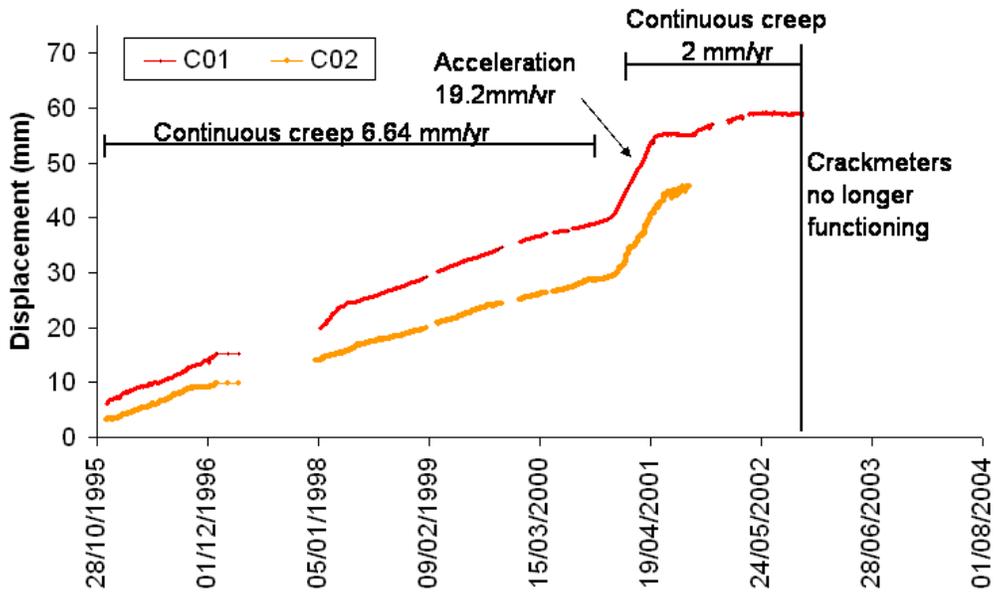
Figure 5.13 Displacement against time recorded at C01 and C02, Newport Road between 1995 and 2002

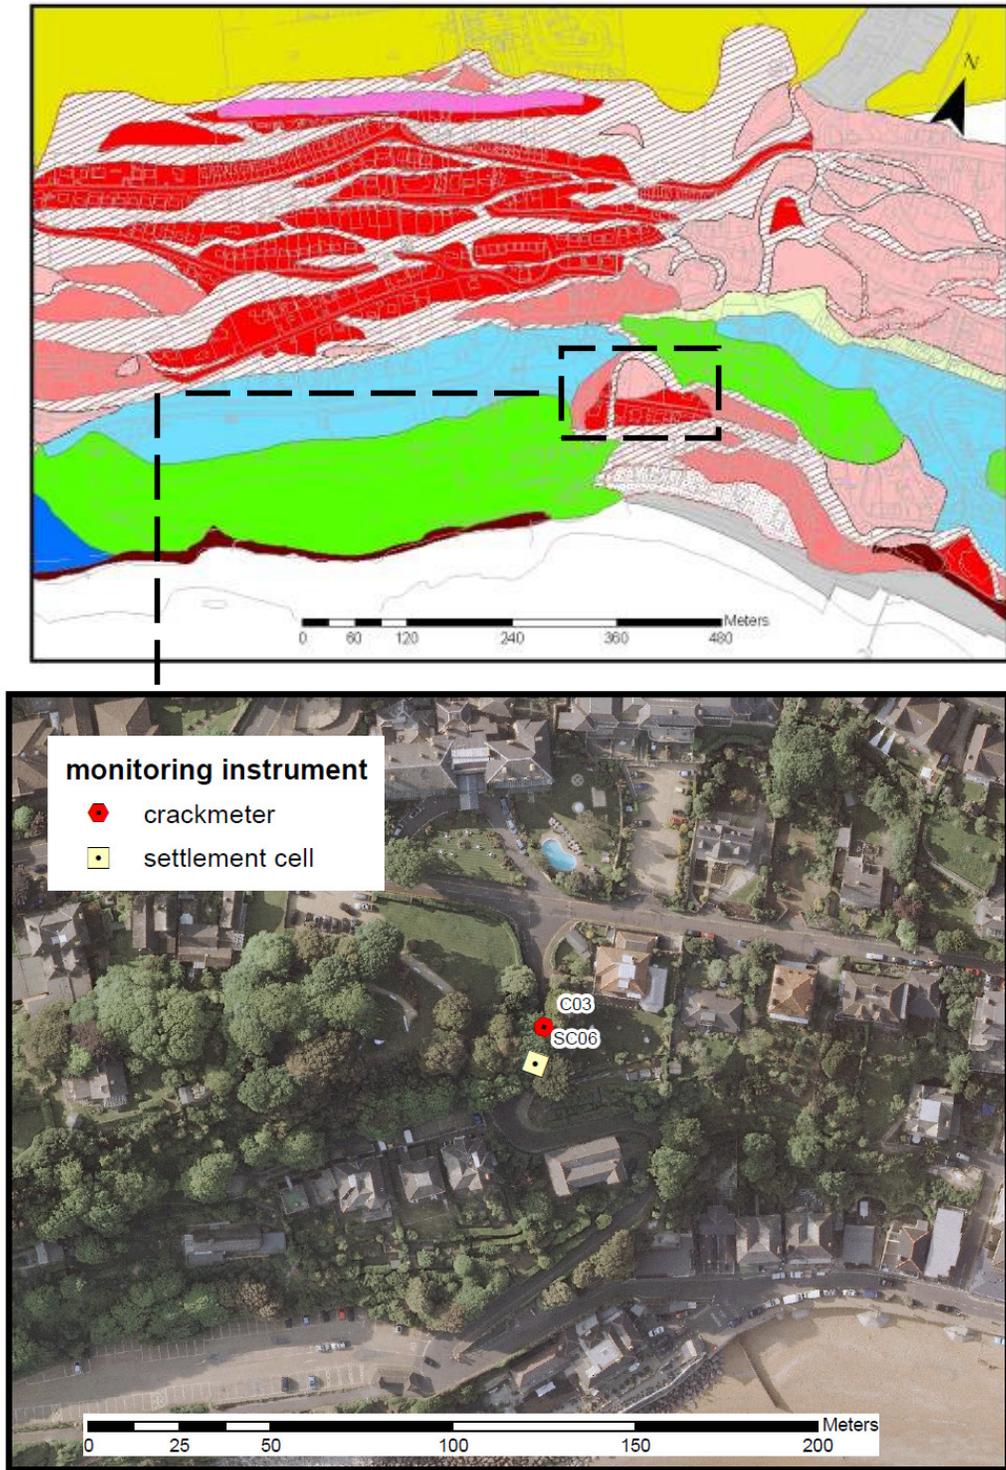
Figure 5.16 Monitoring instruments installed at Bath Road in relation to the site geomorphology mapped by GSL (1991)

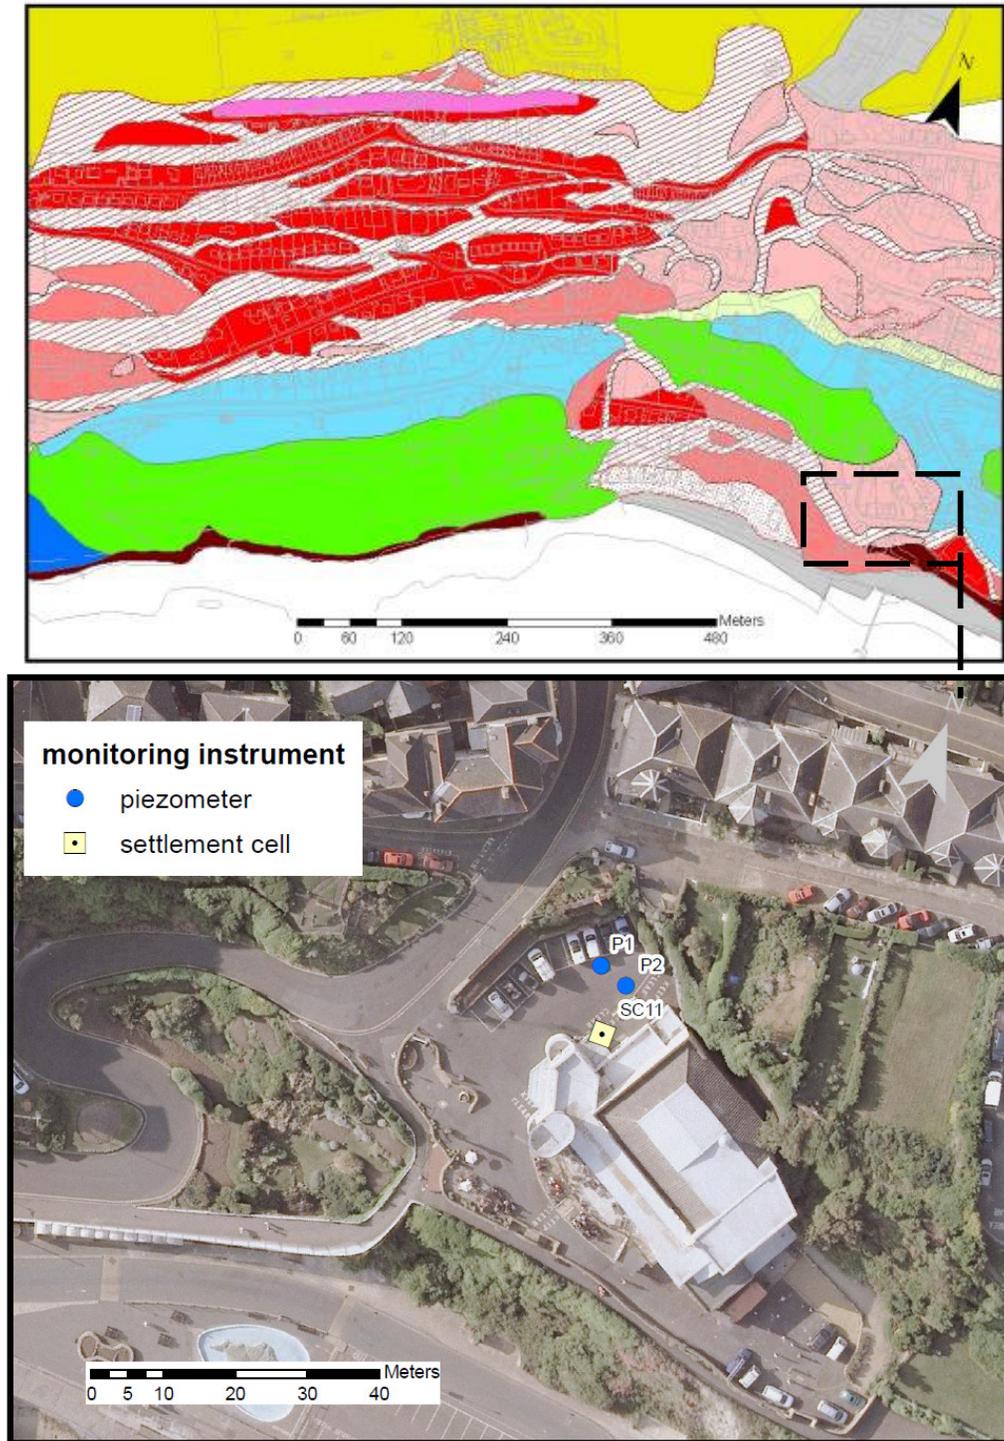
Figure 5.20 Monitoring instruments installed at Winter Gardens in relation to the site geomorphology mapped by GSL (1991)

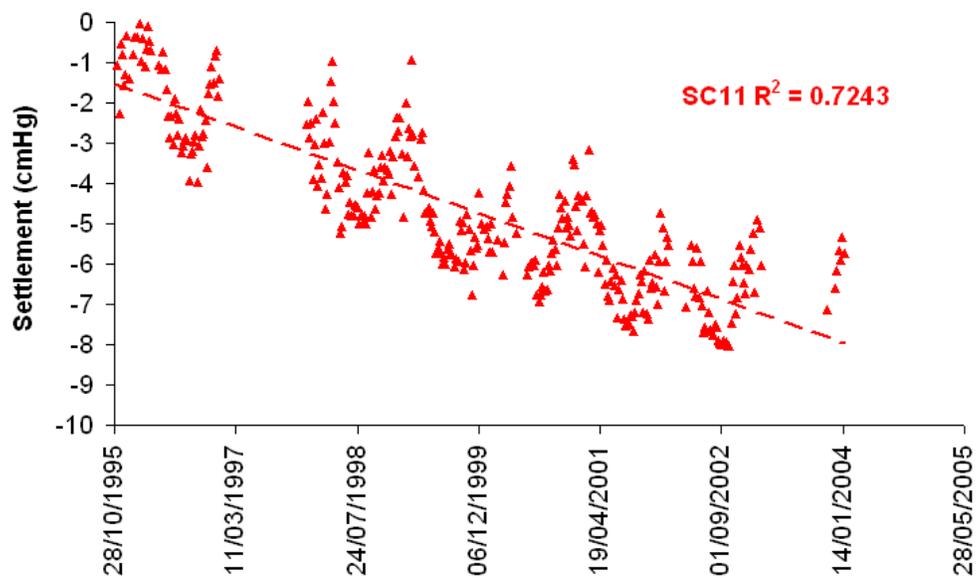
Figure 5.21 Settlement records at SC11, Winter Gardens (1995-2004)

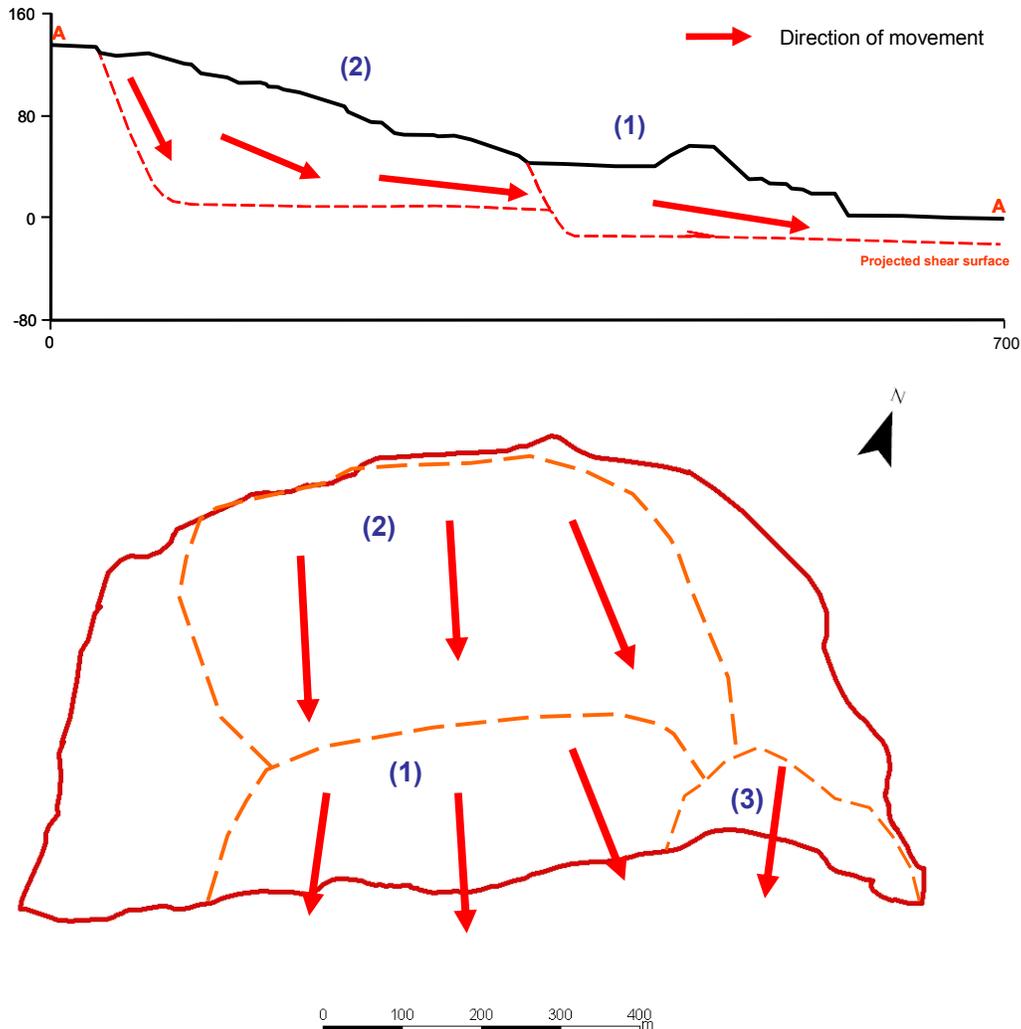
Figure 5.23 Spatial movements of the Ventnor landslide units

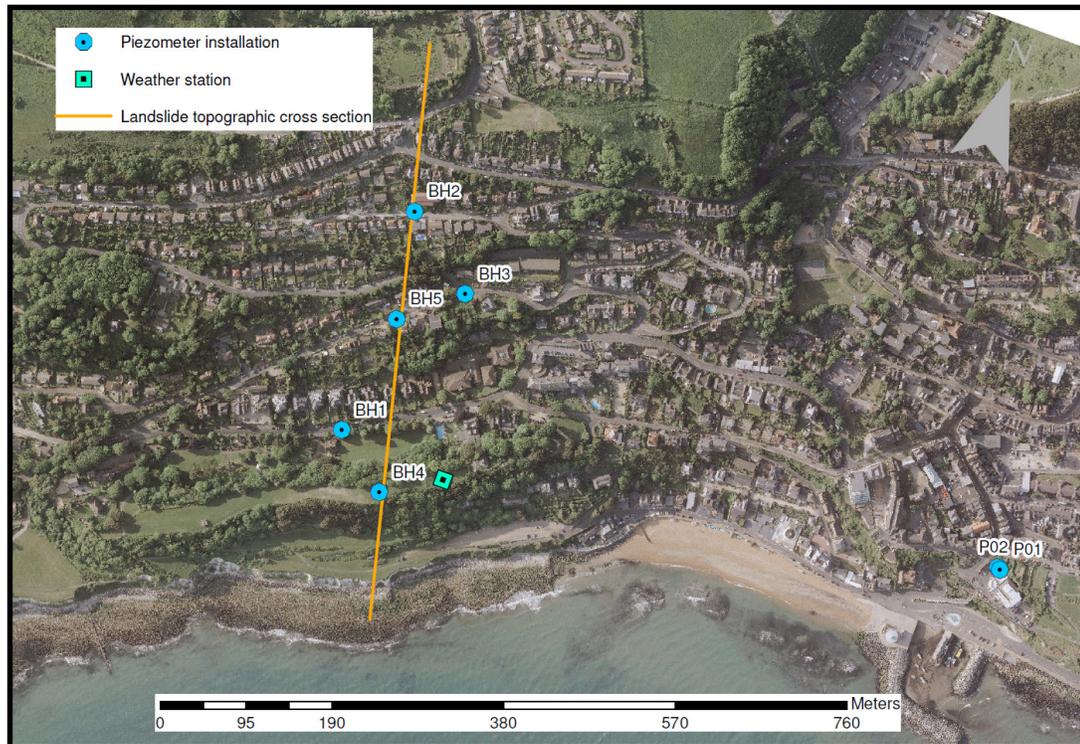
Figure 5.24 Piezometer and weather station locations, Ventnor Town

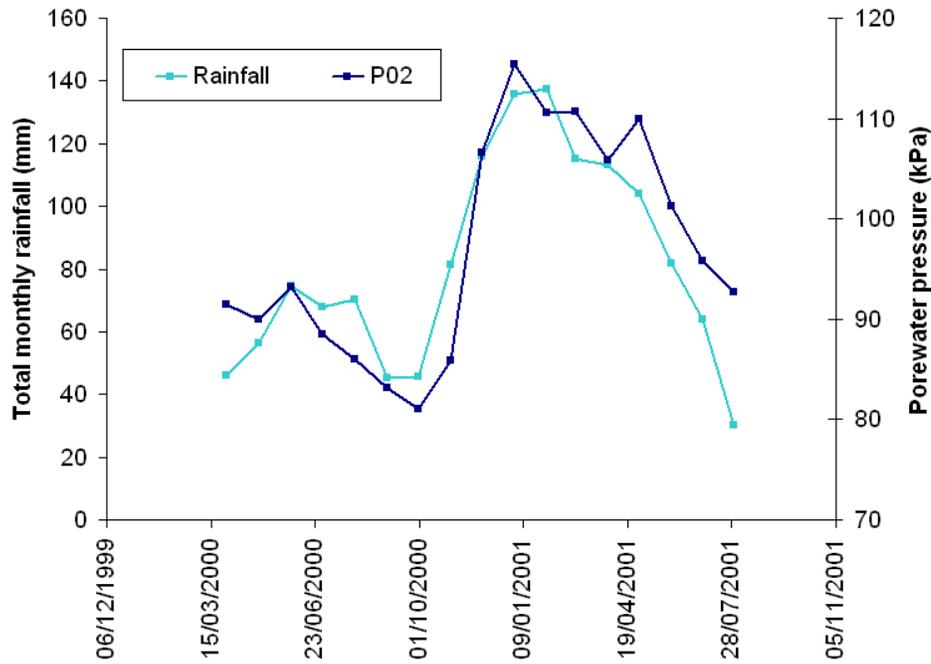
Figure 5.38 Comparison of 4 month running mean rainfall and porewater pressures at P02 between March 2000 and July 2002

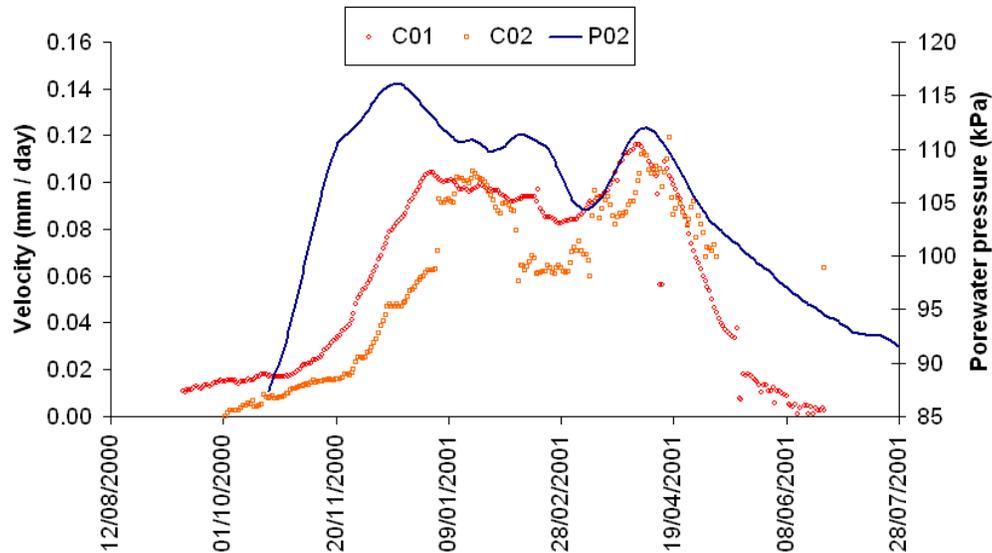
Figure 5.60 Relationship between velocity measured at the Newport Road (C01 and C02) and porewater pressure (P01) between 23/06/2000 and 28/07/2001

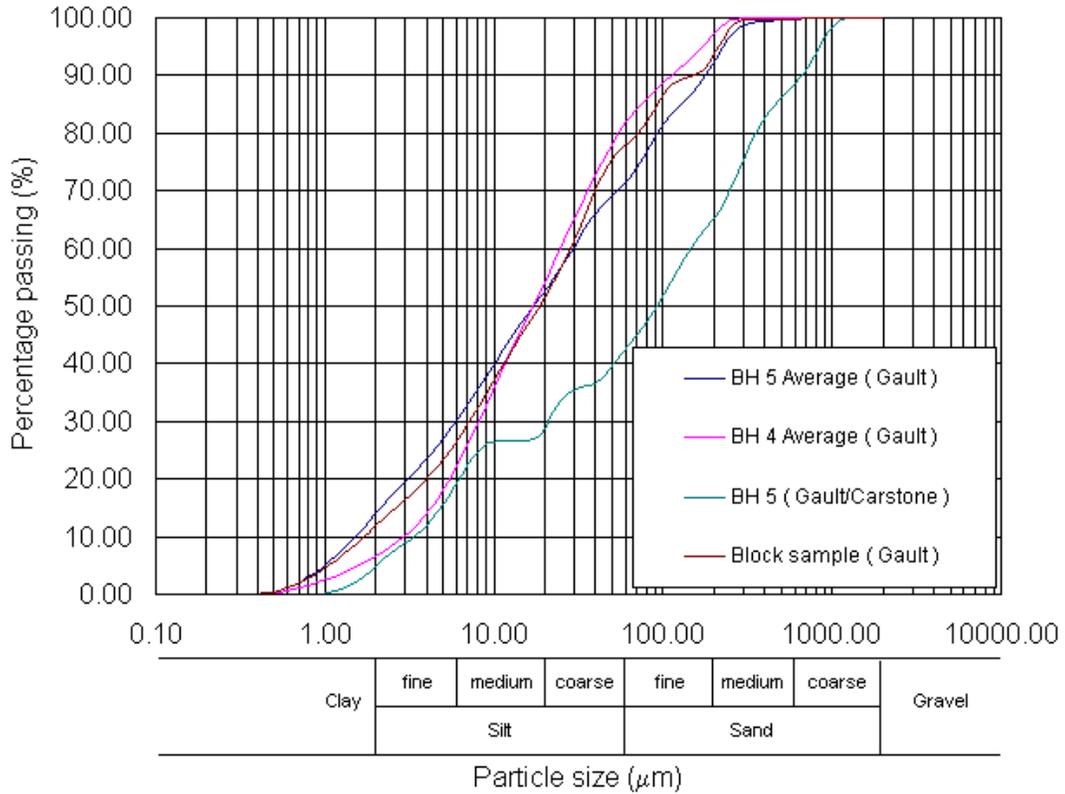
Figure 6.1 Particle size distribution chart for Gault Clay samples collected from BH4, BH5 and BS and Gault- Carstone transition zone in BH5

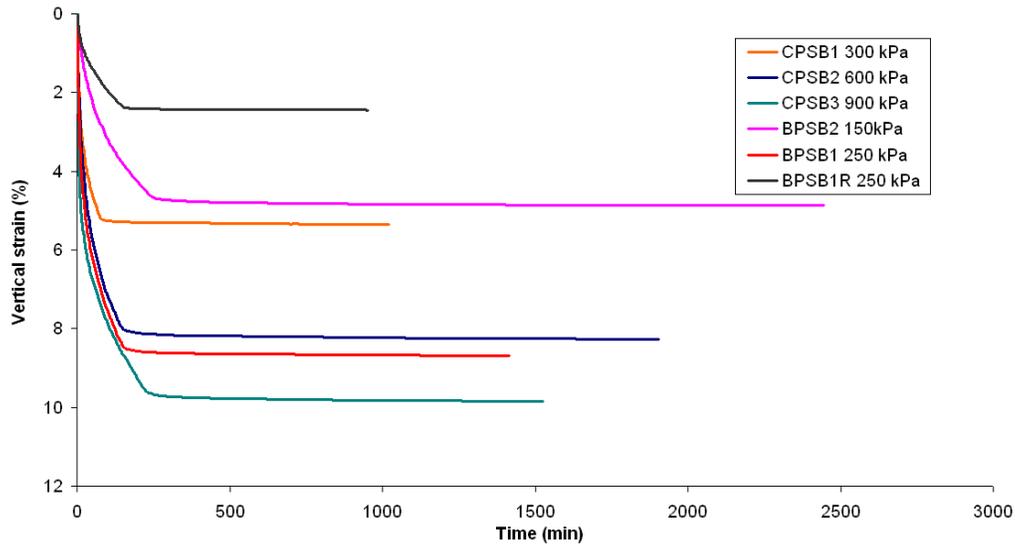
Figure 6.7 Consolidation curve for Gault-Carstone transition zone samples at effective stress of 150, 200, 300, 600 and 900 kPa

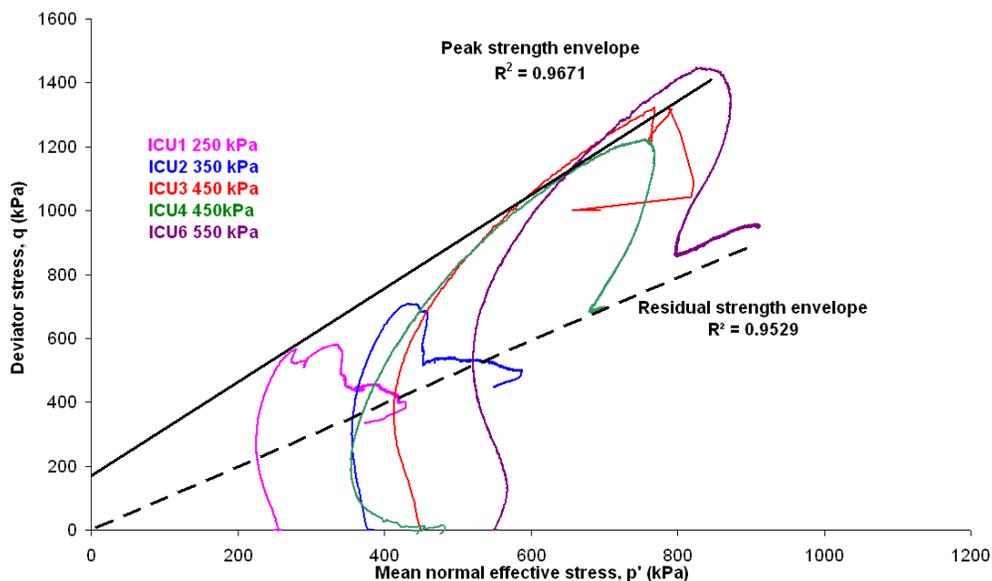
Figure 6.9 Peak and residual strength envelope, undrained triaxial cell testing

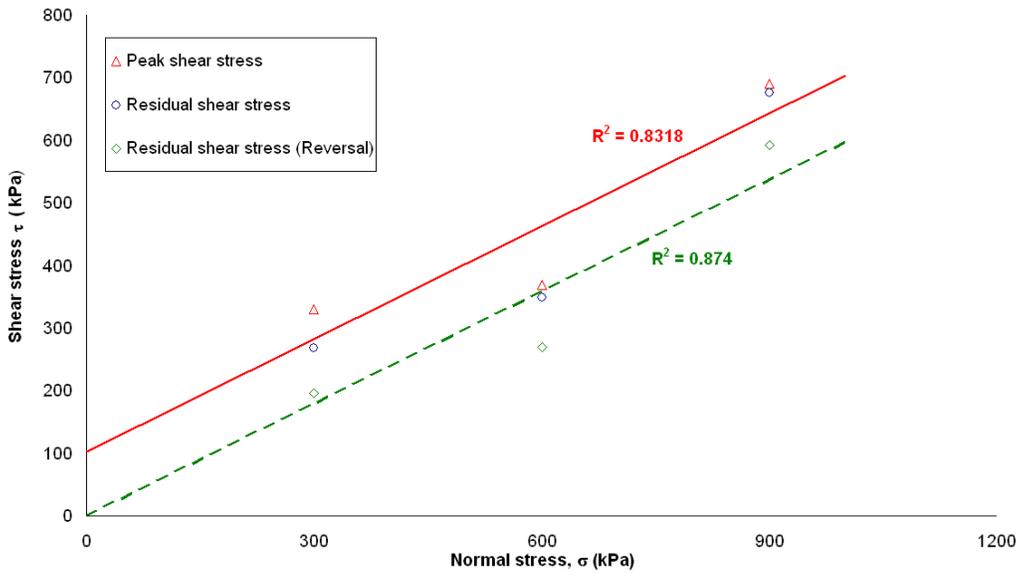
Figure 6.13 Peak and residual shear stress against normal stress using all CPSB tests on the Gault/ Carstone transition zone material

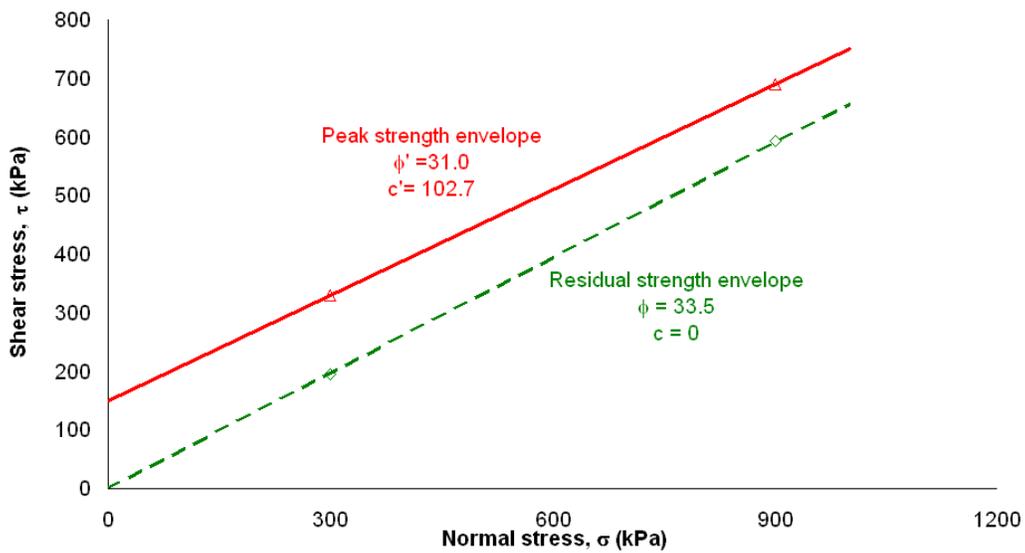
Figure 6.14 Construction of the peak and residual strength envelope failure envelope, Gault/ Carstone transition material
