The Progressive Development and Post-failure Behaviour of Deep-seated Landslide Complexes

JONATHAN MARTIN CAREY

PhD thesis

This thesis is submitted in accordance with the regulations for the degree of Doctor of Philosophy in Durham University, Department of Geography, 2011

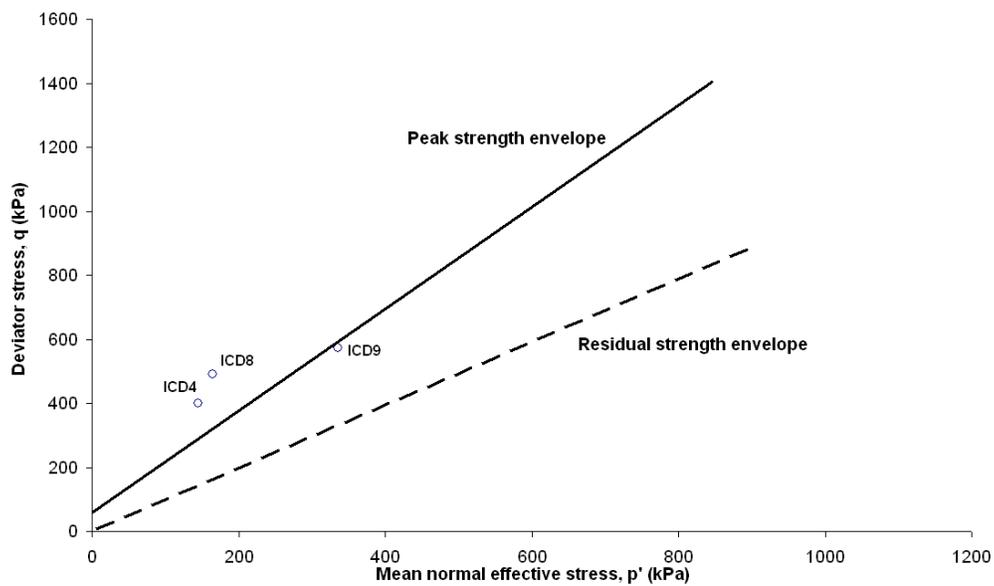
Figure 6.23 Comparison of p' at failure of PPR testing and the ICU failure envelope inclusive of Carey 2002 tests

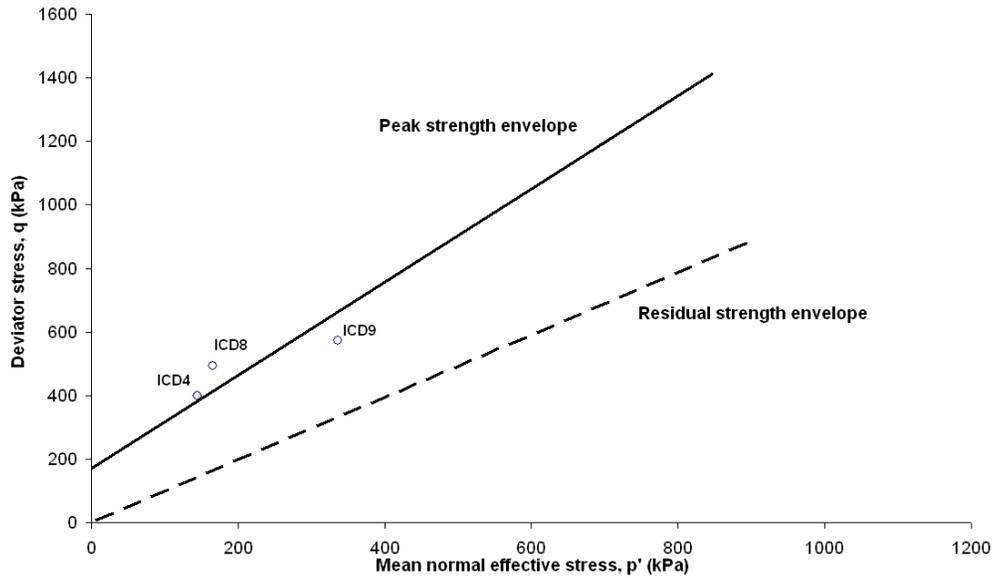
Figure 6.24 Comparison of p' at failure of PPR testing and the ICU failure envelope based on thesis results

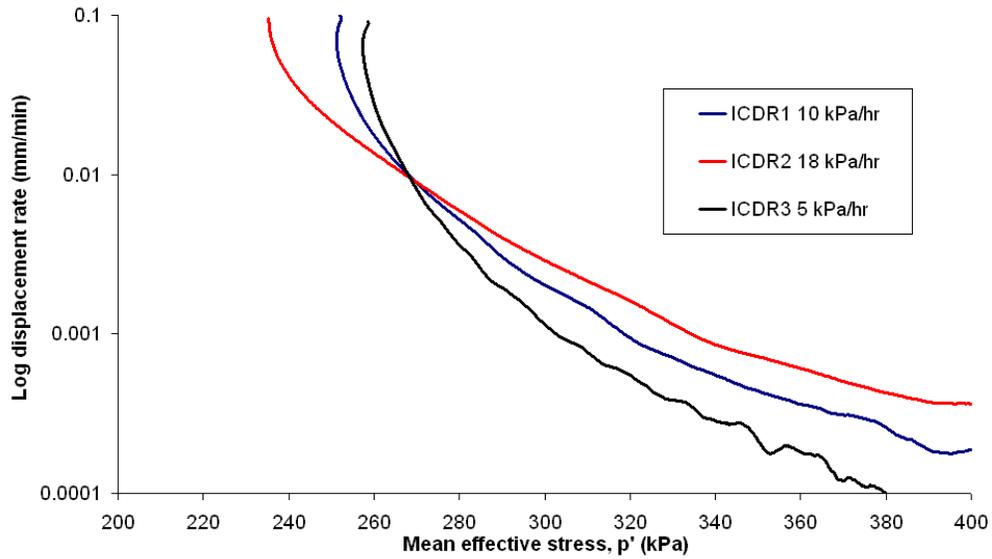
Figure 6.41 Displacement rate against p' , at constant q of 400 kPa, samples ICDR1, ICDR2 and ICDR3

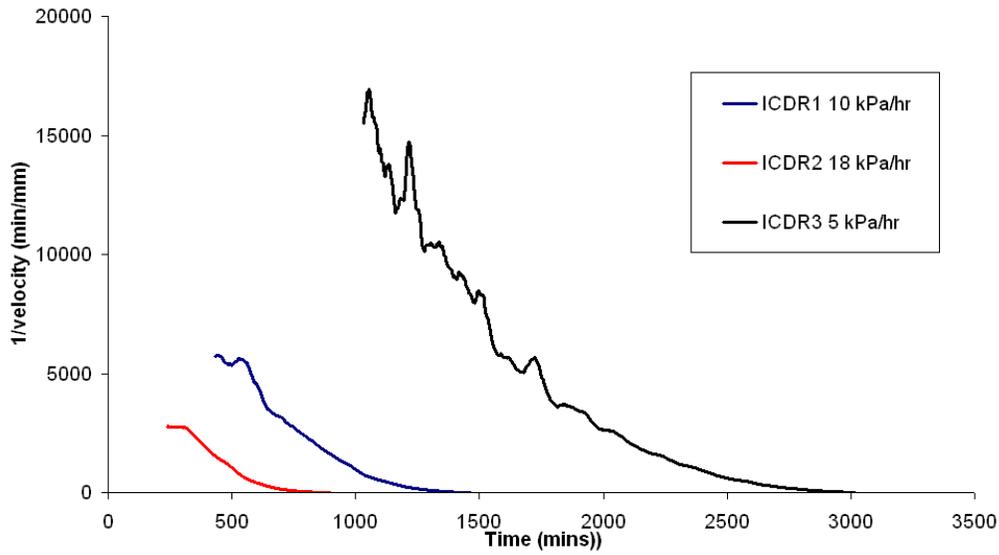
Figure 6.45 $1/v - t$ at constant q of 400 kPa, samples ICDR1, ICDR2 and ICDR3

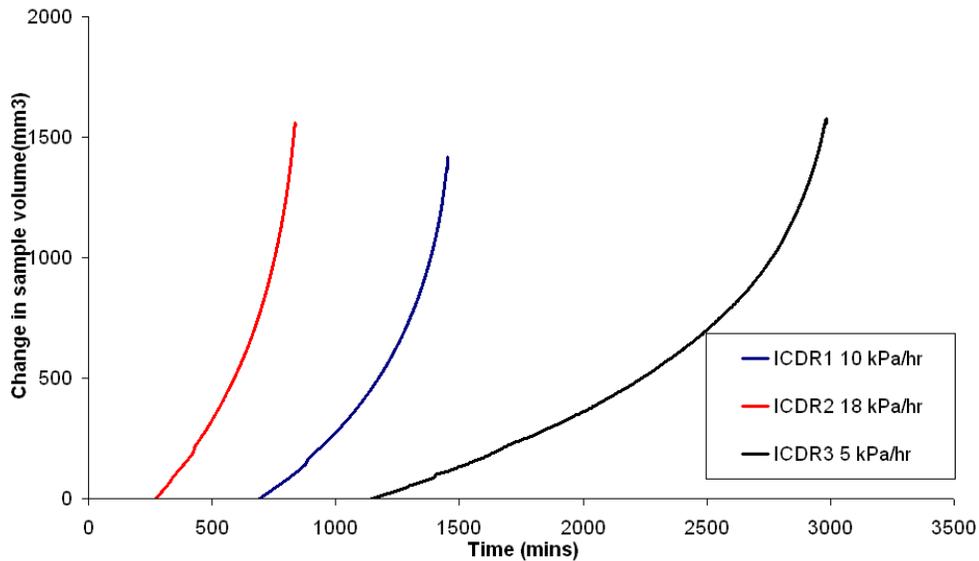
Figure 6.46 Change in sample volume through time at constant q of 400 kPa, samples ICDR1, ICDR2 and ICDR3

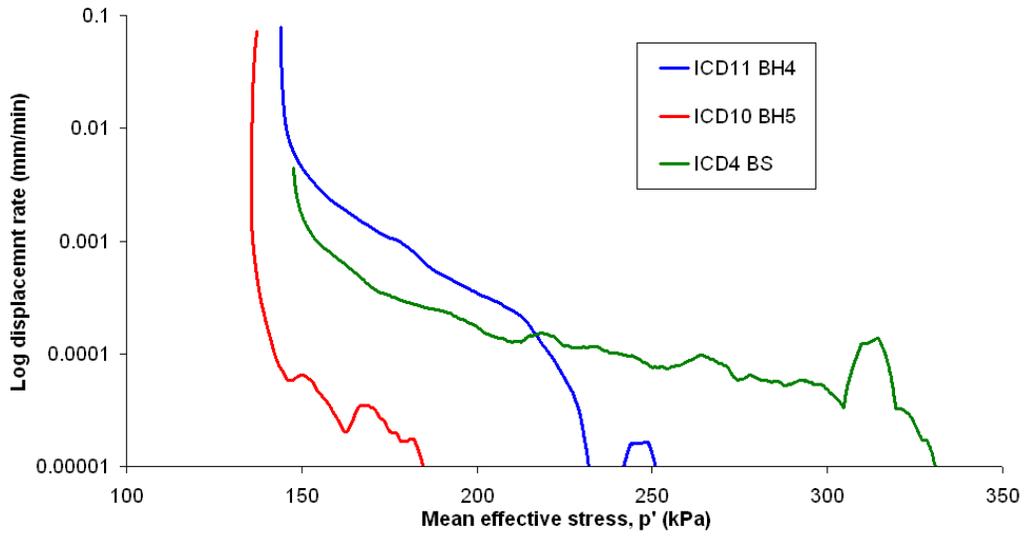
Figure 6.48 Displacement rate against p' , at constant q of 400 kPa, samples ICD4, ICD10 and ICD11

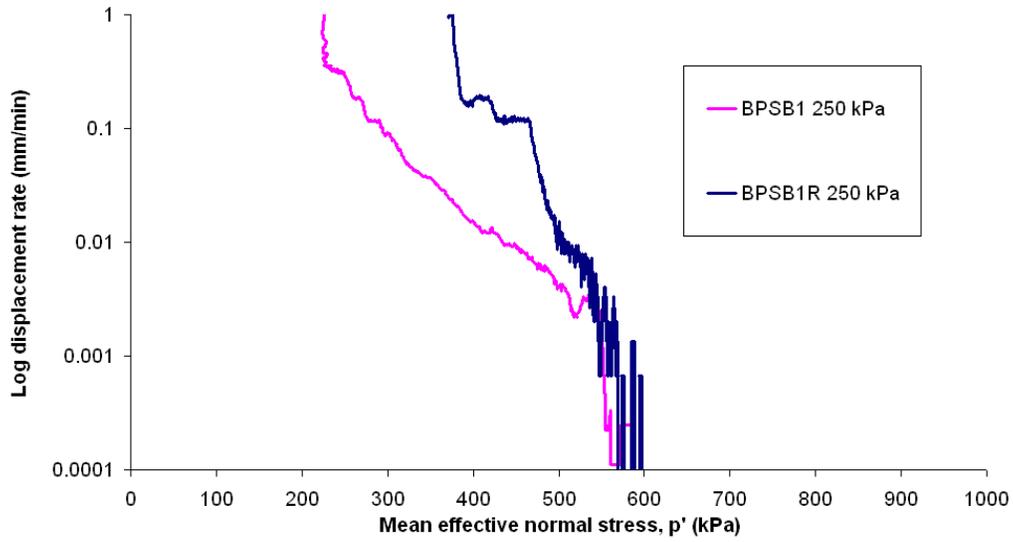
Figure 6.58 Displacement rate against p' at constant $q = 250$ kPa from initial $p' = 600$ kPa, samples BPSB1 and BPSB1R

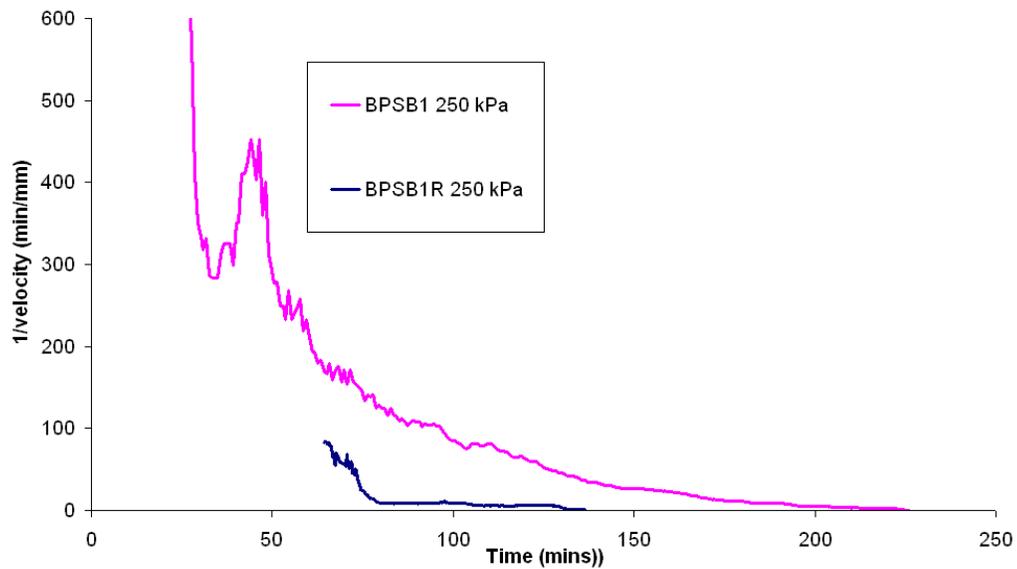
Figure 6.62 $1/v - t$ at constant $q = 250$ kPa from initial $p' = 600$ kPa, samples BPSB1 ad BPSB1R

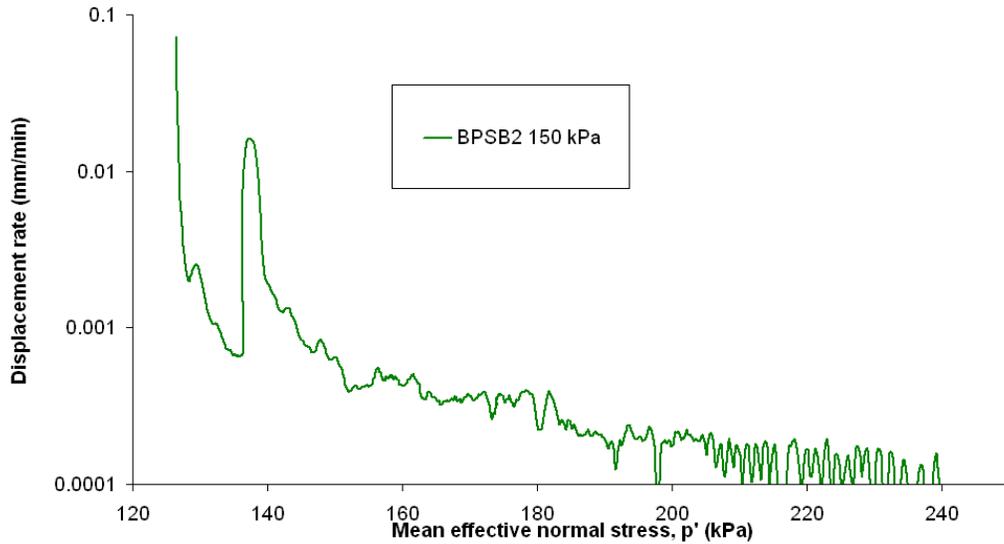
Figure 6.63 Displacement rate against p' at constant $q = 150 \text{ kPa}$ from initial $p' = 250 \text{ kPa}$, sample BPSB2

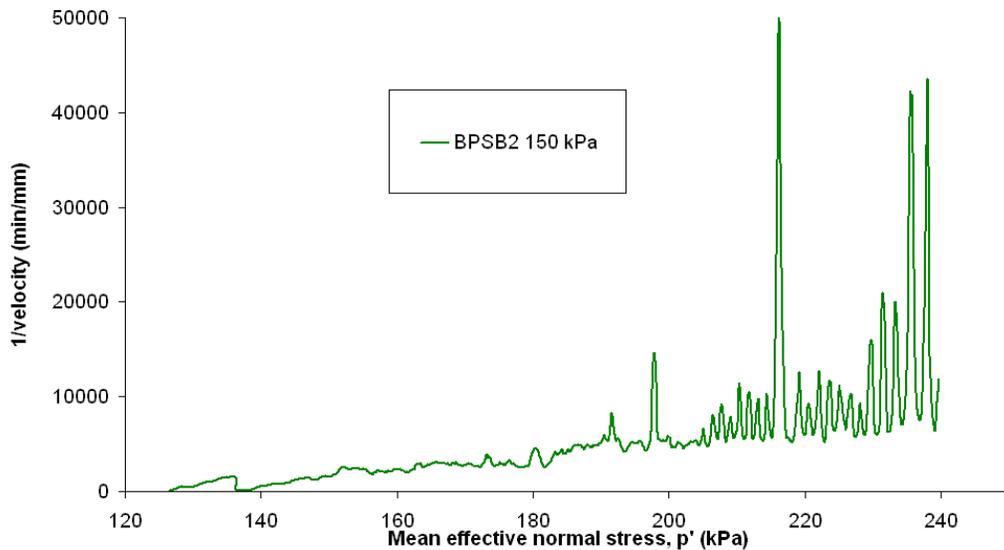
Figure 6.64 $1/v - p'$ at constant $q = 150 \text{ kPa}$ from initial $p' = 250 \text{ kPa}$, sample BPSB2

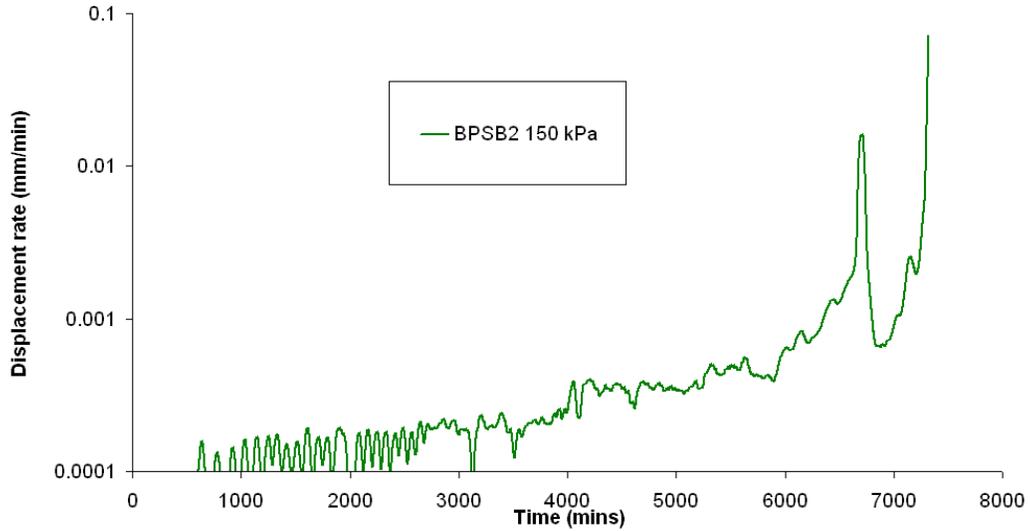
Figure 6.65 Displacement rate against time at constant $q = 150 \text{ kPa}$ from initial $p' = 250 \text{ kPa}$, sample BPSB2

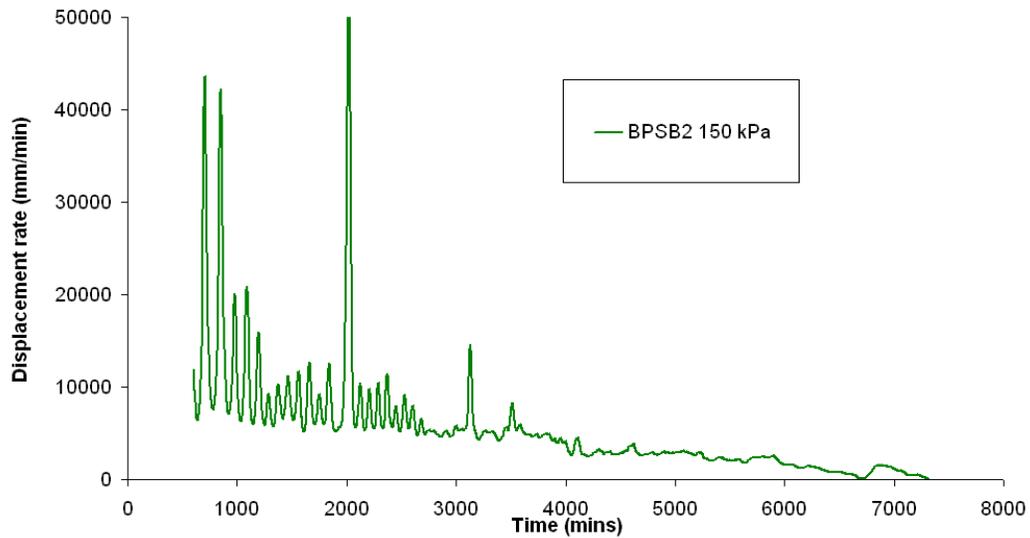
Figure 6.66 $1/v - t$ at constant $q = 150 \text{ kPa}$ from initial $p' = 250 \text{ kPa}$ sample BPSB2

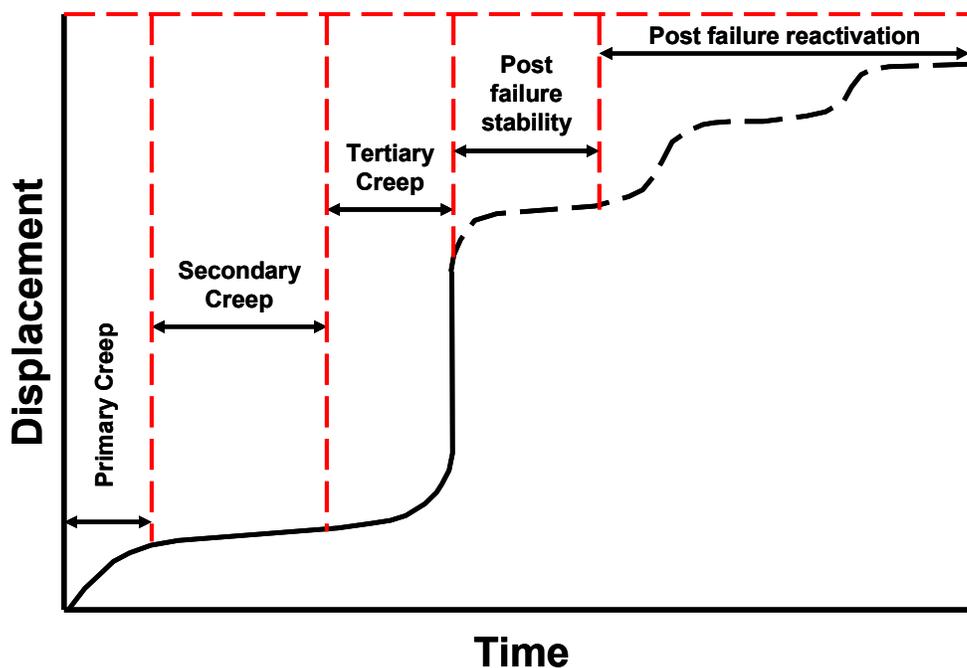
Figure 7.1 Concept of progressive landslide development and post failure creep (adapted from Varnes, 1978; Petley and Allison, 2006)

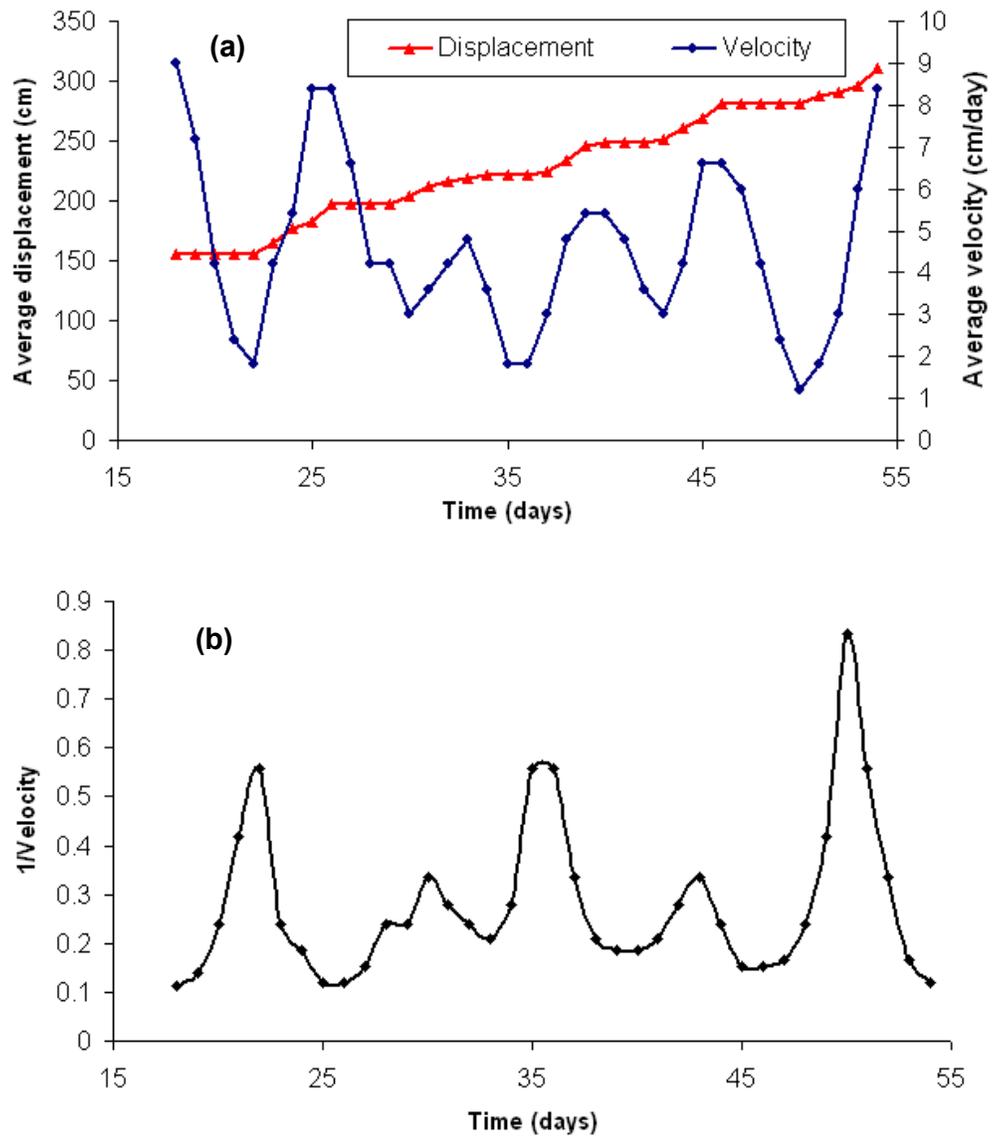
Figure 7.7 Secondary creep, New Tredegar (a) average displacement and displacement rate (b) 1/velocity against time

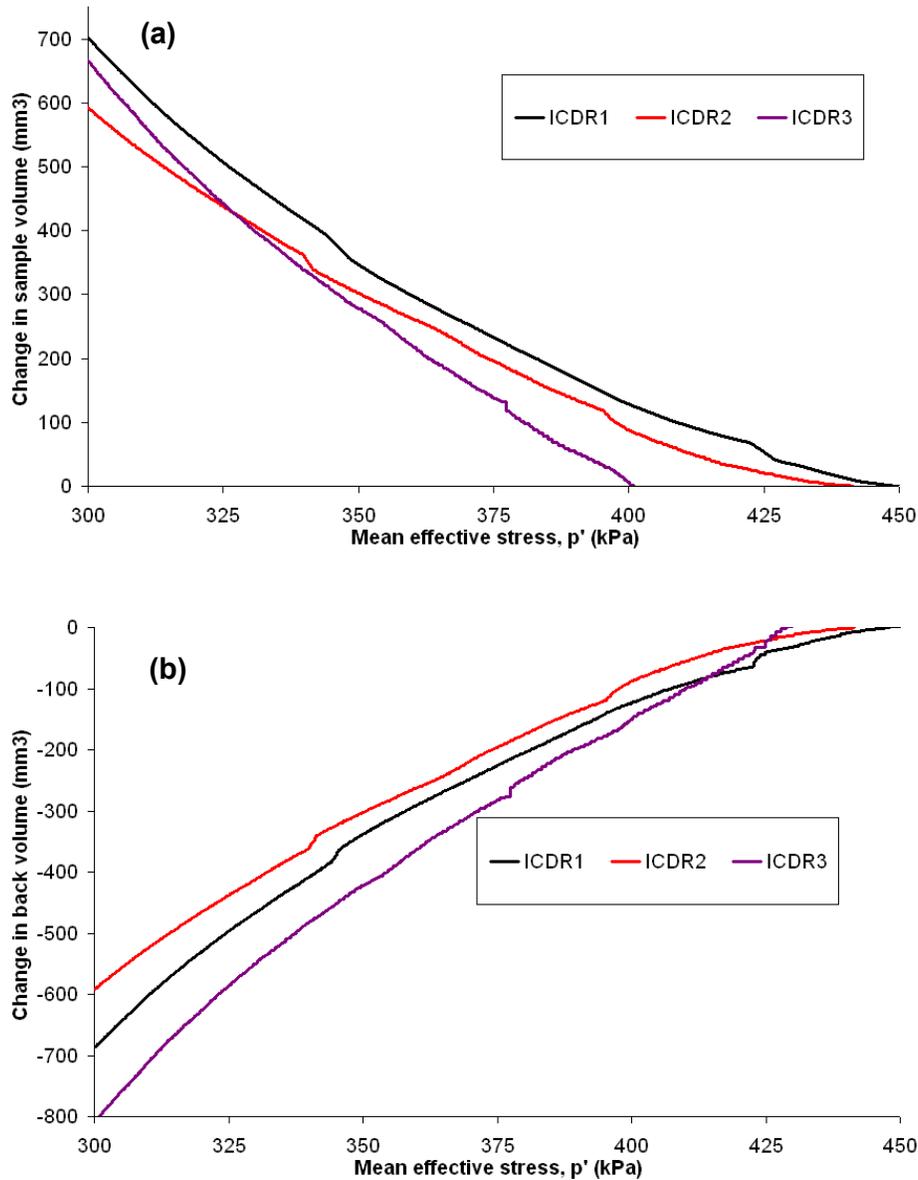
Figure 7.10 Initial displacements in remoulded Gault ICD PPR tests (a) change in sample volume against p' (b) change in back volume against p'

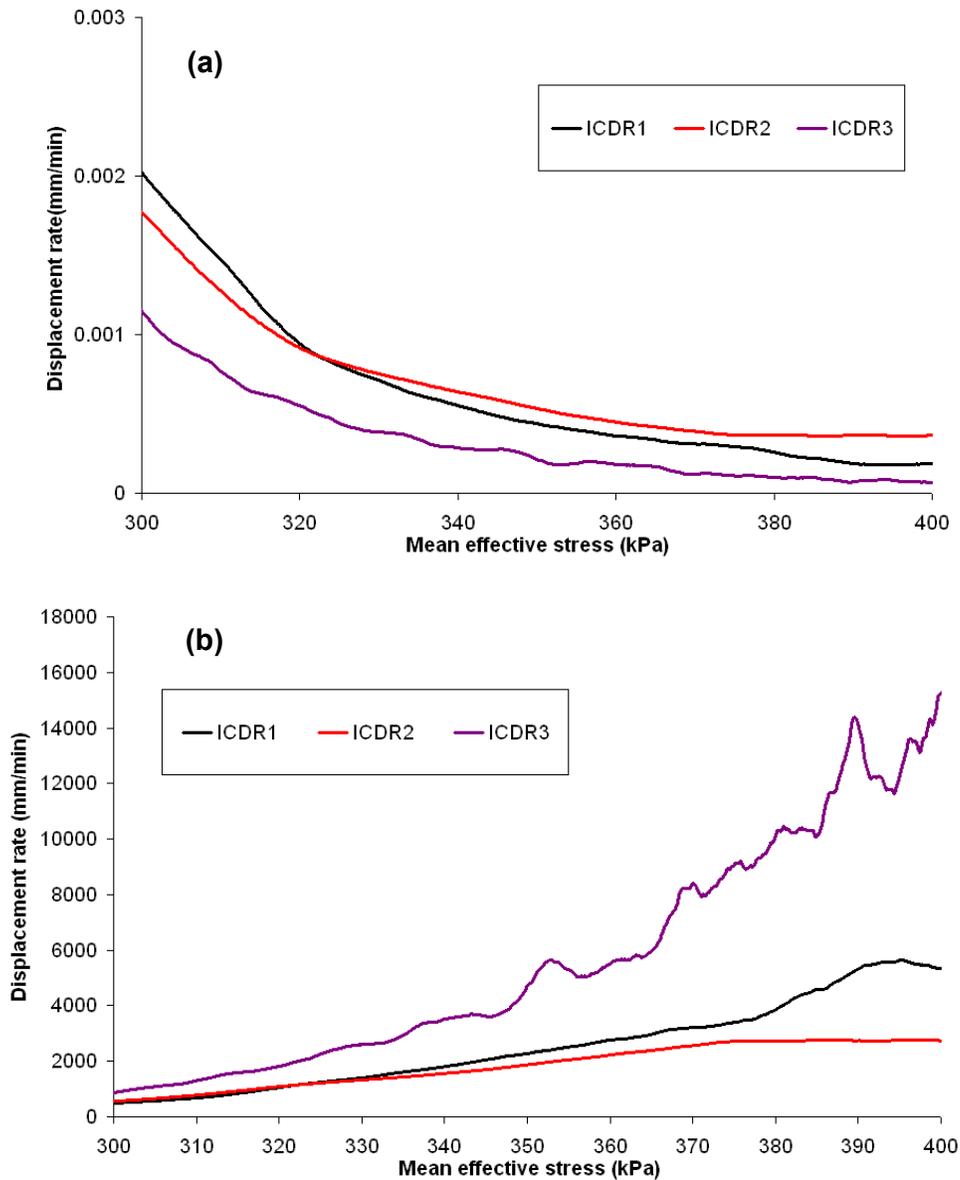
Figure 7.11 Initiation of displacement in remoulded Gault ICD PPR tests (a) Displacement rate against p' (b) $1/v - p'$ space

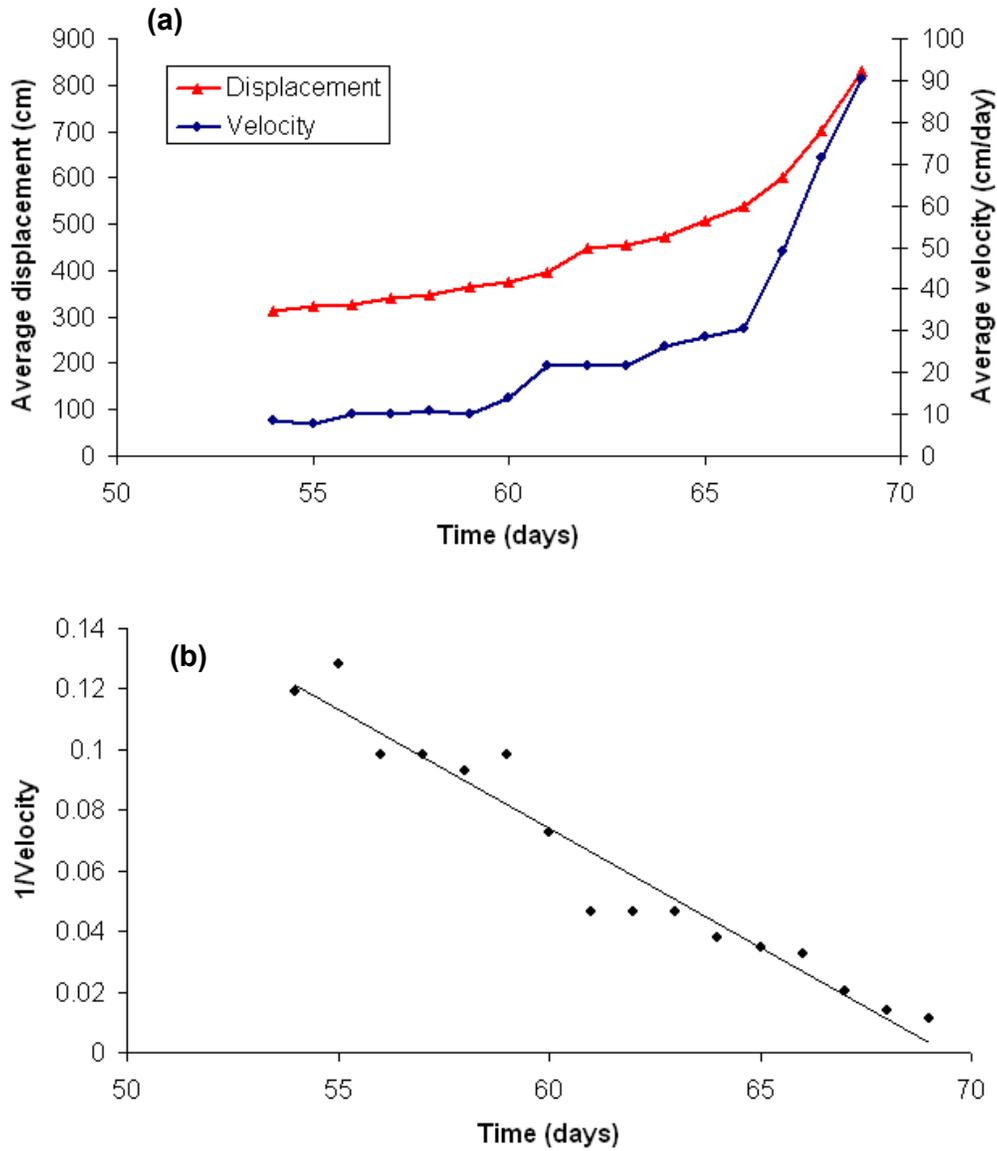
Figure 7.12 Acceleration to failure, New Tredegar (a) displacement and velocity against time (b) $1/v - t$ space

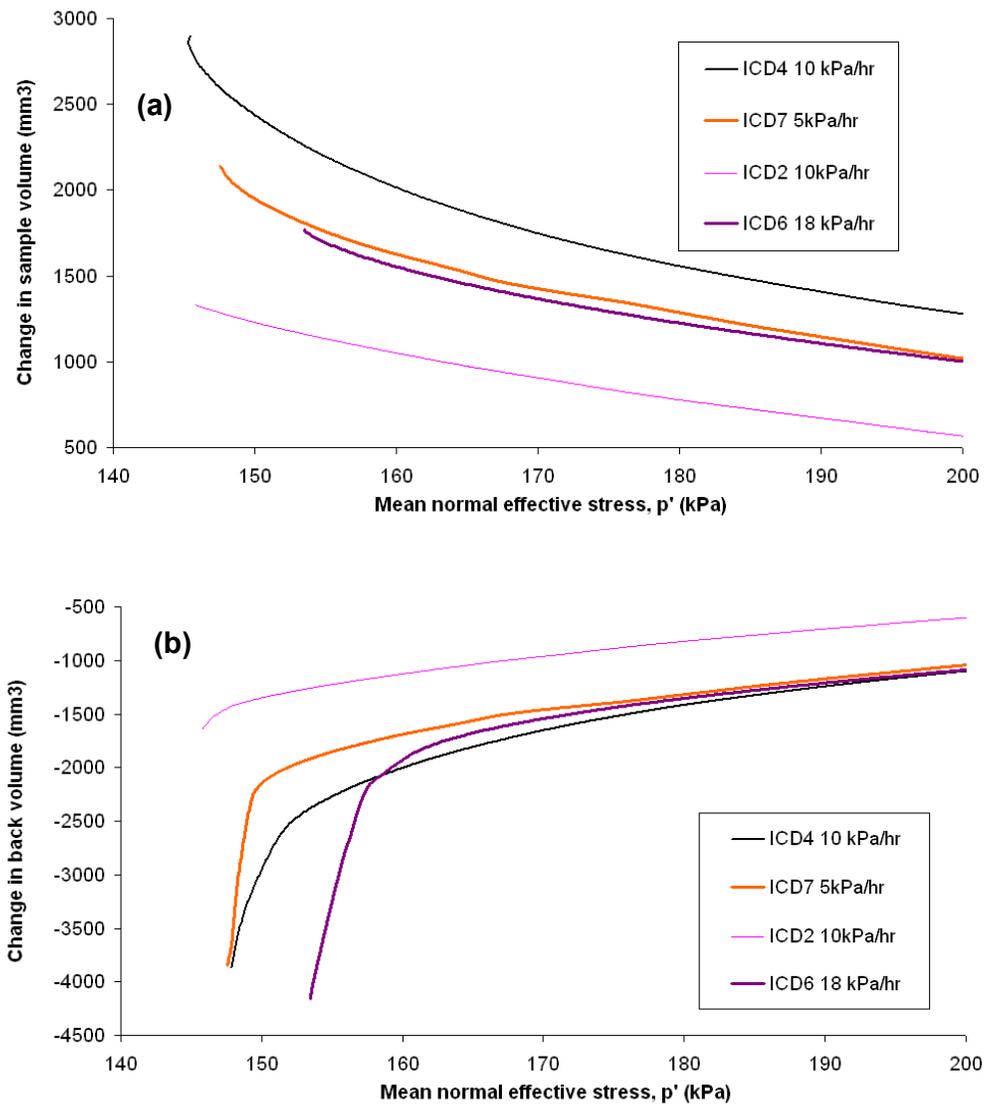
Figure 7.13 Acceleration to failure in intact Gault ICD PPR tests (a change in sample volume against p' (b) change in back volume against p'

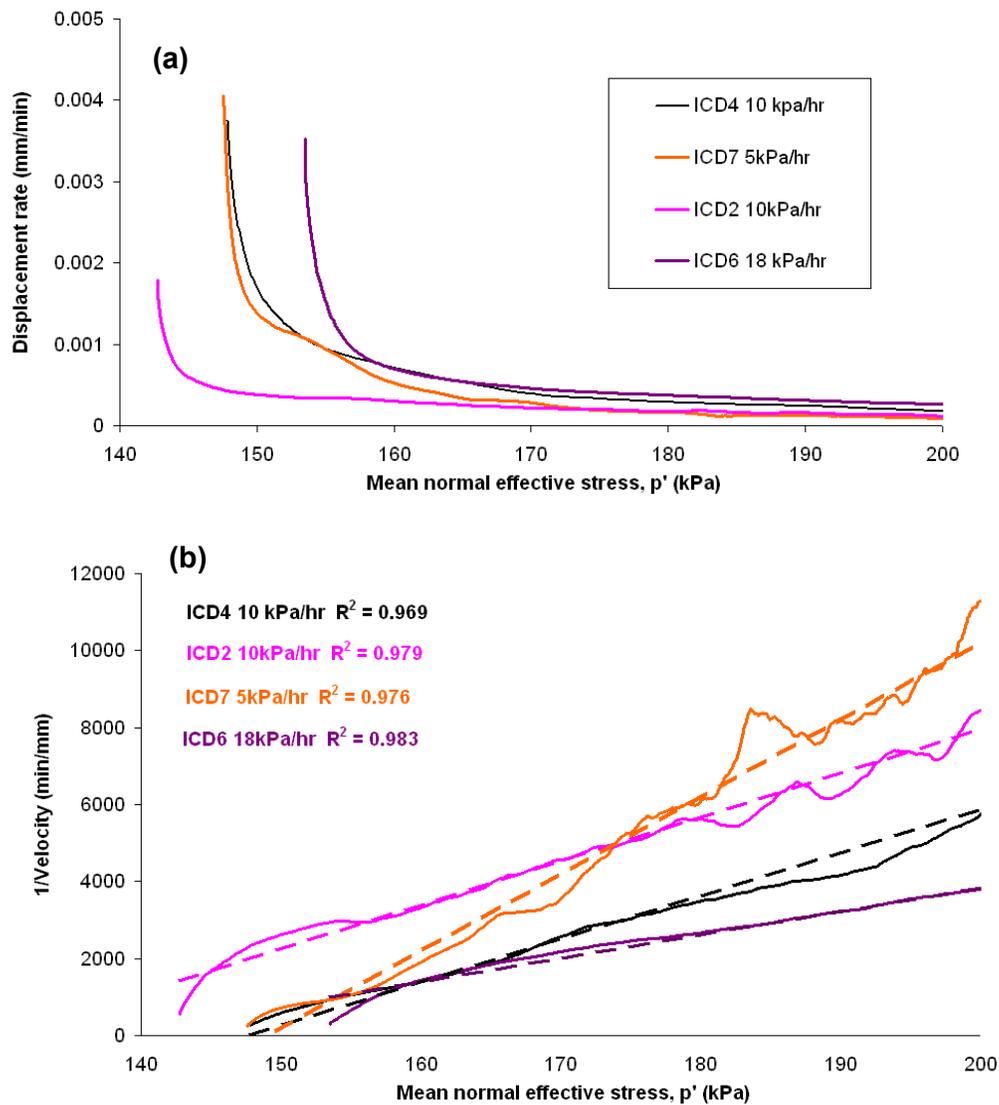
Figure 7.14 Acceleration to failure in Intact Gault ICD PPR tests (a) displacement rate against p' (b) $1/v - p'$ space

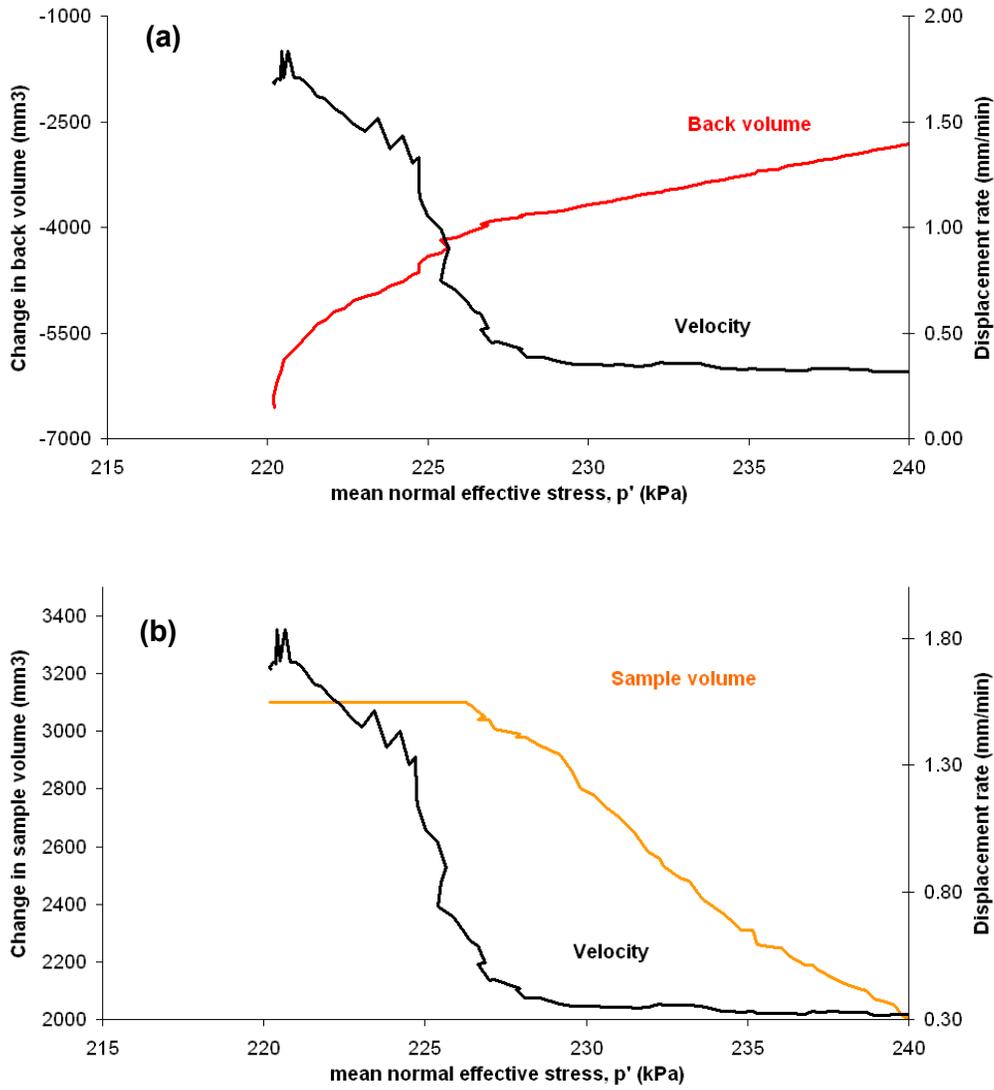
Figure 7.15 Acceleration to failure in Gault Carstone transition BPSB test (a) displacement rate and back volume against p' (b) displacement rate and sample volume against p'

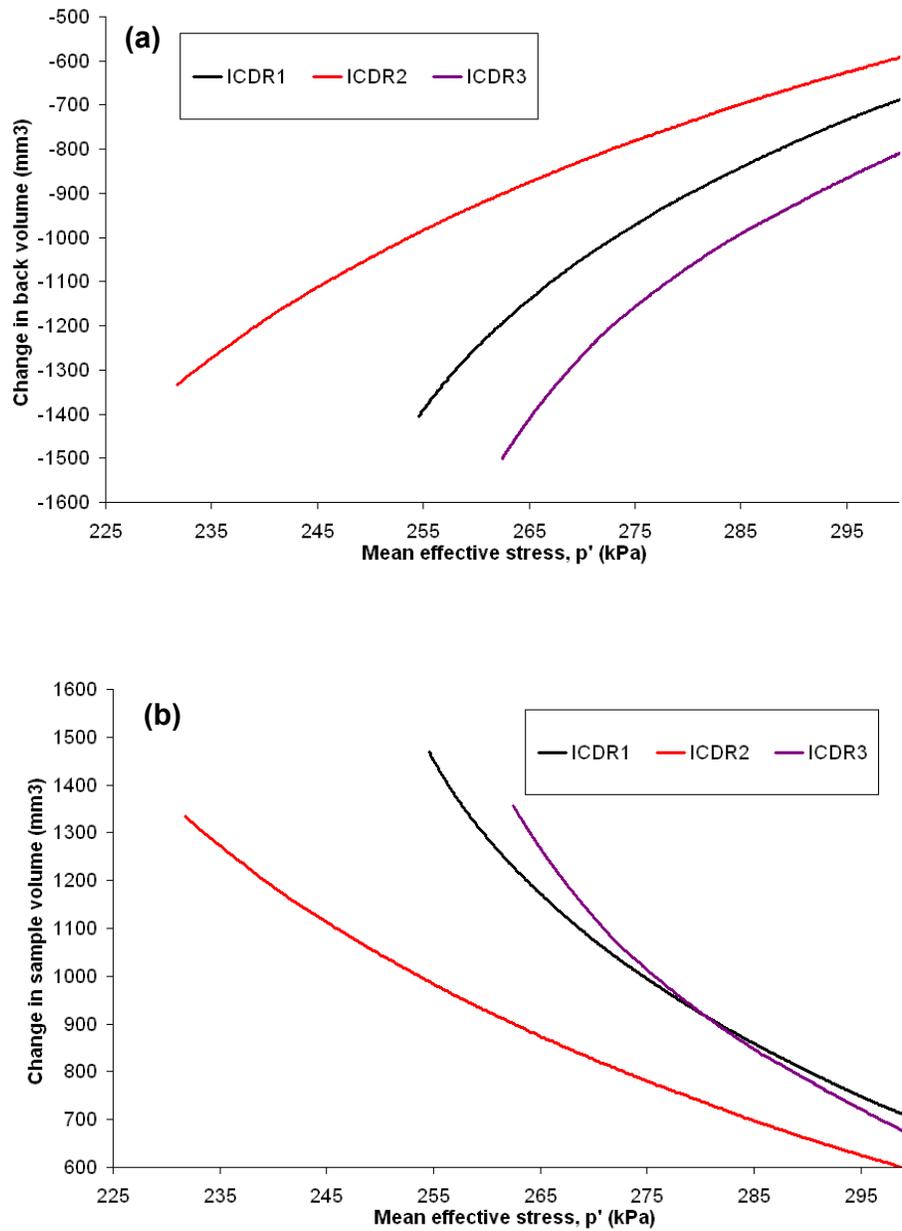
Figure 7.17 Acceleration to failure in remoulded Gault ICD PPR tests (a) change in back volume against p' (b) change in sample volume against p'

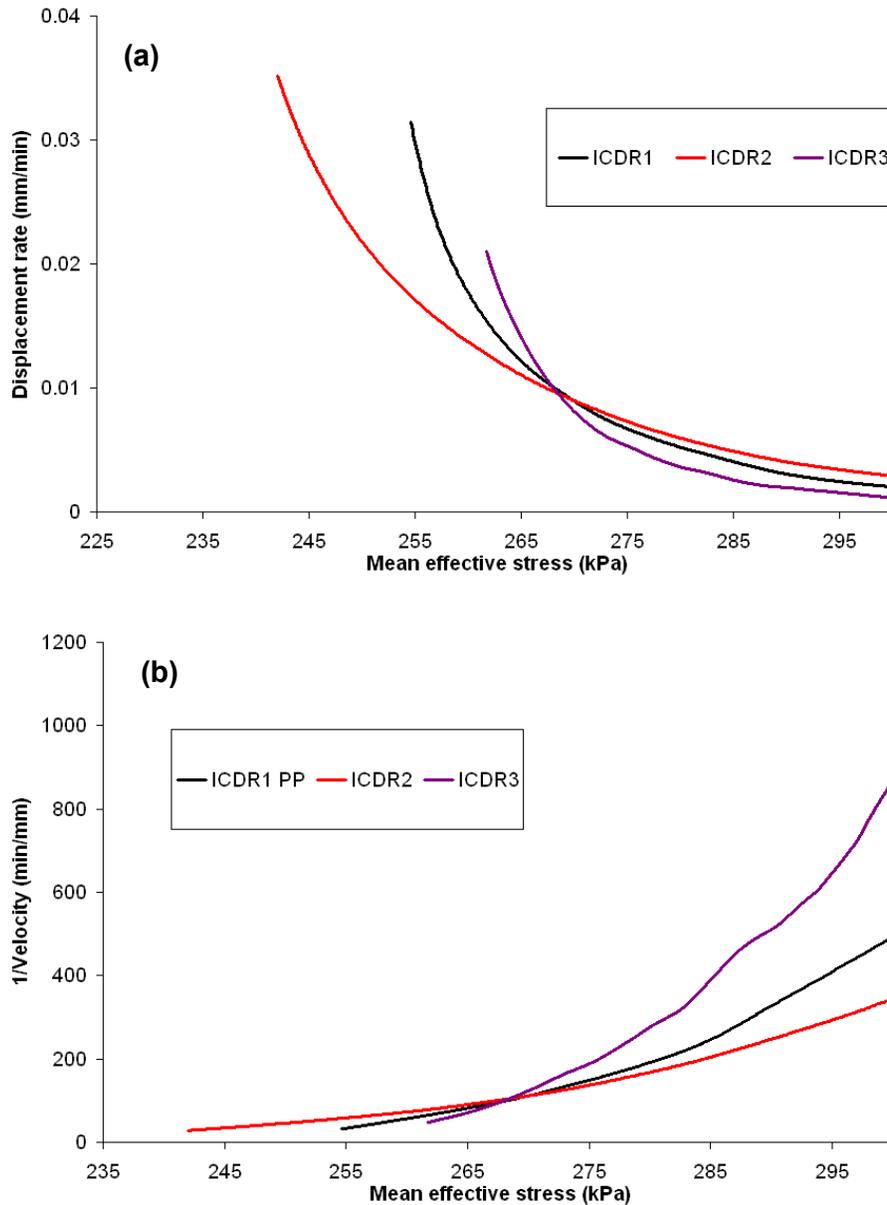
Figure 7.18 Acceleration to failure in remoulded Gault ICD PPR tests (a) displacement rate against p' (b) $1/v - p'$ space

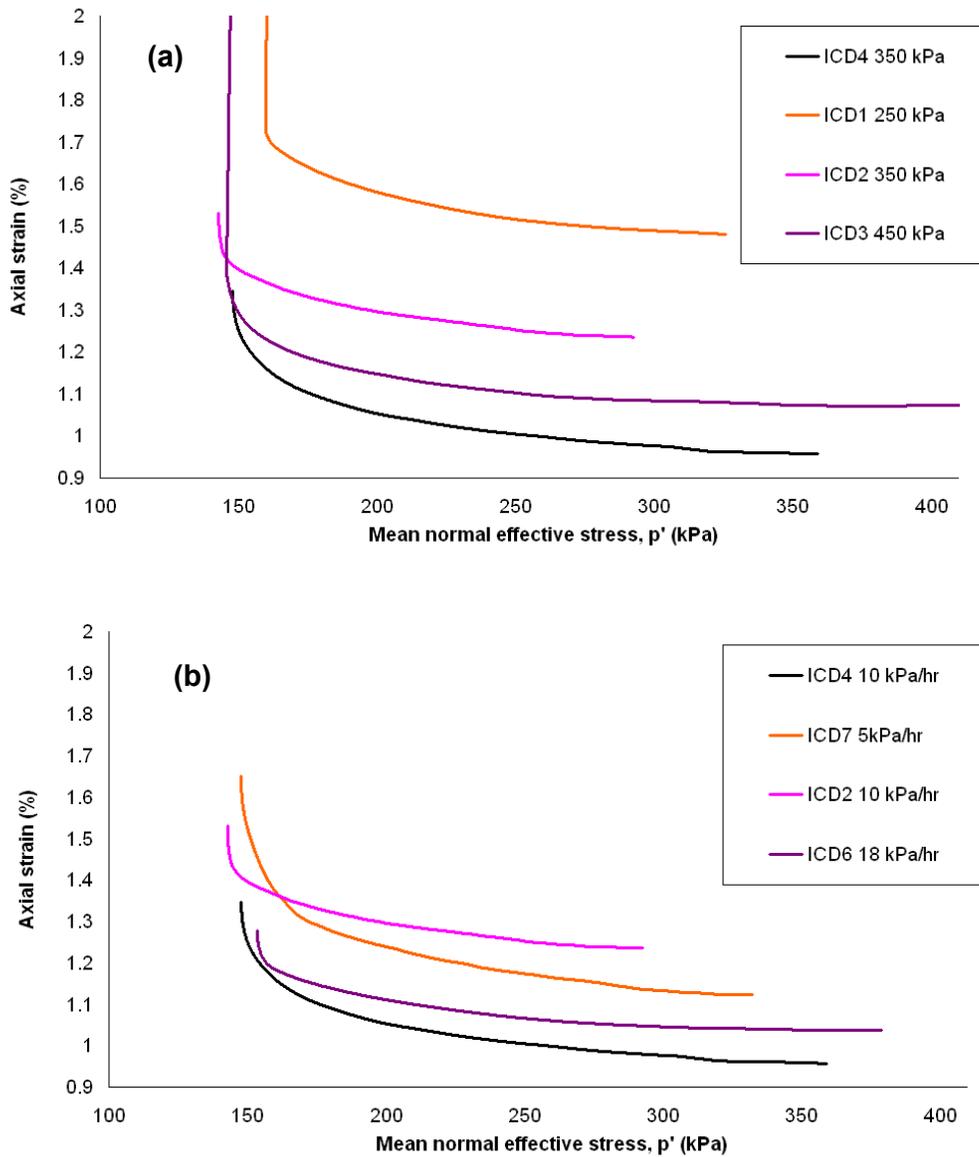
Figure 7.19 Axial strain to failure of intact Gault ICD PPR tests at 400kPa (a) undertaken at different initial confining pressures (b) undertaken at different PPR rates

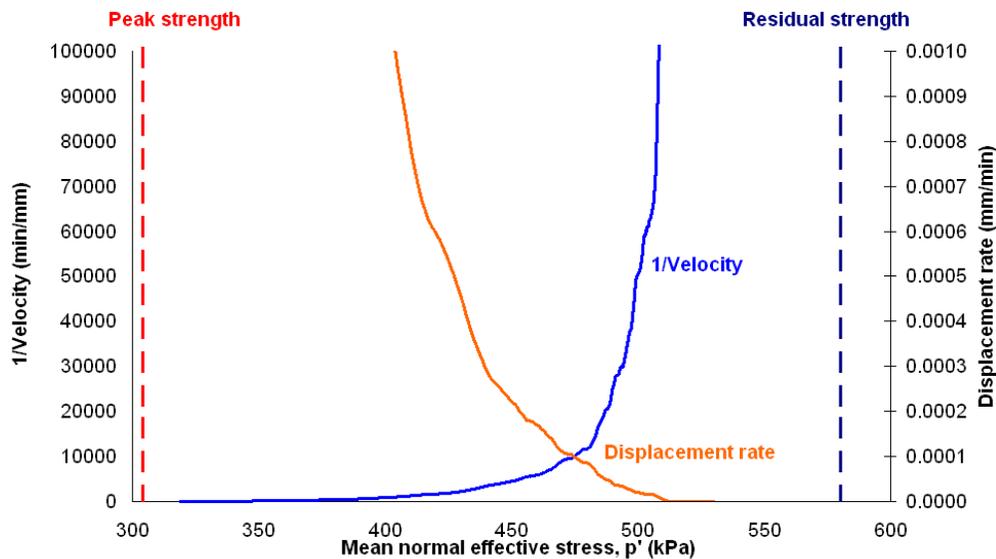
Figure 7.22 $1/v-p'$ and displacement rate against p' in relation to undrained failure envelopes, sample ICD9, PPR 10 kPa/hr, 550kPa

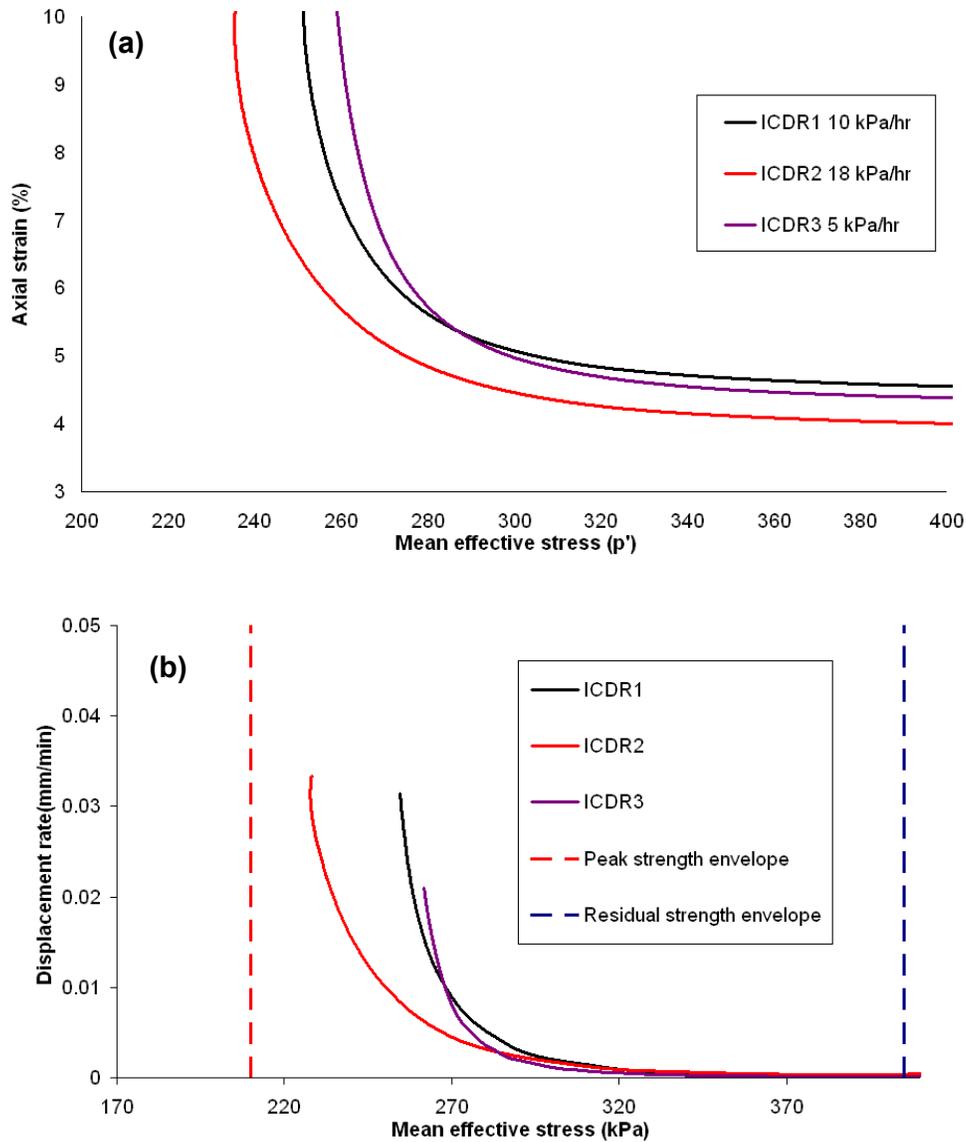
Figure 7.23 Deformation to failure in remoulded Gault PPR tests in relation to the undrained failure envelope, (a) axial strain against p' (b) displacement rate against p'

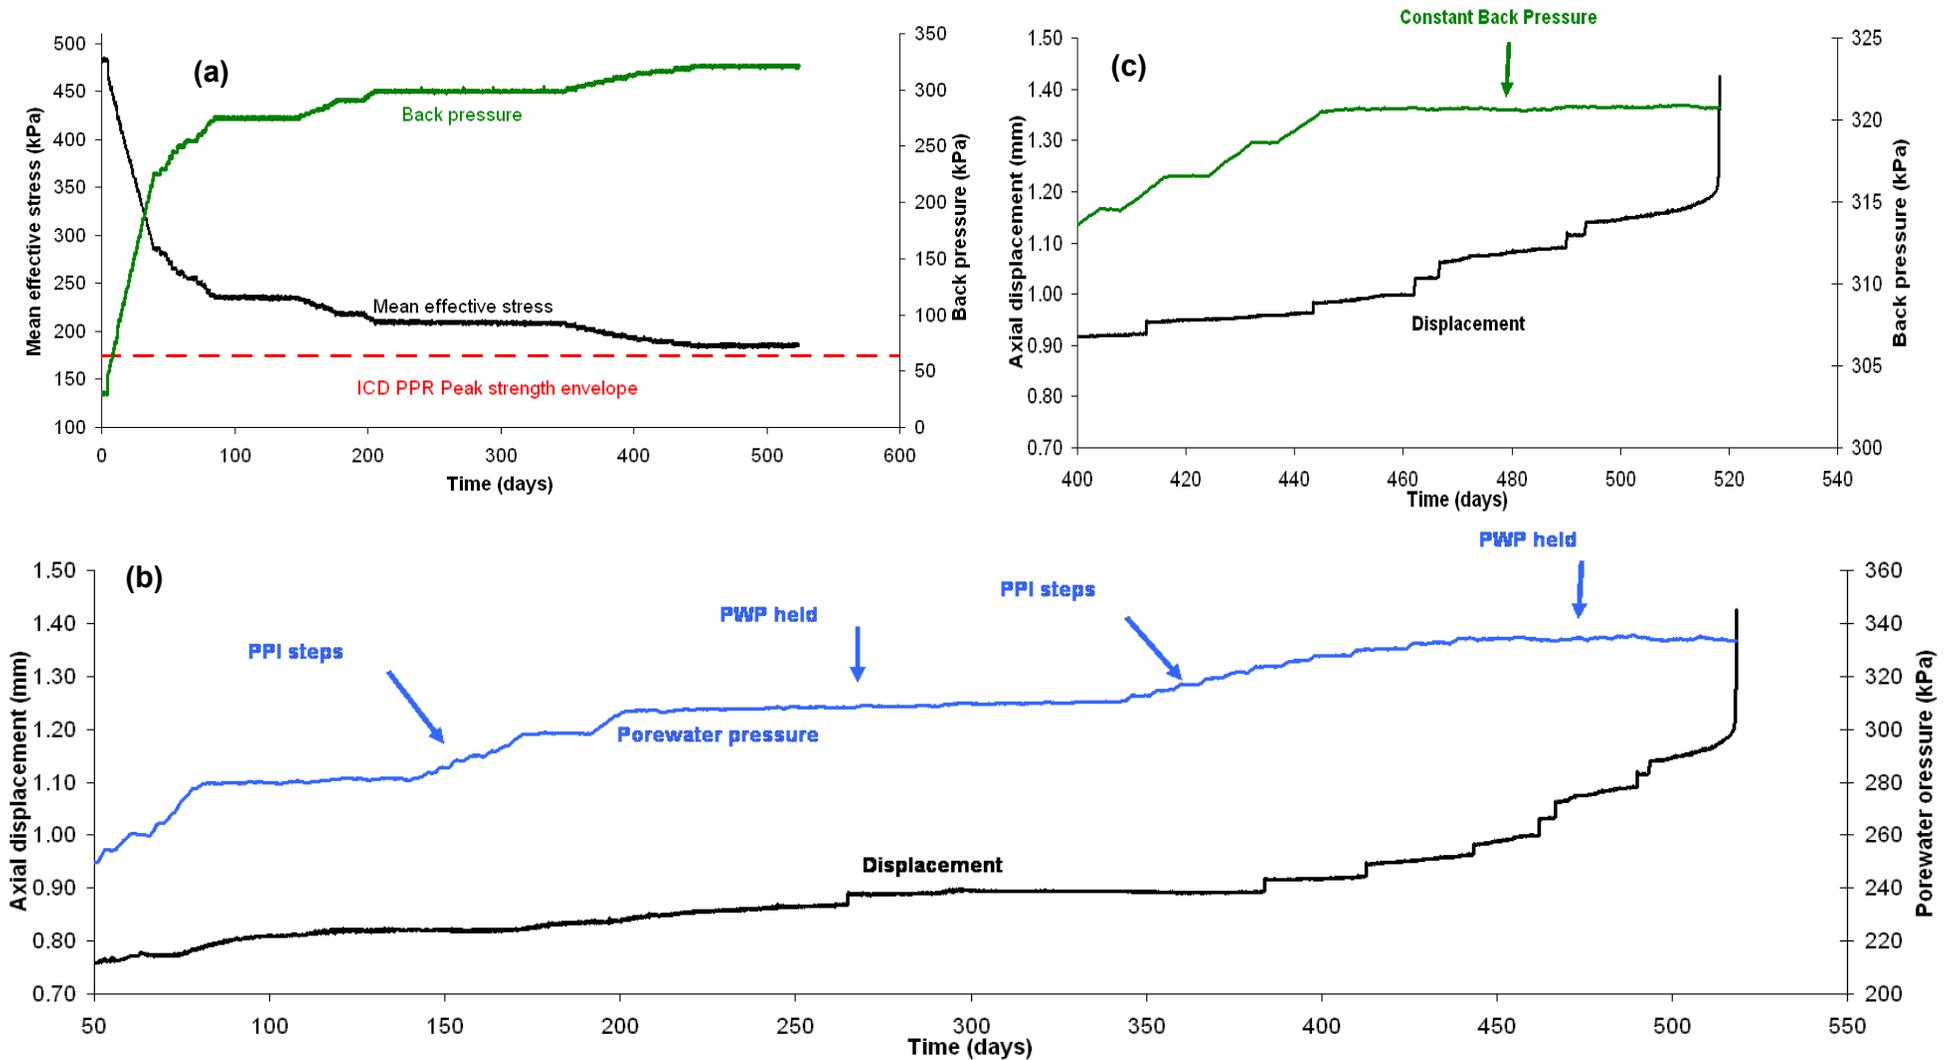
Figure 7.25 The long creep test (a) Comparison of back pressure and mean effective stress in relation to the failure envelope (b) Comparison of porewater pressure and sample displacement throughout the full test (c) Comparison of sample displacement and back pressure to failure.
