The Progressive Development and Post-failure Behaviour of Deep-seated Landslide Complexes

JONATHAN MARTIN CAREY

PhD thesis

This thesis is submitted in accordance with the regulations for the degree of Doctor of Philosophy in Durham University, Department of Geography, 2011

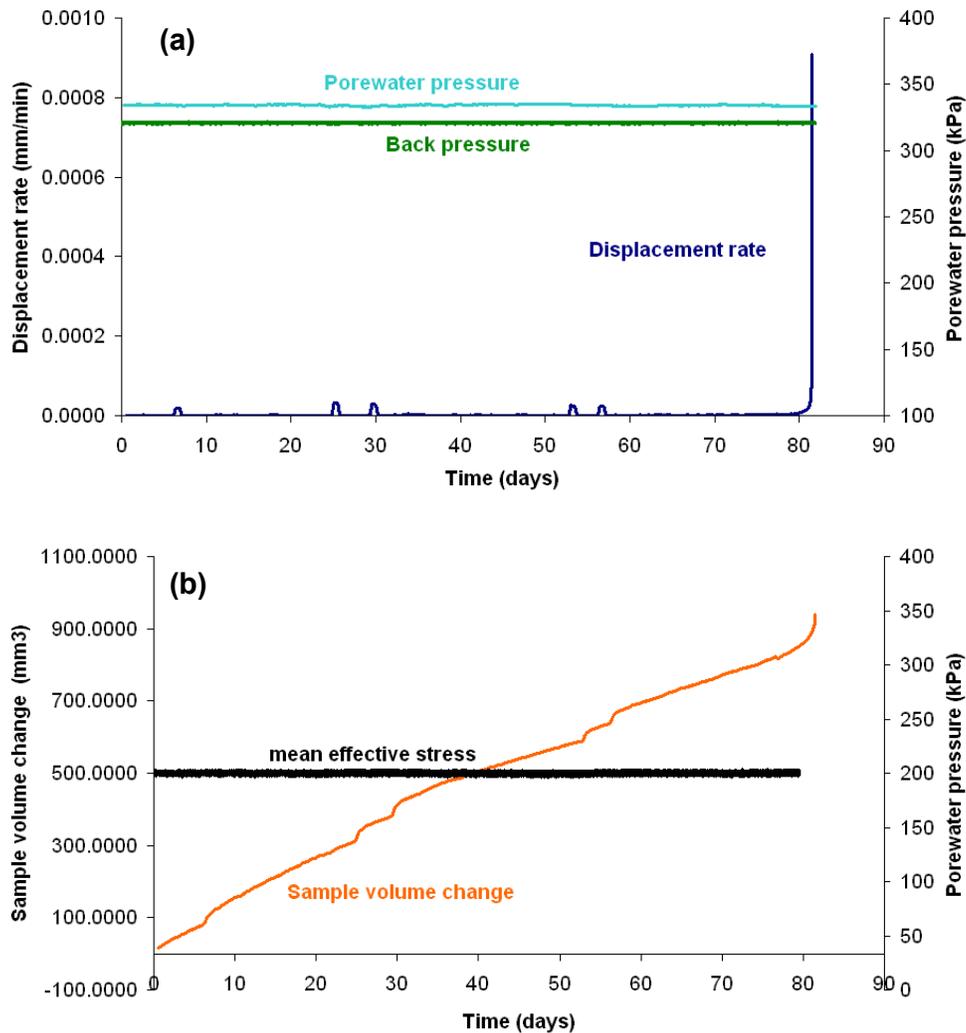
Figure 7.26 Deformation to failure during the final stage of the long creep test
 (a) Comparison of displacement rate with sample porewater pressure and back pressure, (b) Comparison of change in sample volume and sample mean effective stress

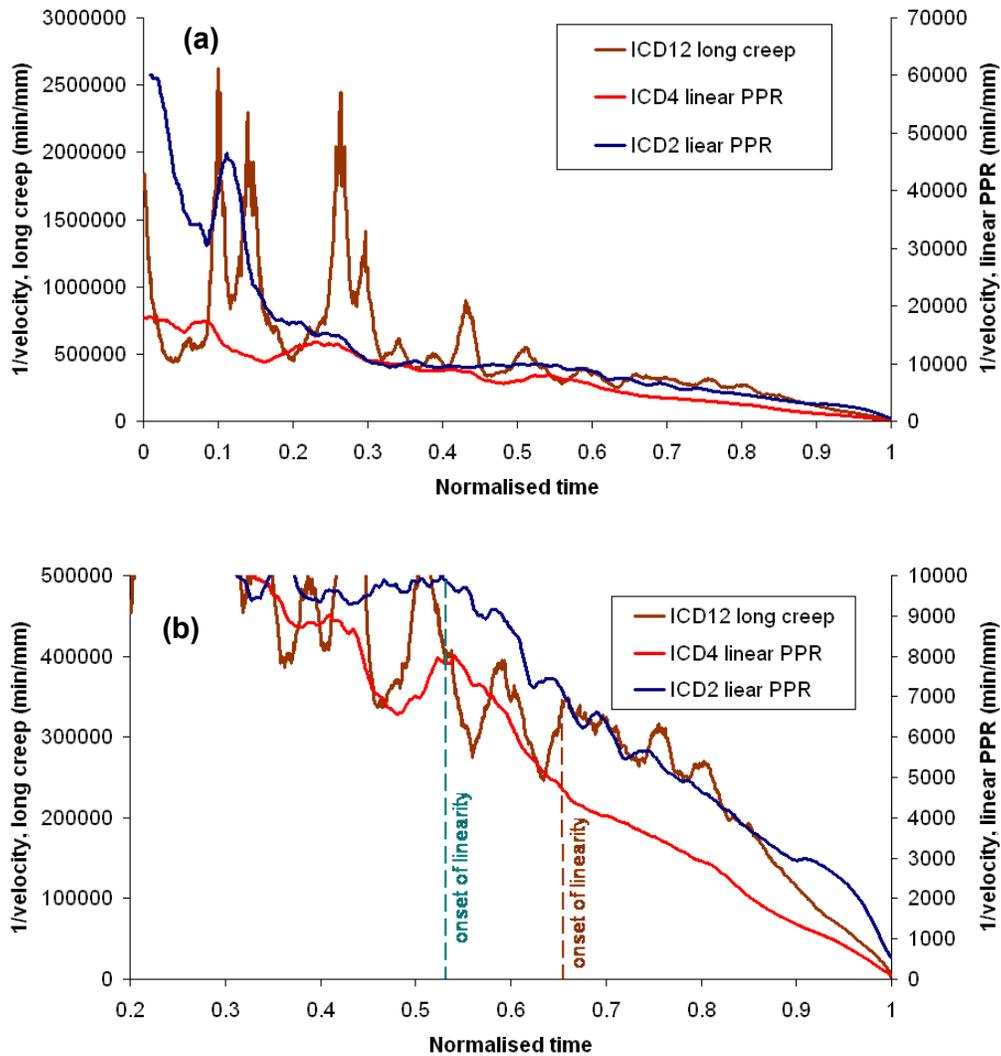
Figure 7.31 Comparison of linear PPR and long creep test (a) $1/v - t$ (b) $1/v - t$ during final stages of failure

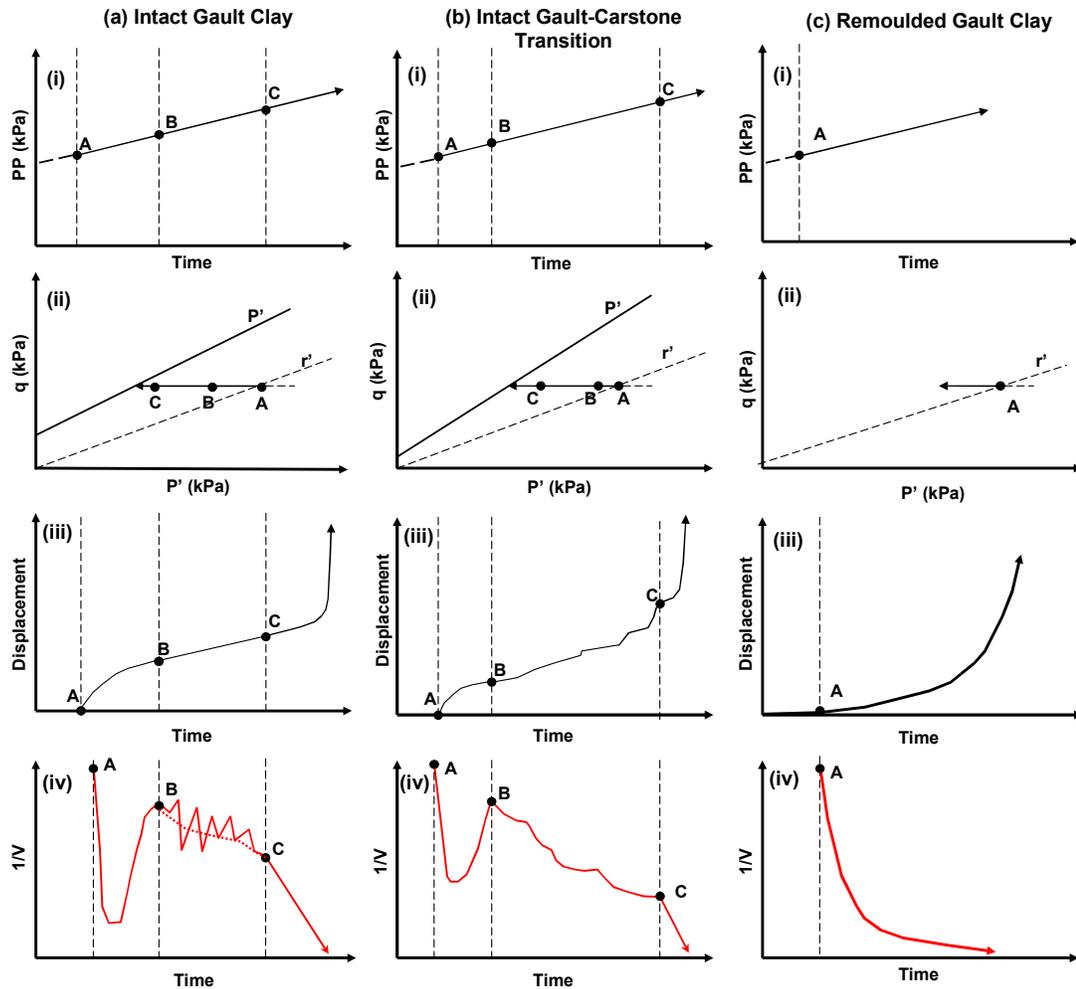
Figure 7.32 Progressive shear surface development patterns observed in PPR test

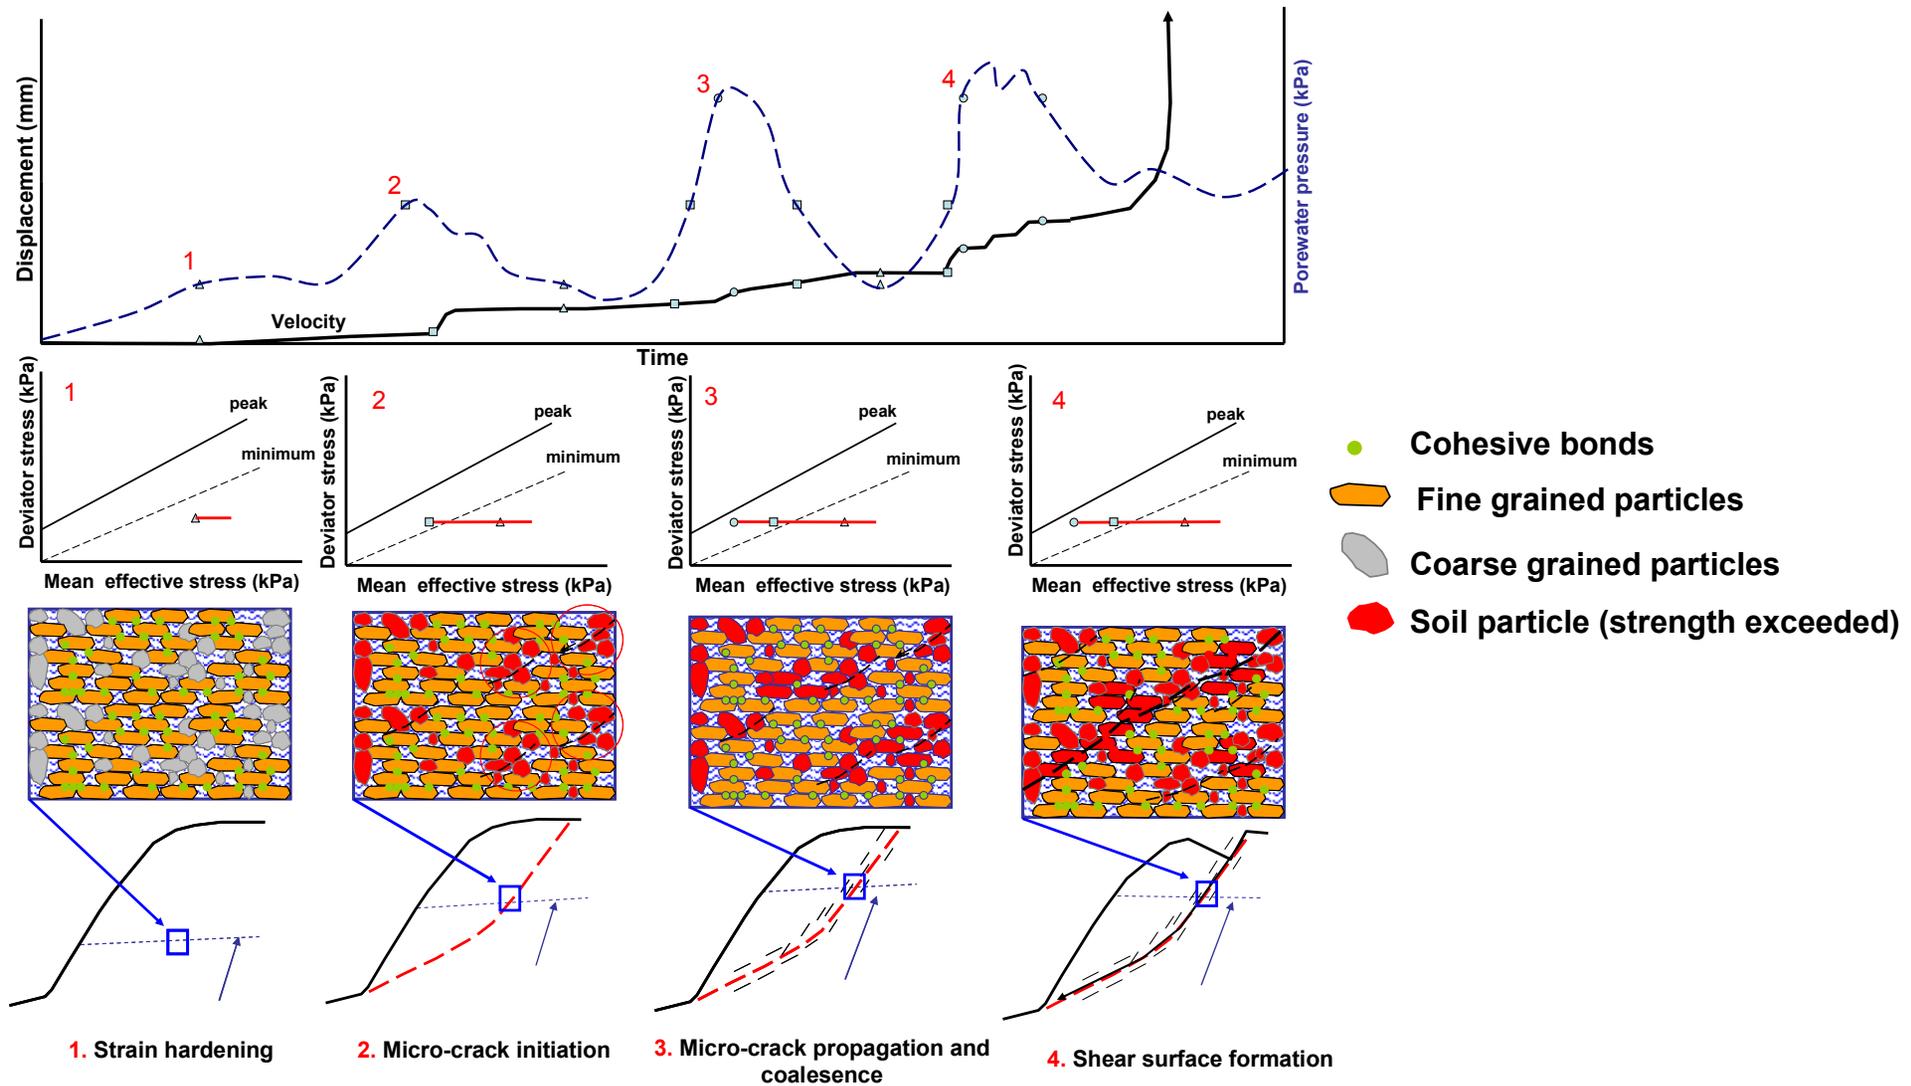
Figure 7.39 A conceptual model for the progressive development of a first time landslide

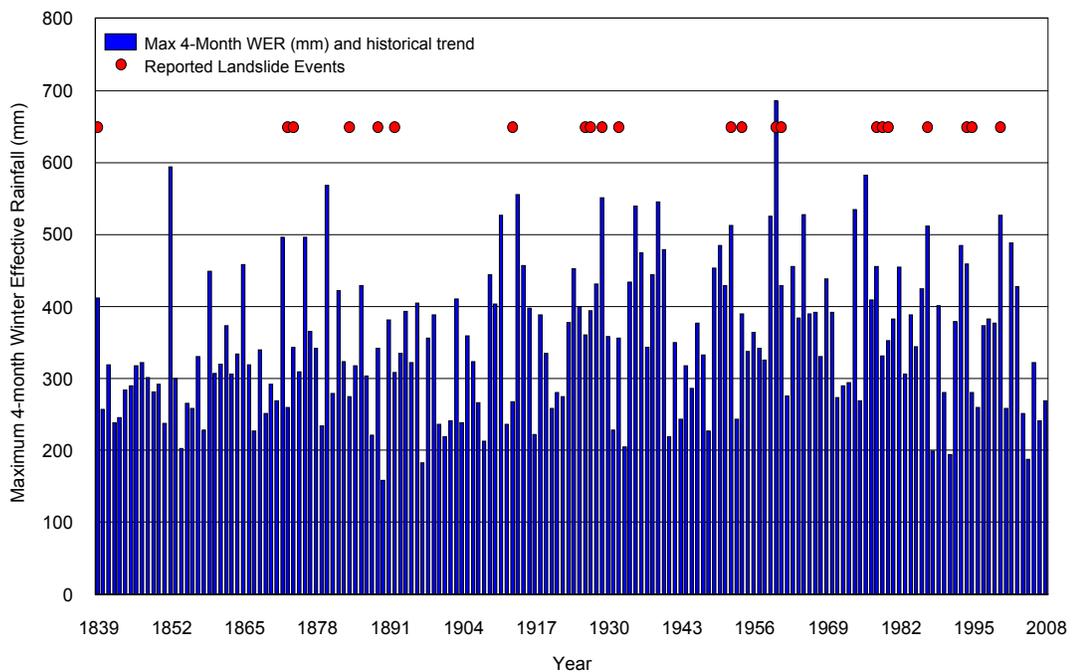
Figure 7.41 Landslide events in relation to Maximum 4 month WER within the Undercliff (after Moore et al., 2007a)
