## Durham E-Theses

*A Prosim Knee Simulator Study of UHMWPE Wear:  
The Effect of Molecular Architecture and New  
Generation Radiation Crosslinking*

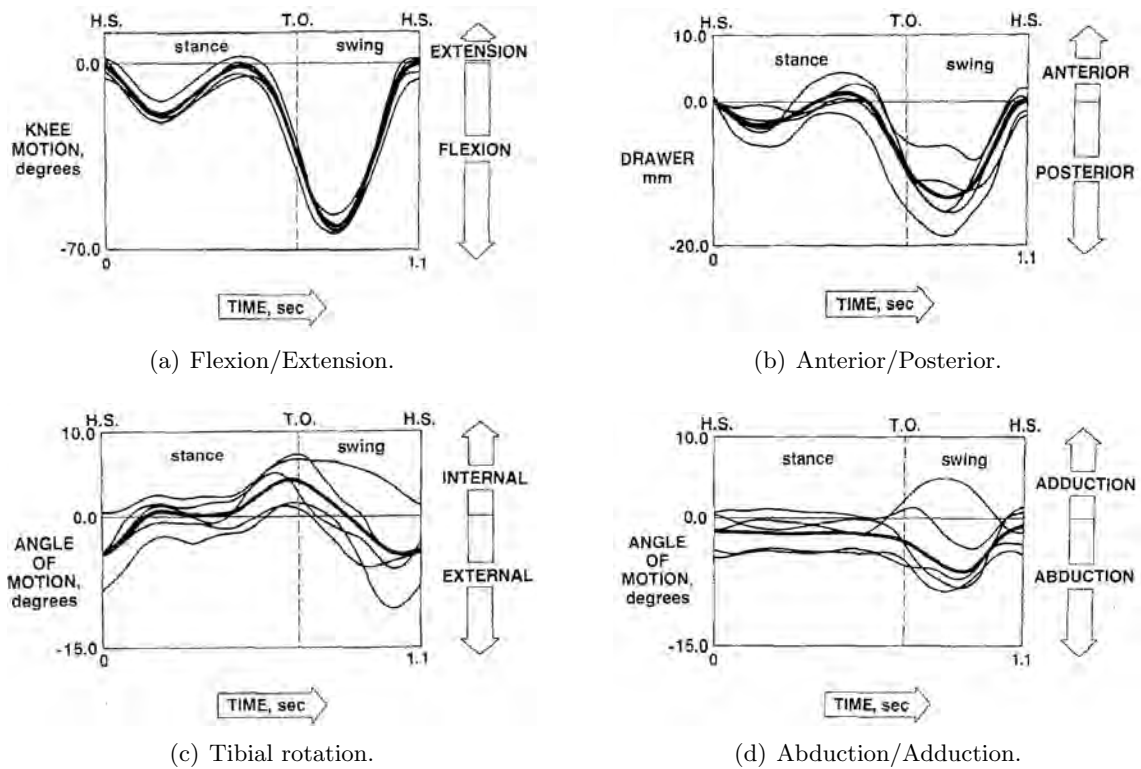
Figure 2.2: Displacements of the natural knee (Lafortune et al., 1992). Thin black lines indicate recorded traces from the five individual subjects. The thicker black line indicates the mean response of the five subjects.

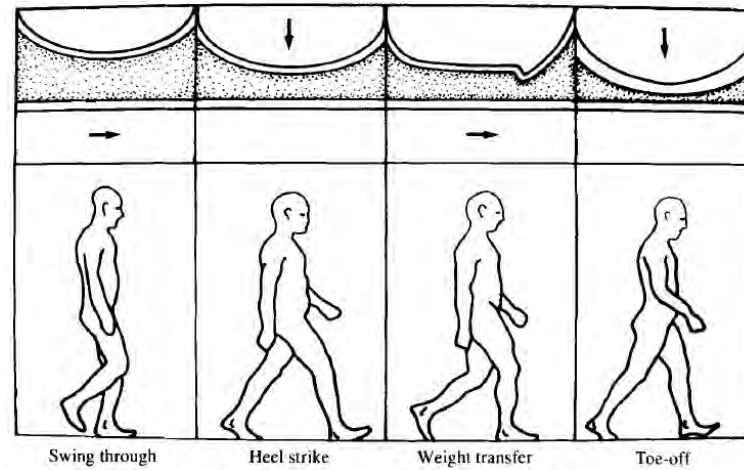
Figure 2.5: Lubrication mechanisms for a right hip joint during a walking cycle (Unsworth, 1991).

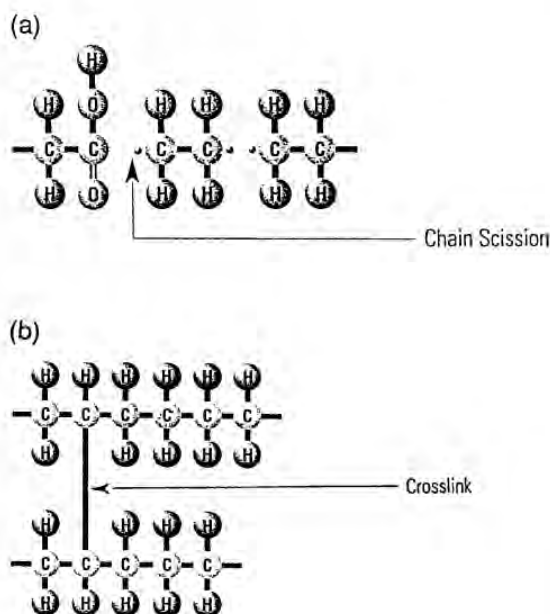
Figure 2.7: The process of chain scission in UHMWPE (a) and the subsequent cross-linking reaction (b) with the formation of covalent C-C bonds between adjacent molecular chains (Lewis, 2001).

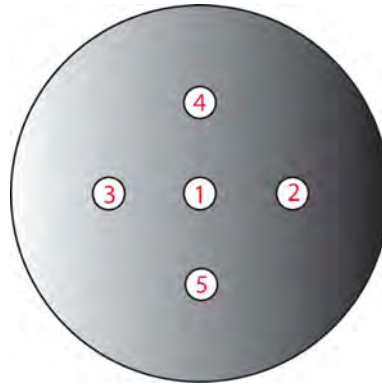
Figure 3.3: Approximate locations of  $R_a$  readings.

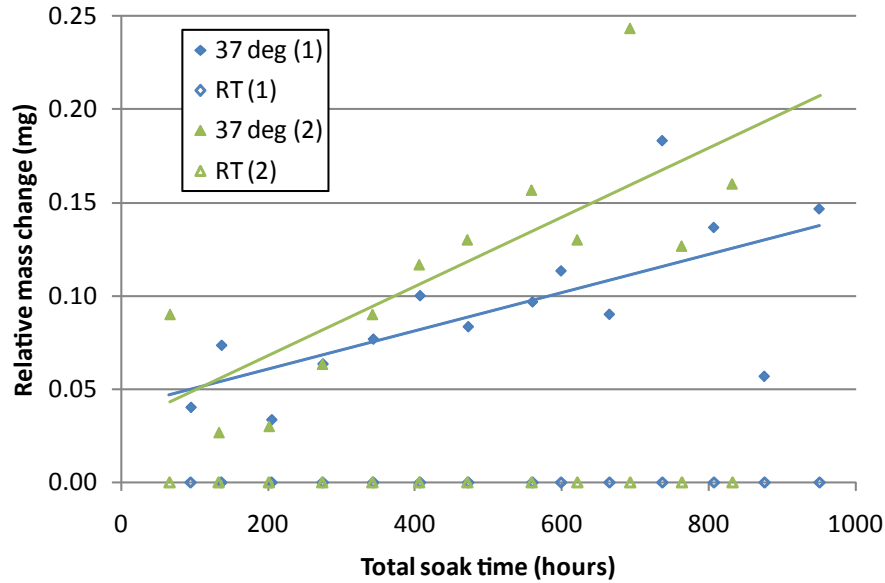
Figure 3.7: Relative mass increase of the two control plates immersed in test lubricant at 37°C with respect to the two control plates immersed in test lubricant at RT.

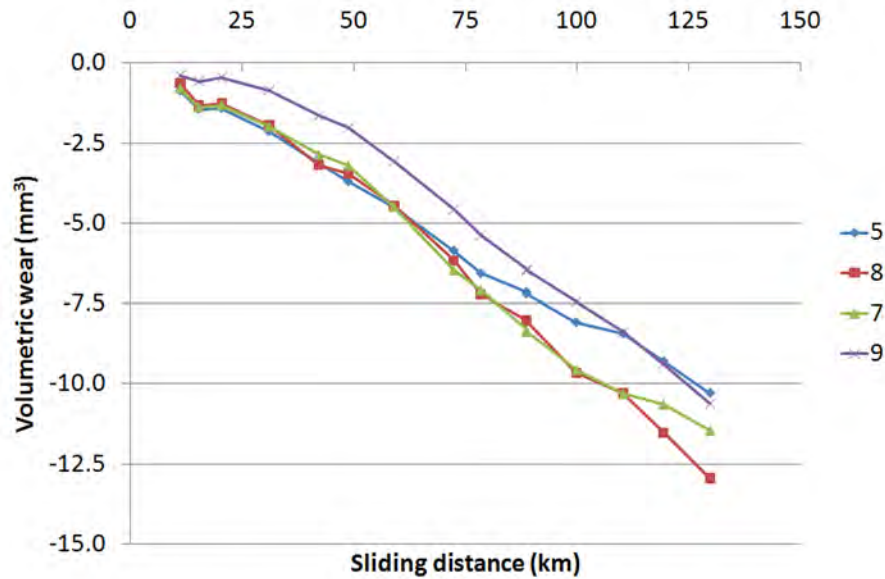
Figure 3.8: Volumetric wear plots of individual commercial UHMWPE plates 5, 8, 7, and 9, on stations 1, 2, 3, and 4, respectively on rig 1.

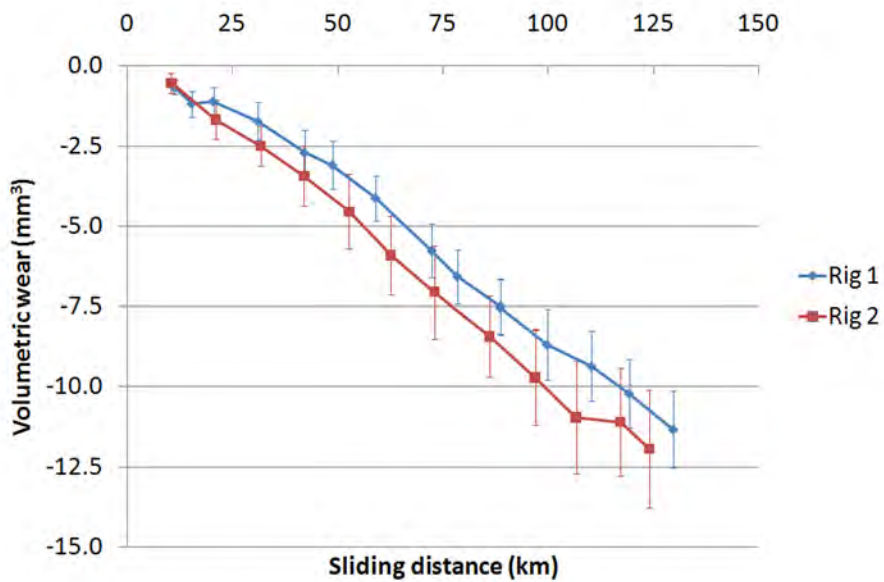
Figure 3.12: Mean volumetric wear plots ( $\pm 1$  SD) of commercial PE plates on rigs 1 and 2.

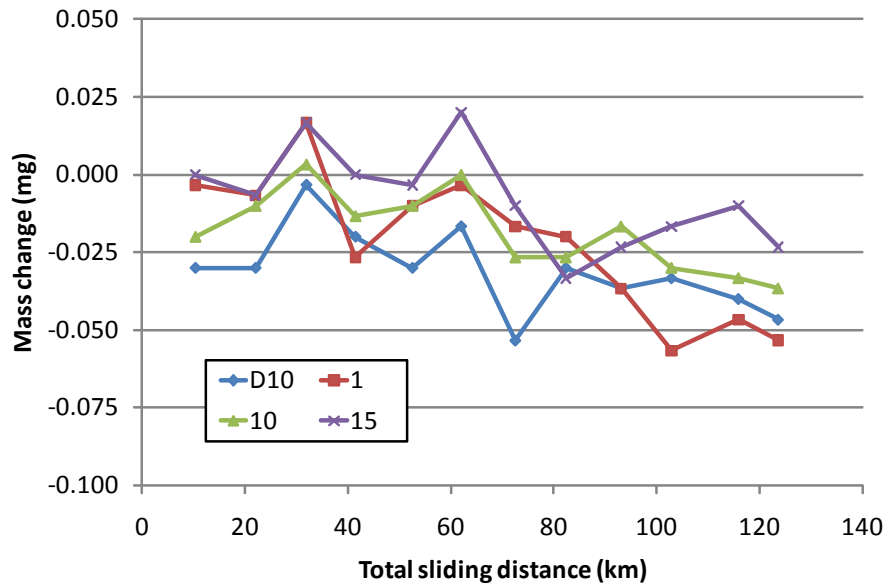
Figure 3.17: Mass change of the four test pins (soak control adjusted).

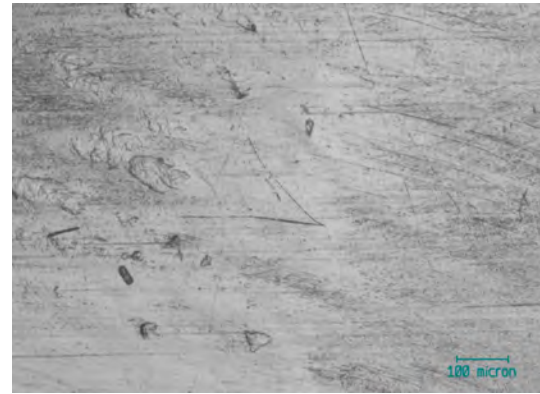
(b) 600,000 g/mol UHMWPE plate at location 5 after 1.0 MC. Note the smooth burnished appearance with material deposition.

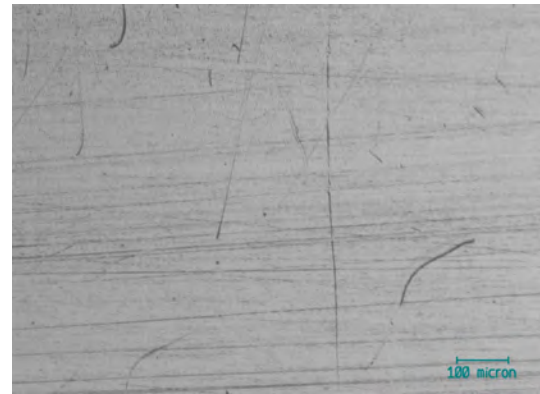
(d) 600,000 g/mol UHMWPE plate at location 4 after 2.0 MC. Note the smooth burnished appearance with fine scratches running in the translation direction.

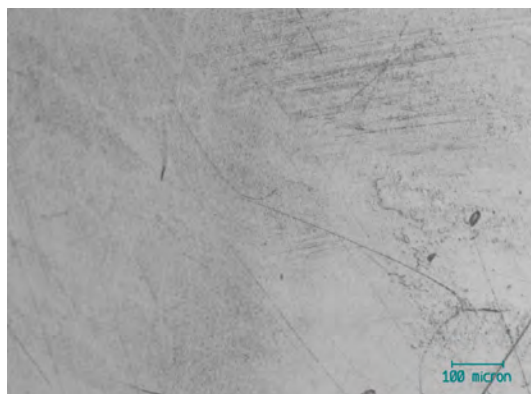
(e) 600,000 g/mol UHMWPE plate at location 1 after 2.5 MC. Note the burnishing with material deposits.

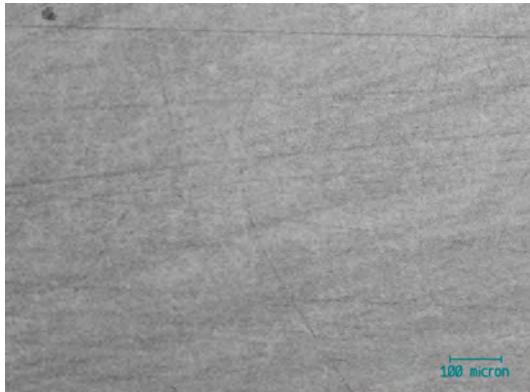
(a) 9,000,000 g/mol UHMWPE plate at location 2 after 0.5 MC. Note the smooth, burnished like appearance.

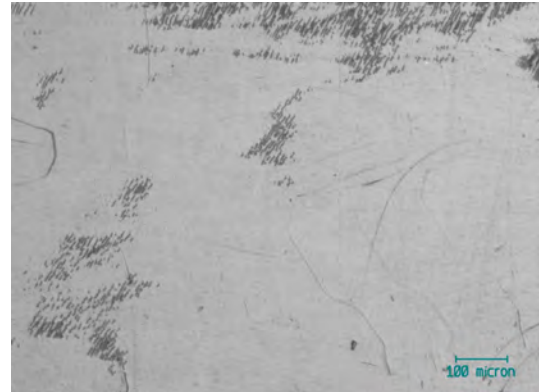
(b) 5,000,000 g/mol UHMWPE plate 3 at location 3 after 0.5 MC. Note the burnishing with sporadic areas of rippling.

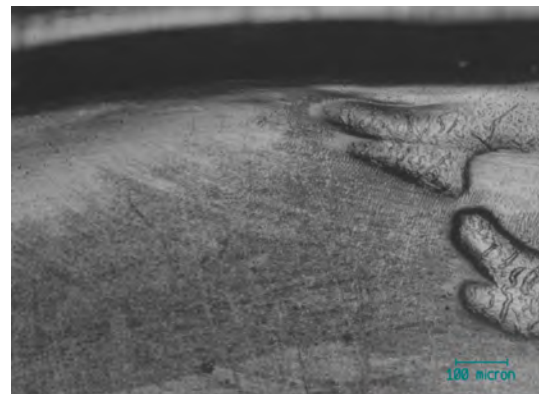
(d) 9,000,000 g/mol UHMWPE plate 3 at location 6 after  $2.0 \times 10^6$  cycles. Note the material deposit at the wear track end.

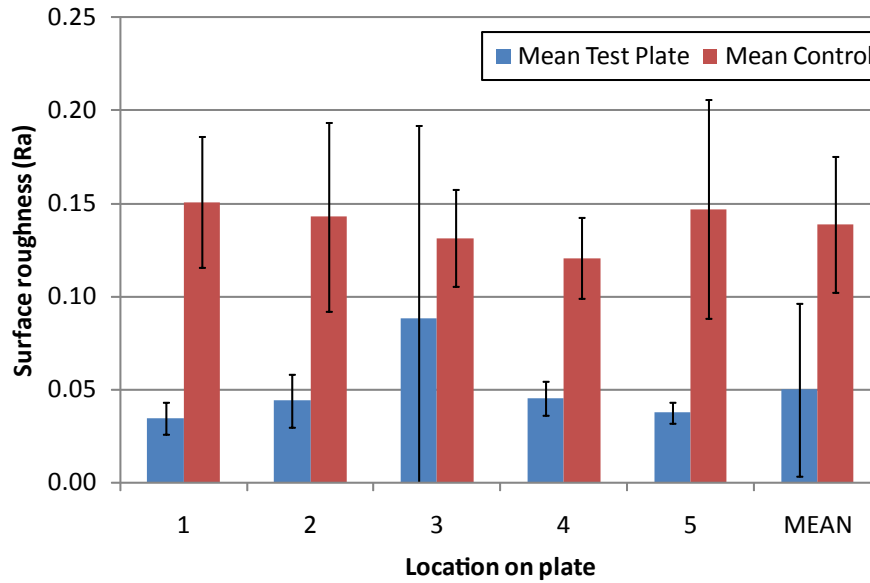
Figure 3.28: Comparison of  $R_a$  of the 4 test plates to the 3 control plates. Error bars are  $\pm 1SD$ .

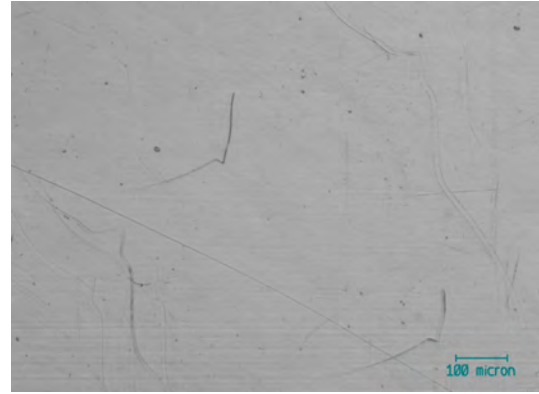
(b) Optical micrograph of plate A1 at location 4 after 0.5 MC. Note the burnished appearance of the plate.

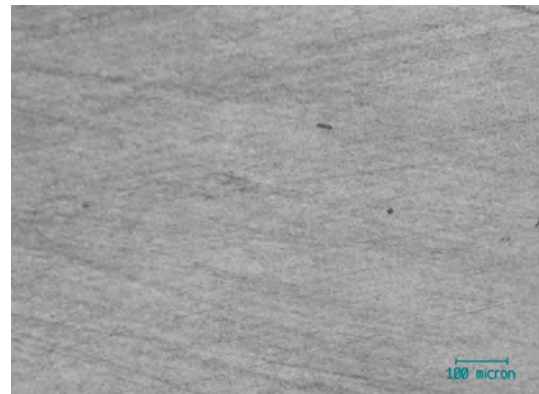
(d) Plate A6 at location 2 after 3.00 MC. Note the burnished surface with fine scratches.

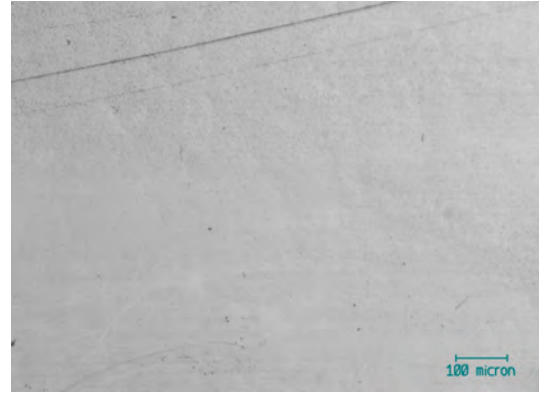
(b) Plate D8 at location 2 after 1.5 MC. Note the burnished appearance of the whole surface.

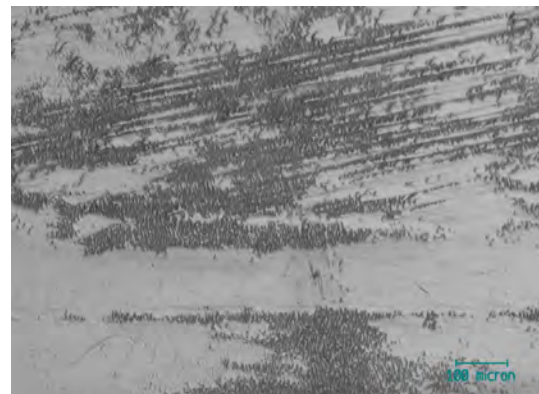
(f) Plate D7 at location 3 after 3.0 MC note the burnishing and ripples, and scratches caused by ripple removal.

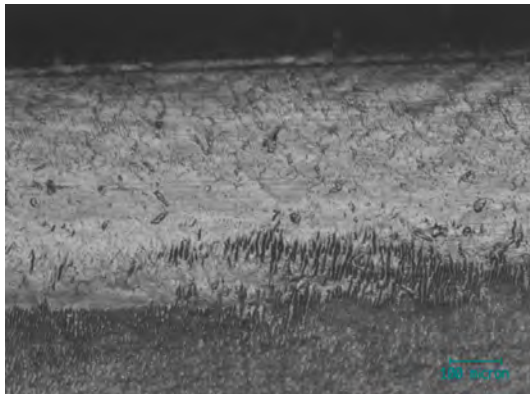
(a) Plate A2 at location 9 after 2.00 MC. Note the dark ripples and cracks towards edge.

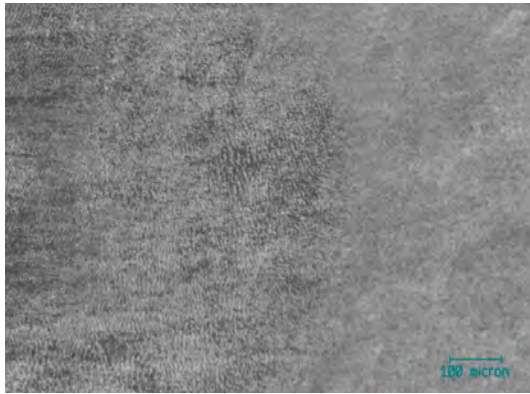
(c) Plate D5 at location 5 after 1.00 MC. Note that ripples stop where there would be no translation, only rotation.

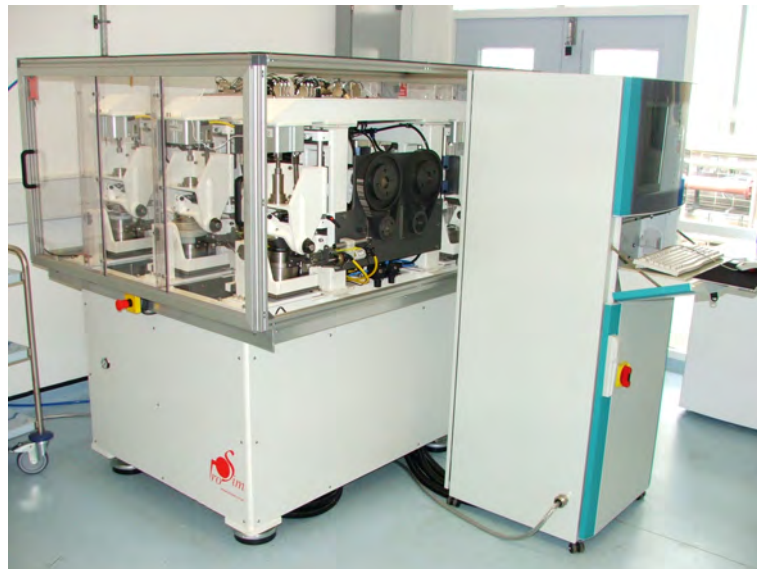
Figure 4.2: The six station ProSim knee wear simulator.

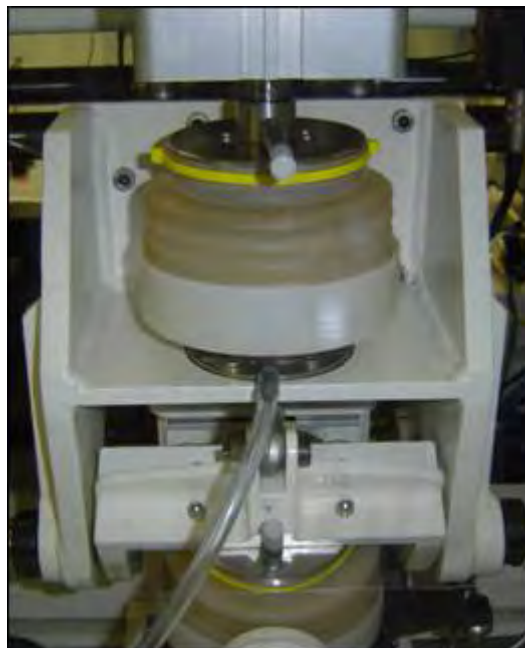
Figure 4.6: The load control station with gaiter *in situ*.

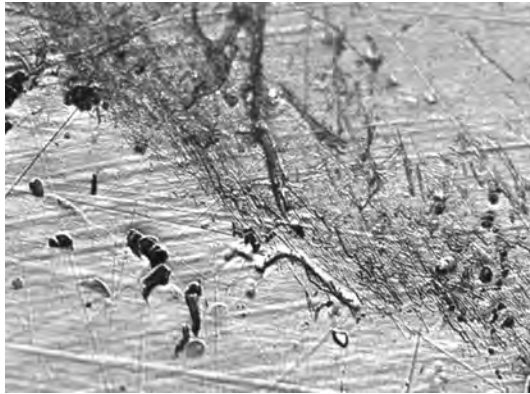
(a) Optical micrograph of tibia surface at the boundary of the contact patch after  $0.5 \times 10^6$  cycles of loading.

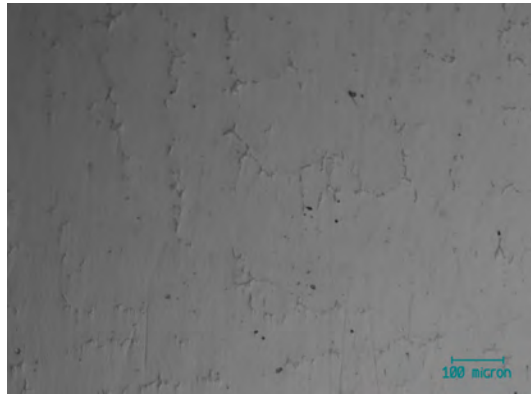
(a) Optical micrograph of Femur 7. This was contacting with the LSC and no surface damage is visible.

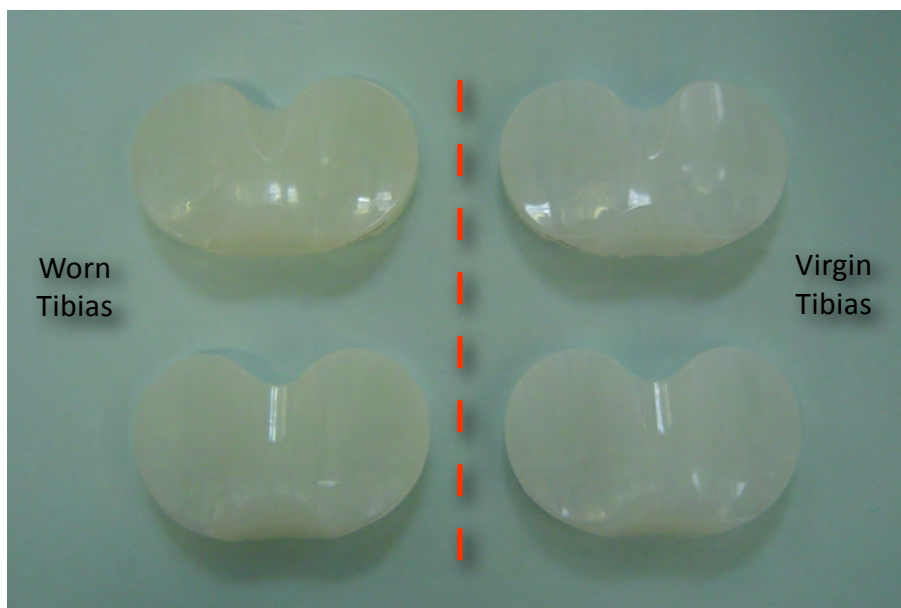
Figure 5.26: Photograph of the four tibia bearings used in the load soak test indicating the discolouration of the previously worn tibias (on left) compared to the virgin tibias (on right) caused by their previous immersion in the test lubricant for long periods of time.

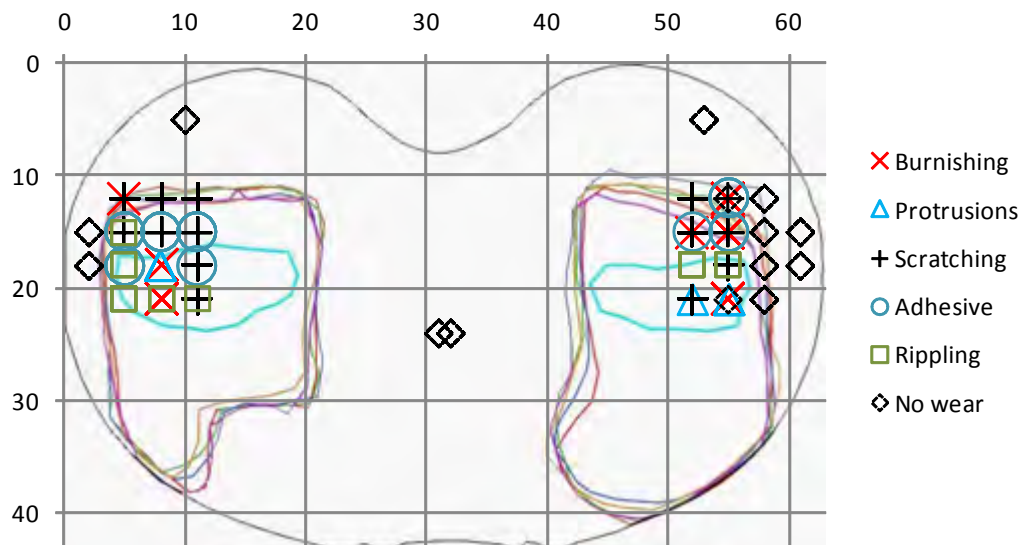
Figure 5.34: Locations of the different types of observed wear on the UHMWPE tibia tested for  $1.0 \times 10^6$  cycles. The medial side of the tibia is the left side of the image.

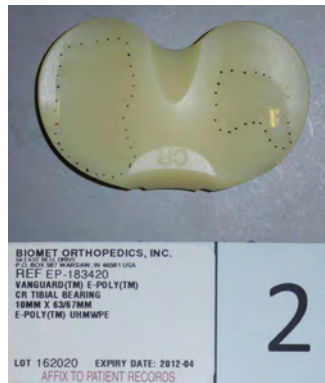
(b) Wear scar on E1<sup>TM</sup> tibia 2 after  $2.5 \times 10^6$  cycles of testing.

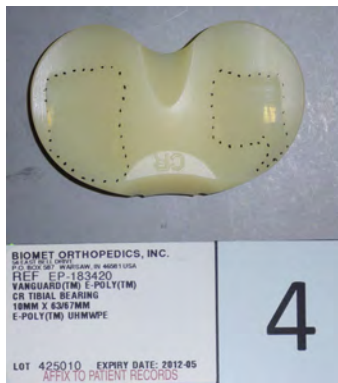
(d) Wear scar on E1<sup>TM</sup> tibia 4 after  $2.5 \times 10^6$  cycles of testing.

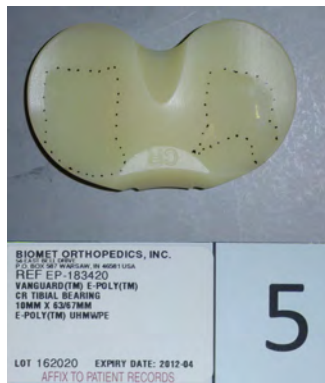
(e) Wear scar on E1<sup>TM</sup> tibia 5 after  $2.5 \times 10^6$  cycles of testing.

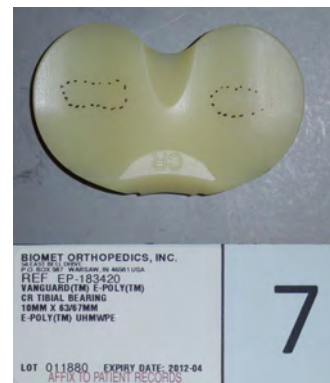
(g) Wear scar on E1<sup>TM</sup> tibia 7 (LSC) after  $2.5 \times 10^6$  cycles of testing.

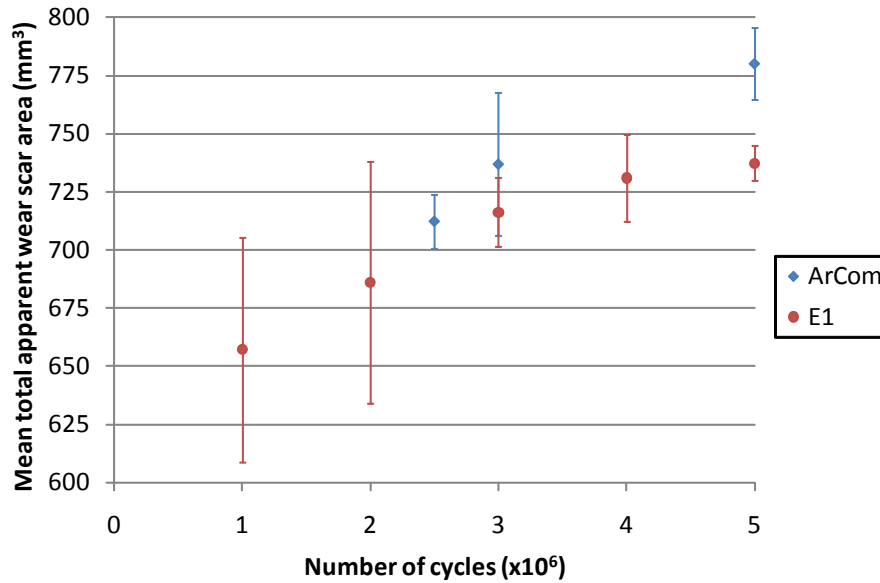
Figure 6.36: Comparison of the mean apparent wear scar areas for both the ArCom<sup>®</sup> and E1<sup>™</sup> components at increasing test durations. Plot shows mean of E1<sup>™</sup> tibias (n=6)  $\pm$  1SD and mean of ArCom<sup>®</sup> tibias (n=5) except at 5x10<sup>6</sup> cycles (n=4)  $\pm$  1SD.

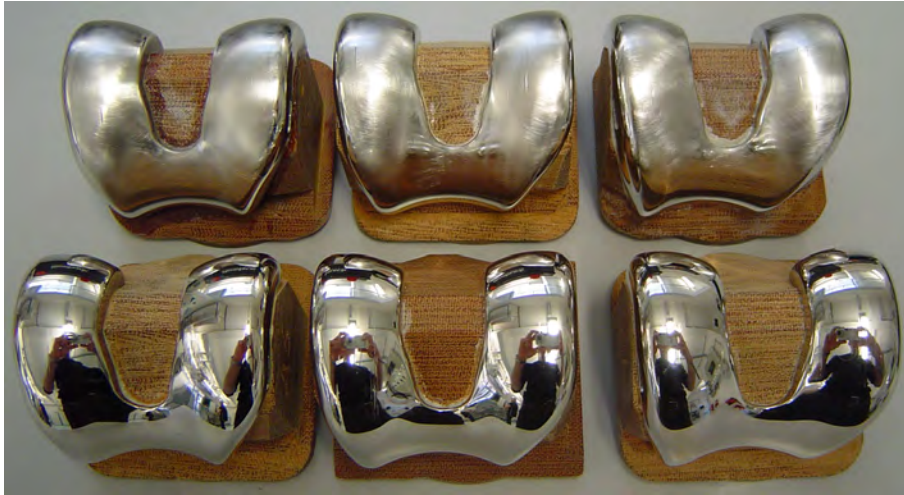
Figure 7.1: Photo showing artificially created scratches on femoral components (top) compared to femoral components after  $11 \times 10^6$  cycles of wear testing (bottom).

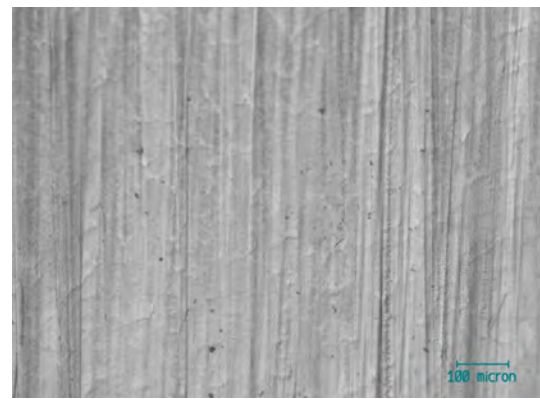
(d) E1<sup>™</sup> tibia 4 at location X8 Y15. Note the increased scratching parallel to the AP sliding direction.
