The House of Kadmos at Mycenaean Thebes: A preliminary re-examination of the architecture

Anastasia C. Dakouri

**Thesis submitted for the degree of Master of Arts by research
Department of Classics, University of Durham
Durham 1998**

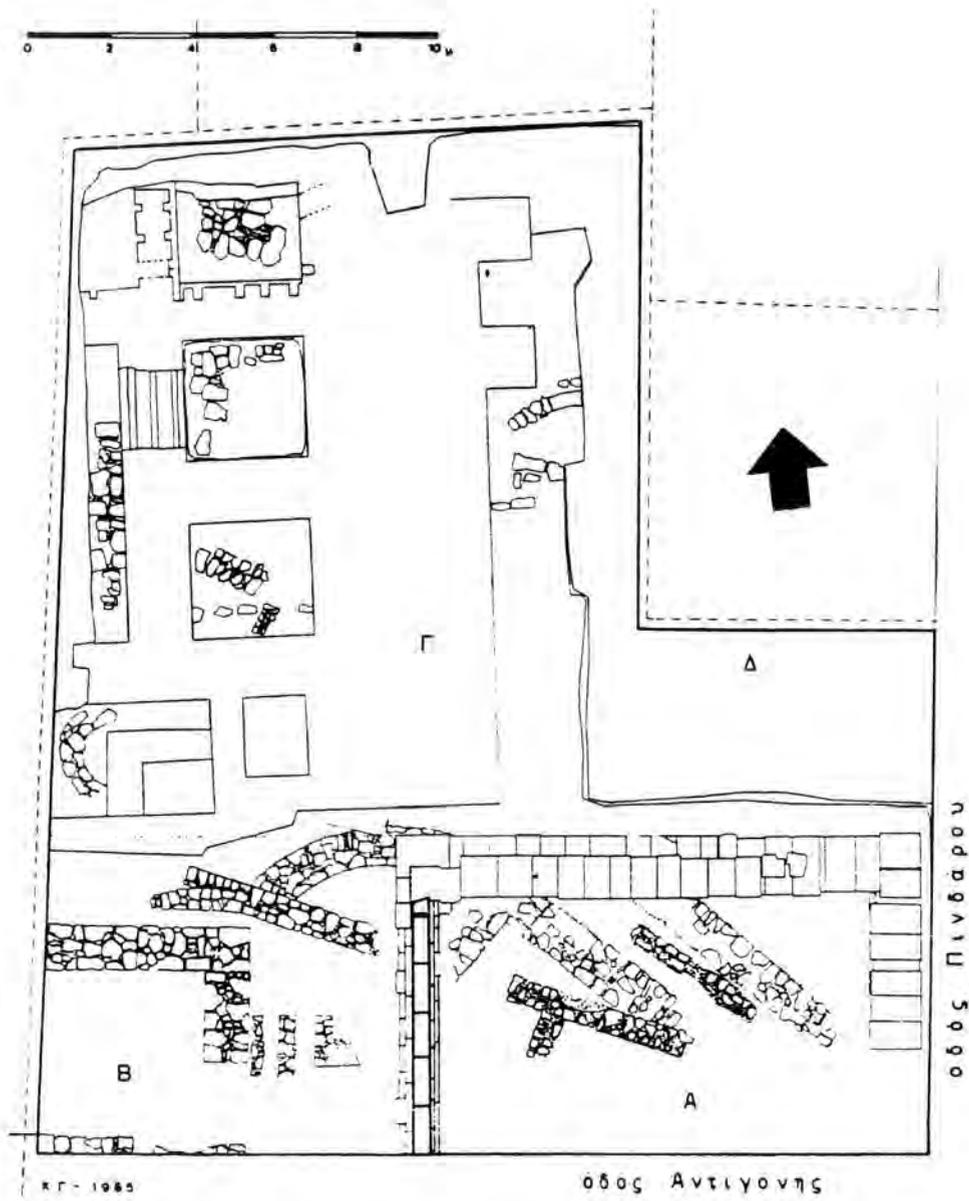
XXI. Reconstructions of the plan (after Symeonoglou 1985, figs. 2.9, 2.10)

Symeonoglou's reconstruction of a columned porch⁵ at "*Room Γ*" presupposes the northward extension of *Wall C30*: the shape of the "column base" (*IV.2.1.3.; figs. XXI, XXX*) attributed to the "porch" makes it more likely that it was embedded in stone foundations and that only the flattened rise projected above floor level.

(Symeonoglou 1985, 222; *fig. XXI*); Keramopoulos also implied an opening there, by proposing that the corridor received day-light through *Wall C30* (Keramopoulos 1928, 47). But we noticed that a layer of pulverised red clay mortar marked the western end of the corridor. The clay matrix lies on top of a bedrock rise that was incorporated in *Wall's C30* foundation at *Rooms E* and *II*. No masonry survives there, since it was destroyed by the early modern wall to its west.⁶

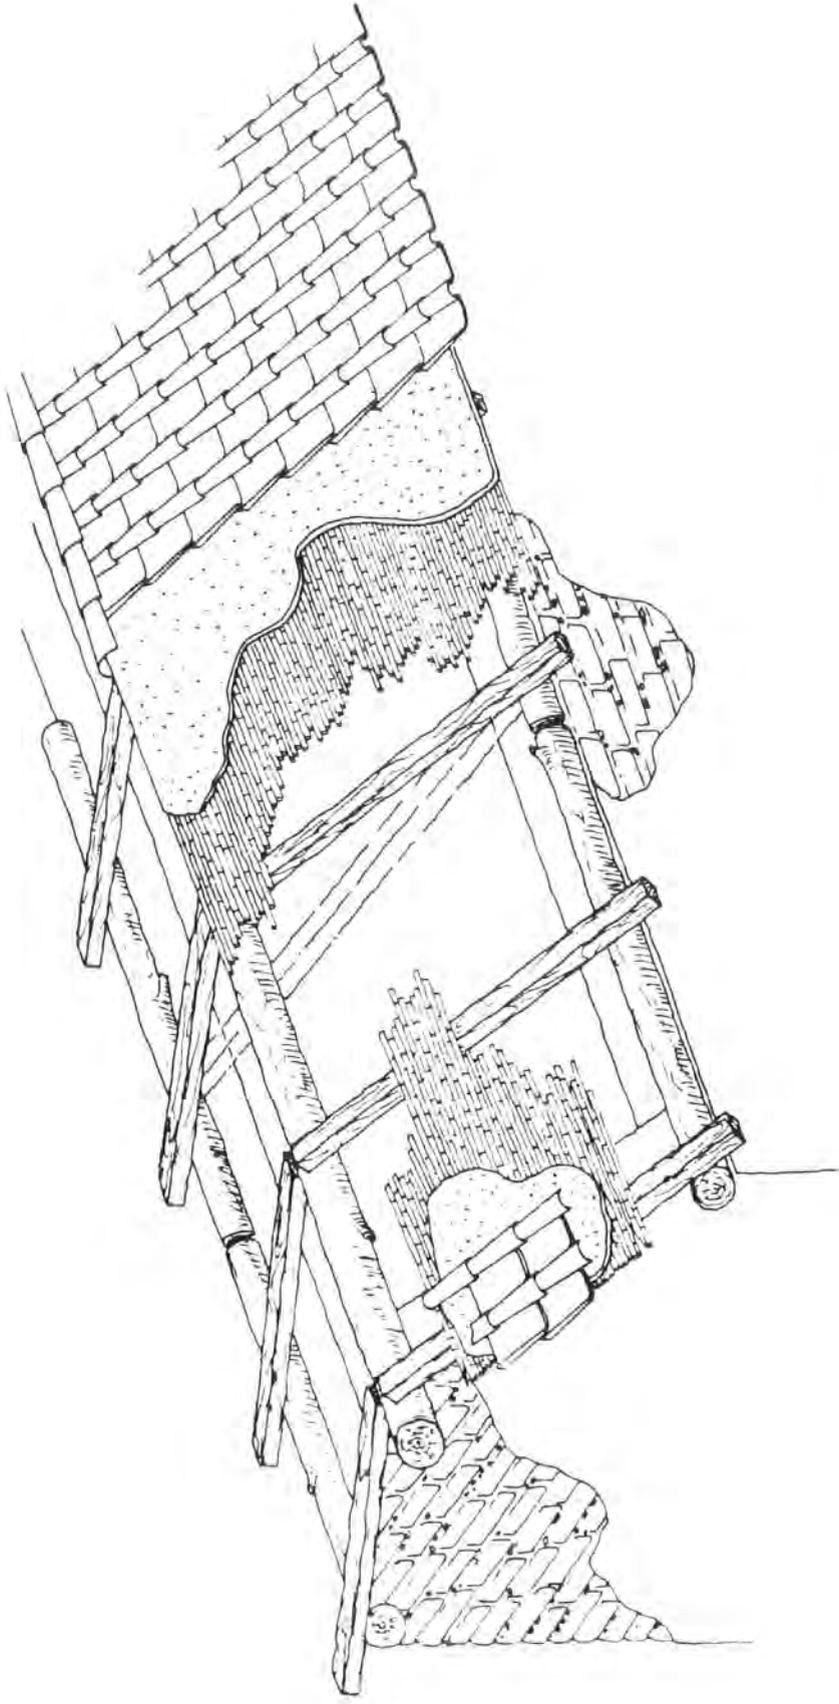
XXXVI. Ceiling construction detail (after Danisman 1968, fig. 6e)

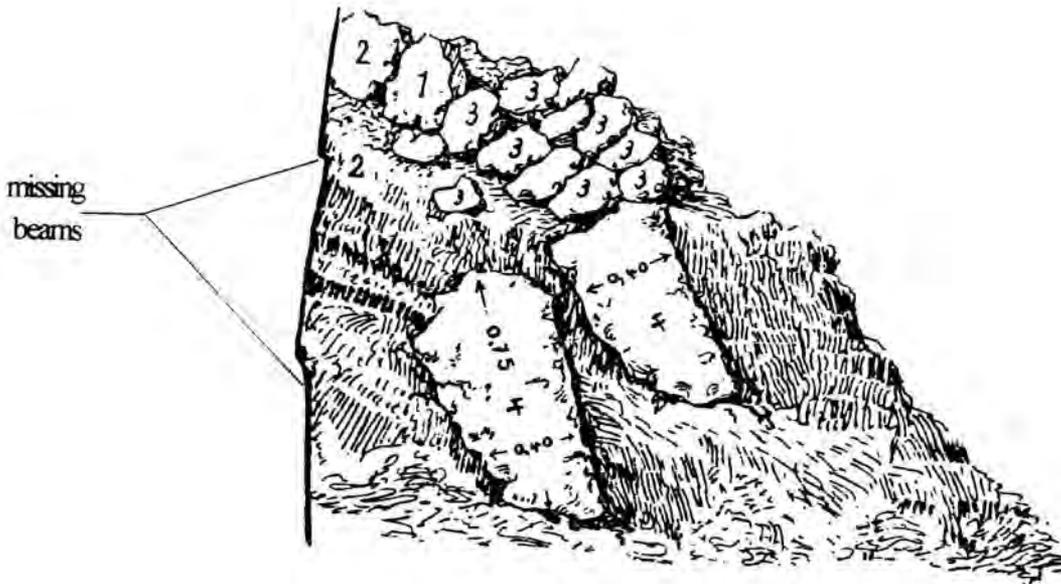
XXXVIII. Fallen roof beams in *Room II* (after Keramopoulos 1927, fig. 3)

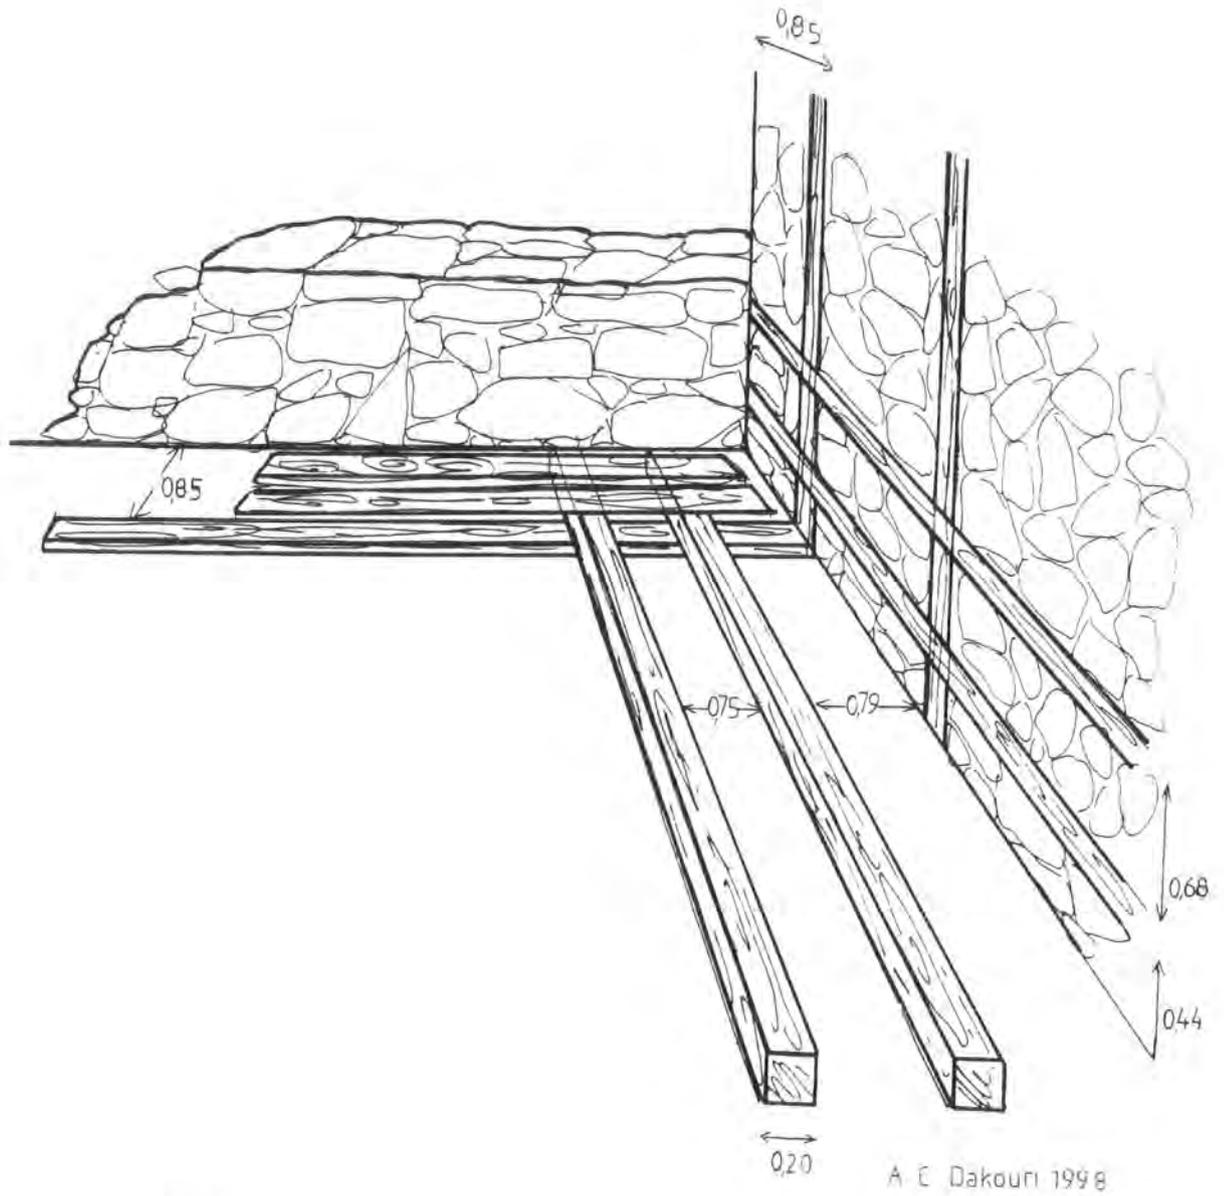
XLIX Some timber beams used at the House of Kadmos

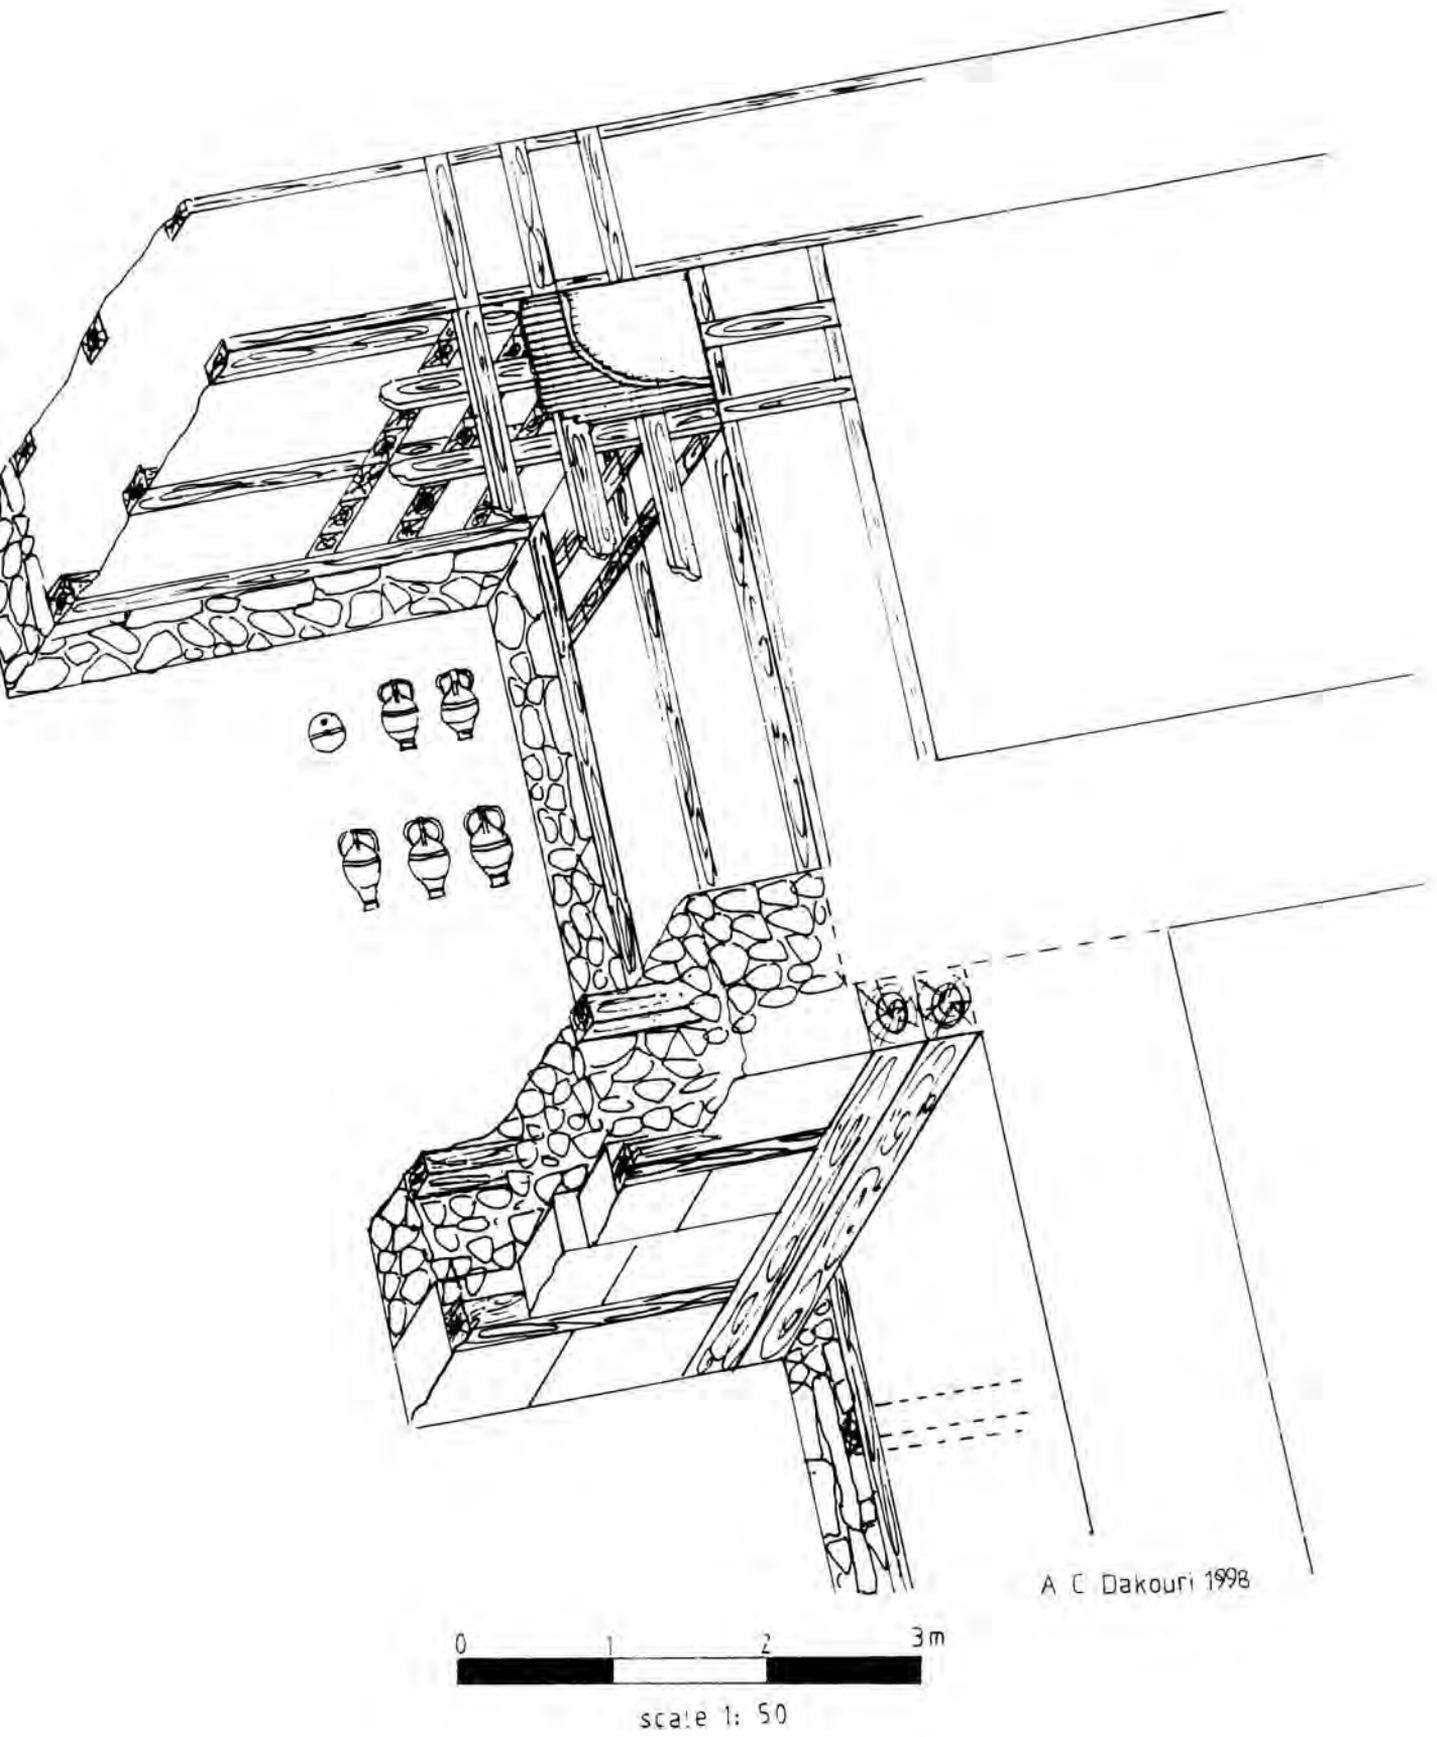
L. Reconstruction of the timber floor of *Room II* and the frame of *Wall C 23*,
according to Keramopoulos 1927
