Tribological and Structural Characterisation of Ceramic on Metal Hip Replacements

WILLIAMS, SARAH REBECCA (2010) Tribological and Structural Characterisation of Ceramic on Metal Hip Replacements. Doctoral thesis, Durham University.

A Thesis presented for the degree of
Doctor of Philosophy

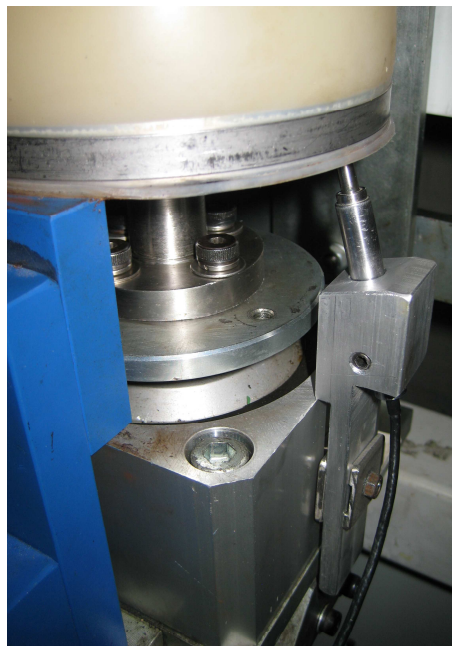
(b) *Superior inferior displacement*

Figure 4.4: Images of LVDT measurement during MXS tests.

A linear variable displacement transformer (LVDT) was used in an attempt to record inferior superior and medial lateral displacement during microseparation testing. However, ‘true’ displacements could not be measured due to the space constraints of the simulator and the equipment available. Figure 4.4 shows the position of the LVDT and the jigs used to hold the transducer. The x-axis is labelled ‘counts’. Each walking cycle takes 1 second, and each second is represented by 1000 ‘counts’. Each Figure shows 2.5 seconds therefore 2.5 gait cycles.

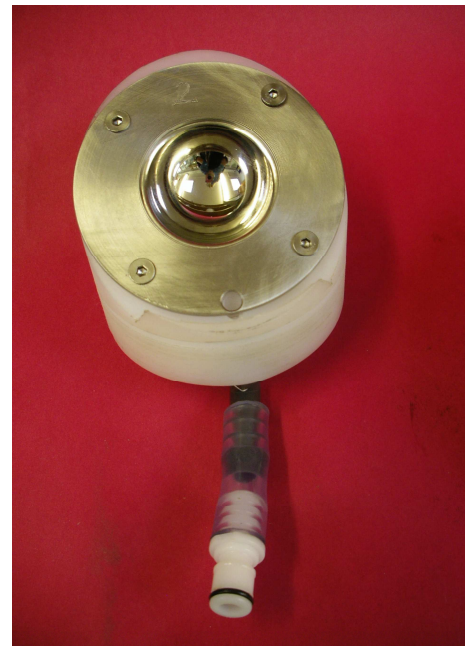
(b) UHMWPE cup holder with clamping ring

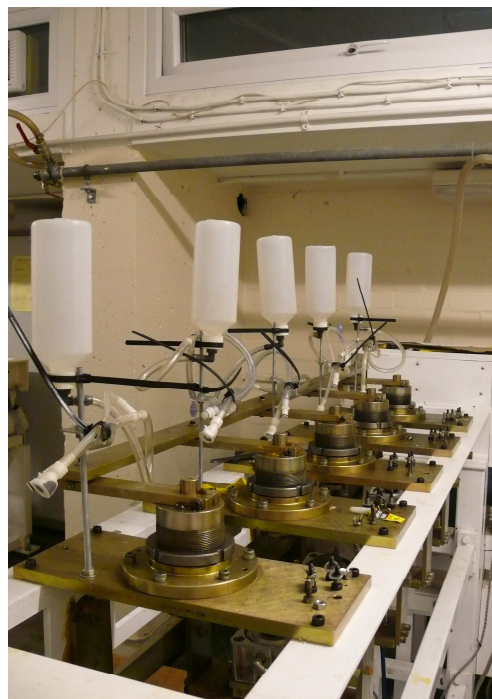
(c)

Figure 5.8: *Bottle configuration on the wear simulators, to provide space for air to escape, and reduce the possibility of dry contact.*

gaiter to escape from the bearing surface, see Figure 5.8.

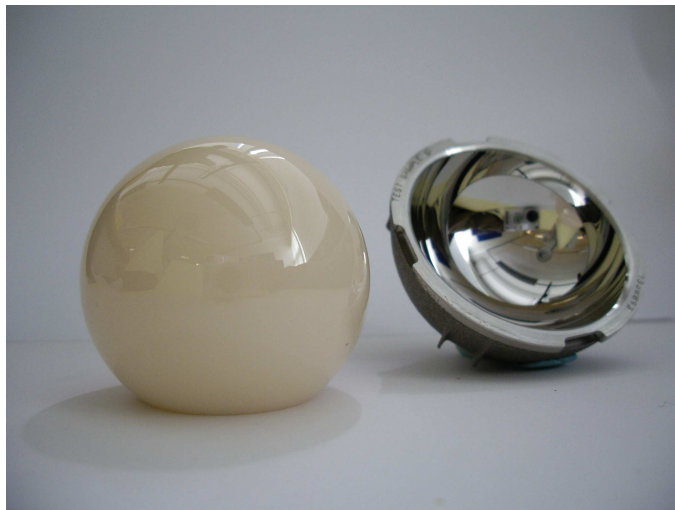
Figure 6.1: 38mm alumina head and as-cast CoCrMo alloy cup

A set of six, 38 mm diameter alumina femoral heads were paired with as-cast CoCrMo acetabular cups, an example of which is shown in Figure 6.1. The components were paired to give radial clearances close to $100\ \mu\text{m}$. The pairings are shown in Table 6.1.

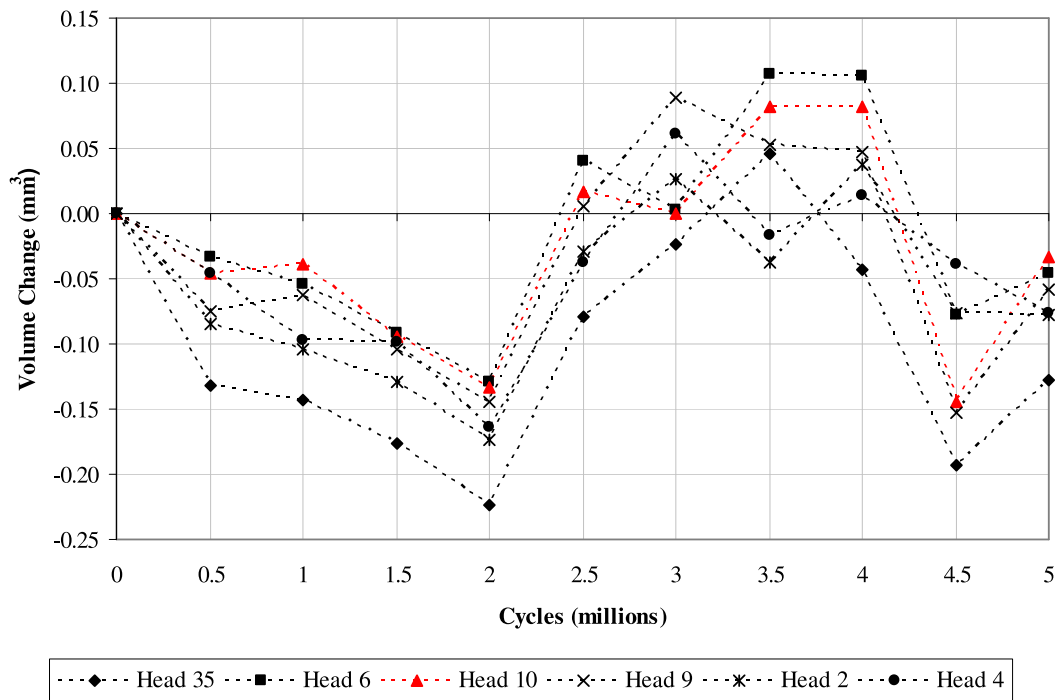
Figure 6.2: Volume change of 38 mm alumina femoral heads under standard wear conditions (Control = head 10).

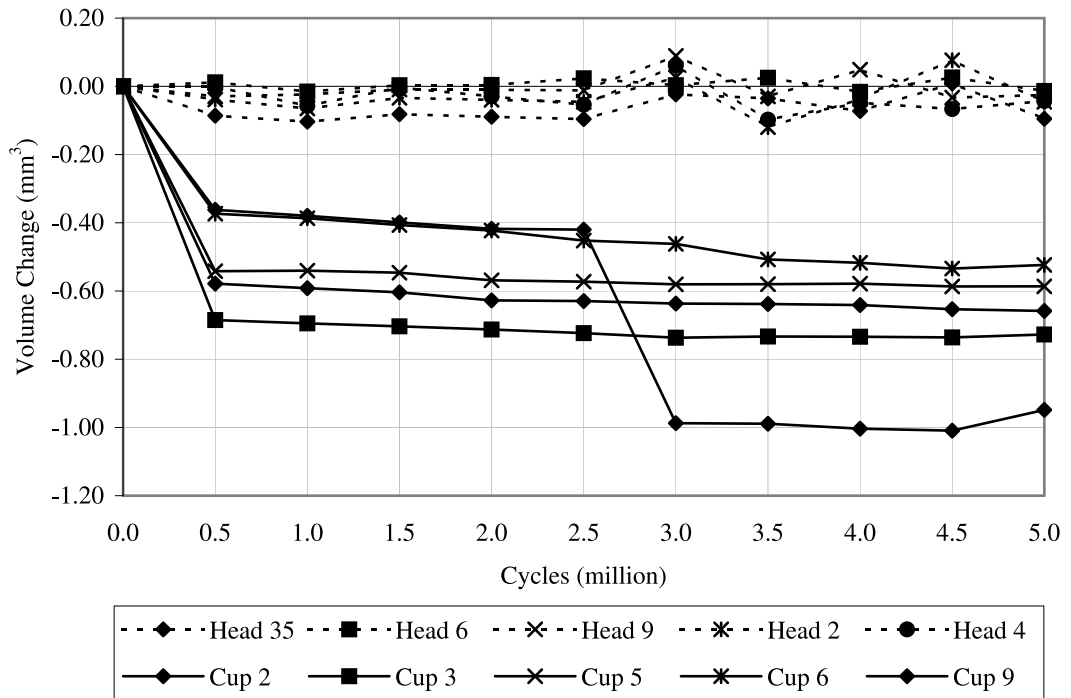
Figure 6.4: Volume change of 38 mm alumina:CoCrMo under standard wear conditions (adjusted using the loaded soak control).

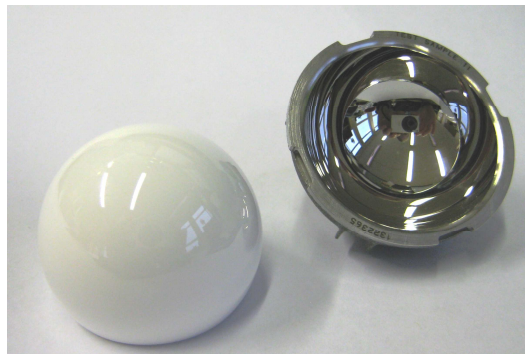
Figure 7.1: 38mm ZTA head and as-cast CoCrMo alloy cup

A set of six, 38 mm diameter zirconia toughened alumina (ZTA) femoral heads were paired with as cast CoCrMo acetabular cups, as shown in Figure 7.1.

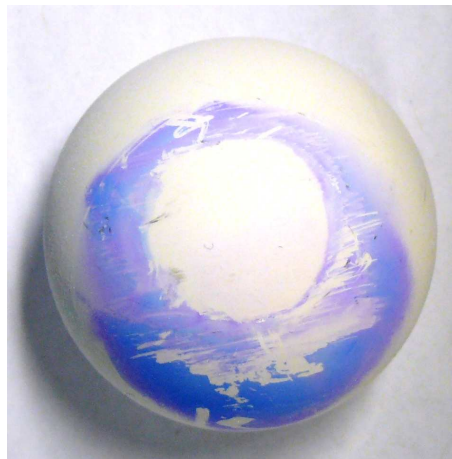
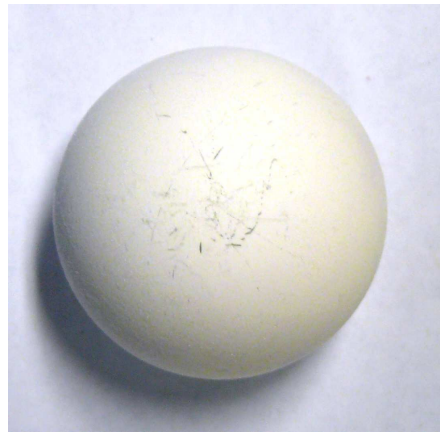
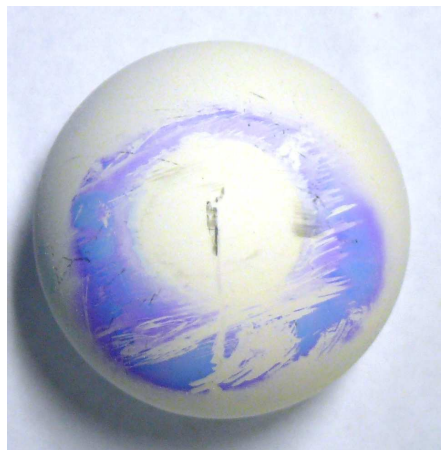
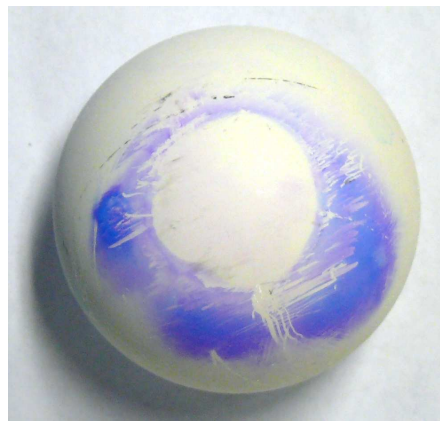
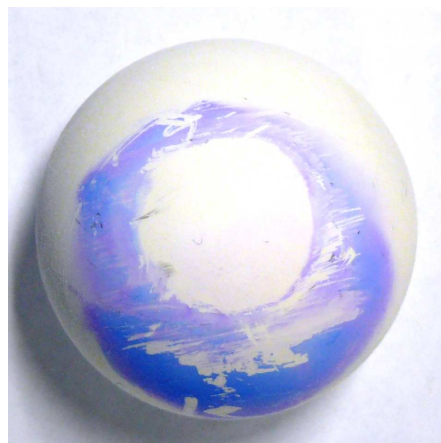
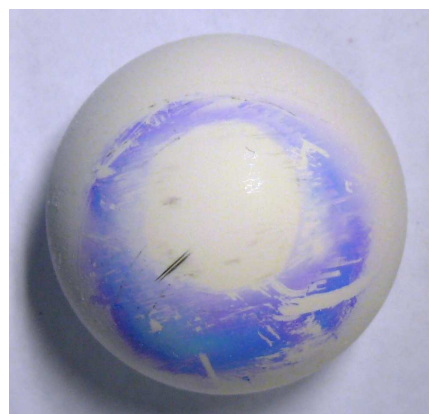
The white substance deposited during wear testing was stained blue using non permanent ink. This allowed the wear patch on the pole of the heads to be visualised. The blue coloured deposit surrounding the circular wear patch indicated the position between the head and cup where close contact occurred. Figure 7.24 shows the 6 heads after a 0.5 million cycles period of wear (between 4.5 and 5 million cycles of wear). This was typical of each 0.5 million cycles wear period.

No deposition was found on the loaded control joint. A clear circular wear patch was visible on the pole of the active stations with scratches running into the deposit as a result of two body or three body abrasive wear. It can be seen from these images that the majority of the metal transfer occurred outside the wear patch. Head 5 has an area of metal transfer on the pole, which is thought to have occurred during simulator setup/take down during the previous 0.5 million cycles.

Figure 7.24: Stained deposition after 0.5 million cycles of standard wear (total of 5 million cycles) on ZTA 38mm heads.

A white deposit, thought to be protein, was found on all bearing surfaces (except the control) during each 0.5 million cycles wear period as evident in Figure 7.24. Increases in temperature resulting in denaturing of proteins in the lubricant have been found to occur between bearing surfaces resulting in precipitation of the serum proteins and adsorption onto the surfaces [94, 96, 99, 100]. Albumin, an abundant protein in both synovial fluid and bovine serum, has been reported to adsorb to surfaces in both the native and unfolded form depending on the conditions and materials involved [96]. Hypotheses have suggested that tribological processes such as friction and wear can result in adsorption of albumin to certain bearing surfaces [27] some suggesting that unfolding of the secondary structure reveals more of the hydrophobic contact area of the albumin resulting in a compact layer deposited onto the surface increasing the friction compared with native albumin which has a better 3D structure [100]. The majority of the work has concentrated on the deposition of protein onto hydrophobic polymer surfaces, however there are cases in the literature of albumin being adsorbed to metallic and ceramic bearing materials. Interestingly the results differ with some authors suggesting that albumin does not adsorb on surfaces of an alumina on alumina pin on disc tribometer test [99] where other cases have shown albumin to adsorb to both metallic and ceramic surfaces, adsorbing to the metallic one to a greater extent than ceramic [97]. In the current study, deposition was found on all ZTA components (except the control, see Figure 7.24) in the area surrounding the pole, and has previously been reported on alumina femoral heads in the same laboratory ([7]). If an increase in temperature due to friction can lead to unfolding of the proteins and adsorption onto the bearing surfaces, protein adsorption is likely to occur in regions where the temperatures are greatest [99]. It is expected in hip replacements this region is the area where the head and cup fit together in close contact. However, adsorbed molecules will only remain on the surfaces in regions where physical contact and motion does not occur. This may provide an explanation of why deposition is not found in the circular contact region,

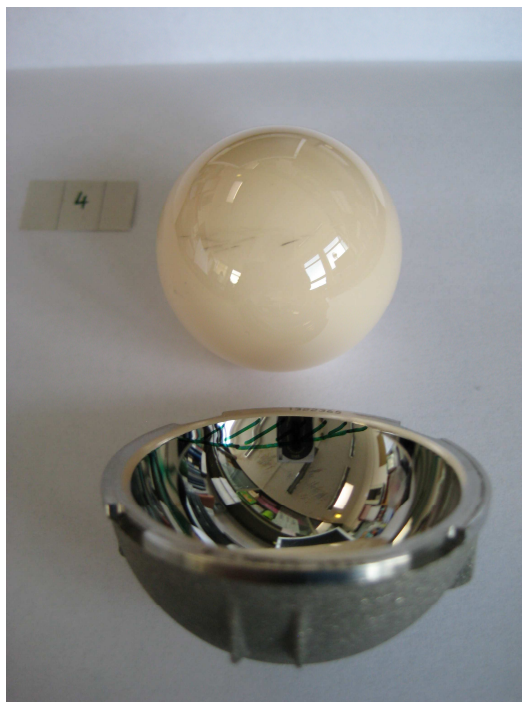
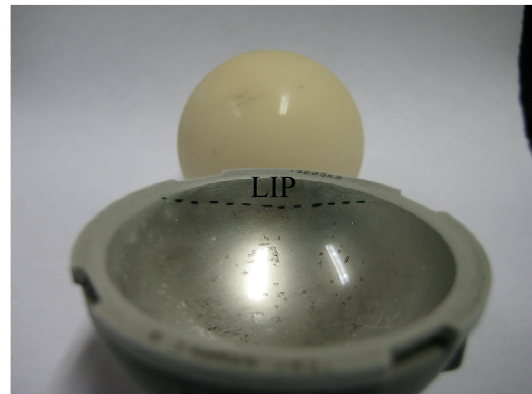
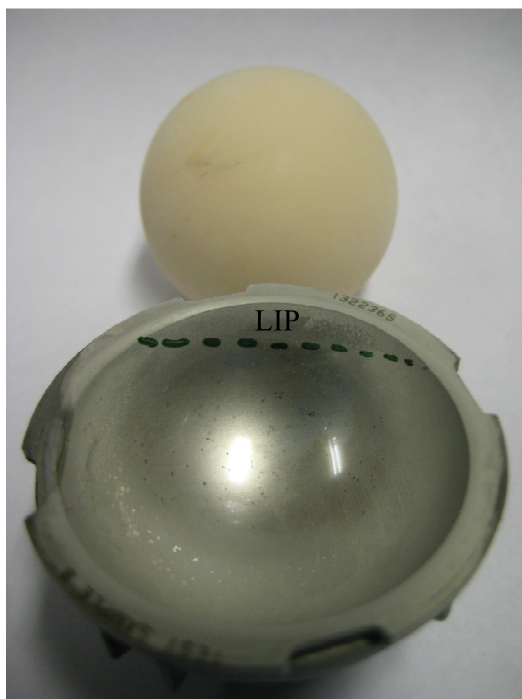
Figure 8.9: Digital images showing the progression of flattened lip formation on the metallic cup over the progression of the wear test. The flattened lip has been highlighted with a non permanent pen.

Digital images were taken to show the metal transfer on the head (Figure 8.8) and the flattened lip on the cup (Figures 8.9 and 8.10). The metal transfer on the head changed as the wear progressed, and the metal was transferred and removed. The lip was visible by eye (see Figure 8.11) however the edges became less distinguishable from the main surface of the cup as the test progressed. Although the width and breadth only increased slightly with number of cycles, it is likely that an increase in the depth (not measured) was the cause of the observed increase in wear rate compared with the standard wear test. A dull patch, possibly a mixture of deposit and metal particles, was often observed on the edge of the flattened lip. This is shown in Figure 8.10.

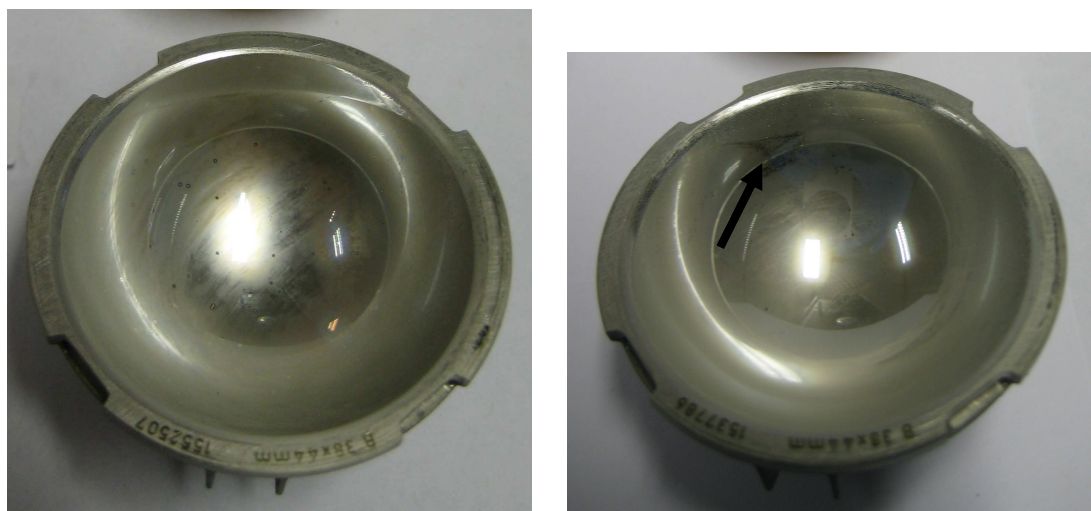
Figure 8.11: Digital images showing the flattened lip (without markings using a non permanent pen) and a dull patch found on the edge of the lip (see arrow).

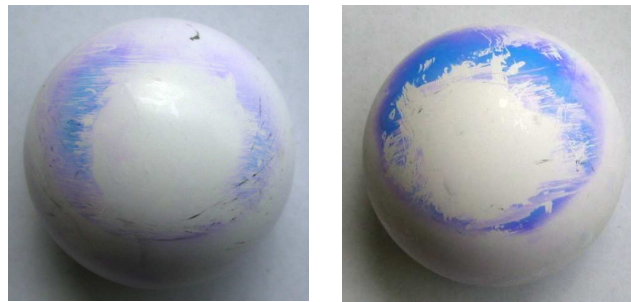
Figure 10.21: *Digital images of stained deposition on the alumina heads during third body particle testing taken at 0.5 million cycles (a & b) and 2 million cycles (c & d).*

(a) *Particles in the lubricant - 0.5mc* (b) *Clean lubricant - 0.5mc*

During wear testing, a white substance was deposited onto the surface of the ceramic heads and metallic cups. The wear patch could clearly be identified on the pole of the head within the clear area which was enclosed within the deposit. Less deposit was seen on the components when particles were present in the lubricant compared with the 'clean' lubricant stations. Figure 10.21 and 10.22 show typical images taken during stage one of testing after 0.5 and 2 million cycles.

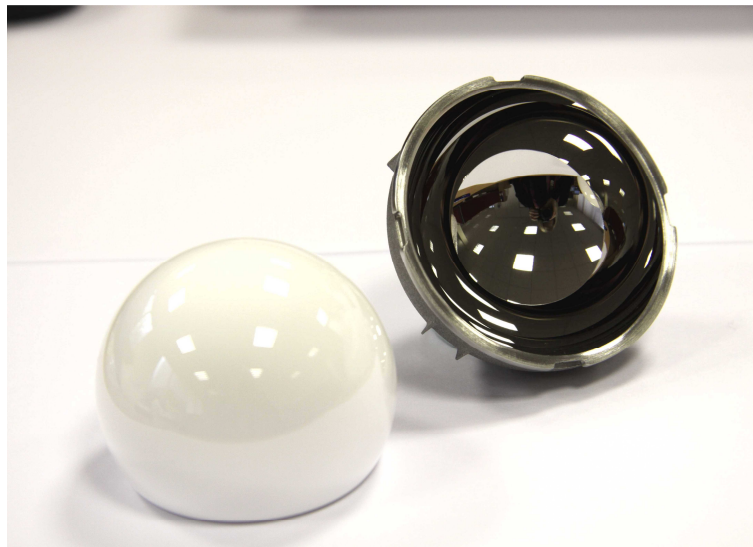
Figure 11.1: 60 mm ZTA femoral head and as-cast CoCrMo acetabular cup.

A set of eight 60 mm ZTA heads and as-cast CoCrMo alloy cups were tested under standard walking conditions. Figure 11.1 shows a typical ZTA head and CoCrMo cup.

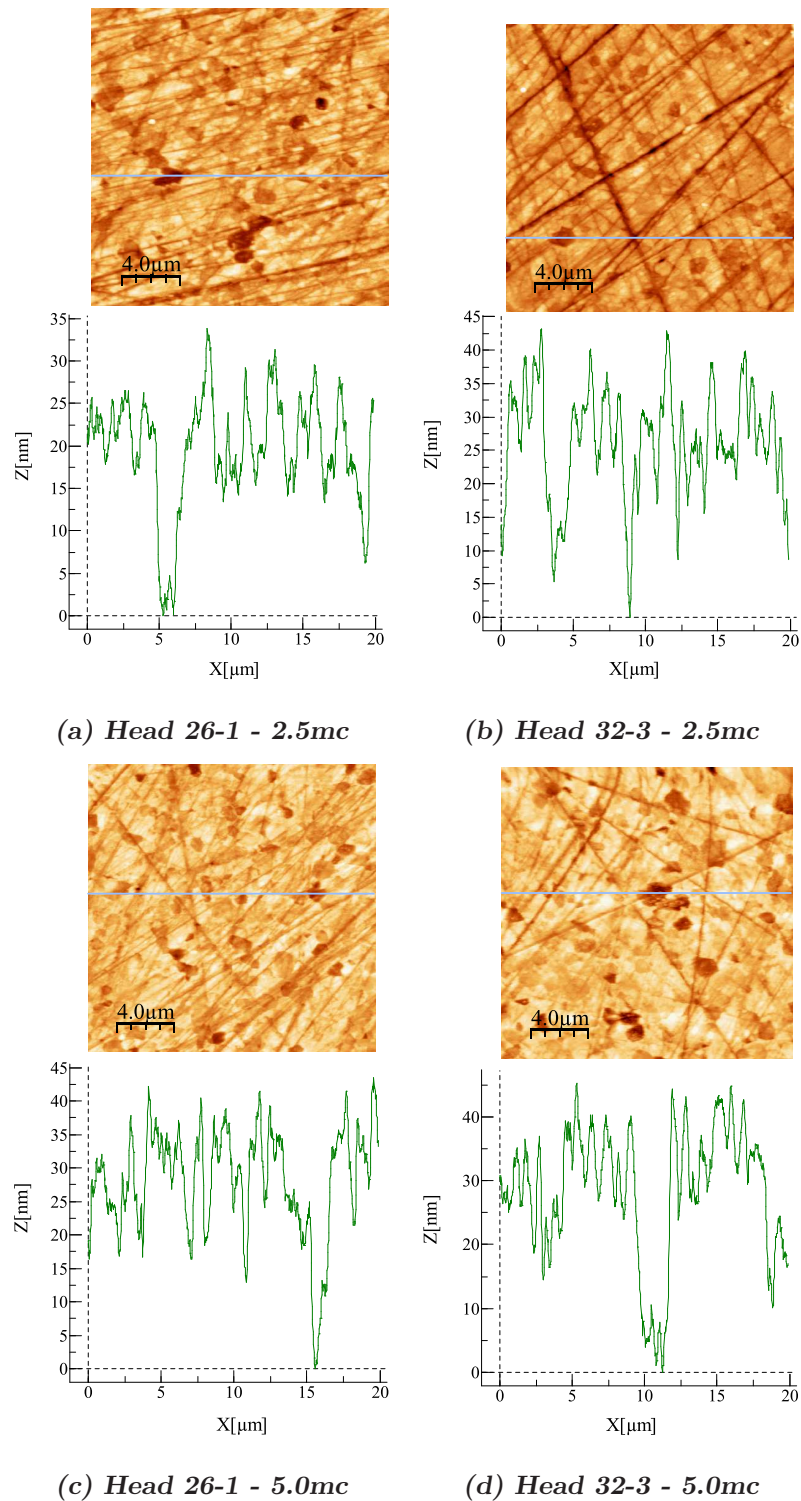
Figure 11.23: AFM line profiles of 60mm heads 26-1 and 32-3 after 2.5 and 5.0 million cycles of wear.
