Durham E-Theses

Slope instability along the north-west coast in Malta

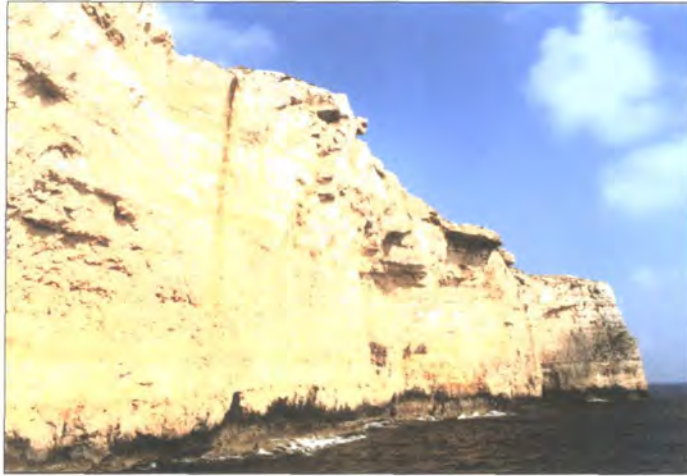
Plate 3.1: Plunging cliffs developed in Lower Coralline Limestone characterize the south and south-west coasts from Benghisa to Fomm ir-Rih. These cliffs are associated with the Maghlaq Fault and reach a height of 200 m in some parts.

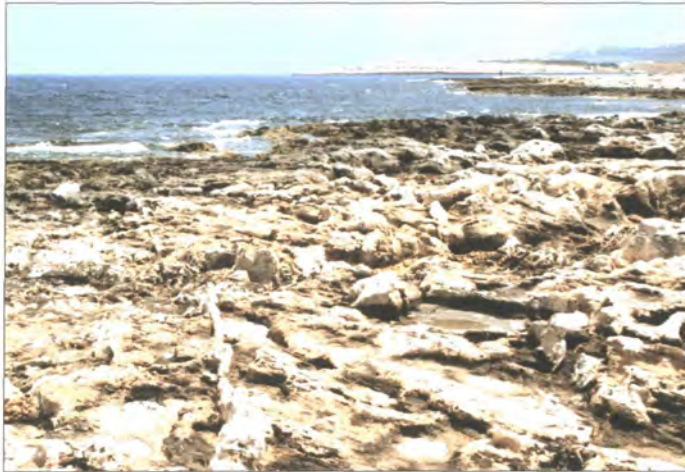
Plate 3.4: Low rocky shore cut in Lower Coralline Limestone on the north-east coast. Pools and lapiés which produce a very irregular surface are the result of corrosion.

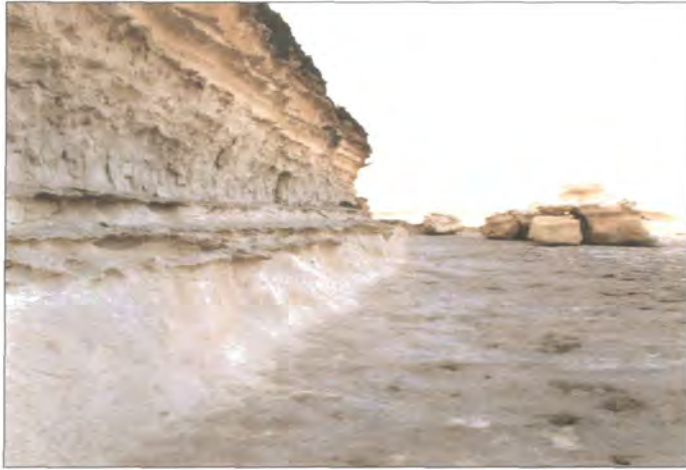
Plate 3.5: Low cliff and shore platform formed in Globigerina Limestone, characteristic of the southern coast. Globigerina Limestone being a softer material than Coralline Limestone displays a smoother surface. This is mainly the result of the mechanical action of waves, especially hydraulic pressure.

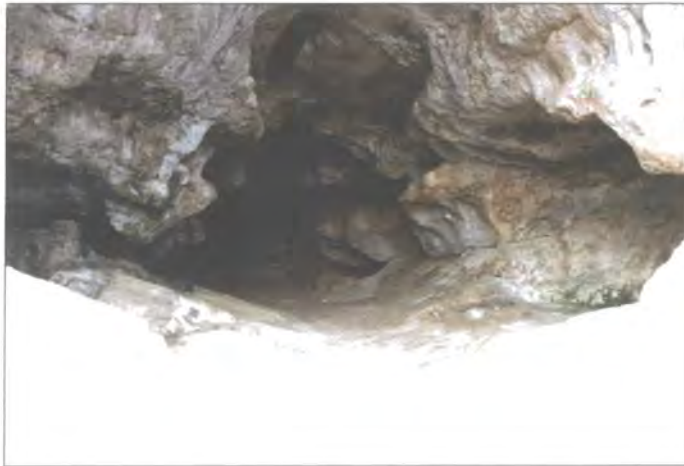
Plate 3.8: Ghar Hasan, found on the southern coast. This cave has formed as a result of karstification. The latter prevails in Coralline Limestone where water charged with carbon dioxide dissolves the calcium carbonate in the porous limestone.

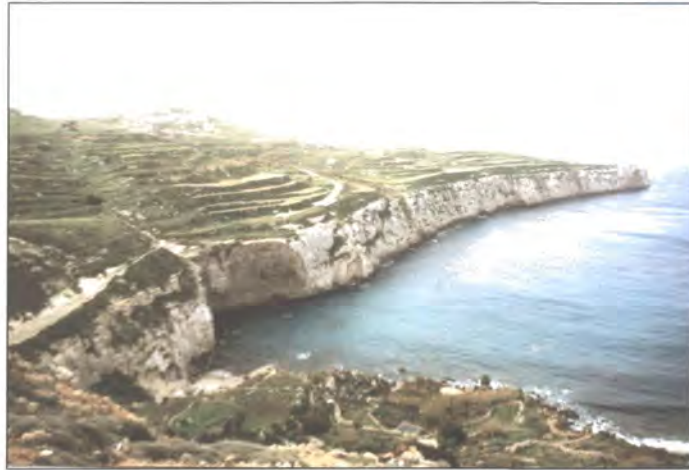
Plate 3.9: The western extremity of the Great Fault featuring Lower Coralline Limestone plunging cliffs. The Great Fault runs along the whole width of the island from Fomm ir-Rih on the west coast to Madliena on the east coast. The terraced fields are the result of human activity.

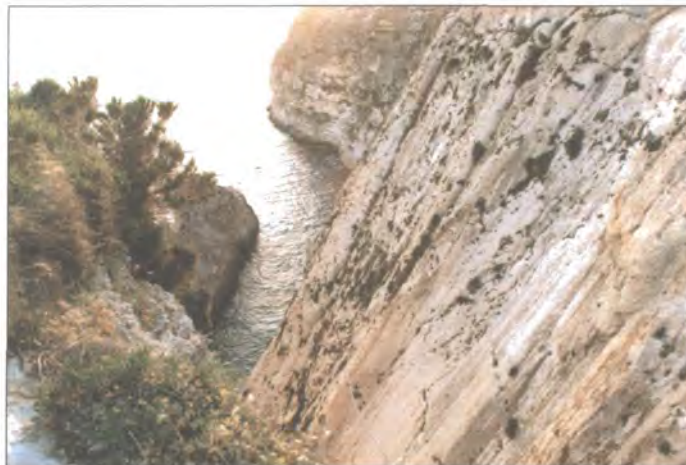
Plate 3.10: Slickenside at Ix-Xaqqa on the south-west coast. This is a result of the Maghlaq Fault which has produced here a vertical displacement of at least 240 m to the south-west. Lower Coralline Limestone (right side) and Upper Coralline Limestone (left side) are found in juxtaposition.

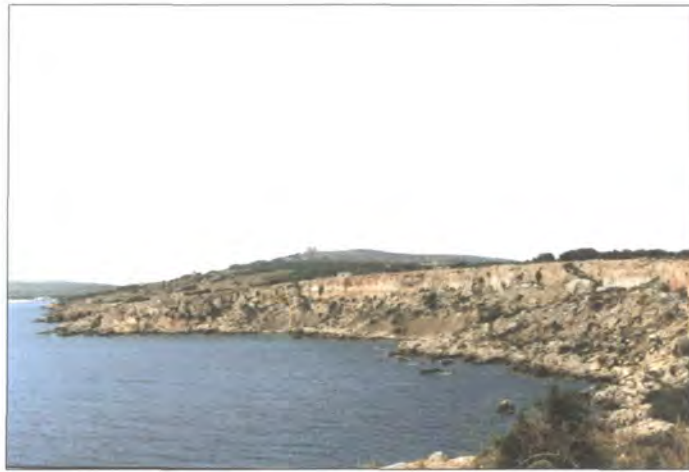
Plate 3.11: Rdum il-Hmar is an example of a semi-circular cove found on the northern shore of Melièha Bay. Semi-circular coves represent a distinct feature of the Maltese coastline and originate from karstic landforms inundated by the sea.

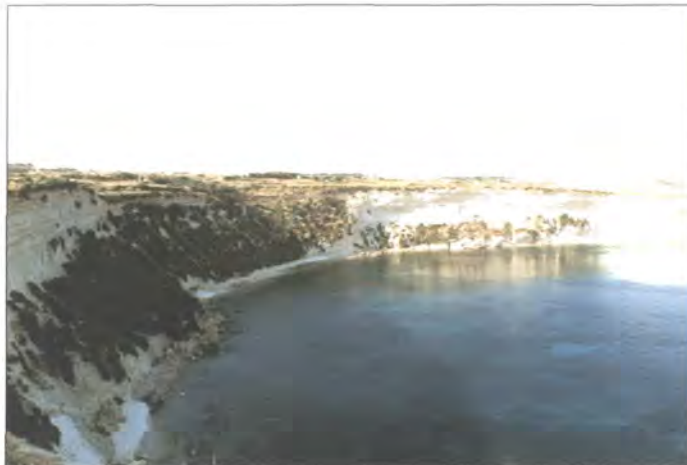
Plate 3.12: Il-Hofra z-Zghira features a semi-circular cove on the south-east coast of Malta. In this case the cove has developed in Globigerina Limestone and is surrounded by cliffs.

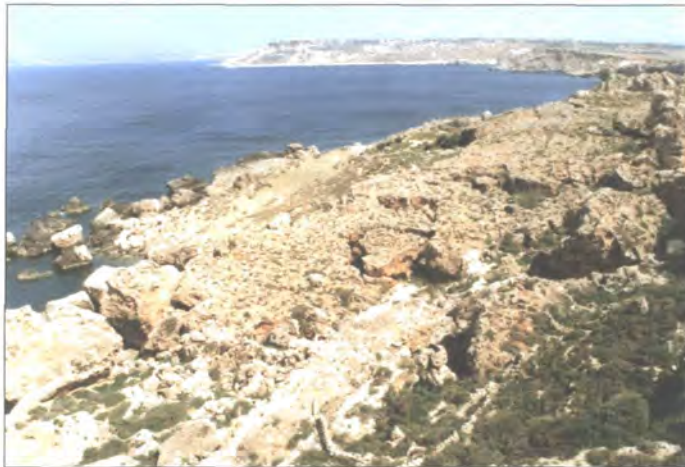
Plate 3.16: An example of a translational slide found at Rđum Majesa on the north-west coast. In the Maltese Islands this type of landslide occurs in the Upper Coralline Limestone. Usually these slides involve a displacement from the *in situ* material to several metres downslope and in some cases extending to the shoreline.

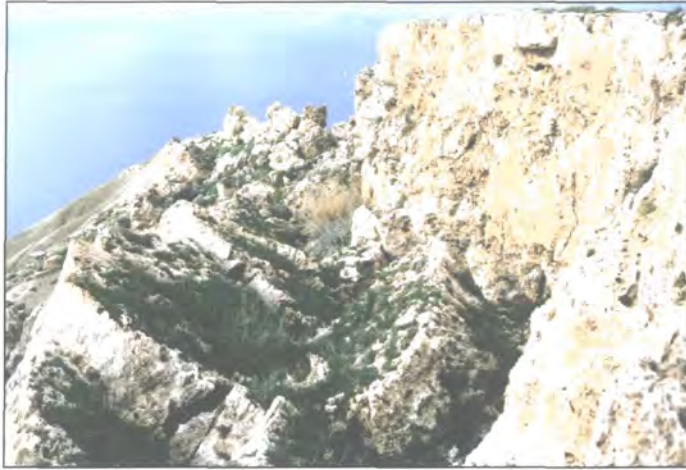
Plate 3.17: An example of a rotational slide found at Ras il-Pellegrin on the north-west coast. Rotational slides, similar to translational slides, develop in the Upper Coralline Limestone. These slides are usually found below the *in situ* material from where they have been detached and involve a rotational movement on the slip surface resulting in a tilted upper surface.

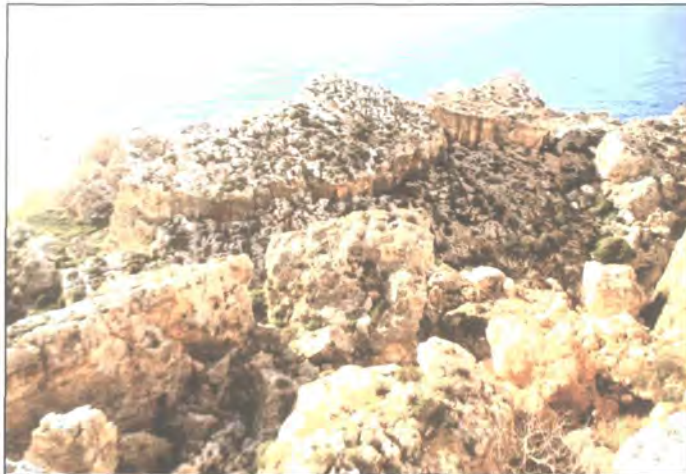
Plate 3.18: Complex of rotational slides at Ras il-Wahx on the north-west coast. Ras il-Wahx offers the best example of multiple rotational slides most commonly found at headlands along the Maltese coasts. Here rotational slides occur in multiple succession covering an area of about 400 m².

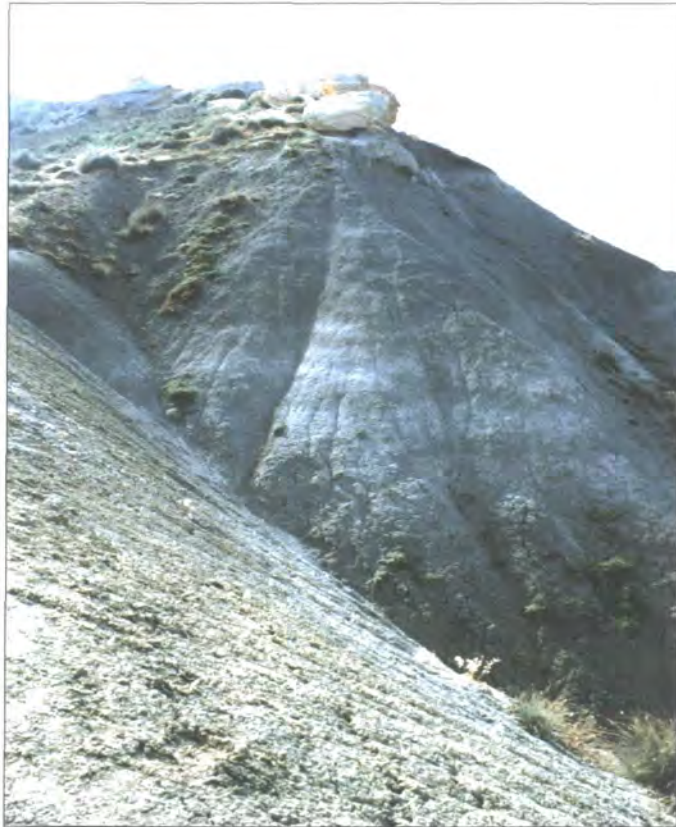
Plate 3.19: Where Blue Clay is exposed it features slopes. At the coast these slopes usually extend from the Upper Coralline Limestone plateau to sea-level. The clay slopes featured here are situated at the southern end of Ghajn Tuffieha Bay, overlooking Gnejna Bay and connecting Il-Qarraba with the mainland.

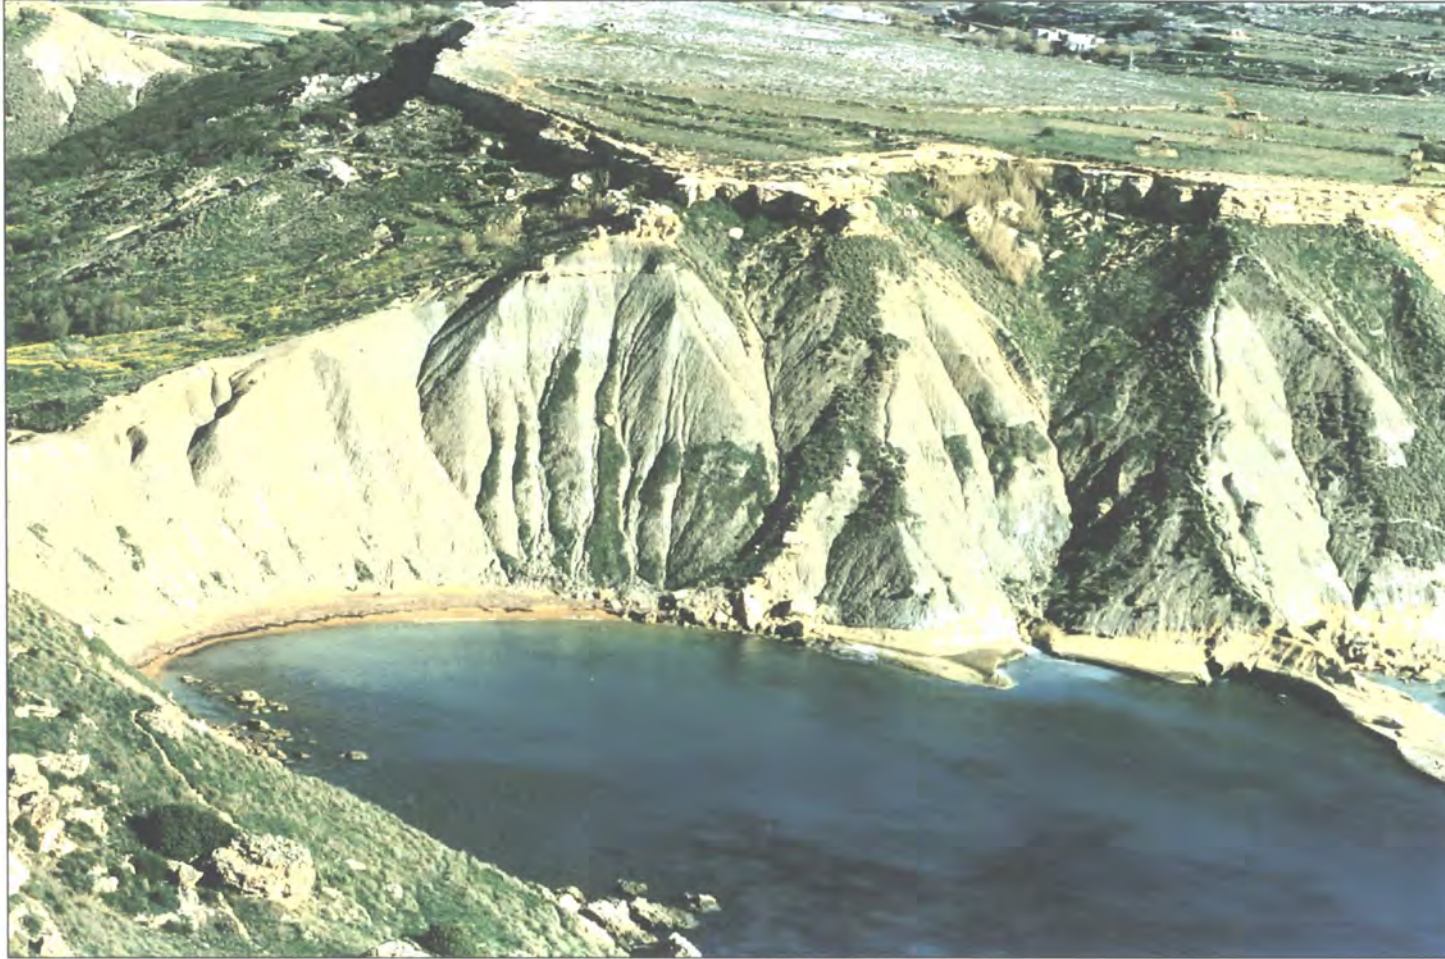
Plate 3.22: Clay slopes examined at Gnejna Bay, close to Il-Qarraba. In this section the clay slopes are almost completely bare of vegetation cover due to a steep gradient. Above the clay slopes the Upper Coralline Limestone plateau is evident. The vegetated clay slopes featured in the background on the left, are found at Ghajn Tuffieha Bay, whereas in the foreground part of Il-Qarraba is visible. A small sandy pocket and Globigerina Limestone shore platform are seen at the foot of the clay slopes. The shore platform closest to the sandy pocket marks the northern limit of the area under study.

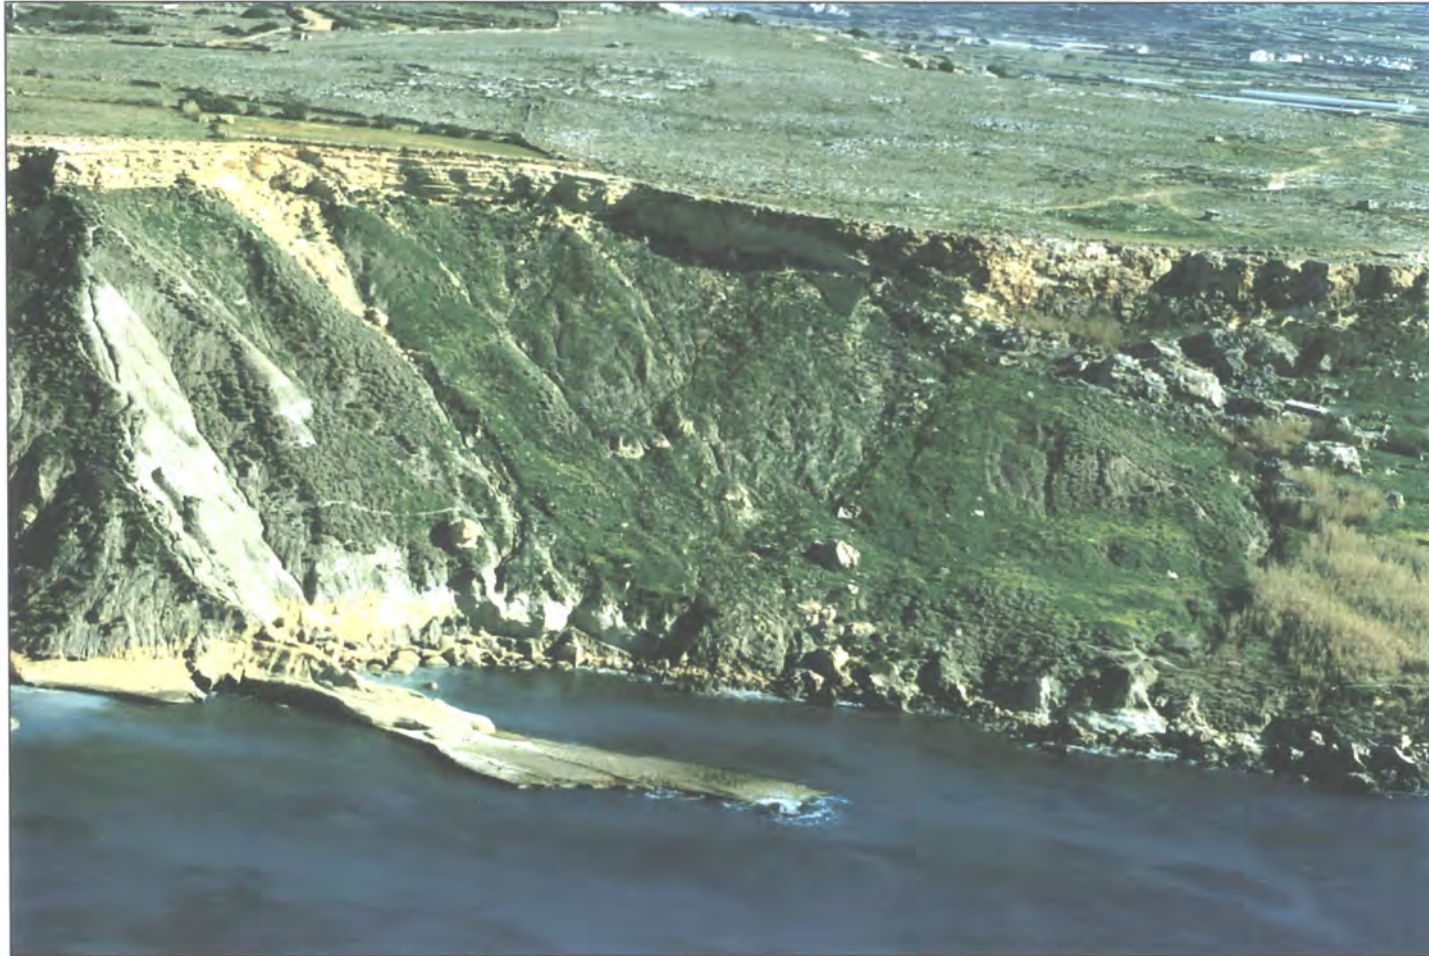
Plate 3.23: Clay slopes examined at Gnejna Bay, close to the reeds. Slopes in this section are vegetated since the gradient is not so steep. The Upper Coralline Limestone plateau and scarp face are visible in the background, whereas the Globigerina Limestone cliff and shore platform are seen in the foreground. The reeds at the lower right side mark the southern limit of the area under study.

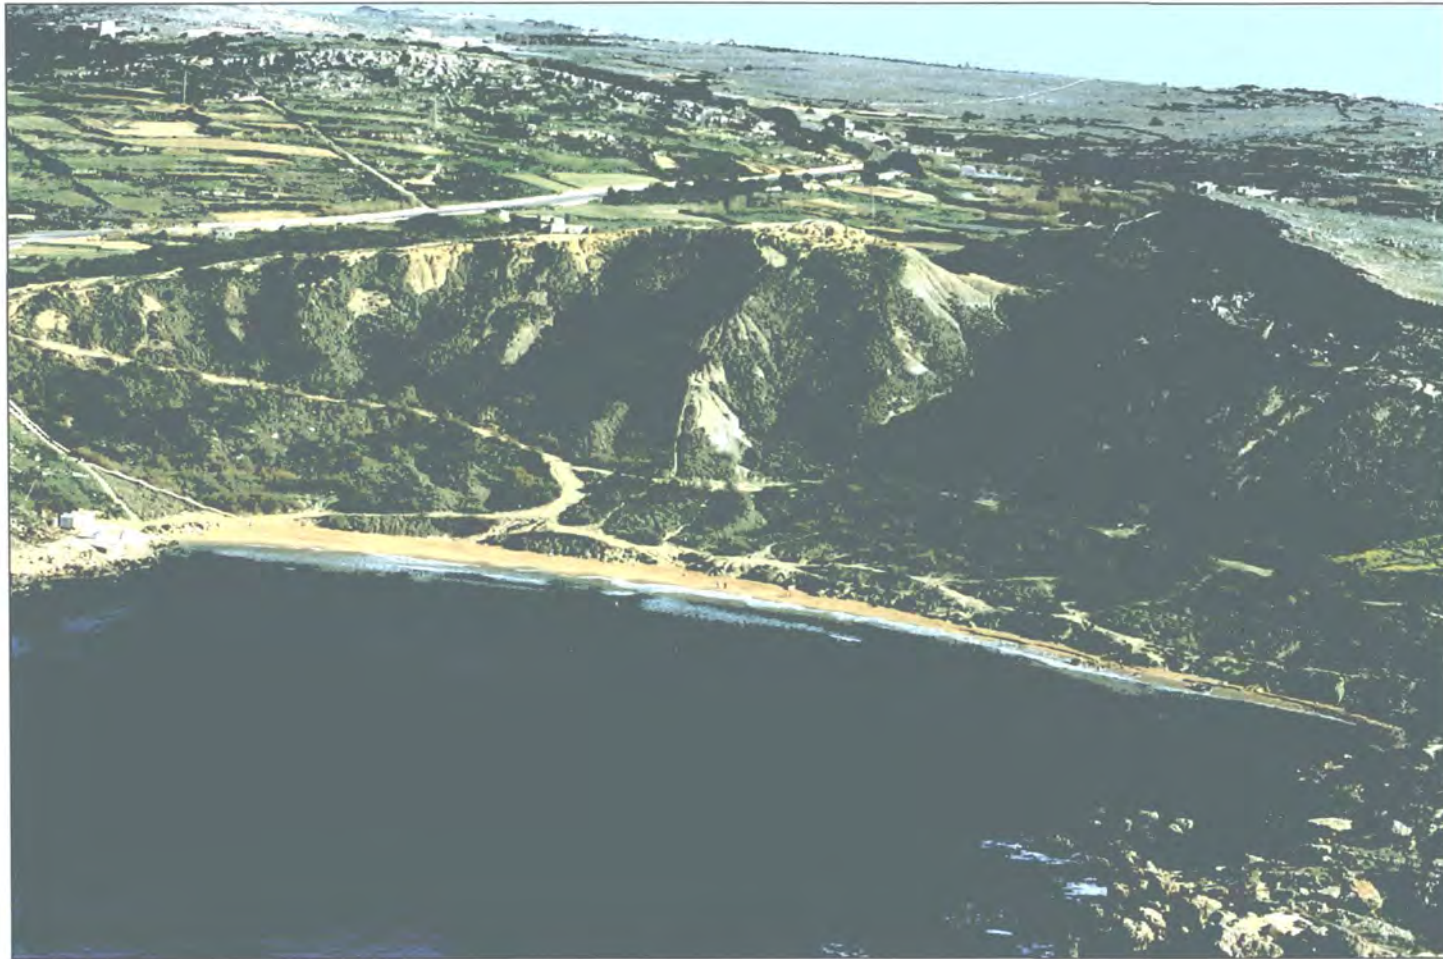
Plate 3.24: An aerial view of Ghajn Tuffieha Bay. The clay slopes extend from the back of the sandy beach to the base of the Upper Coralline Limestone plateau. The sandy beach stretches along the whole length of the Bay. Ghajn Tuffieha Bay has been designated as an area of ecological importance by the Planning Authority in 1995 and is a protected site by law. The Bay is at present managed by the GAIA Foundation, a Non-Governmental Organisation which was responsible for a recent afforestation project.

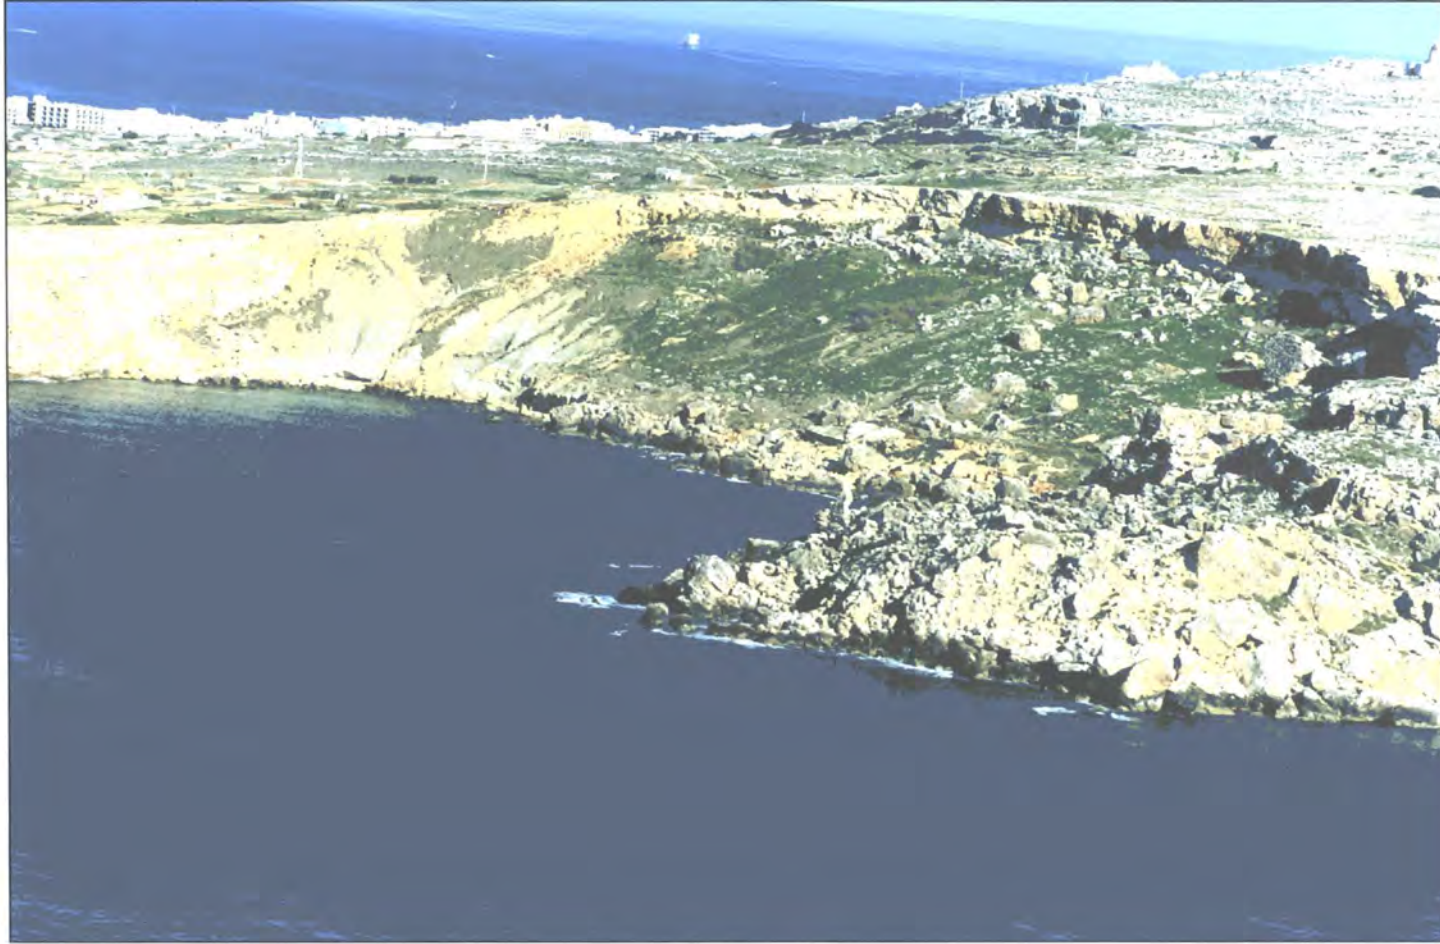
Plate 3.25: A side view of Rdim id-Delli. The steepest clay slopes are located close to the Upper Coralline Limestone plunging cliff on the left side. Mudslides are active in this section. Rockfall is found extensively throughout the entire area. The Upper Coralline Limestone plateau forms part of Mellicha Ridge. In the background Mellicha Bay is visible.

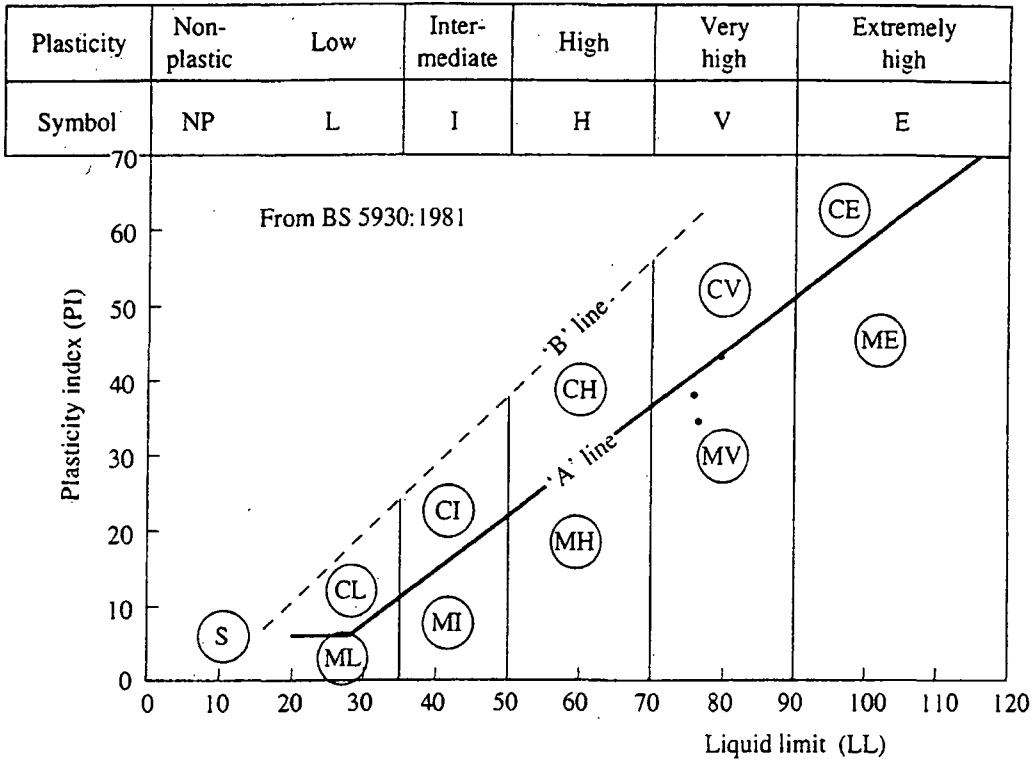
- A - Rdum id-Delli
- B - Gnejna Bay
- C - Ghajn Tuffieha Bay

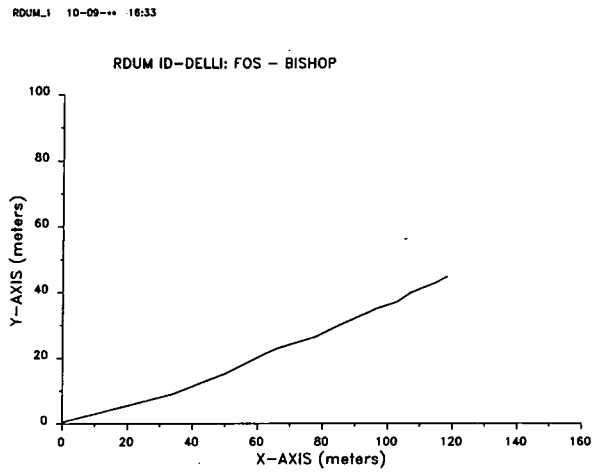
Figure 5.5: Slope stability plots for Rdum id-Delli generated by the Simplified Bishop Method

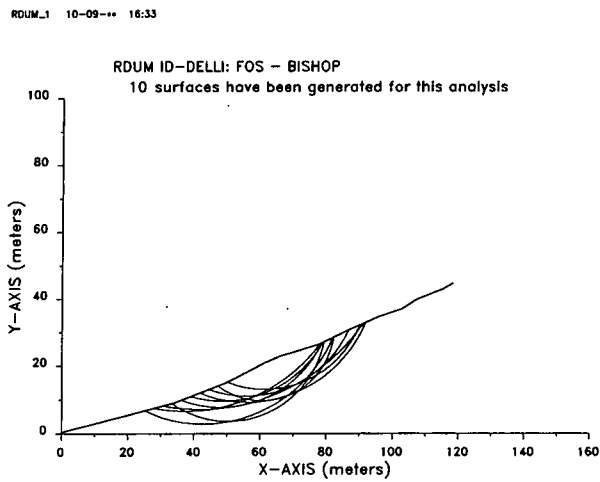
(b) Generated failure surfaces
