*the origins and treatment of derelict land in county
Durham*

The origins and treatment of derelict land in County Durham

**The University of Durham
Department of Geological Sciences
January 1998**

This thesis is submitted in partial fulfilment of the requirements for the
degree of M.Sc. in Environmental Management Practice

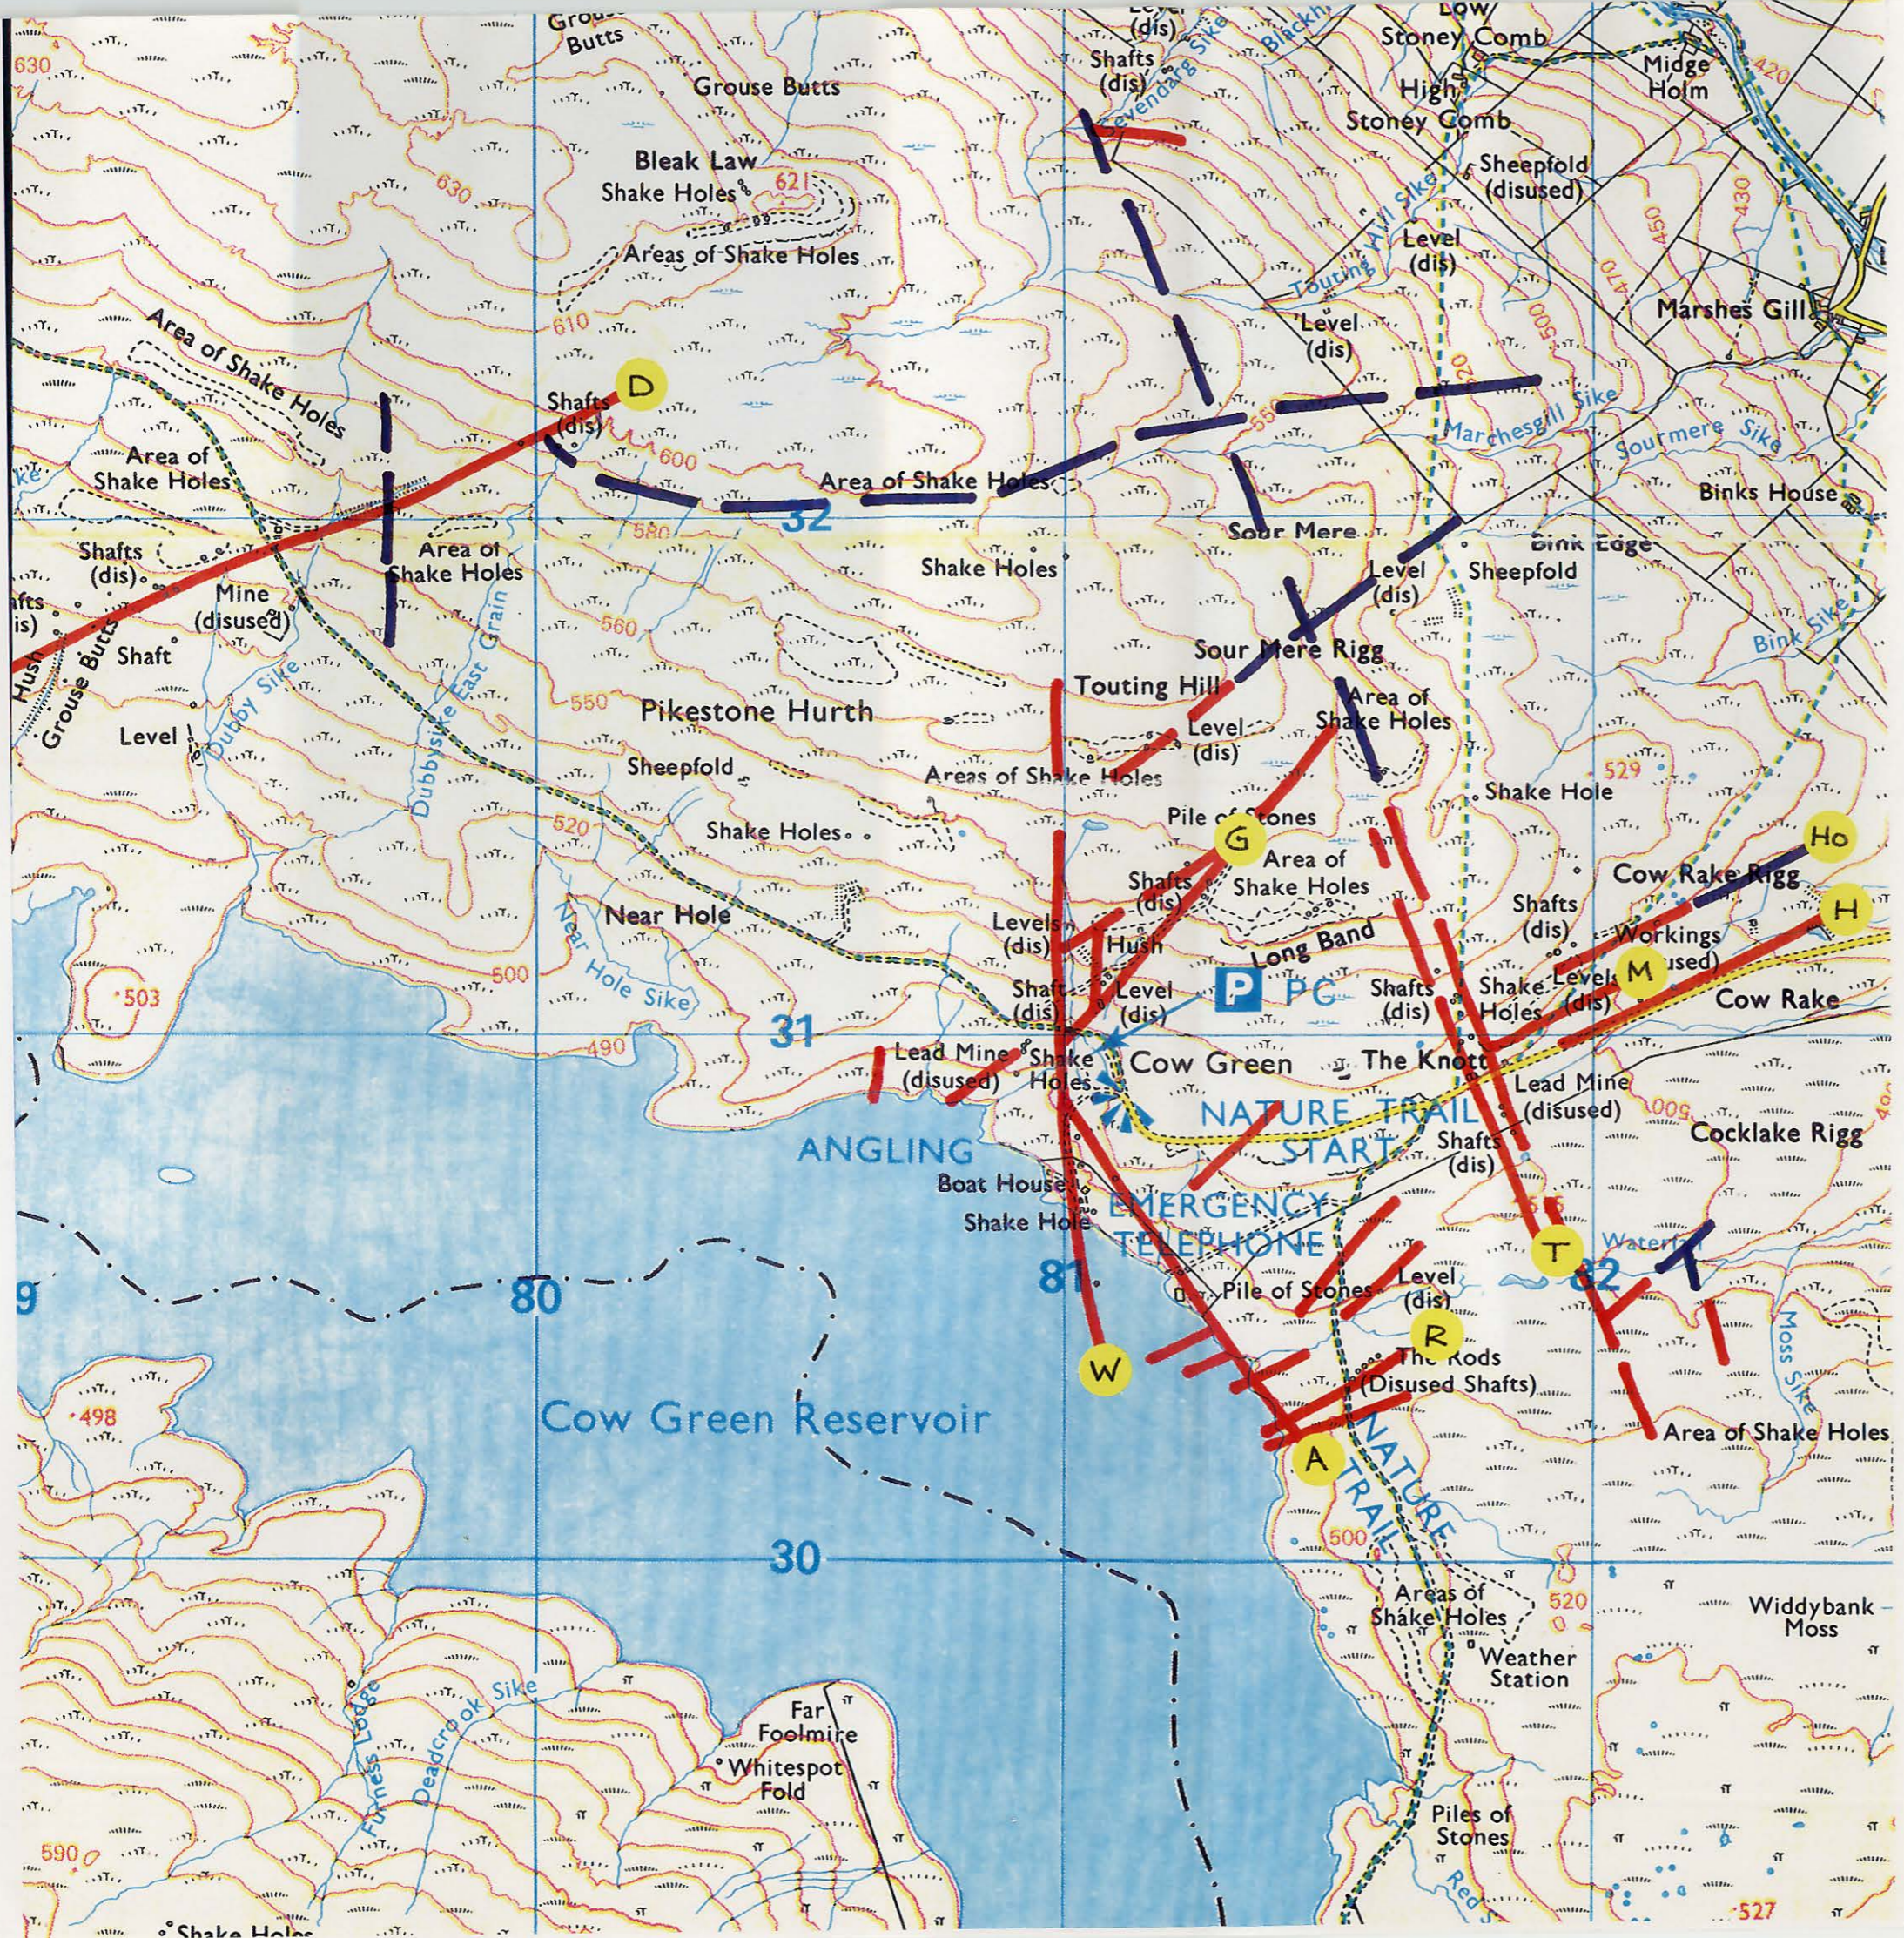
Figure 11.1
Barite Mines - Cowgreen

There is some lack of correlation between the information quoted in records, and that plotted on Ordnance Survey sheets. For example the adit (No.3) plots as a shaft with an adit some

— Mineralised Vein
 - - - Conjectural
 - - - Fault - conjectural
 D Dubbysike
 G Greenhush
 W Winterhush
 A Angle vein
 R Rods
 T Teesdale
 Ho Hopkins
 M Middle
 H Holmes

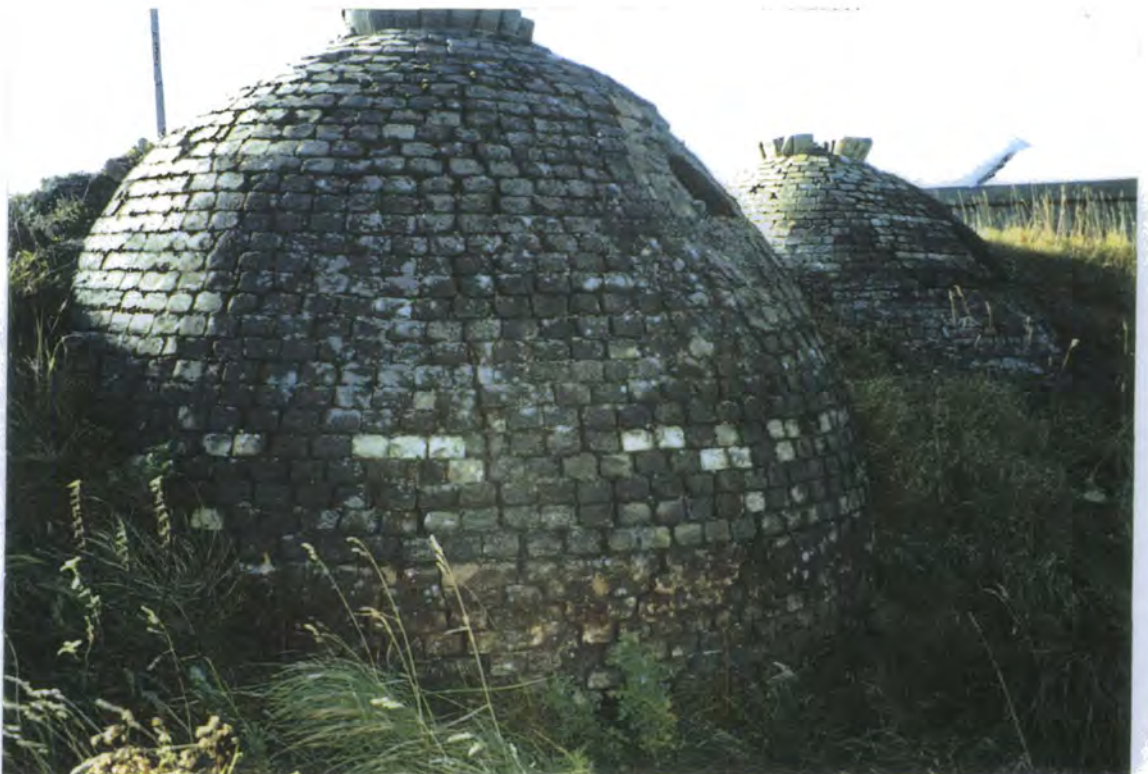
Figure 13.2

Beehive Oven

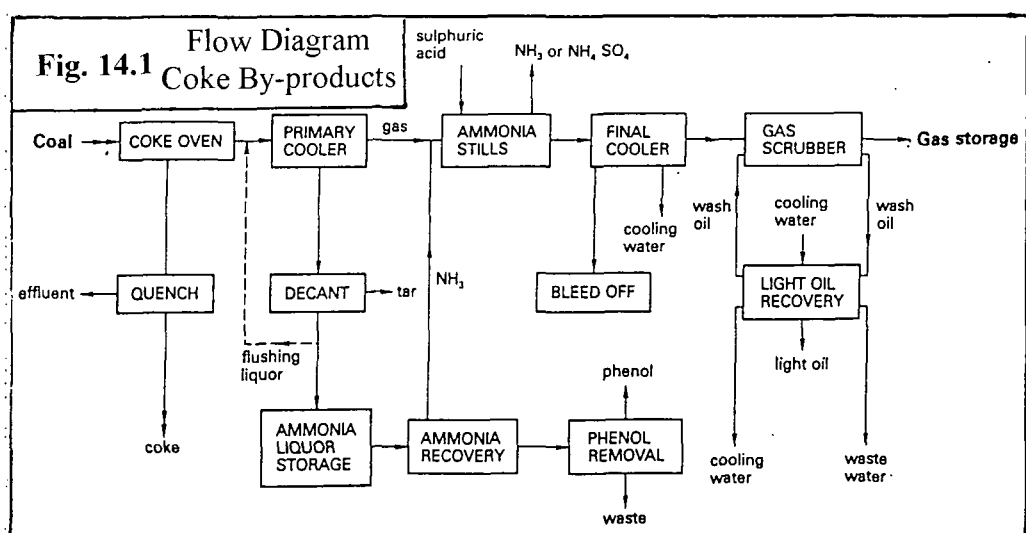
Although the advent of natural gas from the North Sea and elsewhere has superseded the use of town gas derived from coal, the gas made available is utilised in the iron and steel making process to maximise efficiency. A similar purifying activity takes place giving rise to by-products which are generally the most important compounds in respect of potential contamination. A typical process flow diagram is shown in Fig.(14.1).

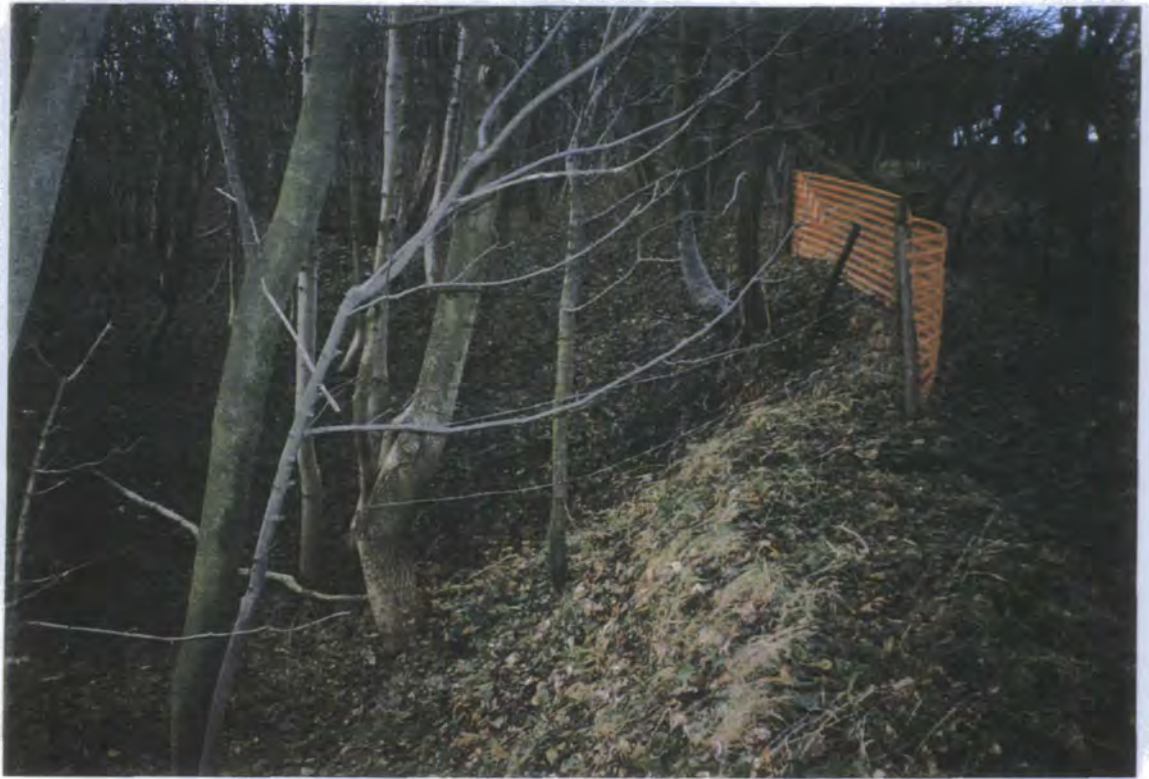
Figure 17.1 Coal Shaft - Footpath

(a) O.S. Sheet 33 was selected in the western area which, although containing many old abandoned mines, had also been heavily opencasted, resulting in far fewer sites potentially requiring remedial works. Initial screening by name alone suggested 15 mines or groups which appeared to be worth further examination and closer inspection of old O.S. maps revealed that these contained in all 37 features (Appendix 3). From a primarily visual point of view only one site was included in the local authority's schedules and this was classified as not justifying reclamation. Two other sites however, identified in this review, are in close proximity to housing and public access routes and should be considered for treatment, even under the original policy. In none of the cases could stability of the heaps be seen as a major problem. From a safety point of view, taking into account the other potential dangers posed by old mine workings, risk clearly relates to the presence of a receptor, and this is then dependent on the proximity of buildings or on public access being available. Of the 37 shafts and drifts identified only one could be clearly thought of as being a risk and this has obviously been realised by the local authority with safeguards being put in place (Figure 17.1).

Remedial works or a footpath diversion will ultimately be required. Although other examples are present of shafts in quite close proximity to footpaths, these routes are little used and can be considered as low risk. The farming community is generally very efficient in monitoring the condition of their land and it is likely that any movement or danger will become apparent to them before the general public. Given the guidance in Table A of the governments consultation document that only a 10% loss should be considered significant in respect of stock, the risk relating to those sites in ordinary agricultural locations has to be put as low (Figure 17.2).

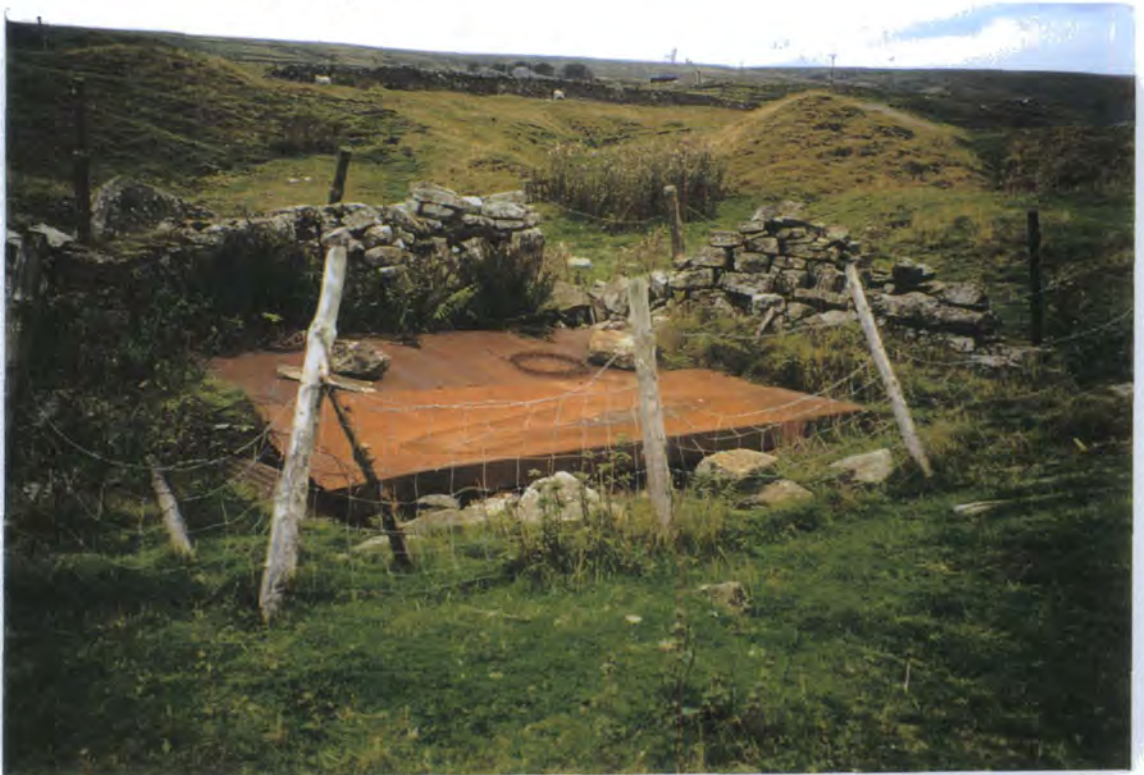
Figure 17.3

on a moorland area is equally unlikely. One level of the remaining four sites is in a works area and not easily approached (Site 5c) and a reopened lead mine is also in private property. The shaft and drift remaining have differing degrees of risk attached to them, based on the probability of access, which was reviewed in the light of weighting relating to frequency of use of the public rights of way in the area, provided by local authority staff closely concerned with countryside and leisure matters. An exercise carried out as part of this study demonstrated that classification of footpaths by usage is a quick and simple exercise and can provide a means of refining the risk potential of derelict sites. The shaft (Site 2a) although clearly visible and with only a poor fence protecting a loosely fitting metal cover, is not a high risk despite it being situated only some 40 metres from a footpath as the route is classified as having the lowest level of usage (Figure 17.3).

Iron Mine - Cover

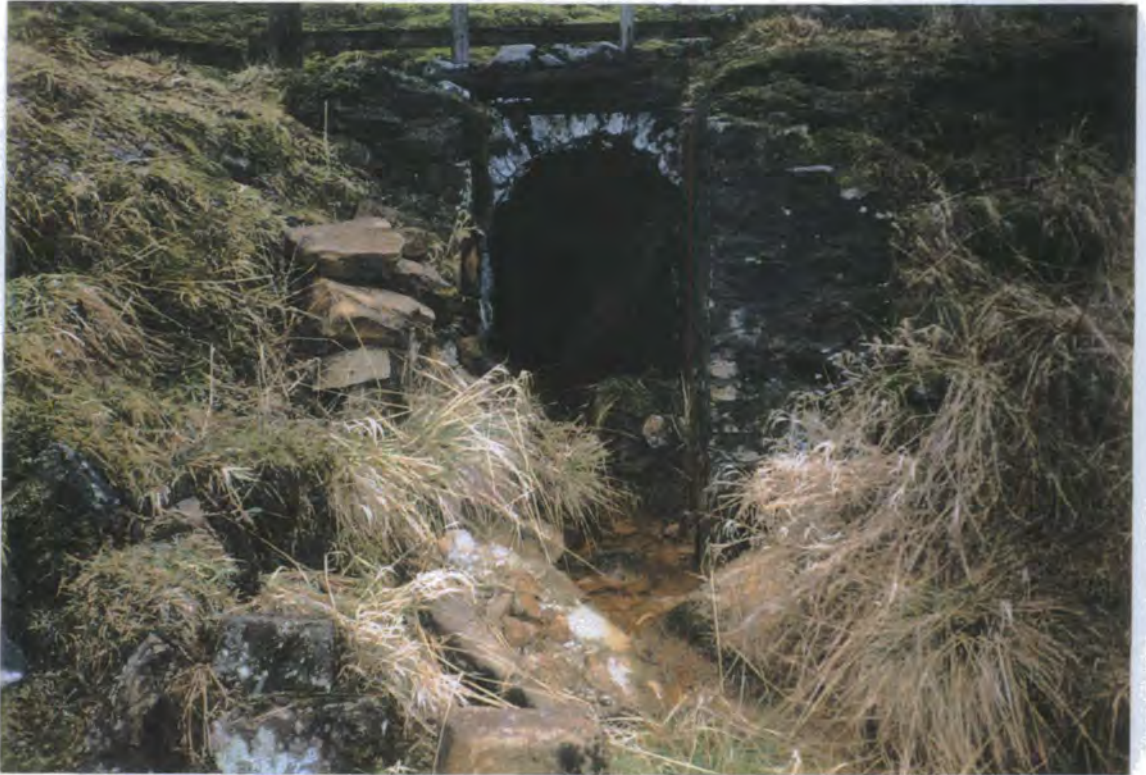
Figure 17.4 Drift Entrance - Iron

The drift on the south east bank of the river (Site 5a) is not a high risk with the entrance clearly visible but it does lie on a footpath designated as having the highest local use. The mine water issuing is clearly polluted with evidence of staining (Figure 17.4).

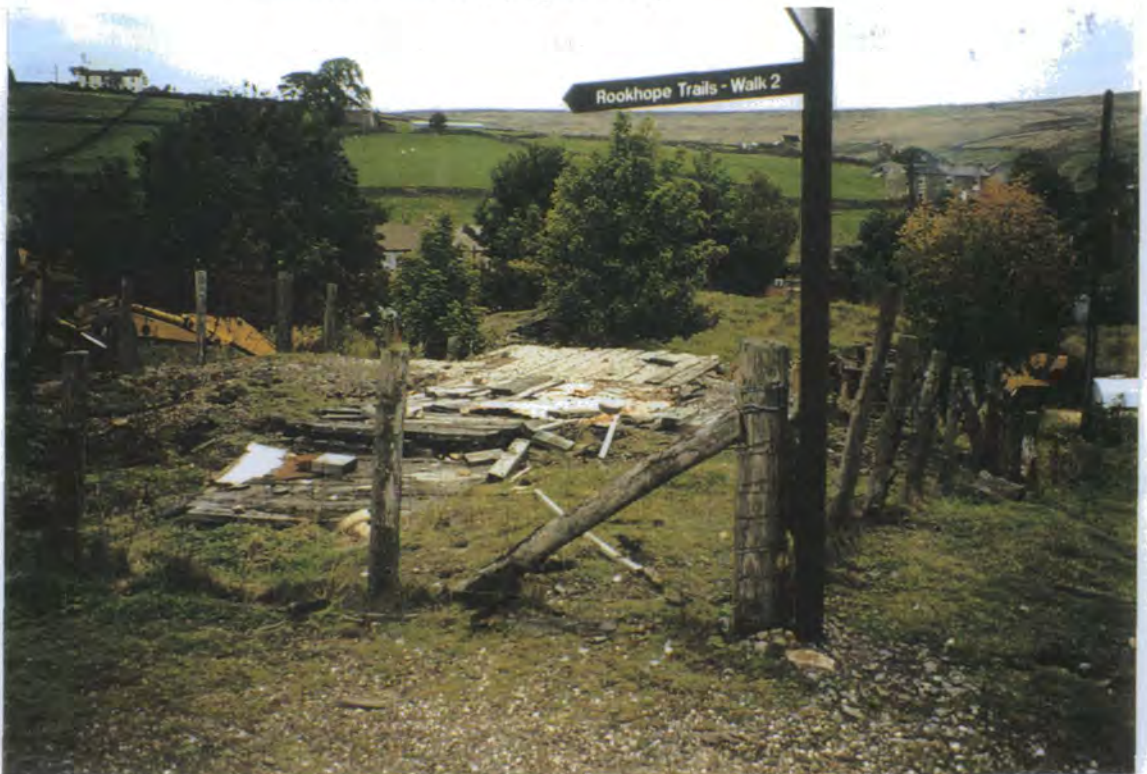
Figure 17.5 Lead/Iron Shaft

Examination of the site also produced a clear example of the problems which can exist in such a complex mining area. In the vicinity of the drift is an engine house shaft which, although almost on the line of the Red Vein, was in fact the main access to Watt's Level serving the Boltsburn East Mine on the north east side of the valley, which was primarily worked for lead. As reserves in the vein were not exhausted when the deep workings were allowed to flood in 1932, consideration was given to reopening the mine and this led to Watt's Level being kept pumped out until the 1950's (Dunham, 1990). The shaft was

apparently filled, but the quality of the work is unknown, and there is only a poor quality fence to deter access to the 54 metre deep shaft and its inadequate timber cover which vandals have attempted to burn. The shaft is immediately adjacent to the 'Rookhope Trail' which has a top classification in terms of usage and there must therefore be a reasonably high degree of risk attached to this site (Figure 17.5).

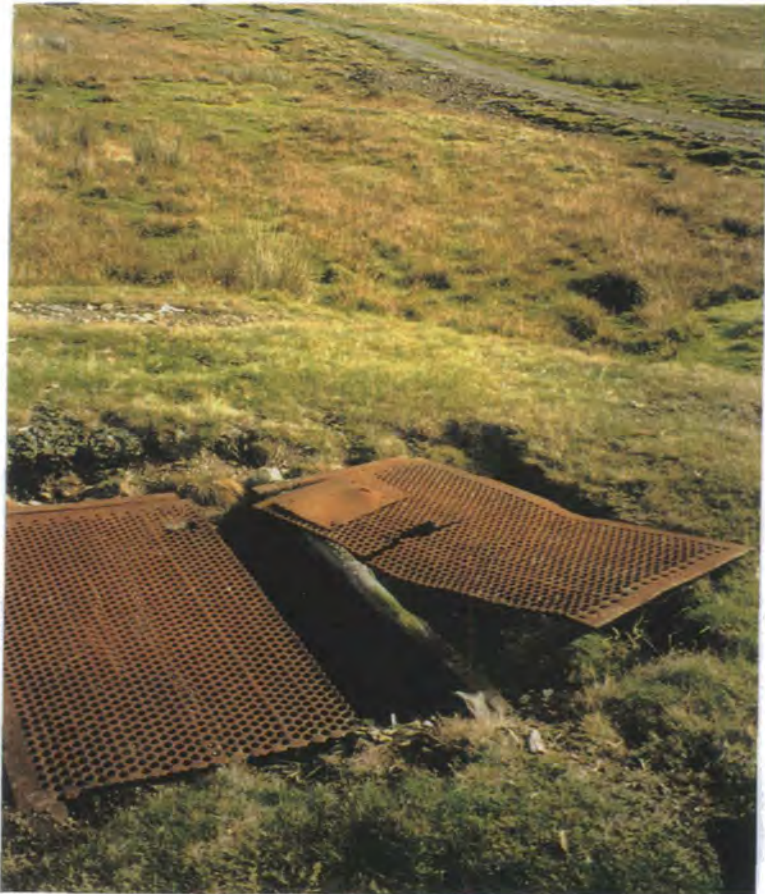
Figure 17.6 Lead Shaft

examined (18) where a level is quoted in mine records but nothing is shown on O.S. sheets other than sink holes in the vicinity. Although there is evidence of ground disturbance on site, no clear entrance can be seen in what appears as a large mound on the verge of a minor road. The last category is that of levels or shafts shown on the O.S. sheets but not identified in mine records. Two sites were looked at (NY9245-2778, NY9583-2963), in both cases being close to footpaths. Circumstances differed on site with the former shaft only visible as a depression in a field whilst the latter site had an open shaft only loosely protected by a metal sheet (Figure 17.6).

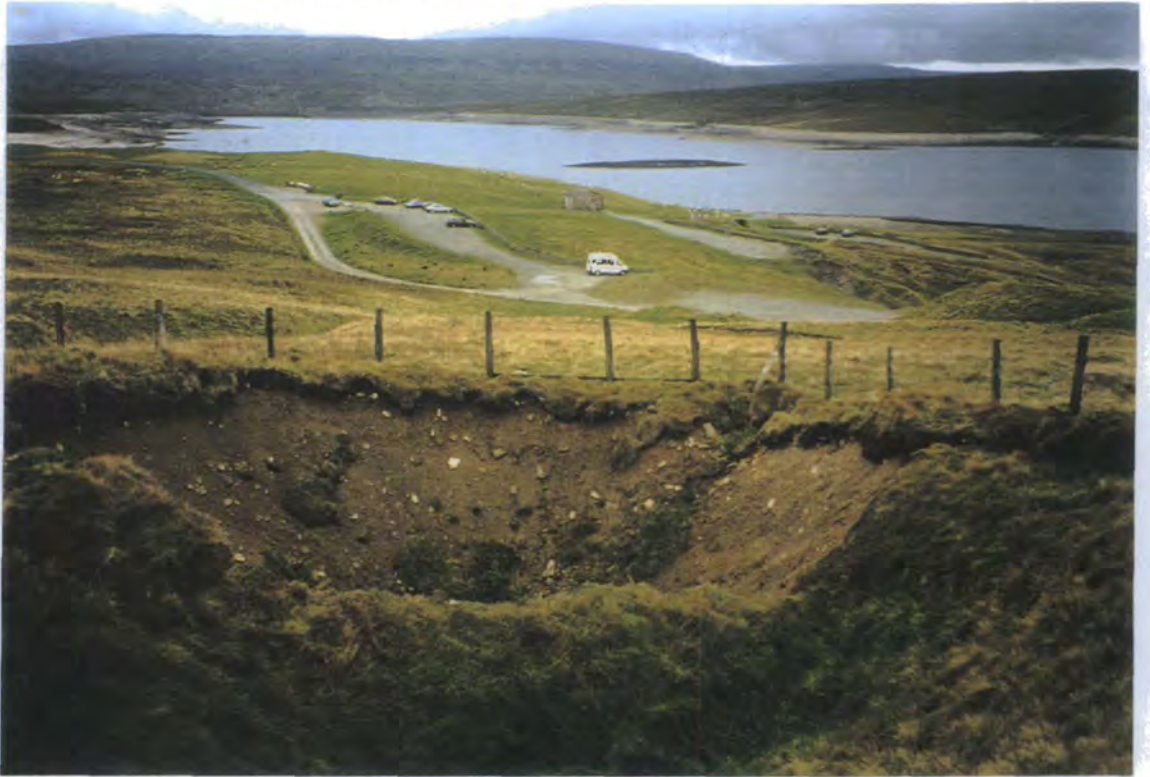
Figure 17.7 Barite Mine - Collapse

area not served by official footpaths, but accessible from the parking places, the collapsed main drift on the Greenhush Vein is visible and further north are recently fenced off subsidence holes (Figure 17.7).

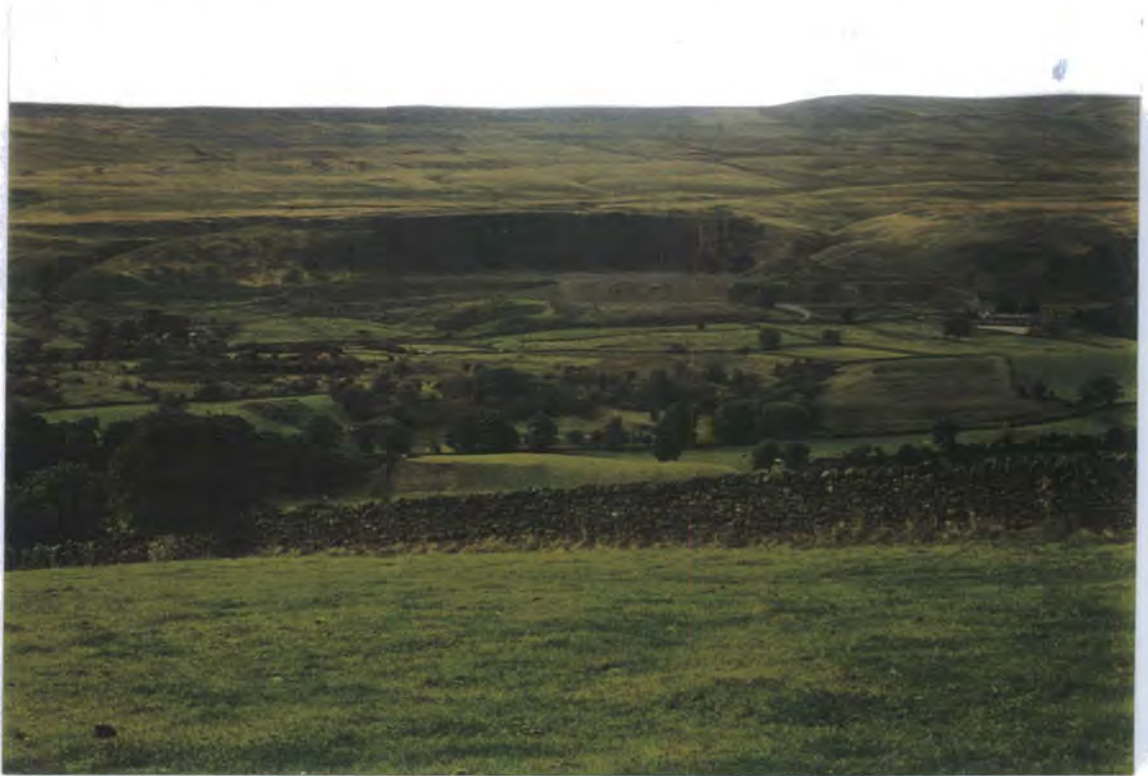
Figure 19.1 Quarry - Teesdale

Quarries and claypits present different problems, but both are apparently low risk. Only where the increasing importance of tourism could be a cause for reassessment would it be possible to justify works on quarries, perhaps in the form of controlled blasting as described earlier (Figure 19.1).
