Contemporary and historic river channel change at Swinhope bum, Weardale: a study of river response to flood events in an upland, gravel-bed stream

Danks, Melanie (1998) Contemporary and historic river channel change at Swinhope bum, Weardale: a study of river response to flood events in an upland, gravel-bed stream. Masters thesis, Durham University.

MSc Thesis, 1998

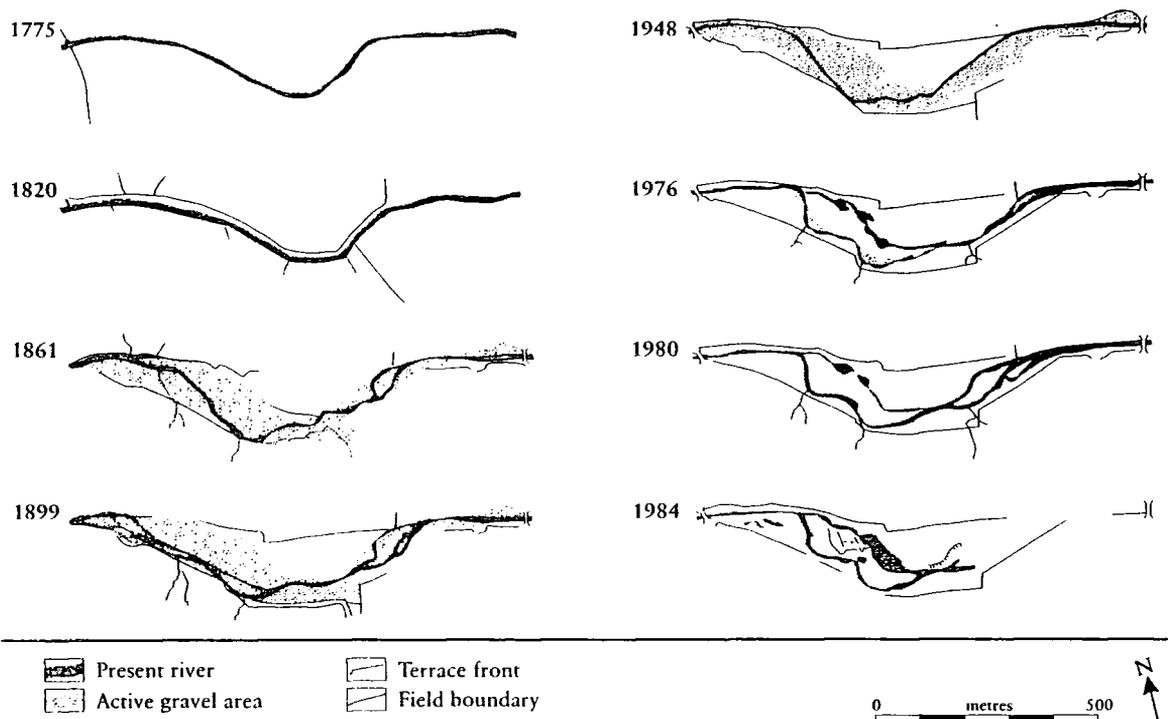
Figure 2.4 Channel change at Blagill, River Nent, 1775-1984 (Macklin, 1986)

The effects of historic mining activities and high magnitude flood events can produce a similar change in channel planform from a meandering to a braided channel, due to inputs of coarse sediment. This makes it difficult to pinpoint the actual cause of river channel change (Lewin *et al*, 1983). Macklin (1986), however, argues that in the case of the River Nent, Blagill, Northern Pennines, the coincidence of metal mining and a series of large floods in the mid 1800's combined to produce a braided channel system which persisted for approximately 100 years before reverting to a single-thread meandering channel (Figure 2.4). Macklin (1997a) suggests that many rivers in the Northern Pennines experienced an increase in sediment supply to their valley floors and this was combined with a change in flood frequency in the latter half of the 19th century. A similar scenario is described for the River Ystwyth in upland mid-Wales (Lewin *et al*, 1977, 1983) where it was possible to conclude that channel planform had responded to a change in sediment supply. However, Lewin *et al* (1977) stress that the input of mining waste has a more localised effect on channel planform change than an input of coarse sediment generated by flood events.

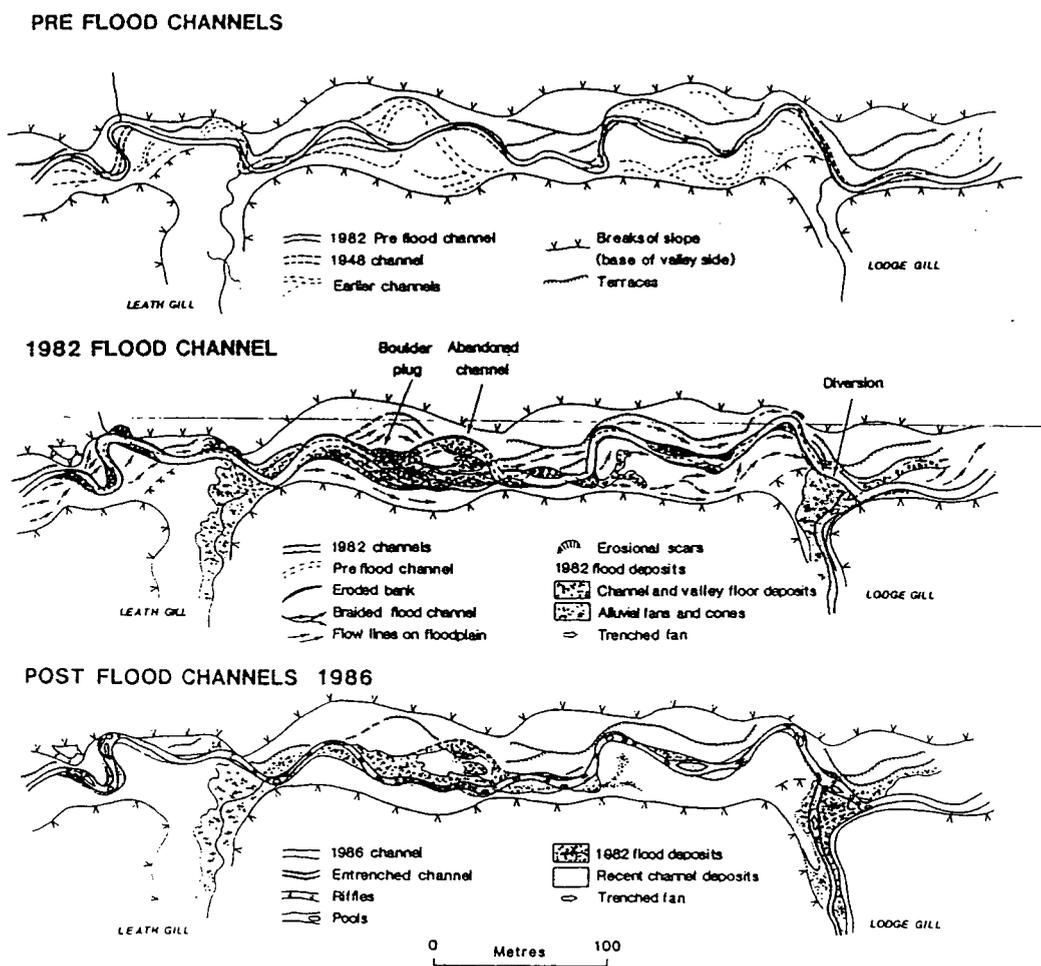
Figure 2.5 Channel response and recovery from the 1982 flood in the Howgill Fells. Example reach in Bowderdale (Harvey, 1991)

Harvey (1991) identified the sudden increase in availability of coarse sediment, generated by a rare flood event in June, 1982, as a key factor in controlling the switching of upland channels from a meandering to a braided pattern. Figure 2.5 shows channel response and recovery from the 1982 flood. Large sub-rounded and angular boulders were fed into the stream system due to trenching in gullies and tributary channels. Sediment input from streamside scars and bank erosion caused more localised channel change. As debris cones blocked pre-flood channels, streams were diverted across the floodplain. Channel blockage by coarse boulder and cobble sediment 'plugs' was a direct cause of major channel avulsion on open bends. The geomorphic effects of the flood were to steepen the gradient and widen the channel which prompted the switch of channel pattern from meandering to braided.

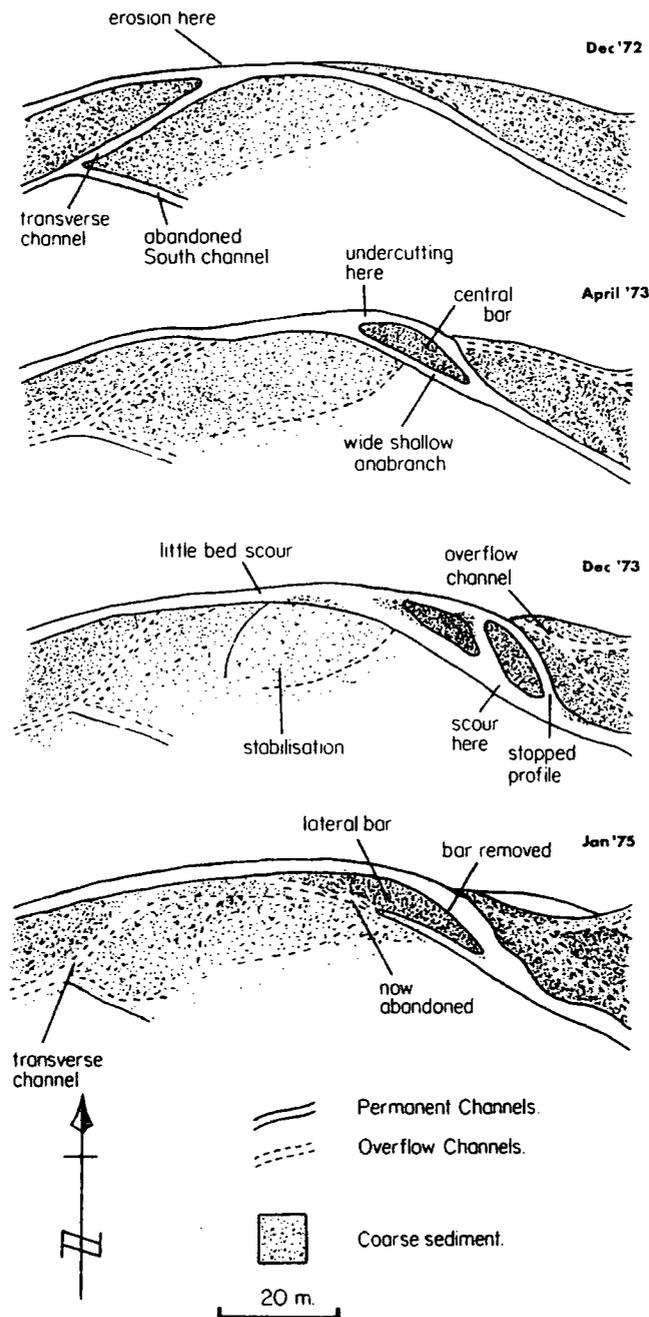
Figure 2.7 Sequence of channel change at Langden Brook (Hitchcock, 1977)

events and the formation of downstream braid bars which may develop into lateral bars has been identified for Langden Brook, Forest of Bowland (Hitchcock, 1977). In braided streams which have an abundant supply of coarse sediment, lateral bars may form downstream of localised bank undercutting if the upstream end of an adjacent channel becomes blocked by coarse sediment during a flood event (Figure 2.7).

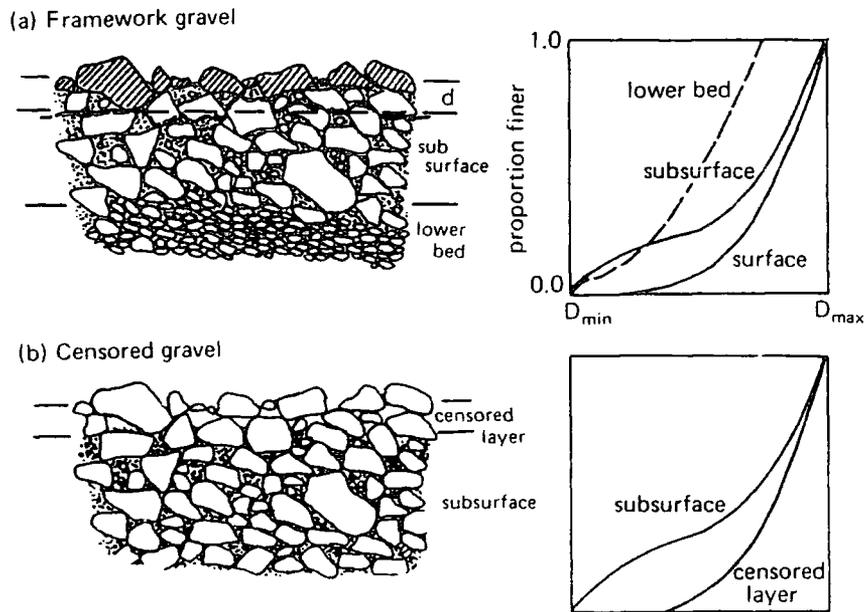
Figure 2.8 Typical structures of framework and censored gravels with grain-size distributions (Church *et al.*, 1987)

Carling and Reader (1982) distinguish between the formation of an 'armour' layer as described by Gomez (1983) and a 'censored' layer observed in Pennine gravel-bed streams. Carling and Reader (1982) argue that during intermediate flows fine materials are winnowed from the interstices of the coarse surface framework, but that during a flood event initially material stored as Ostler lenses are mobilised, followed by matrix material winnowed from the framework gravel. Once the surface layer has been depleted of fines only coarse gravels remain and this is termed a 'censored layer' which protects the underlying finer material until a flood event of sufficient magnitude occurs and is capable of removing framework gravels. The resulting 'open-work' gravel at the surface has a similar size distribution to an 'armour' layer. However whereas an 'armour' layer is a coarse lag layer formed by deposition at the surface of gravel-beds on waning flows which prevents similar or finer material from entrainment, a 'censored' layer does not require any mobilisation of the coarse fabric. Church *et al* (1987) illustrate the differences between a 'framework gravel' and a 'censored gravel' (Figure 2.8).

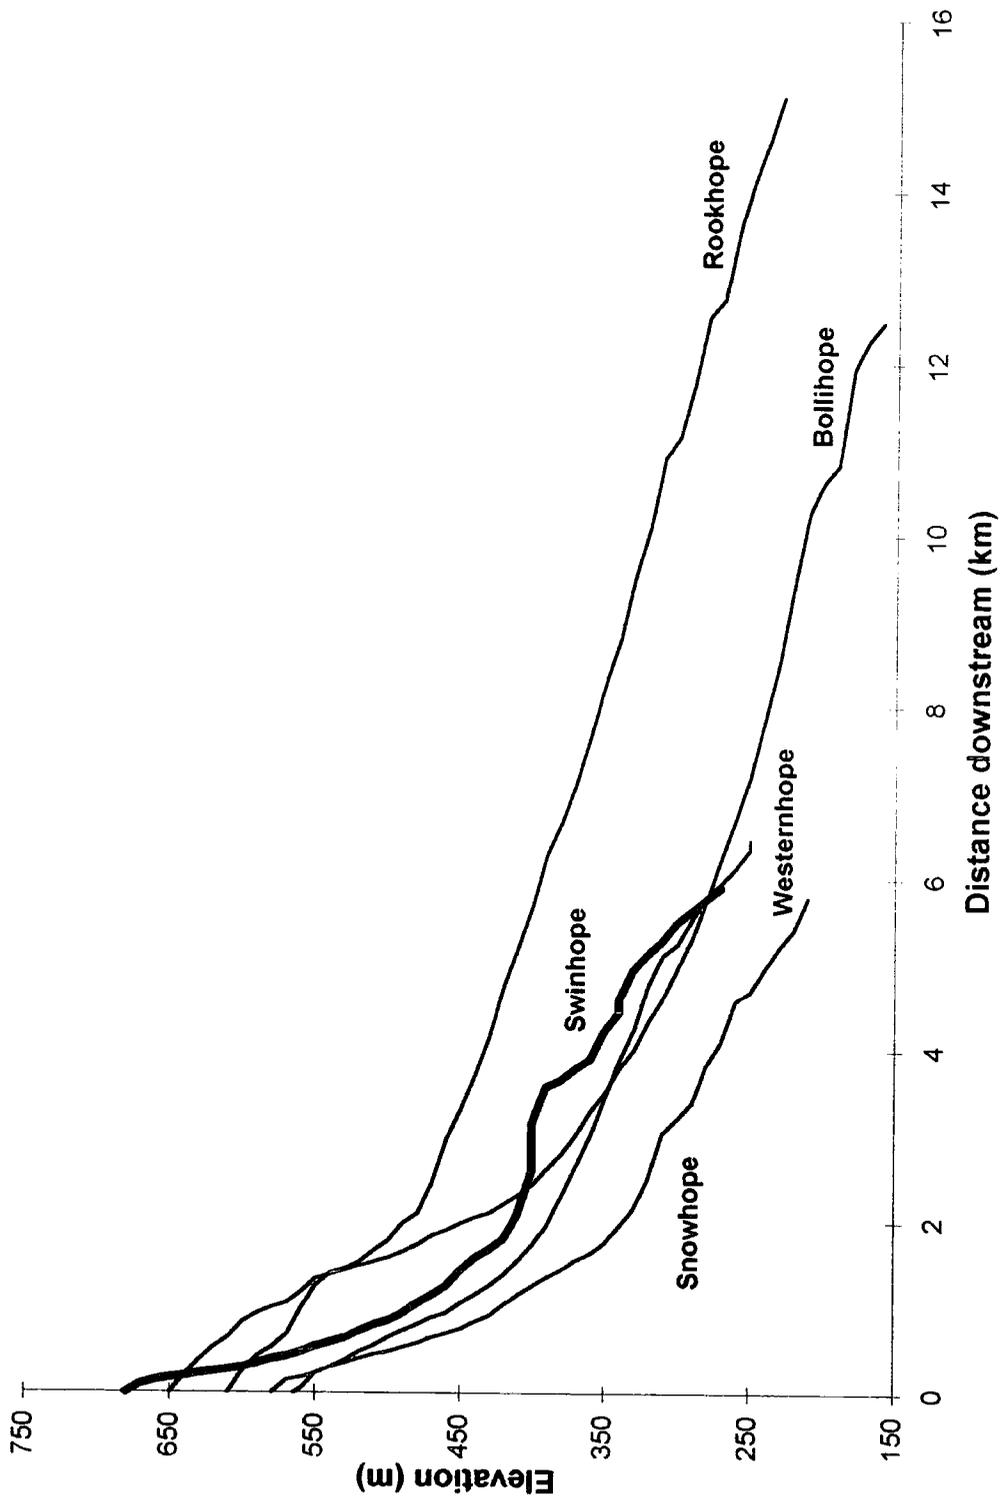
Figure 3.6 Long profile of Swinhope Burn and adjacent catchments

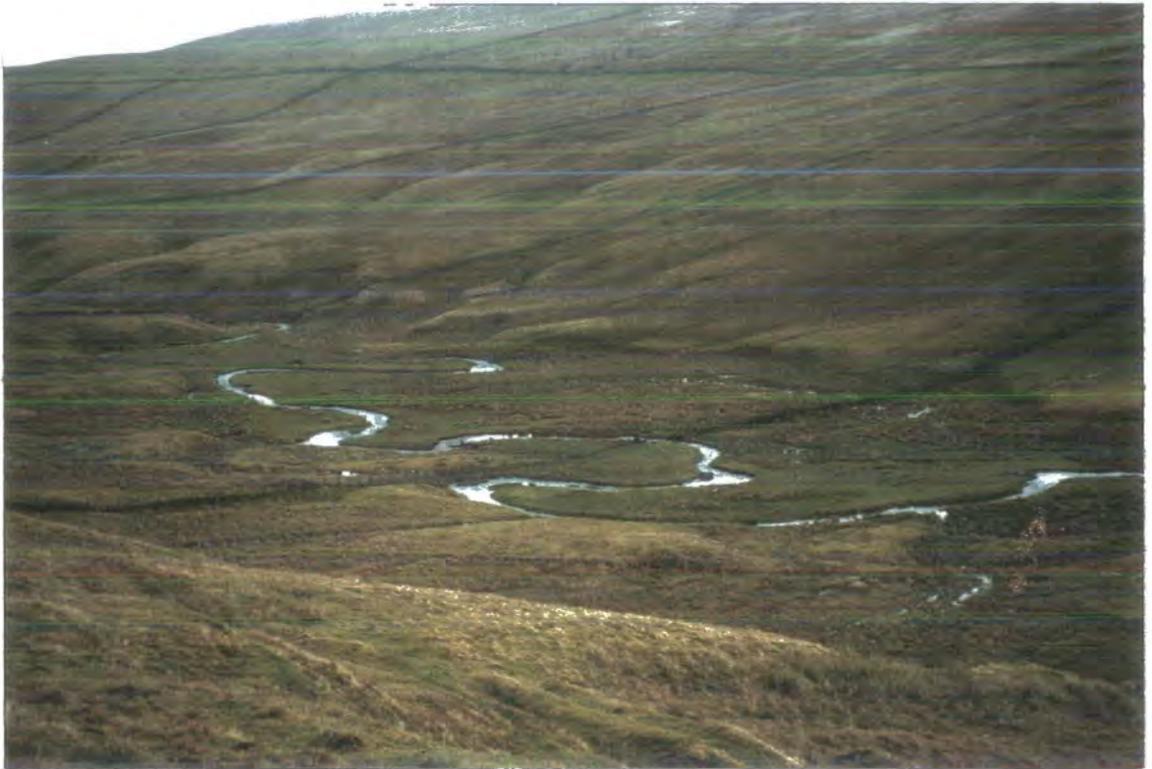
Figure 3.7 Swinhope Burn entering a gorge through the Greenly Hills Moraine showing upstream development of a small floodplain area. Flow is from right to left.

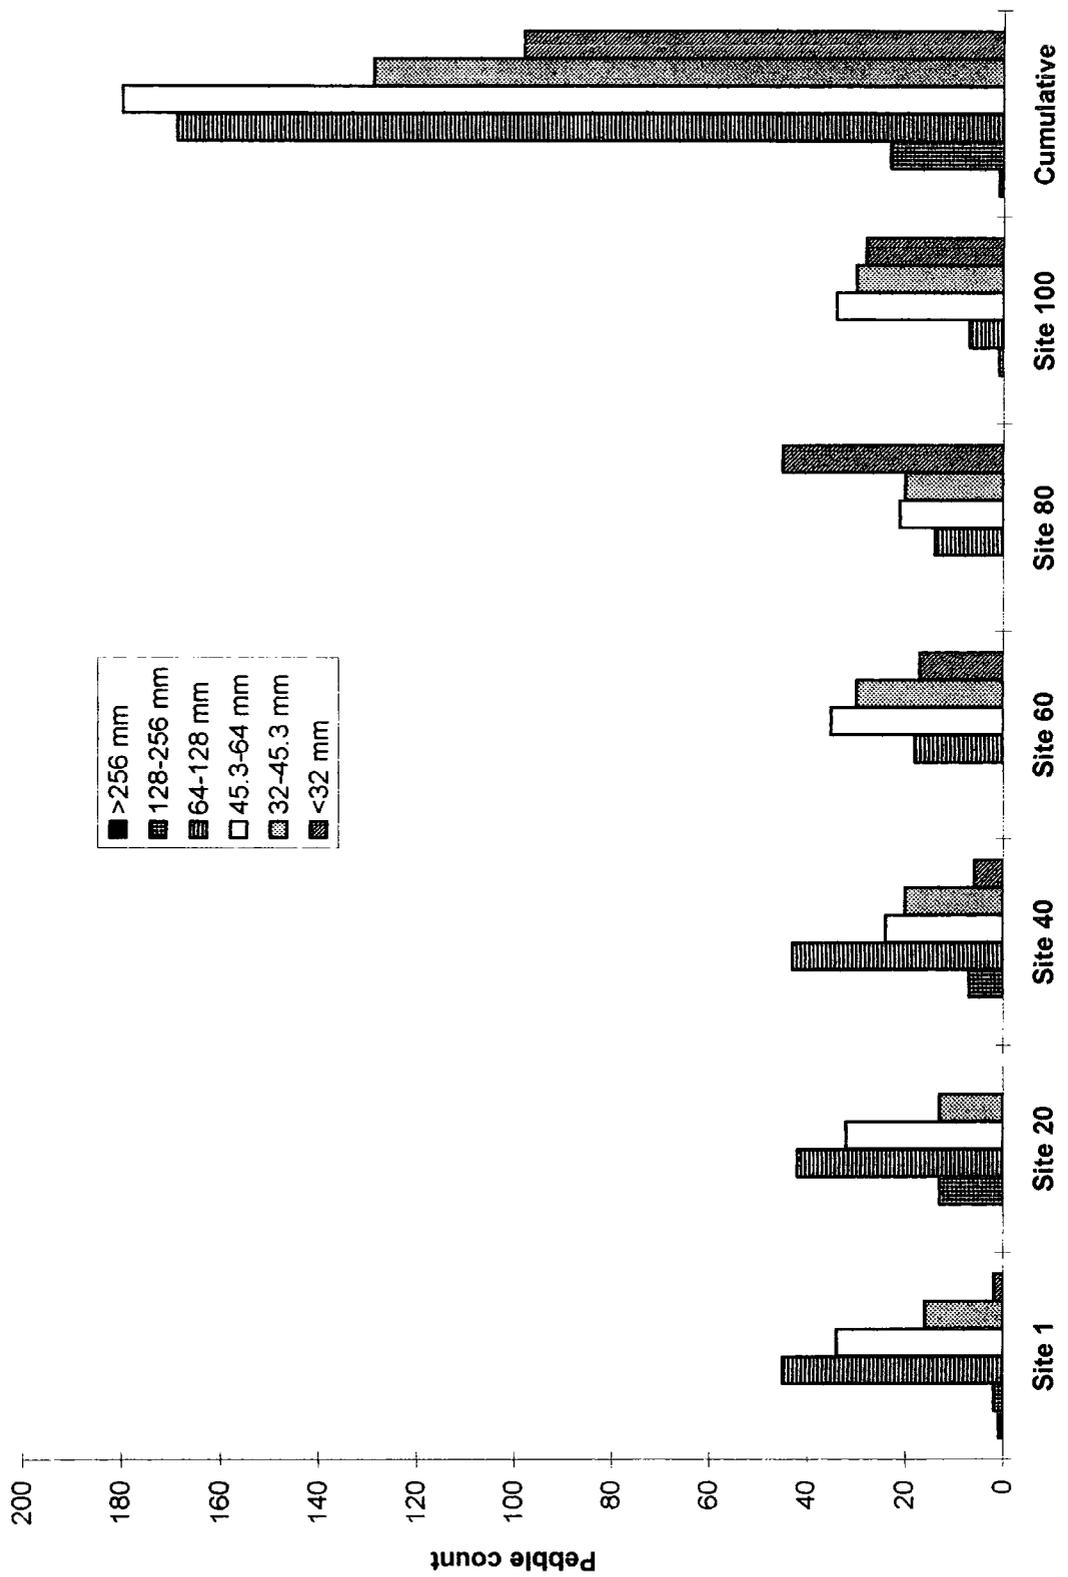
Figure 3.9 Grain-size classes representative of bed material at Swinhope Burn

From the data mean grain-size was calculated for each of the cross-sections. It is appreciated that a sample of 20 particles may not be a good estimate of the mean grain-size. However, this size of sample was chosen because it allows a rapid survey to be undertaken in the immediate post-flood period and by selecting the coarsest particles ensured a consistent sampling method.

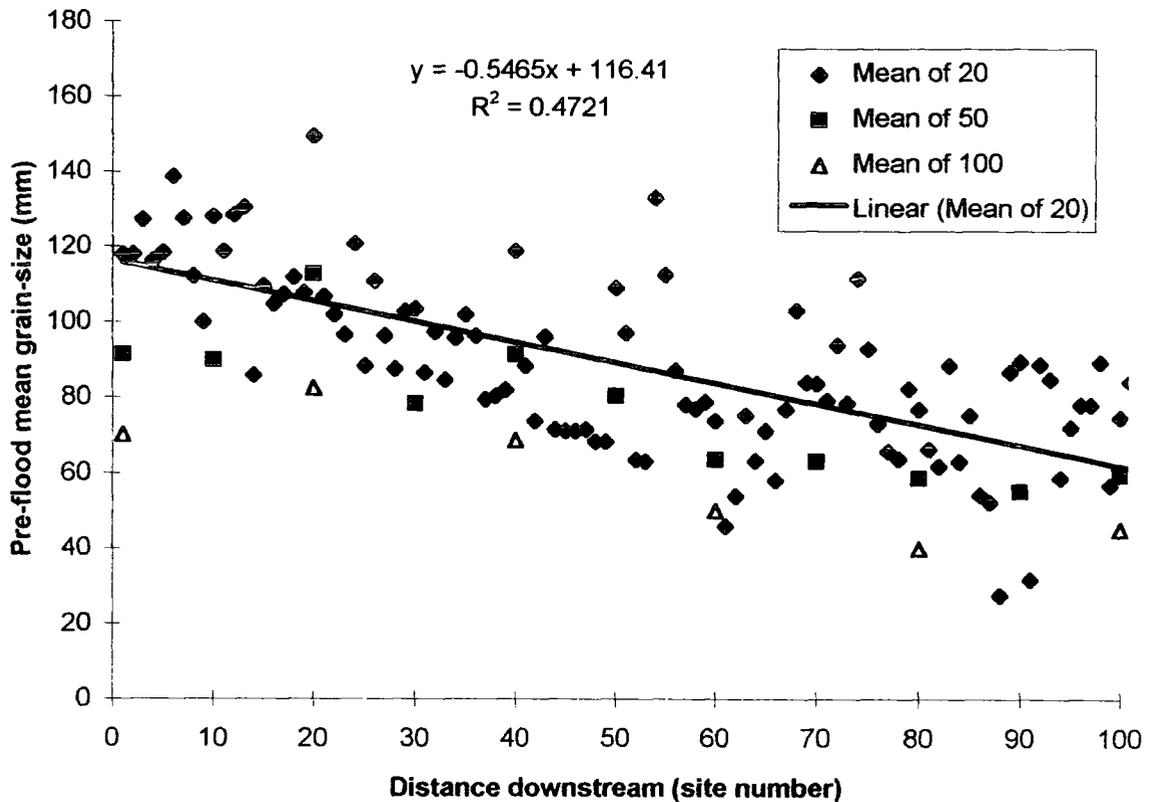
Figure 3.10 Downstream variations in mean-grain size of bed material at Swinhope Burn

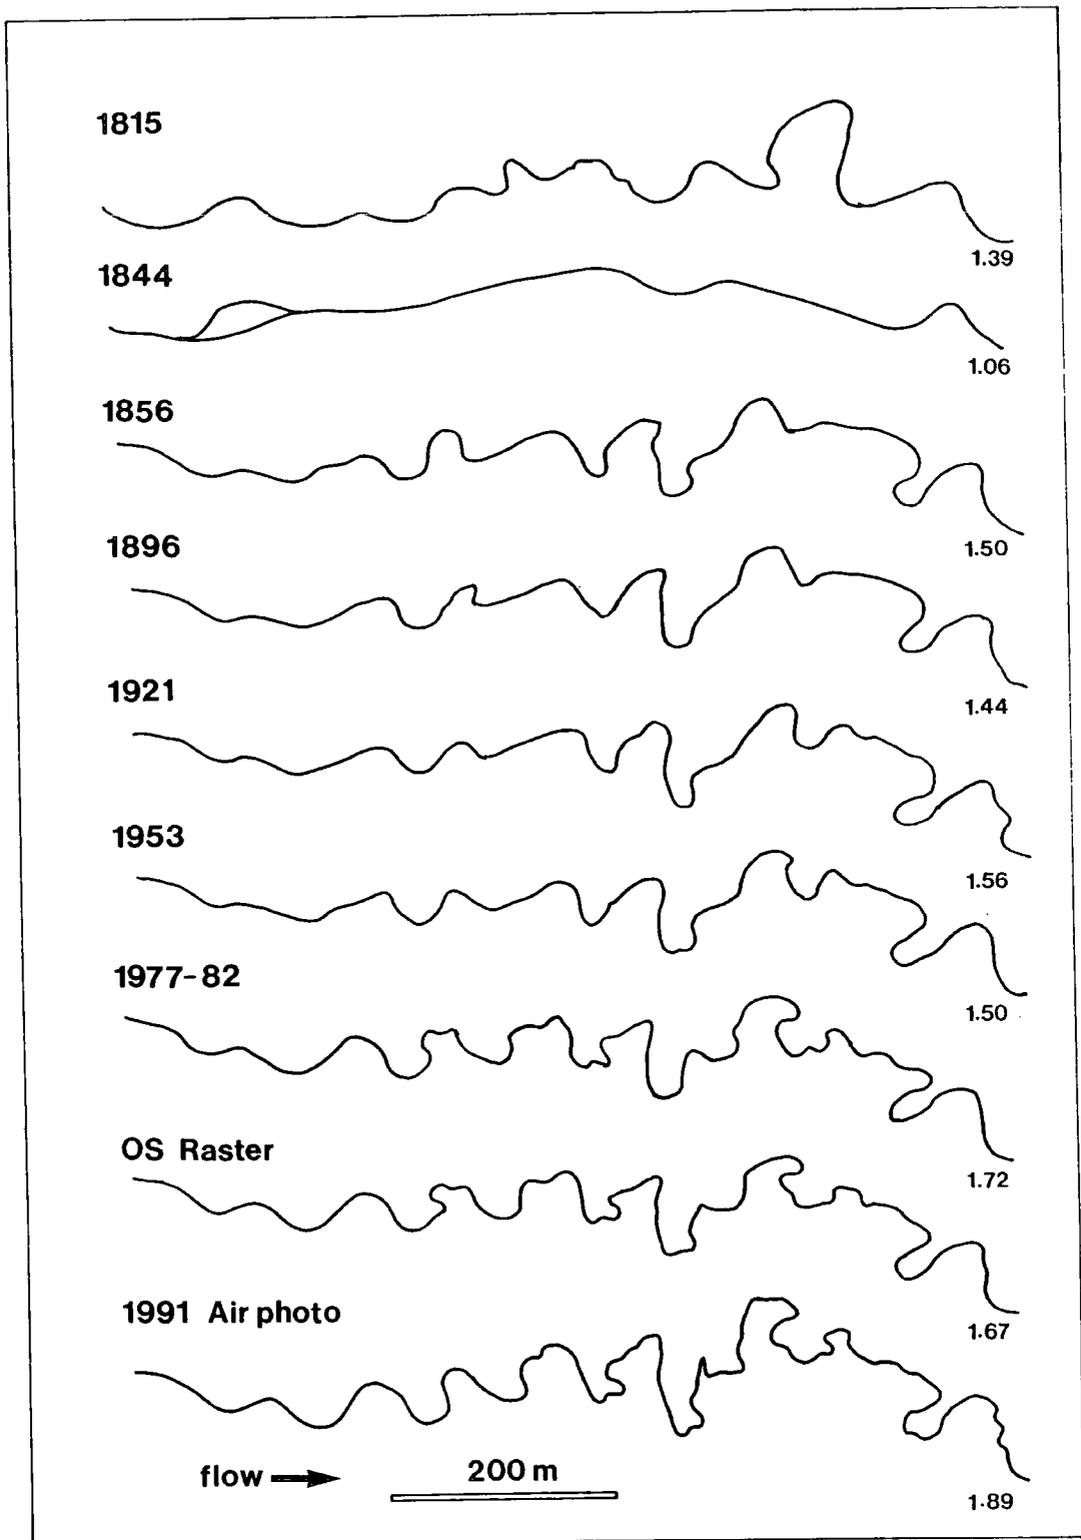
Figure 4.2 Historical evidence of river planform change at Swinhope Burn, Weardale. A full source of references is given in Appendix A.

In contrast to many dynamic gravel-bed rivers of the Northern Pennines which over the historical time period have undergone significant changes in channel planform as a result of large flood events (Macklin *et al*, 1992), large-scale historic mining (Macklin, 1986), land-use change (Macklin *et al*, 1994) or climatic fluctuations (Macklin *et al* 1992b) historic planform change in the Swinhope Burn basin has been insignificant. The study reach has been remarkably stable over the last 180 years with

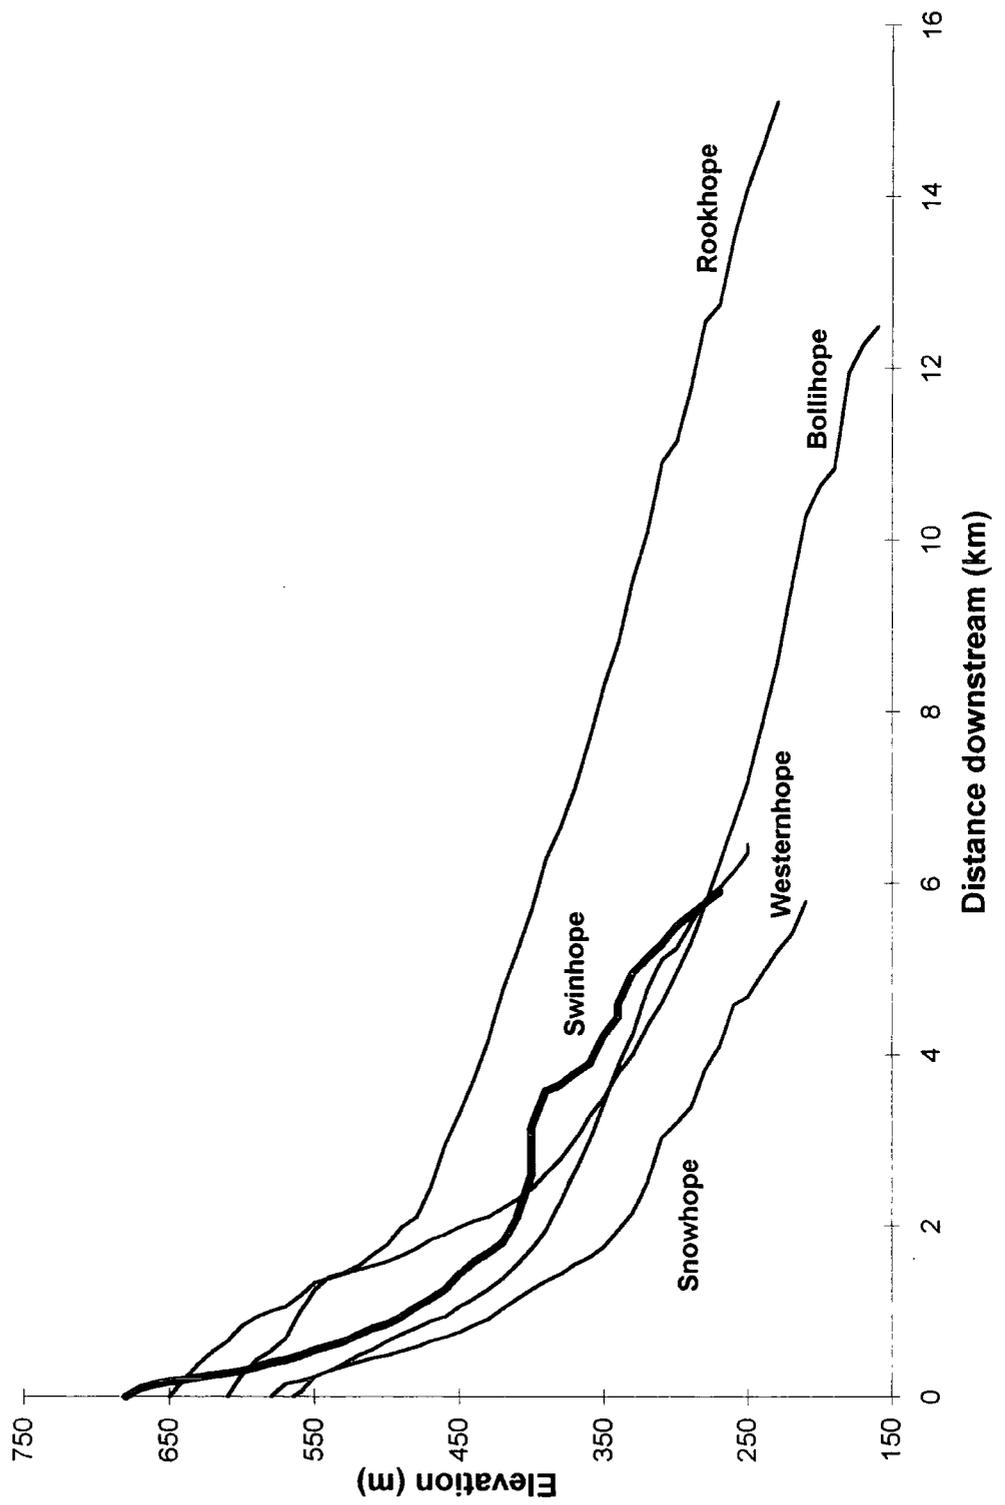
Figure 4.3 Long profile of Swinhope Burn and adjacent catchments

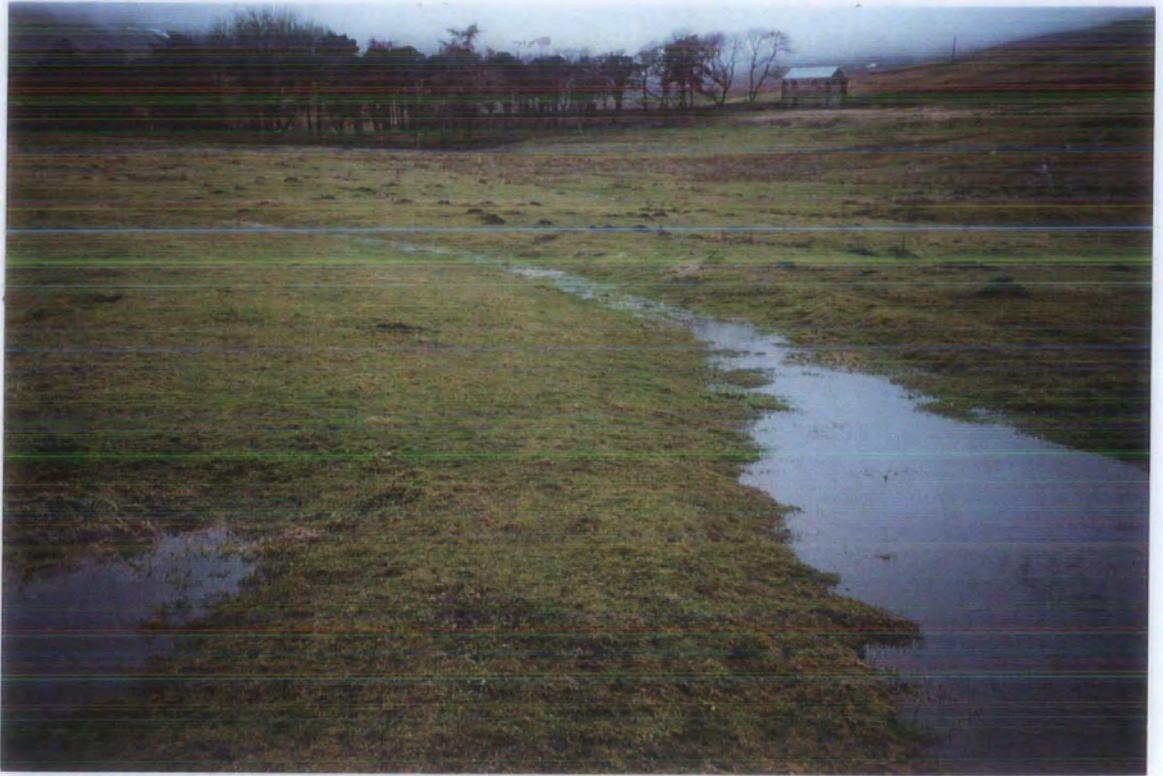
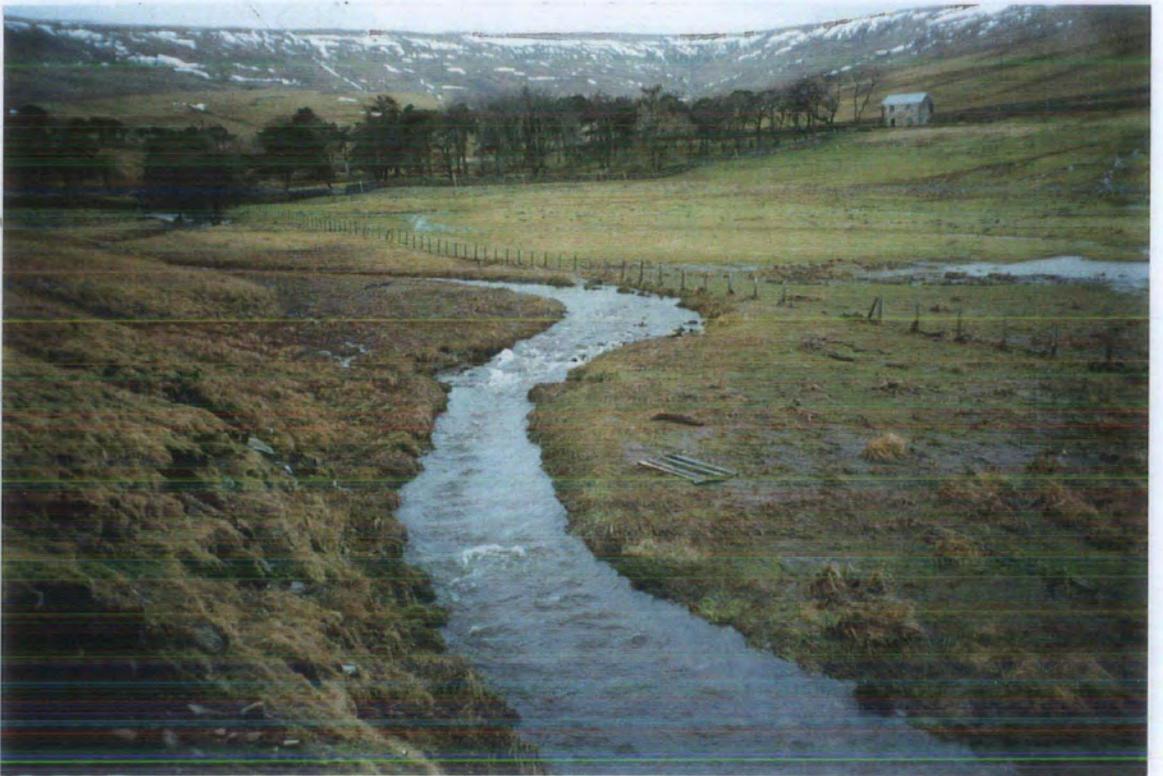
Figure 4.5 Abandoned channel preserved in the floodplain utilised by present day flood flows in the upper reaches of Swinhope Burn

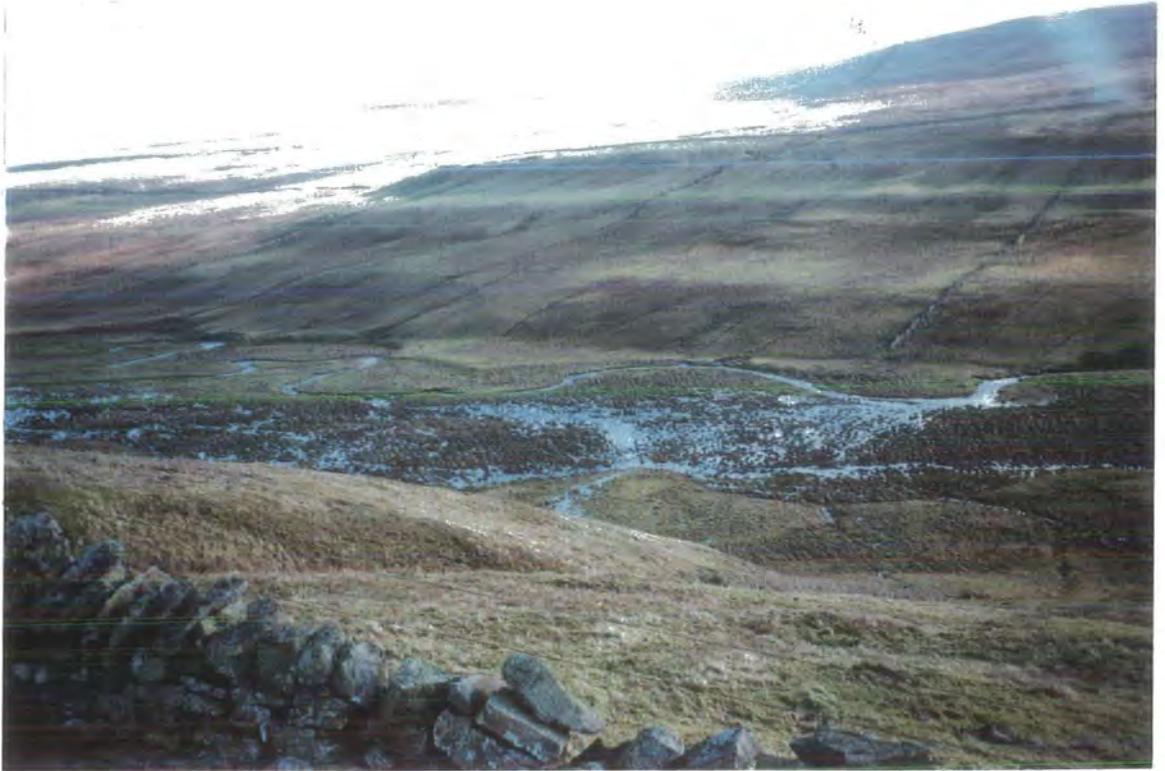
Figure 4.8 Palaeochannels visible in the Swinhope Burn basin utilised by present day flood flows

Documented flood records and field evidence strongly suggest a causal link between the occurrence of a succession of major floods on the River Wear during the 1820's and the change in channel pattern recorded on the 1844 Tithe map. It seems likely that these floods affected the Swinhope Burn basin.

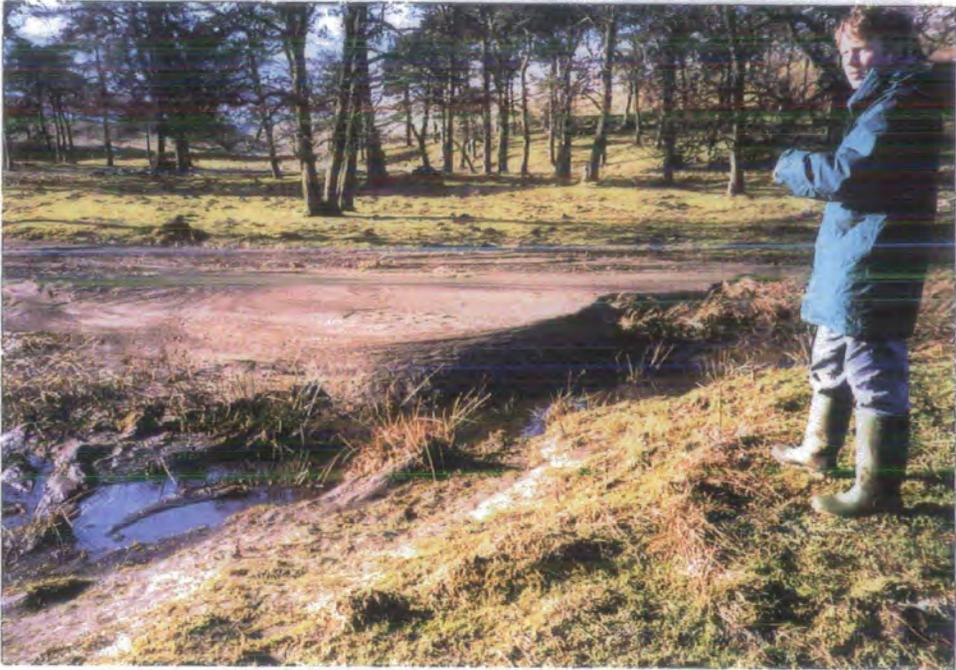
Figure 4.9 Large fan of fine backwater deposits immediately above the study reach at Swinhope Burn resulting from the January, 1995 flood

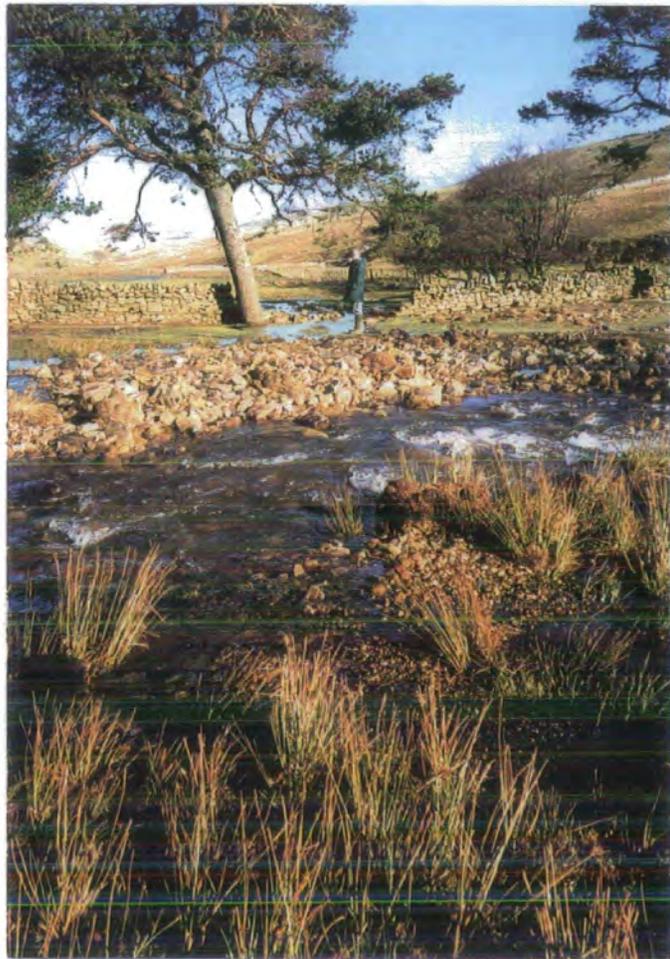
Figure 4.10 Structural damage caused by January, 1995 flood at Swinhope Burn

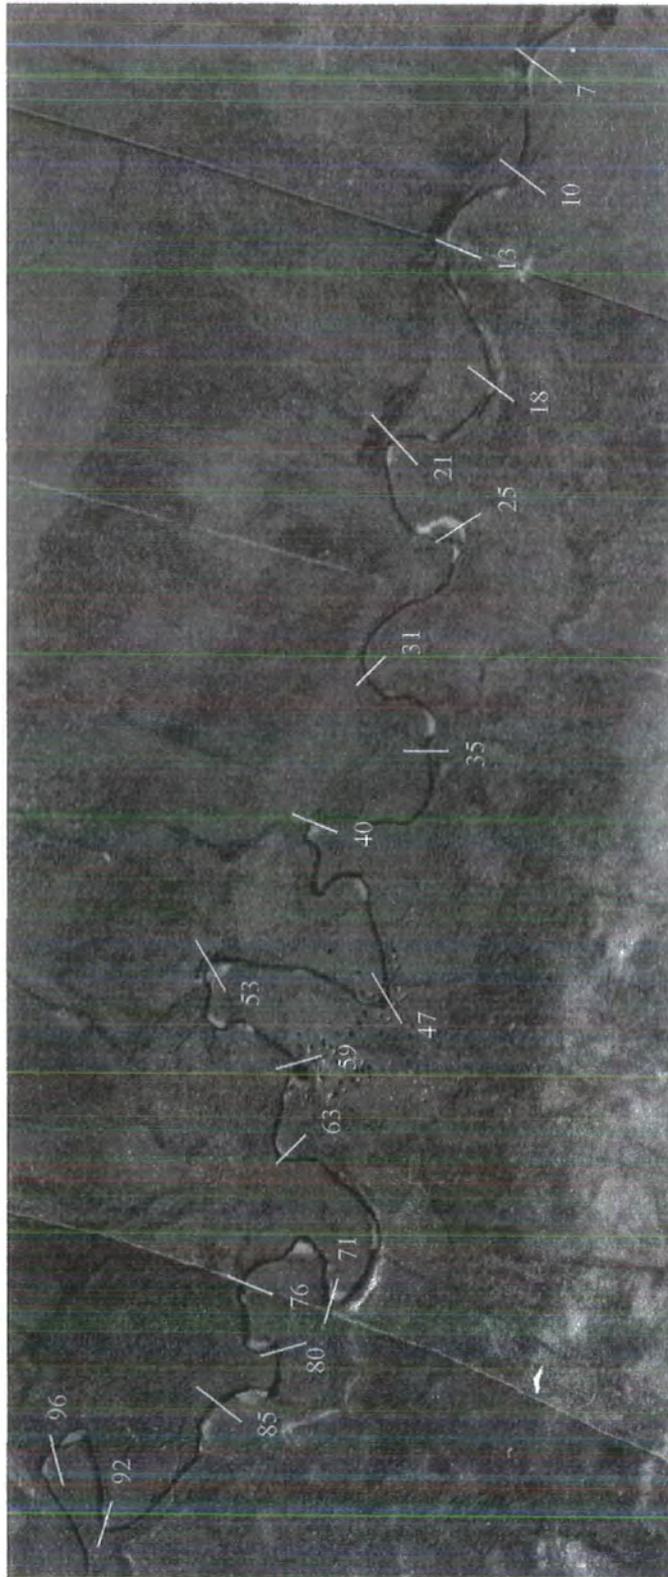
Figure 5.1 Air photograph of Swinhope Burn showing selected cross-section locations (Courtesy of Aerofilms and Durham County Council). Length of reach is approximately 1.4 km.

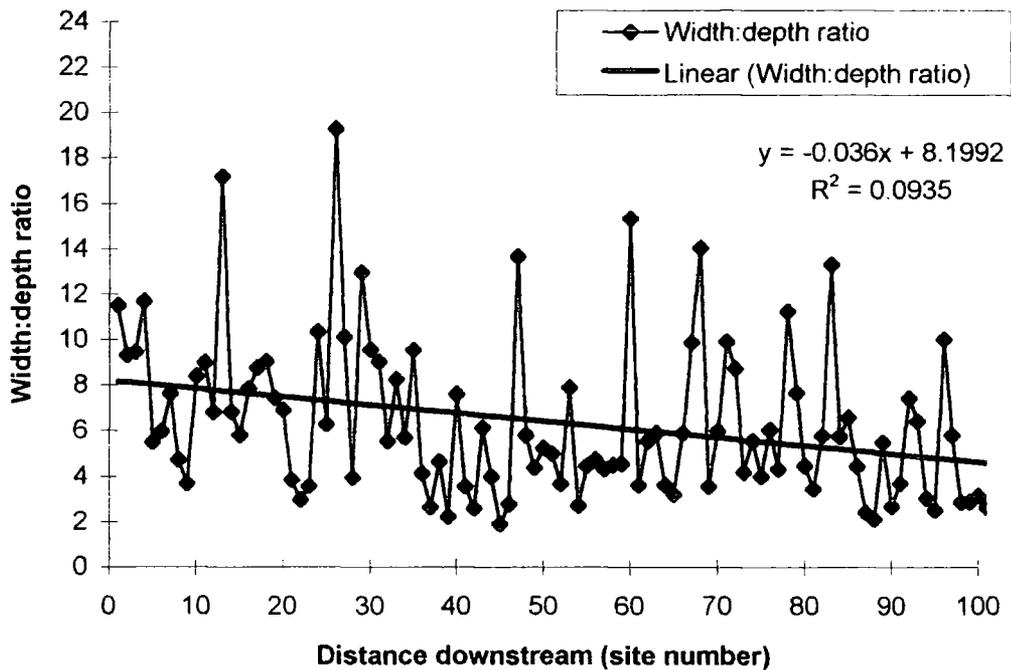
Figure 5.2 Downstream changes in width:depth ratio

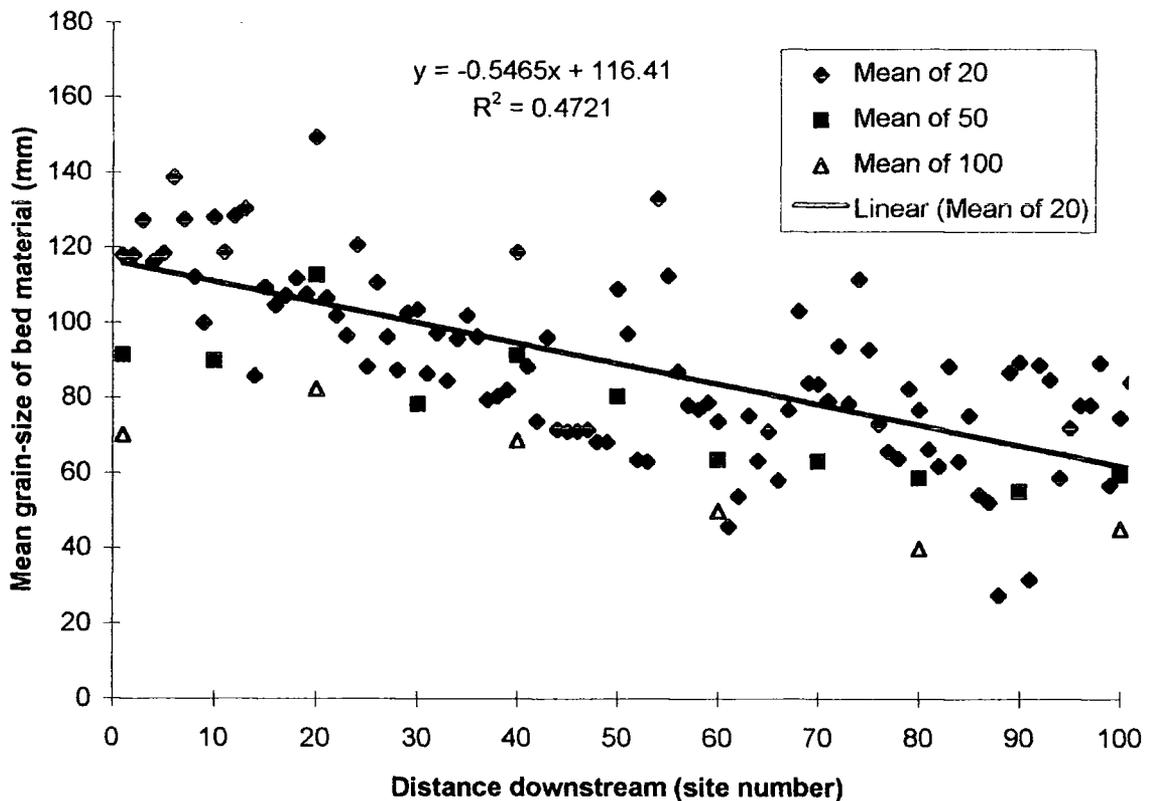
Figure 5.3 Downstream changes in mean grain-size of bed material

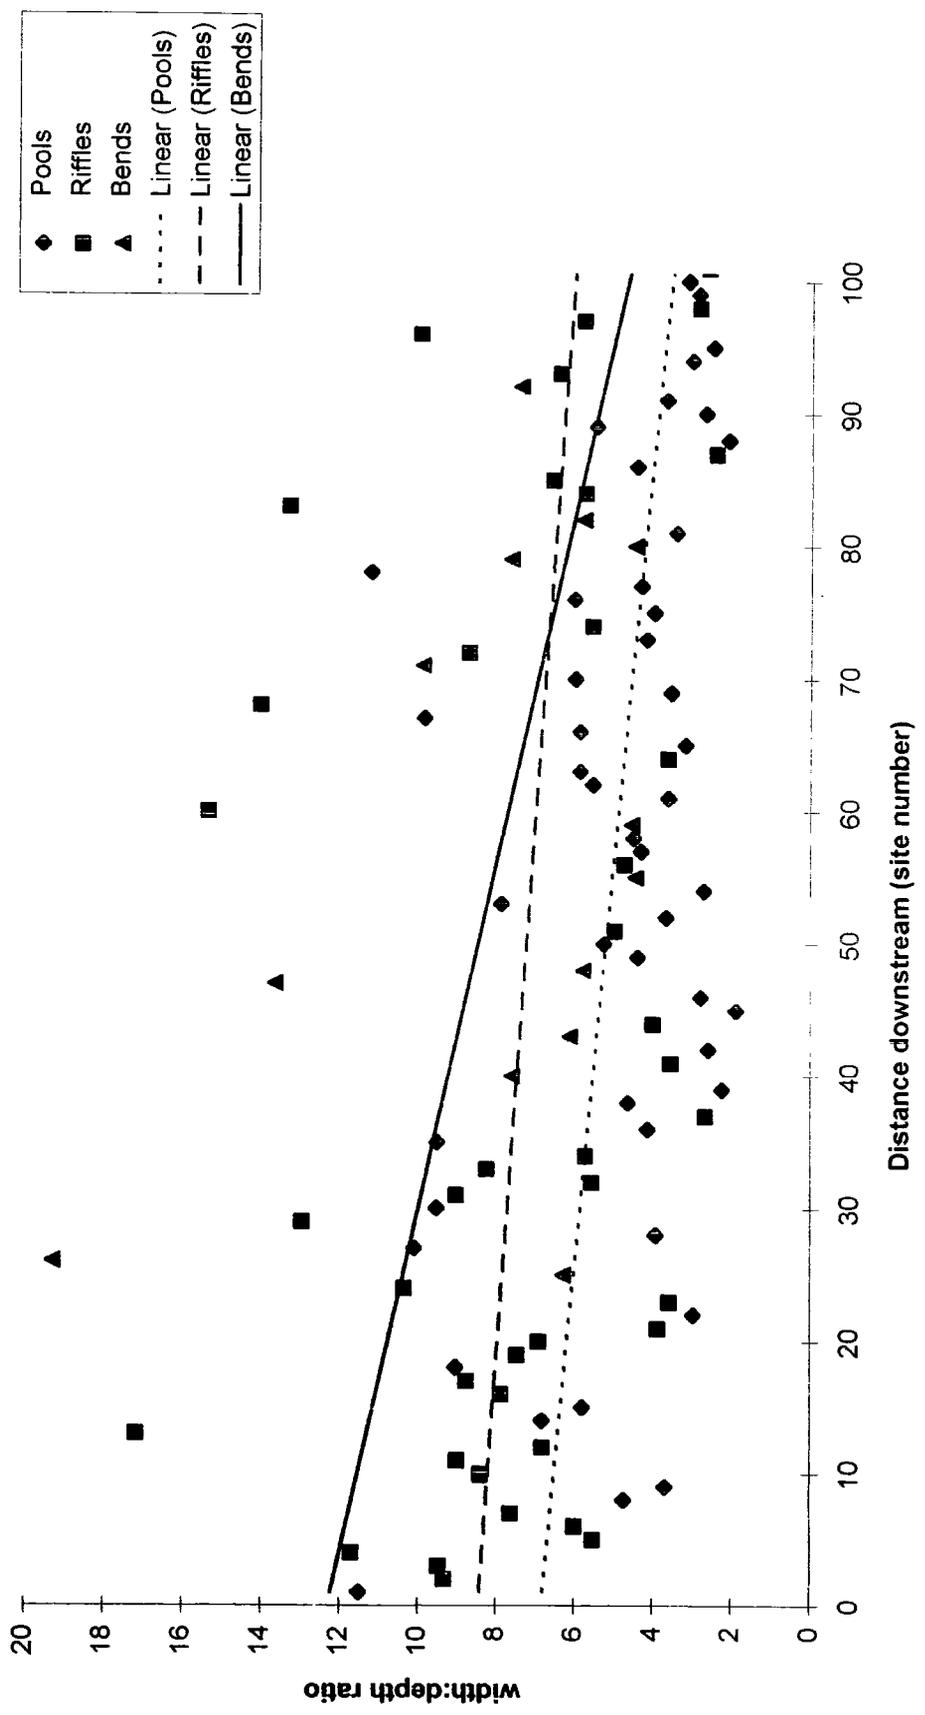
Figure 5.5 Downstream changes in width:depth ratio of pool, riffles and bends

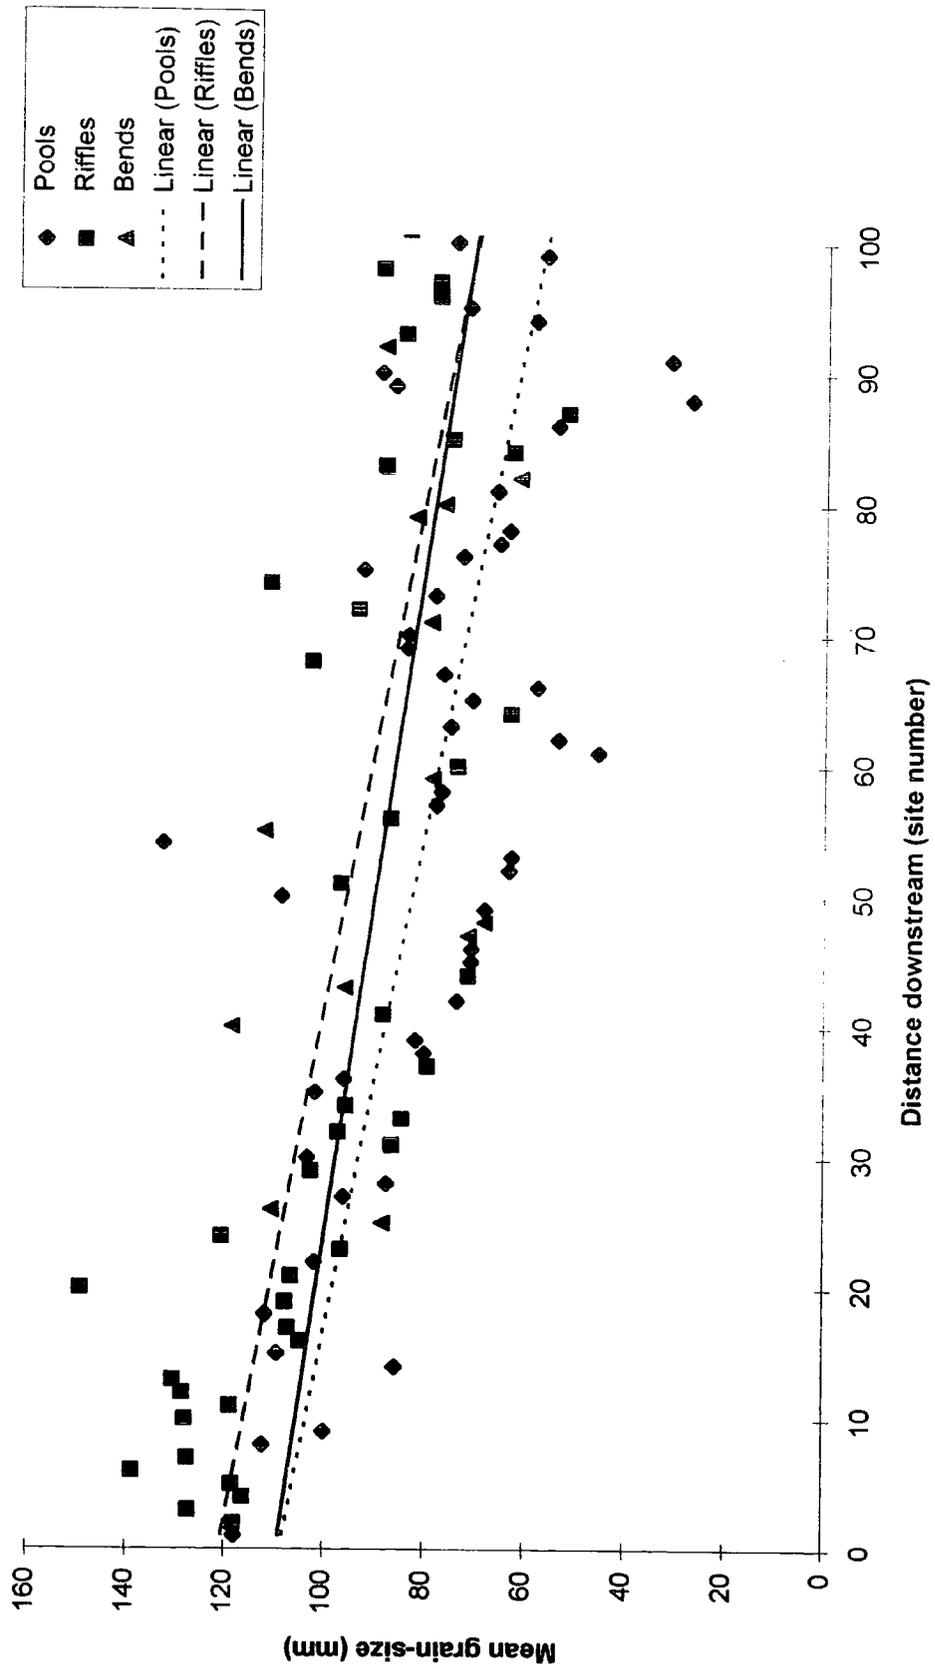
Figure 5.8 Downstream changes in mean grain-size of bed material of pools, riffles and bends
