Contemporary and historic river channel change at Swinhope bum, Weardale: a study of river response to flood events in an upland, gravel-bed stream

Danks, Melanie (1998) Contemporary and historic river channel change at Swinhope bum, Weardale: a study of river response to flood events in an upland, gravel-bed stream. Masters thesis, Durham University.

MSc Thesis, 1998

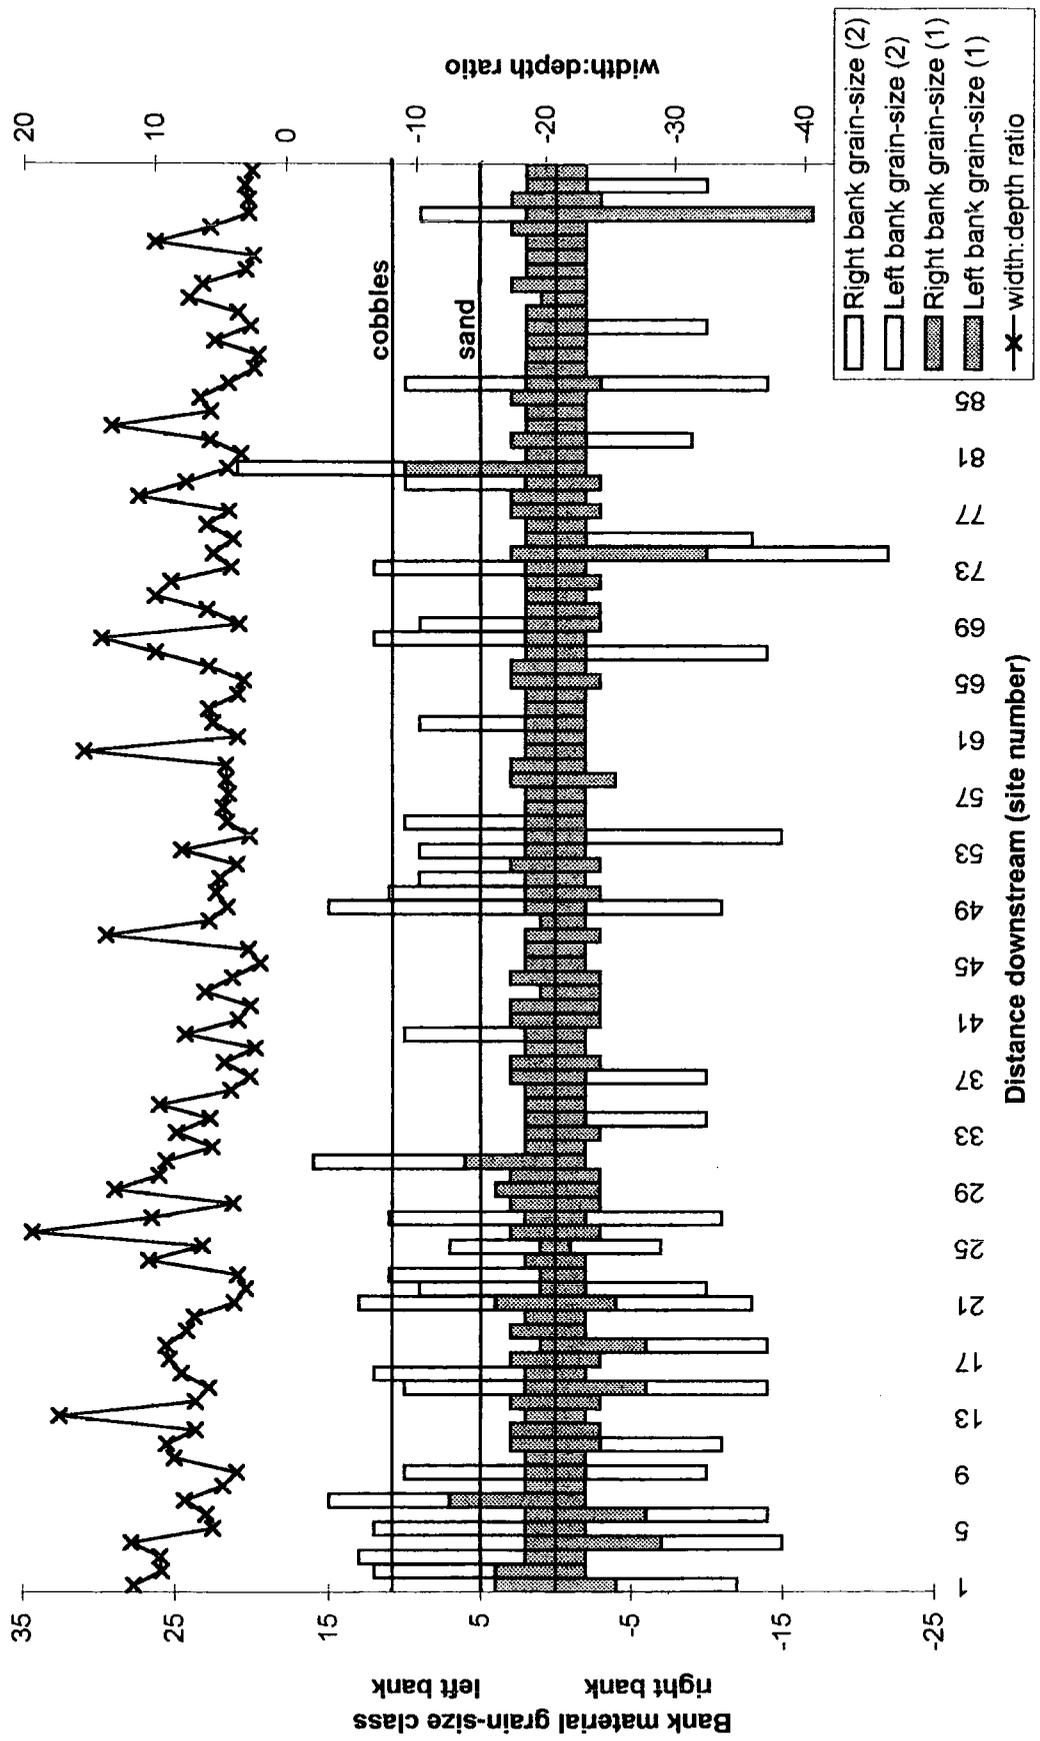
Figure 5.9 Downstream variations in the grain-size of right and left bank material in relation to changes in width:depth ratio

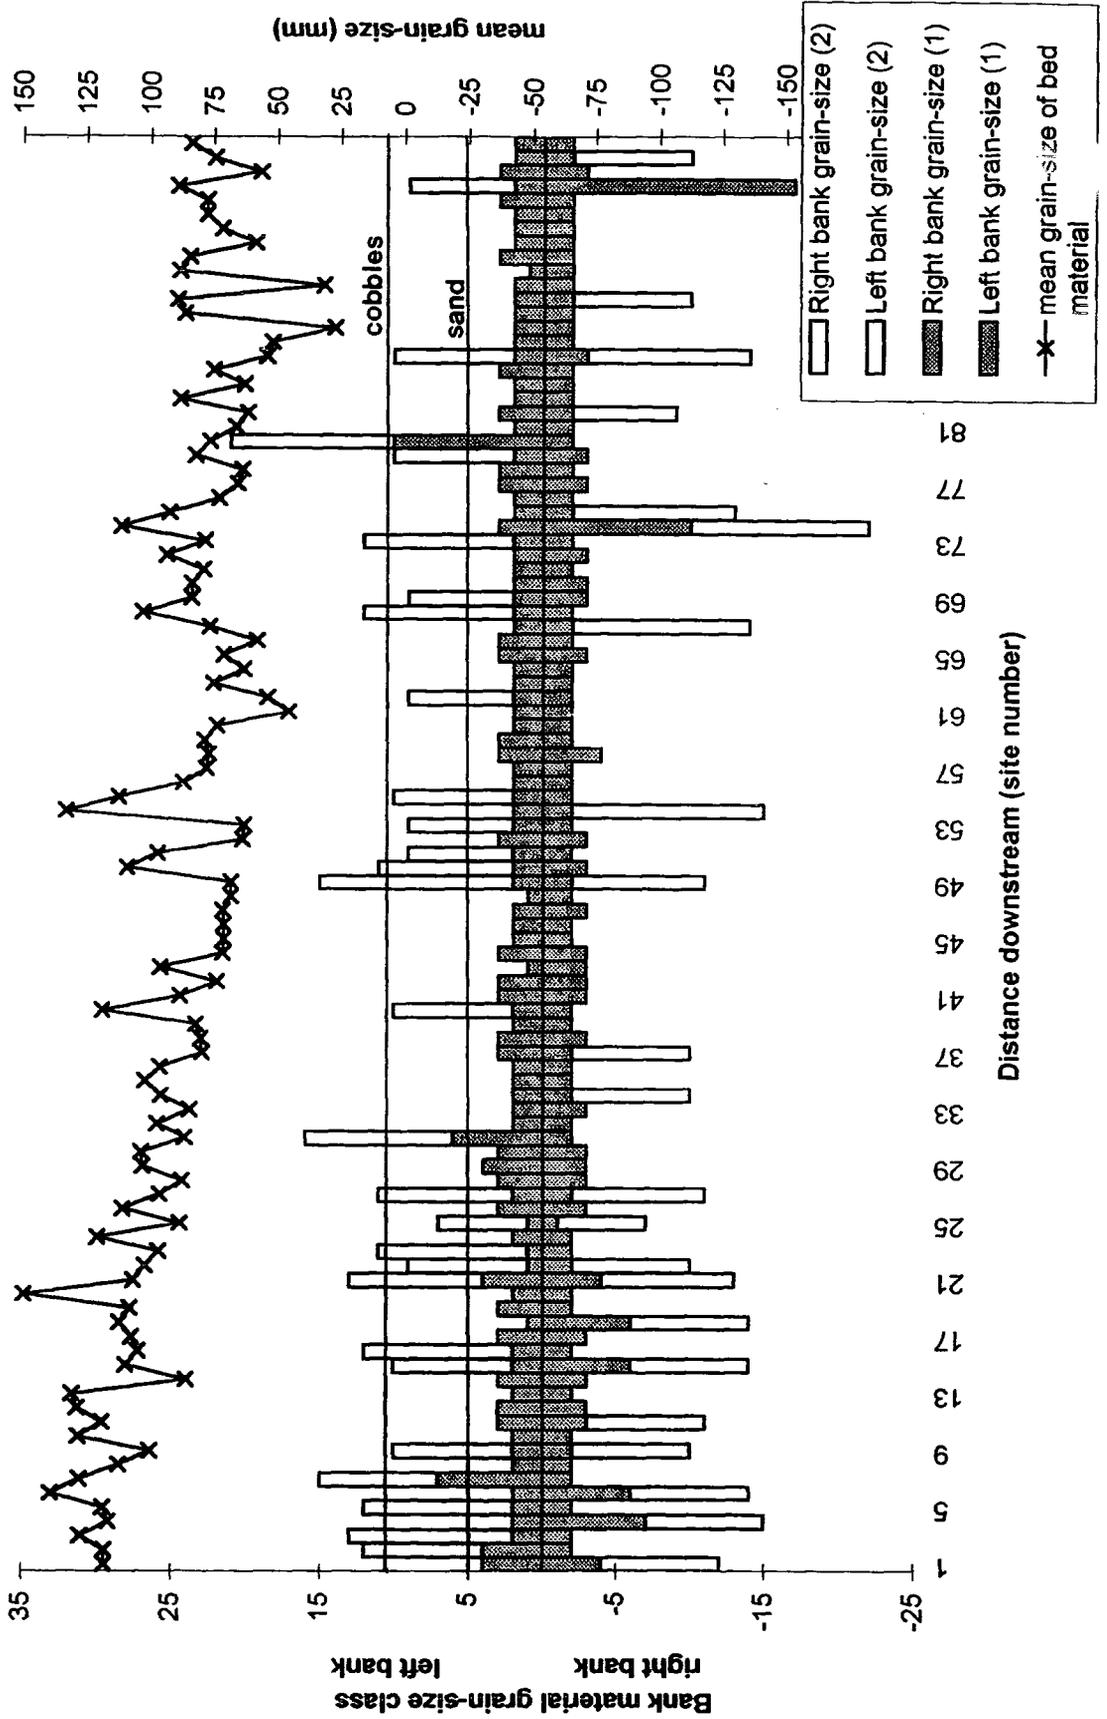
Figure 5.10 Downstream variations in the grain-size of right and left bank material in relation to changes in mean grain-size

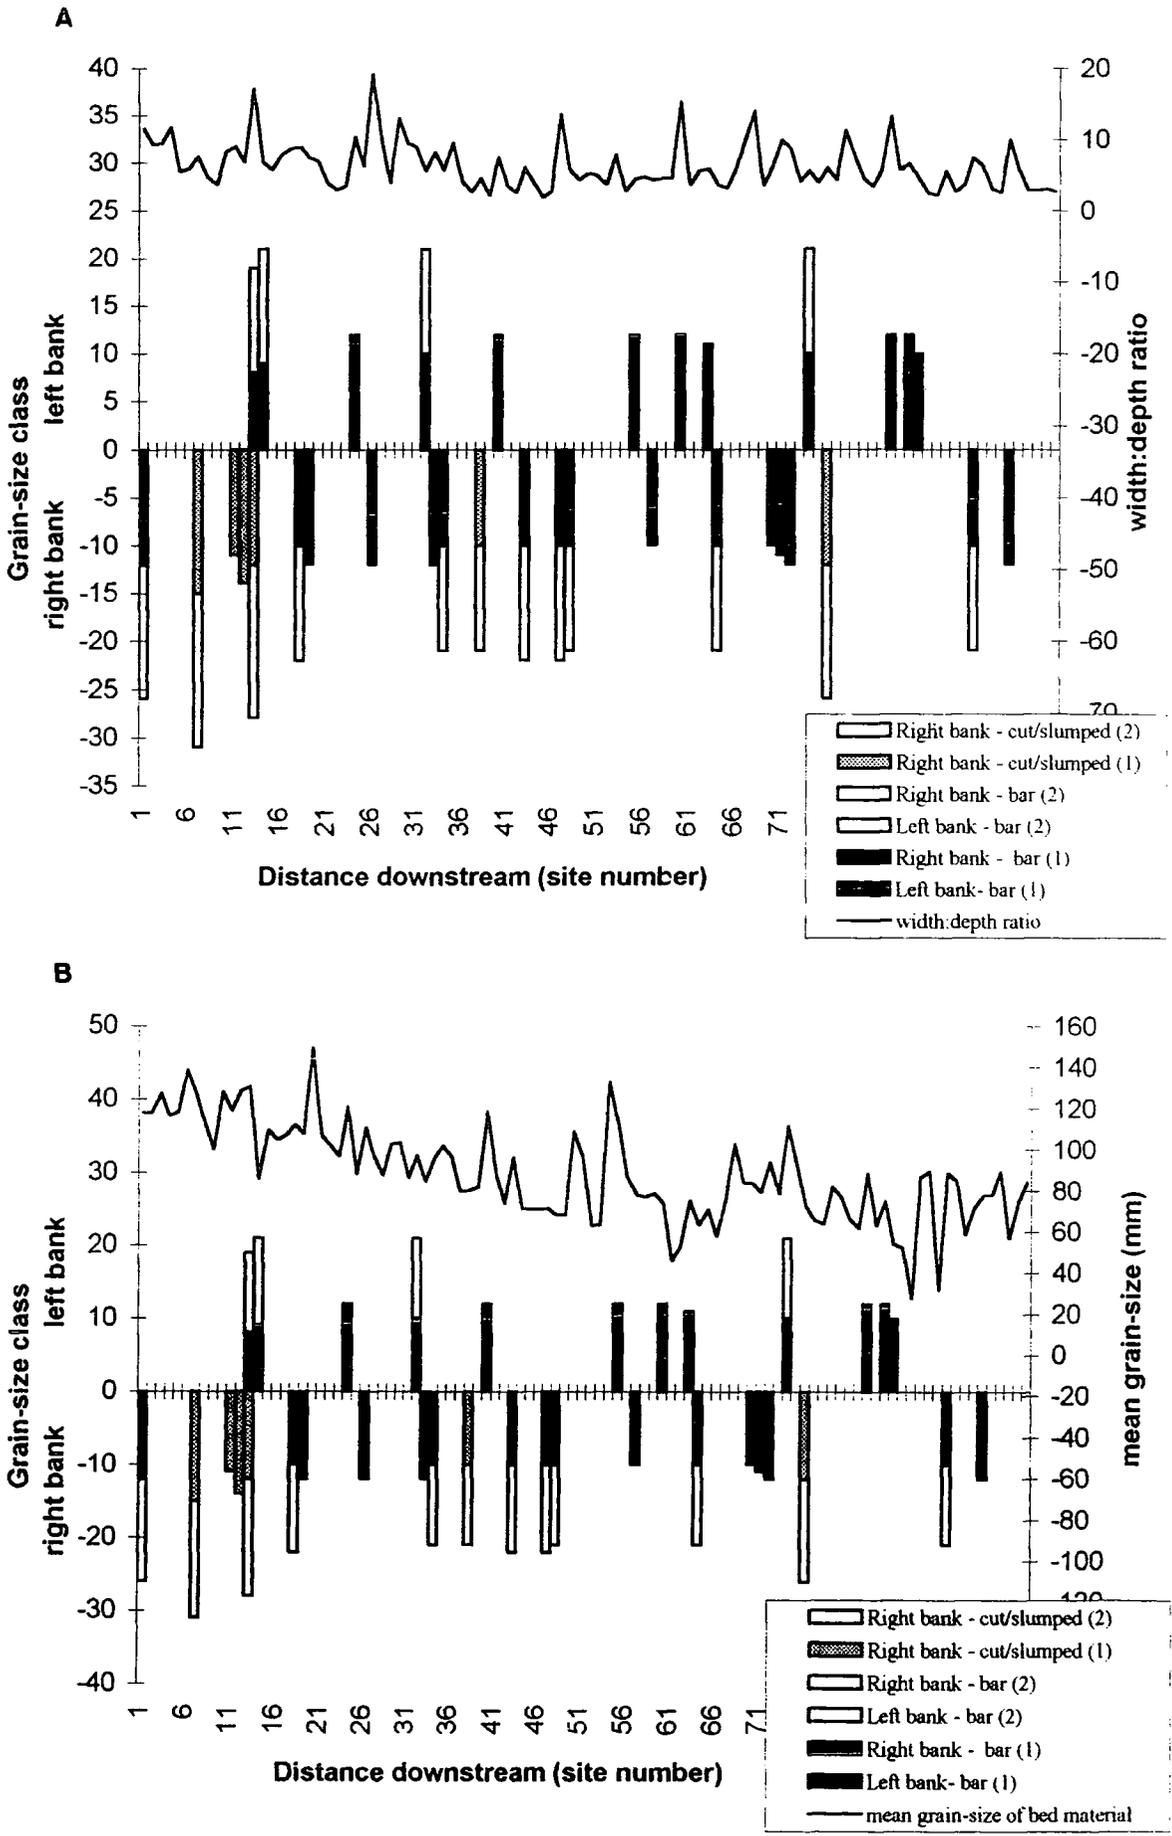
Figure 5.12 Downstream changes in the relationship between the presence of bars and cut banks and variation in the width:depth ratio and mean grain-size of bed material

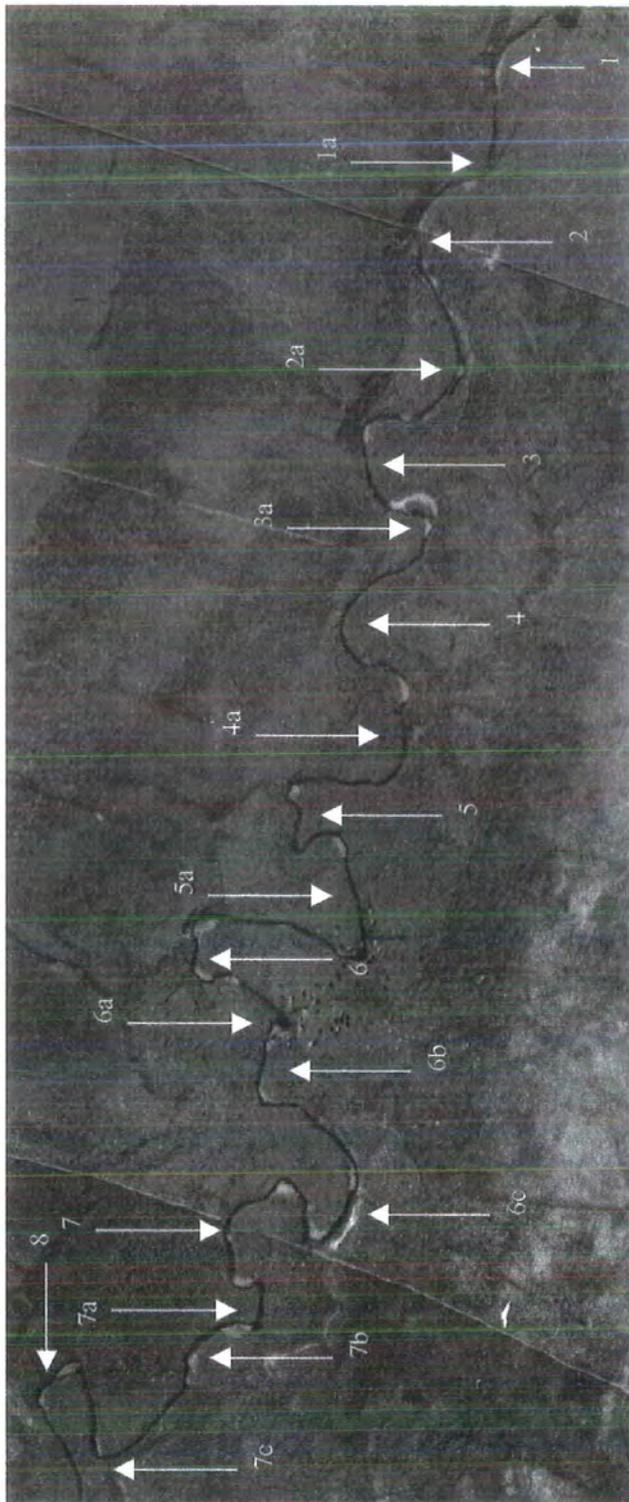
Figure 5.13 Air photograph of Swinhope Burn showing channel sinuosity with bends labelled (courtesy of Aerofilms and Durham County Council).

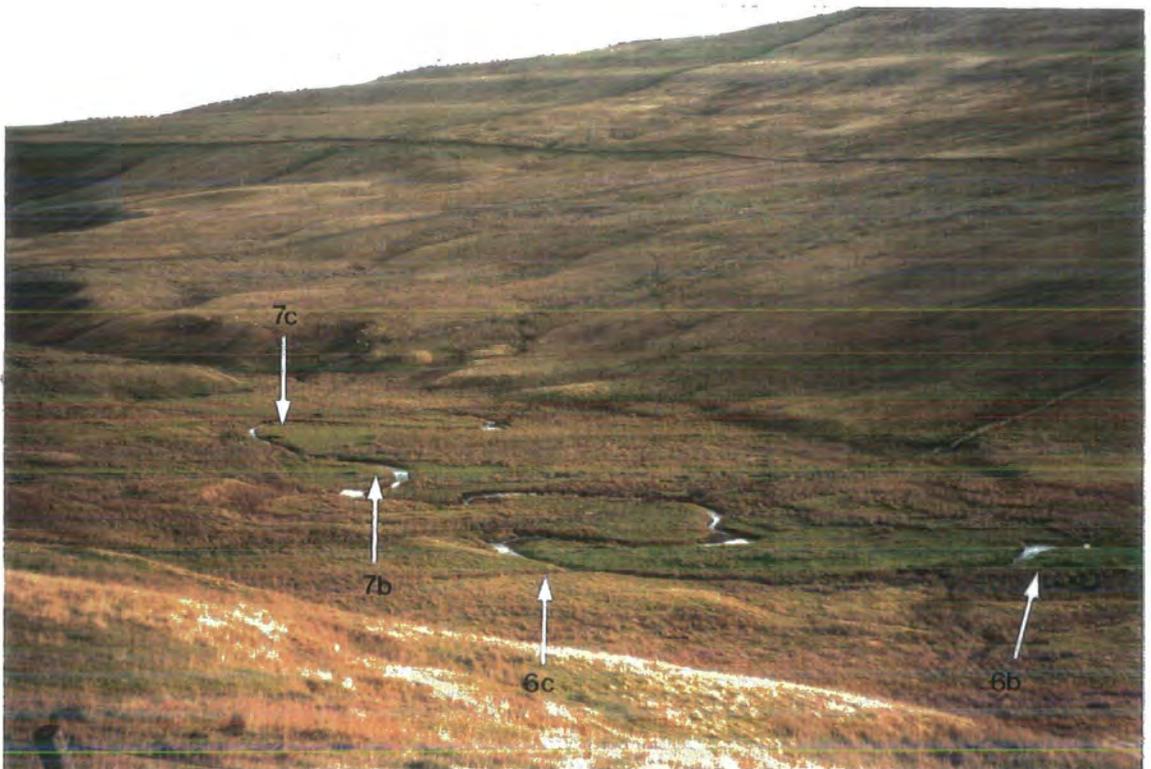
Figure 5.14 Photograph of high and low sinuosity bends in the lower reaches of Swinhope Burn.

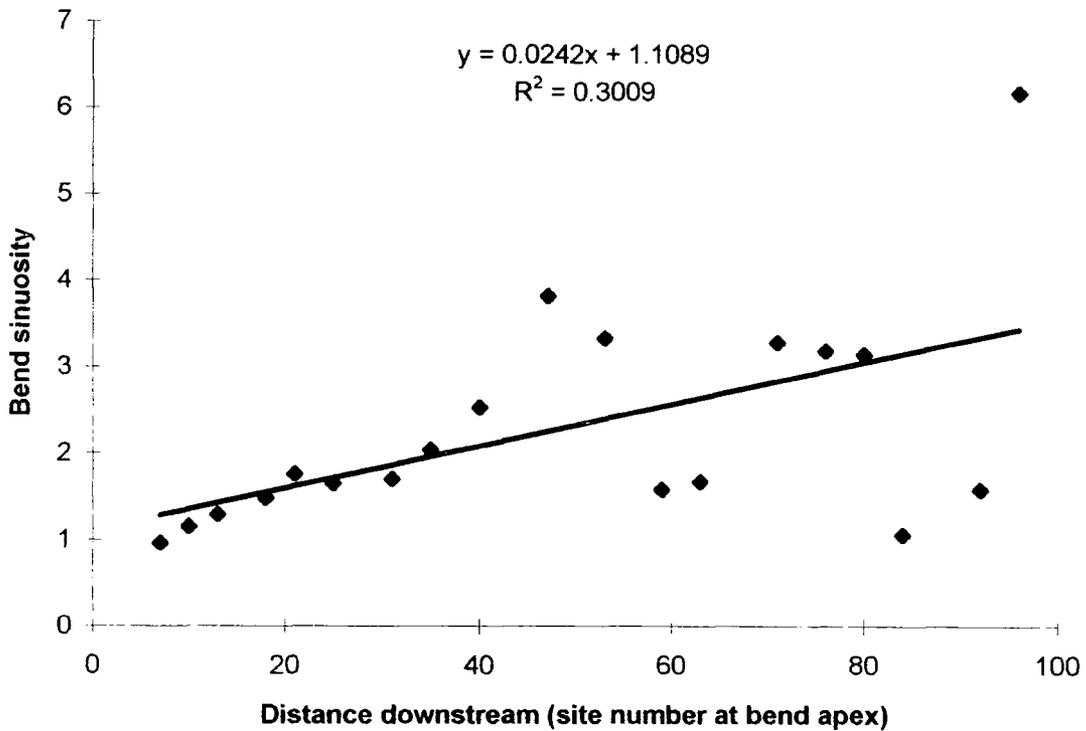
Figure 5.15 Downstream variations in bend sinuosity, Swinhope Burn

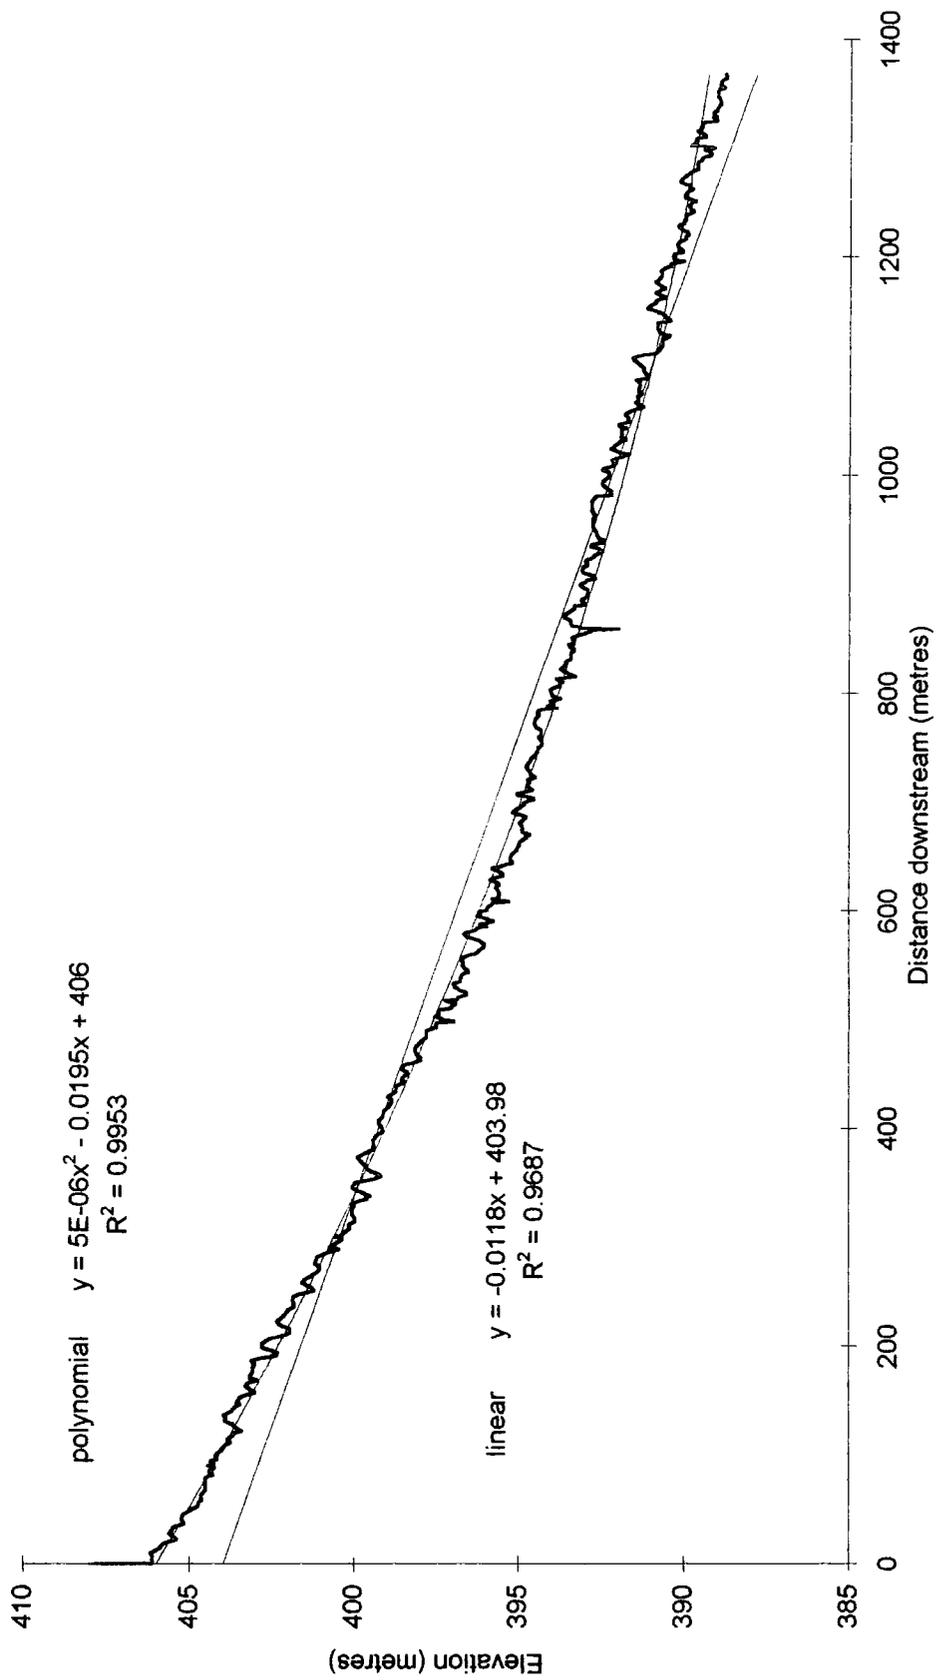
Figure 5.16 Detailed long-profile of channel gradient at Swinhope Burn

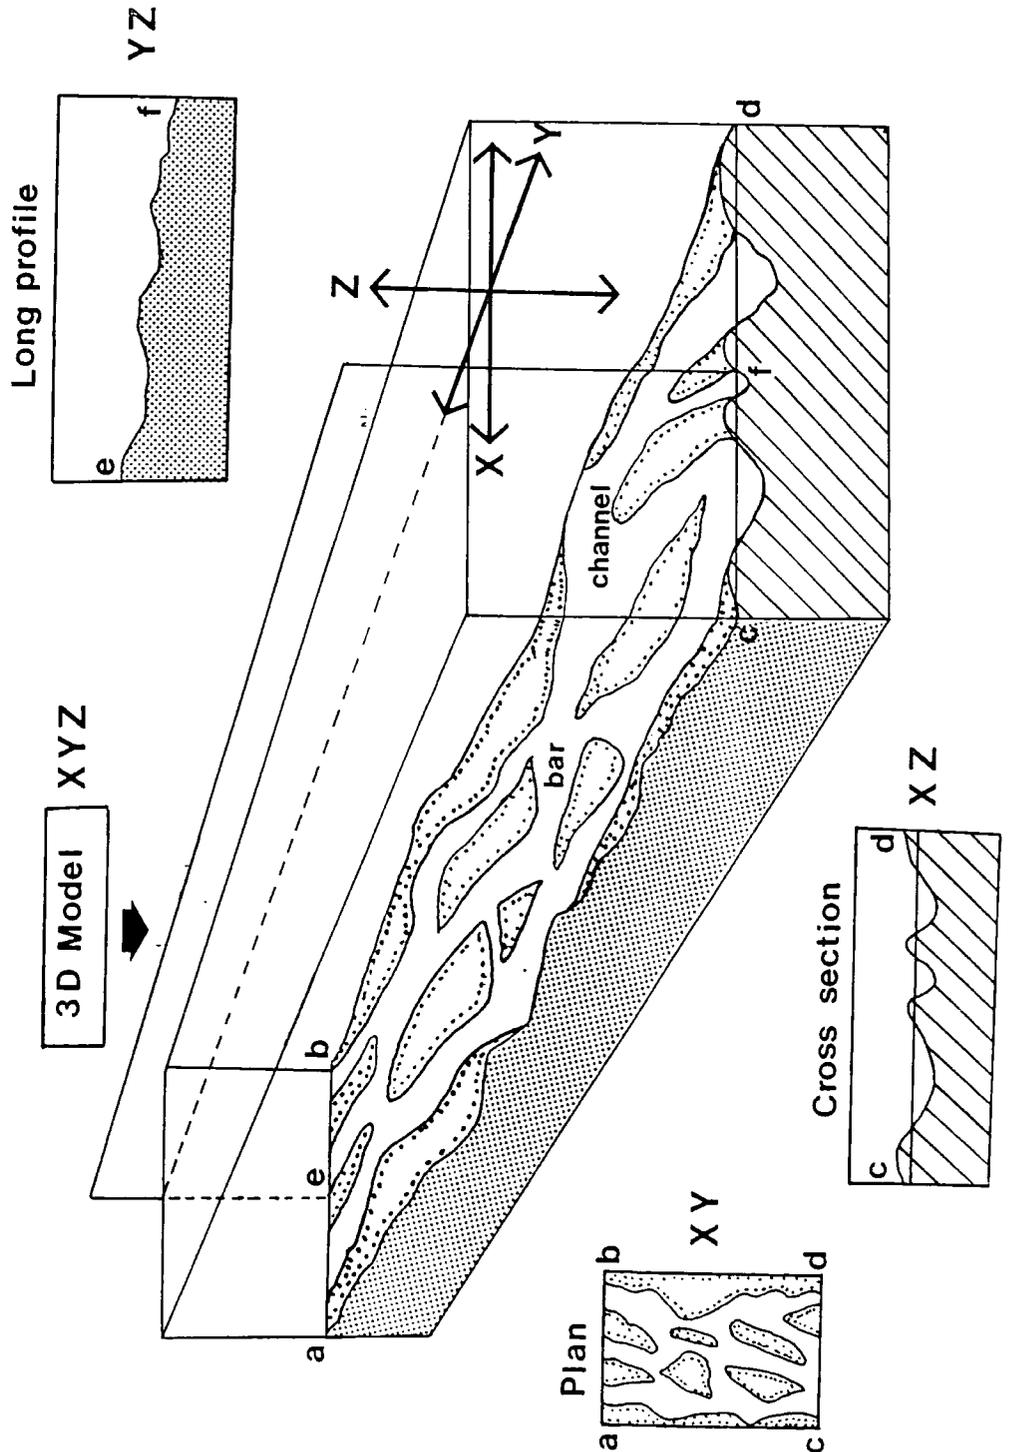
Figure 6.1 The major components of channel form (planform, long-profile and cross-section) represented as different planes of adjustment in a three-dimensional river system. Studies of channel change often focus on a particular dimension (e.g. YZ, XY or XZ) to describe channel adjustments.

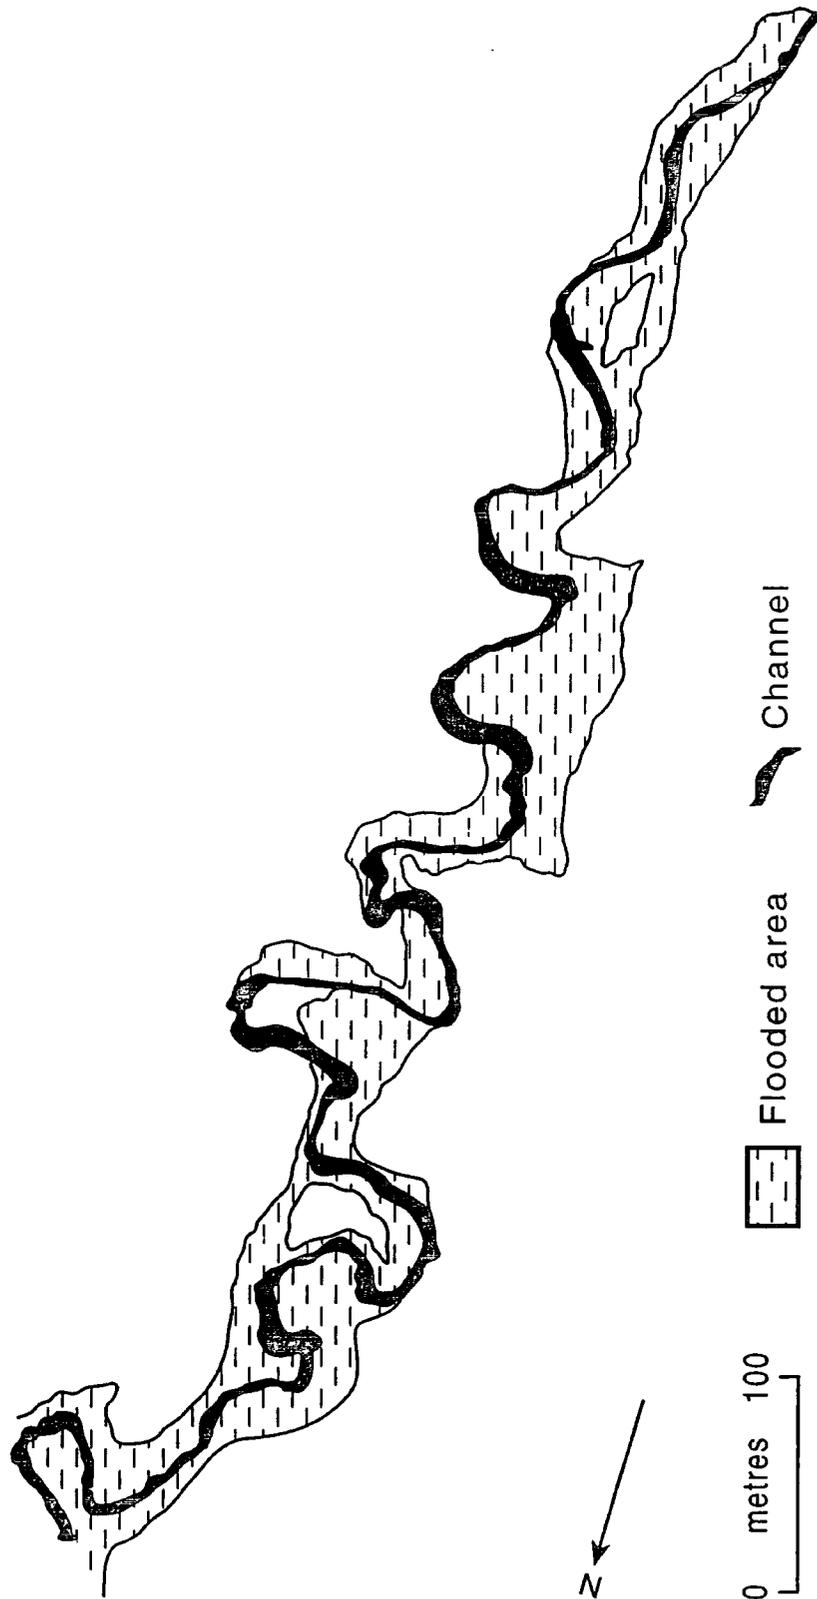
Figure 6.2 Map of extent of a flood of 19th and 20th February, 1997 at Swinhope Burn

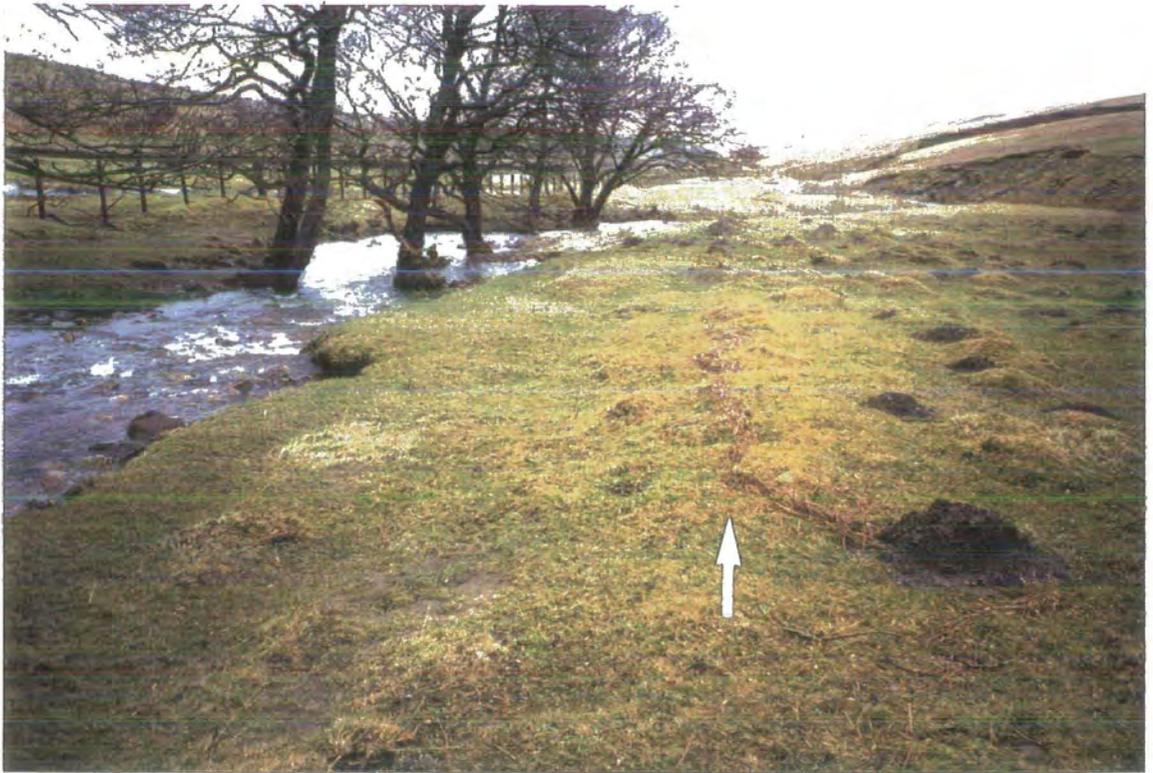
Figure 6.3 Trashlines in the uppermost reaches of Swinhope Burn showing the extent of the flood of February 19th and 20th February, 1997

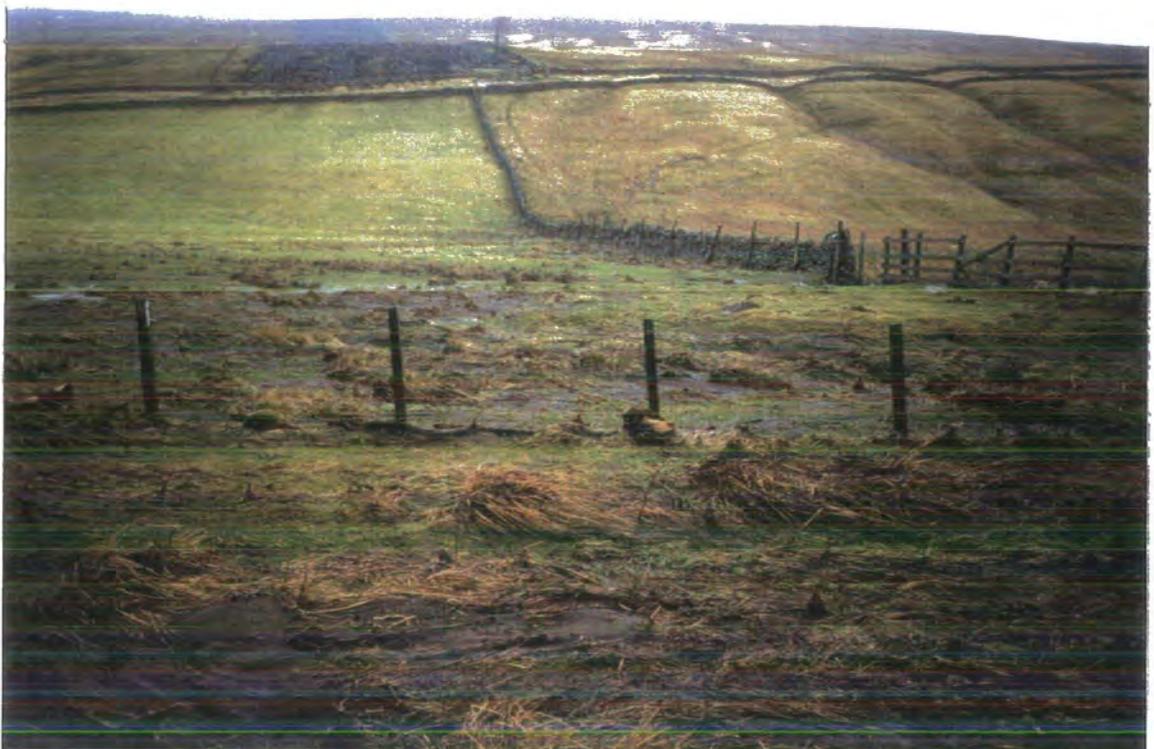
Figure 6.4 Overbank fines, flattened vegetation and standing water, providing evidence of flood limits in Swinhope Burn.

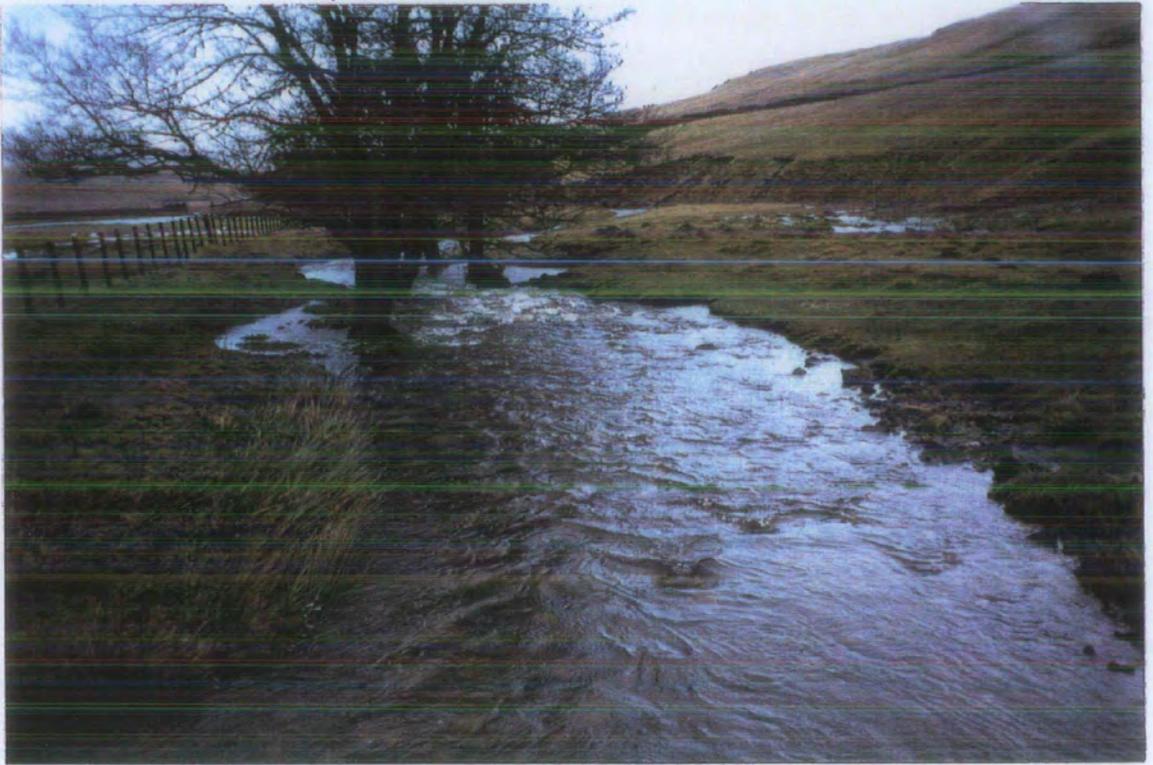
Figure 6.5 Flow remaining at bankfull level in upper reaches, 21st February, 1997

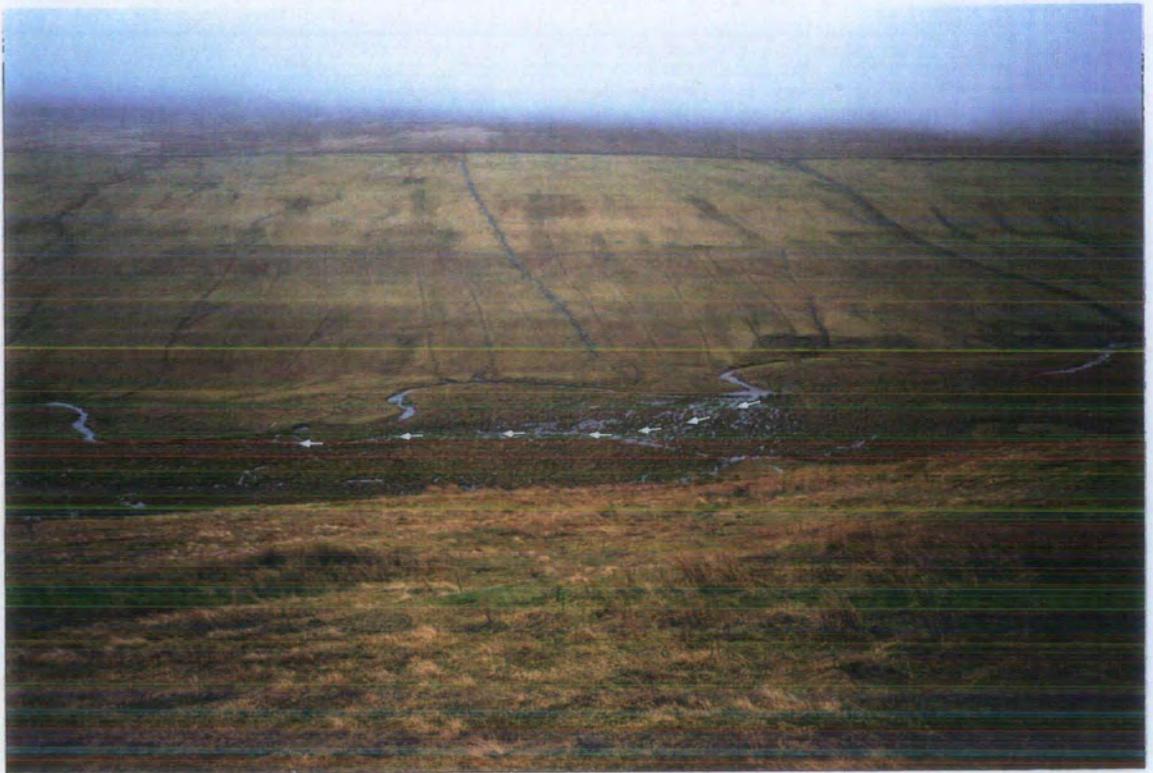
Figure 6.6 Palaeochannels in middle reaches of Swinhope Burn utilised by flood flows, 22nd February, 1997

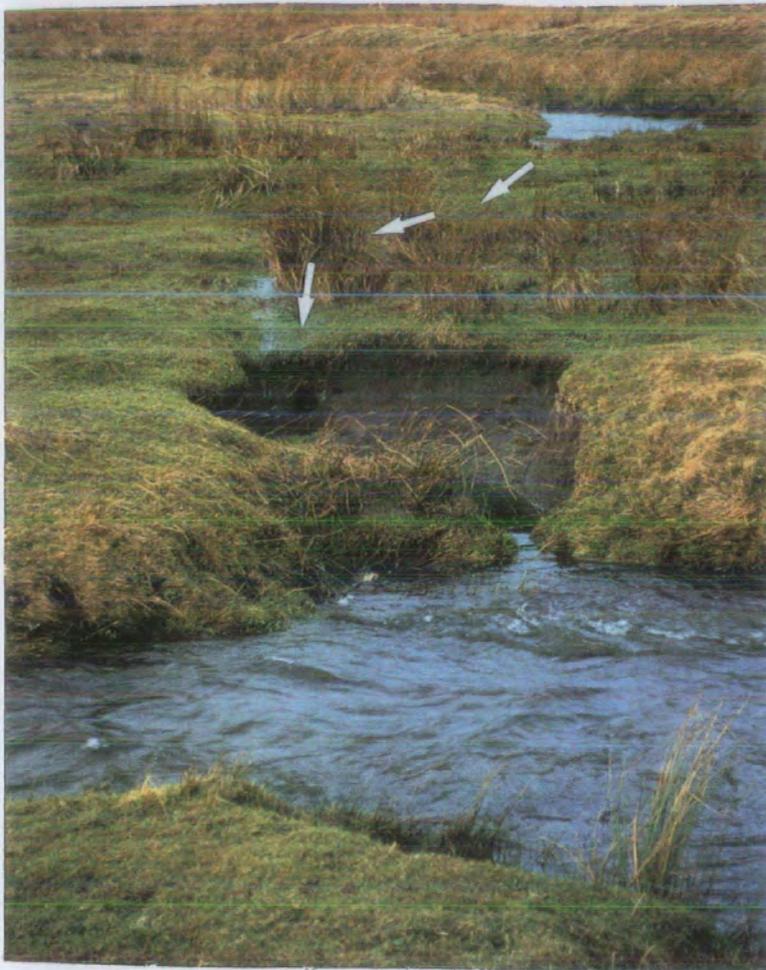
Figure 6.7 Site of potential meander bend cut-off (sections 92-98)

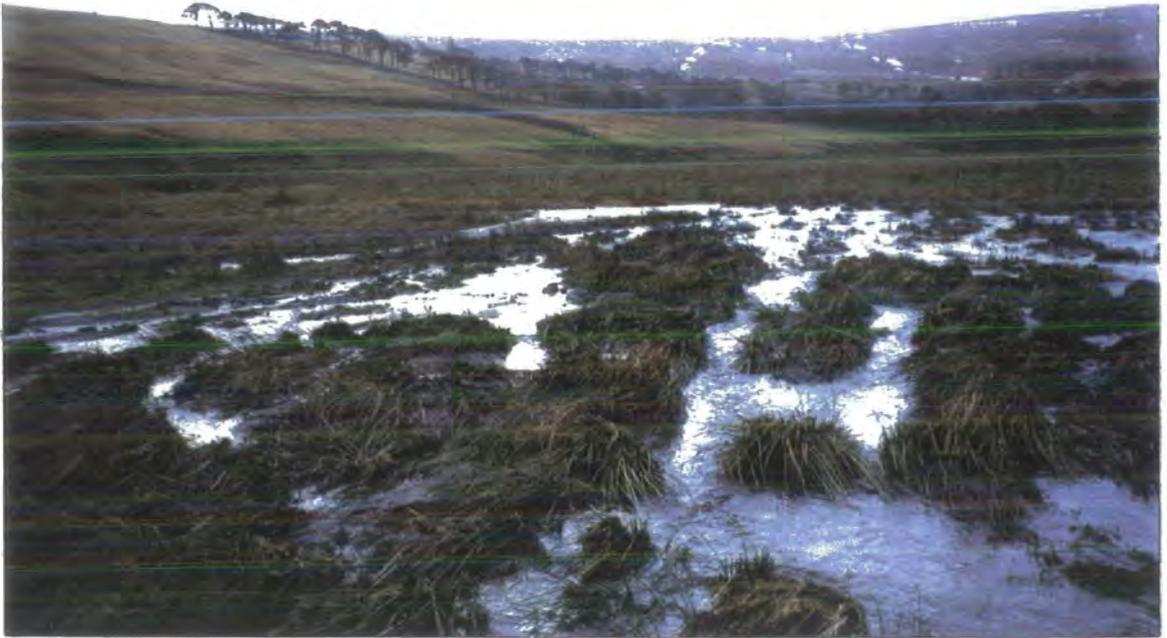
Figure 6.9 Overbank deposition of fines in the upper reach of Swinhope Burn, 22nd February, 1997.

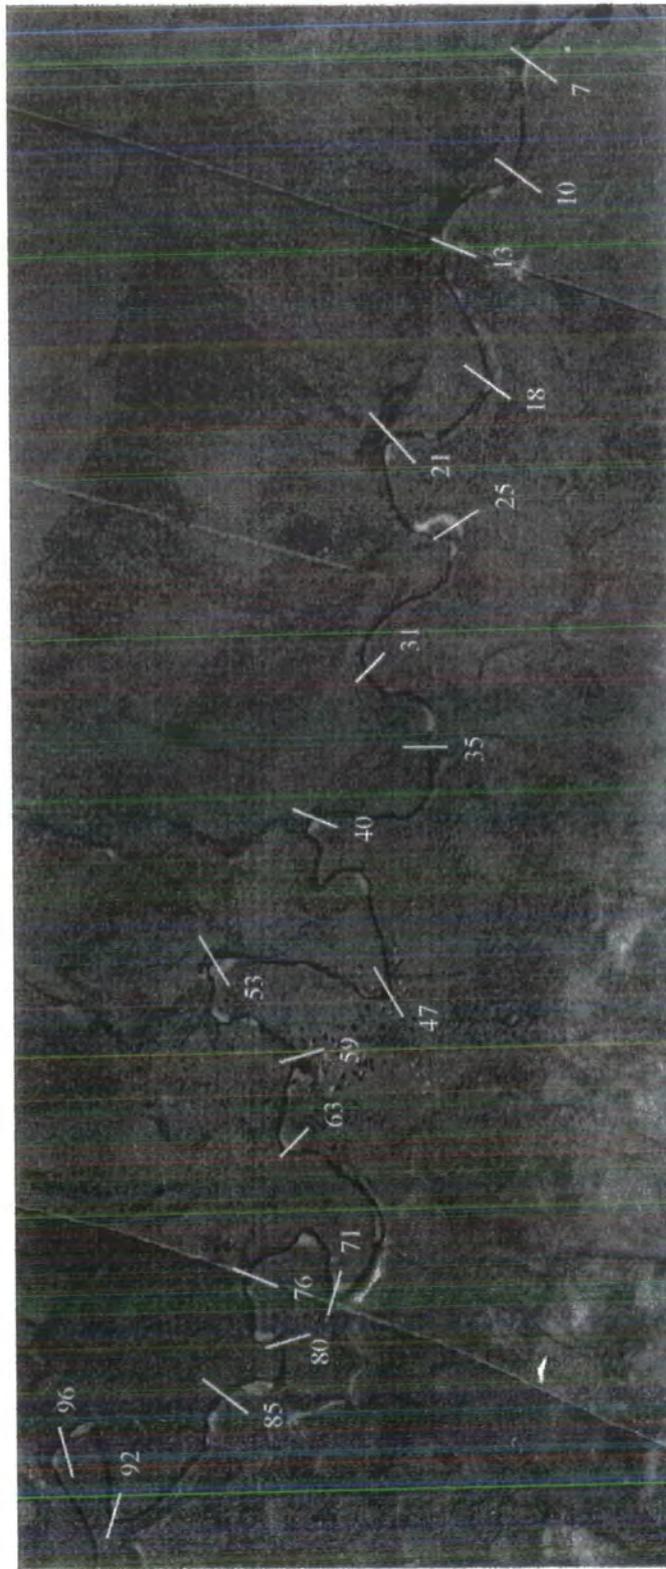
Figure 6.10 Location map showing the distribution of selected cross-sections along the study reach of Swinhope Burn (Air photograph courtesy of Aerofilms and Durham County Council)

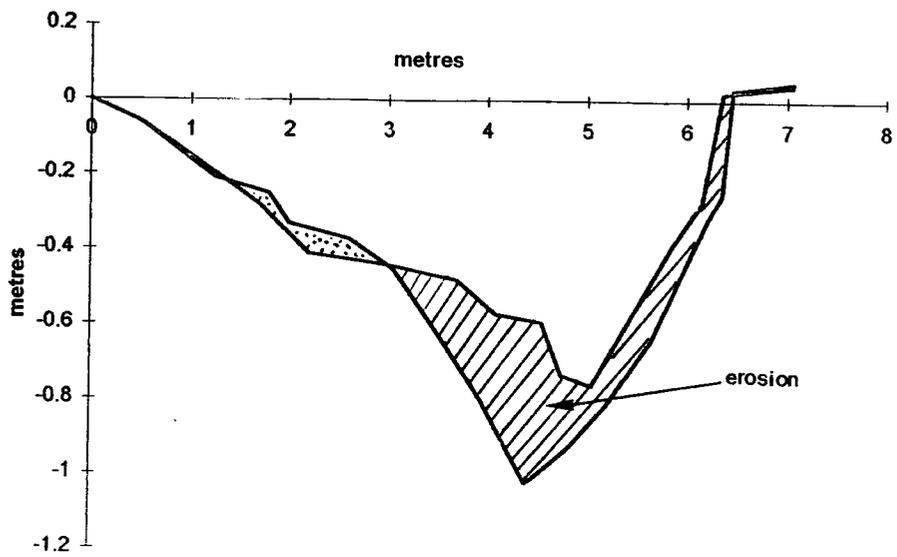
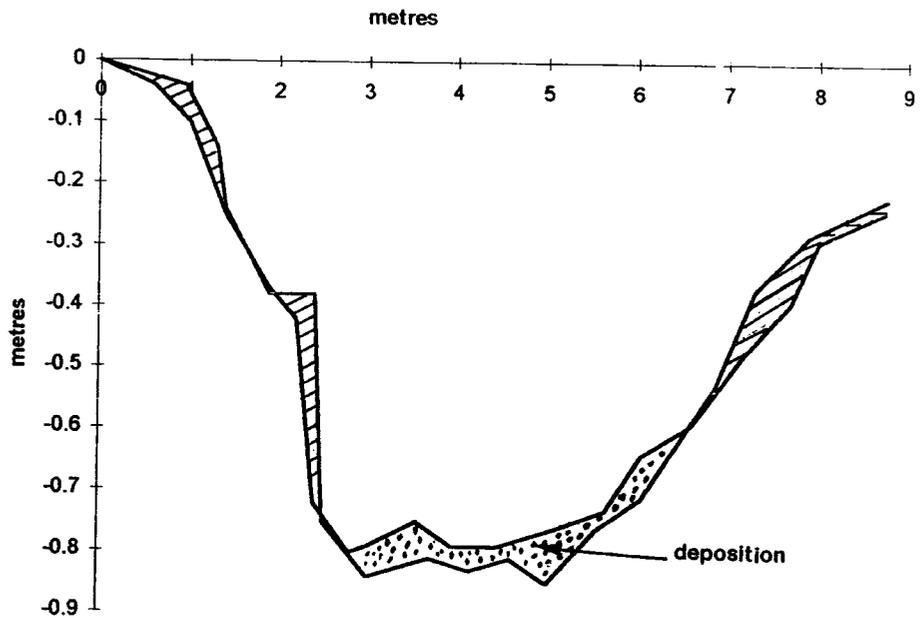
Figure 6.13 Cross-sectional changes at Swinhope Burn, showing channel erosion and deposition (top, section 18, bottom, section 24)

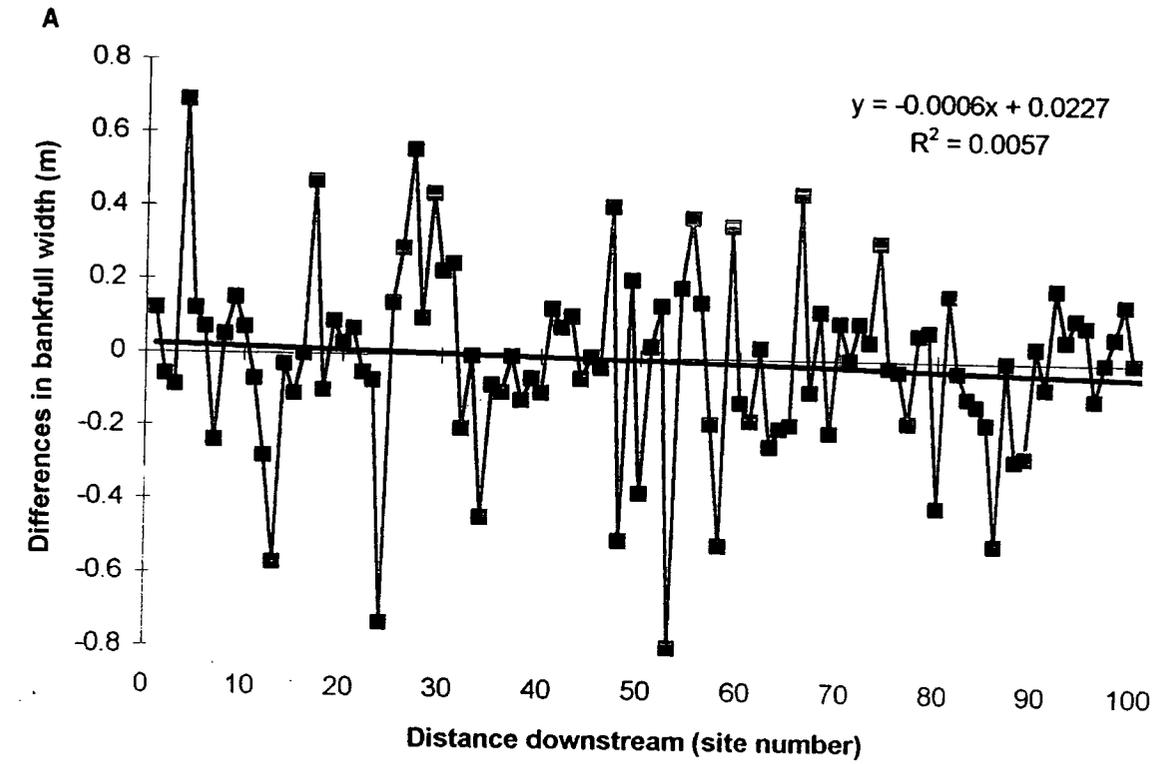
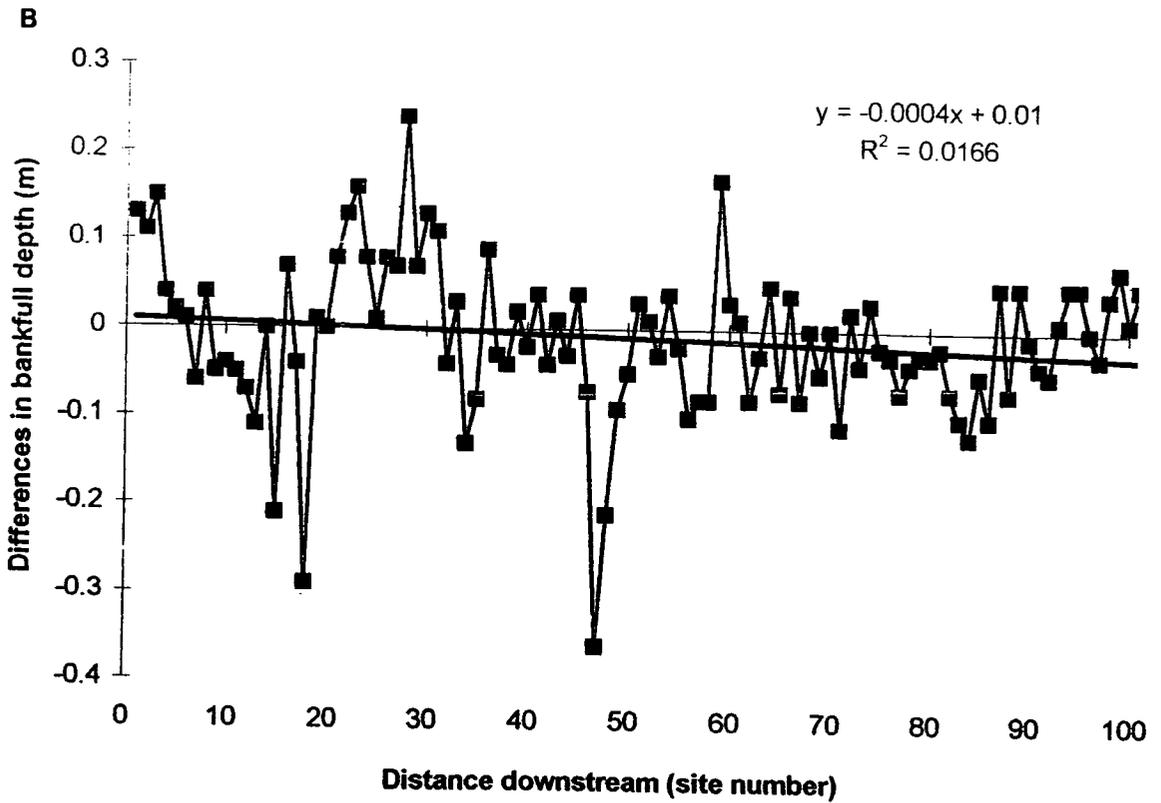
Figure 6.14 Differences in bankfull width (a) and depth (b) between pre-flood and post-flood channel.
