Contemporary and historic river channel change at Swinhope bum, Weardale: a study of river response to flood events in an upland, gravel-bed stream

Danks, Melanie (1998) Contemporary and historic river channel change at Swinhope bum, Weardale: a study of river response to flood events in an upland, gravel-bed stream. Masters thesis, Durham University.

MSc Thesis, 1998

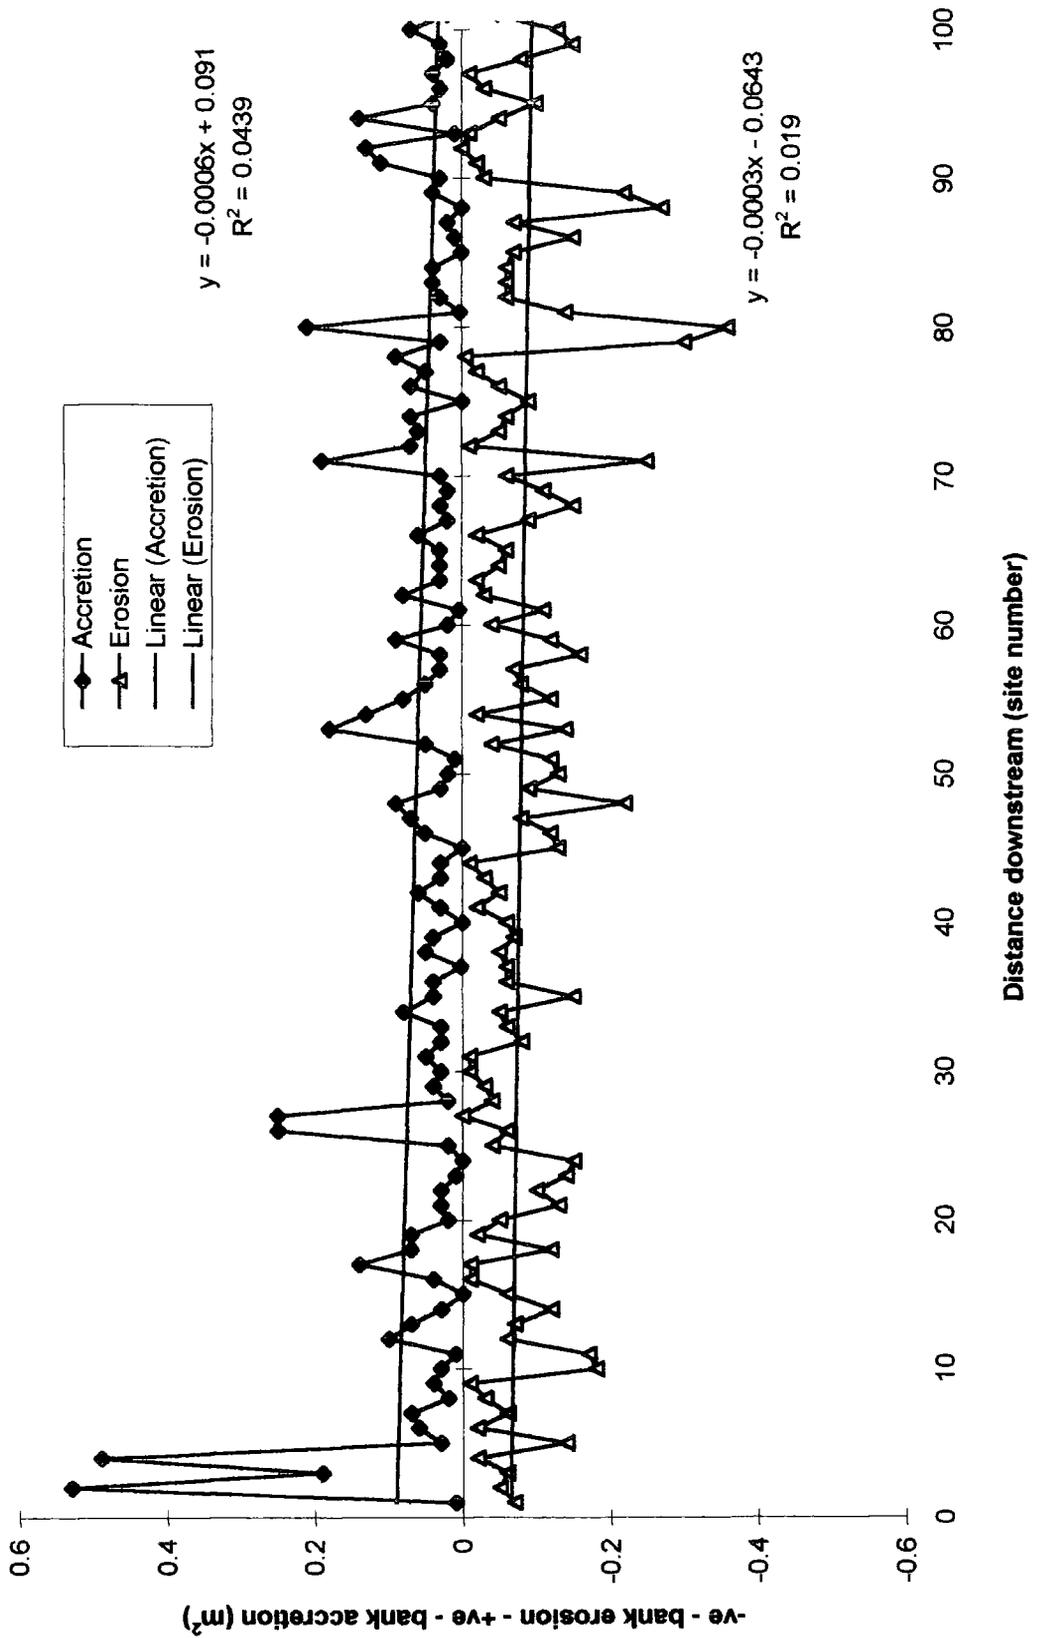
Figure 6.15 Downstream changes in total area bank erosion and bank accretion

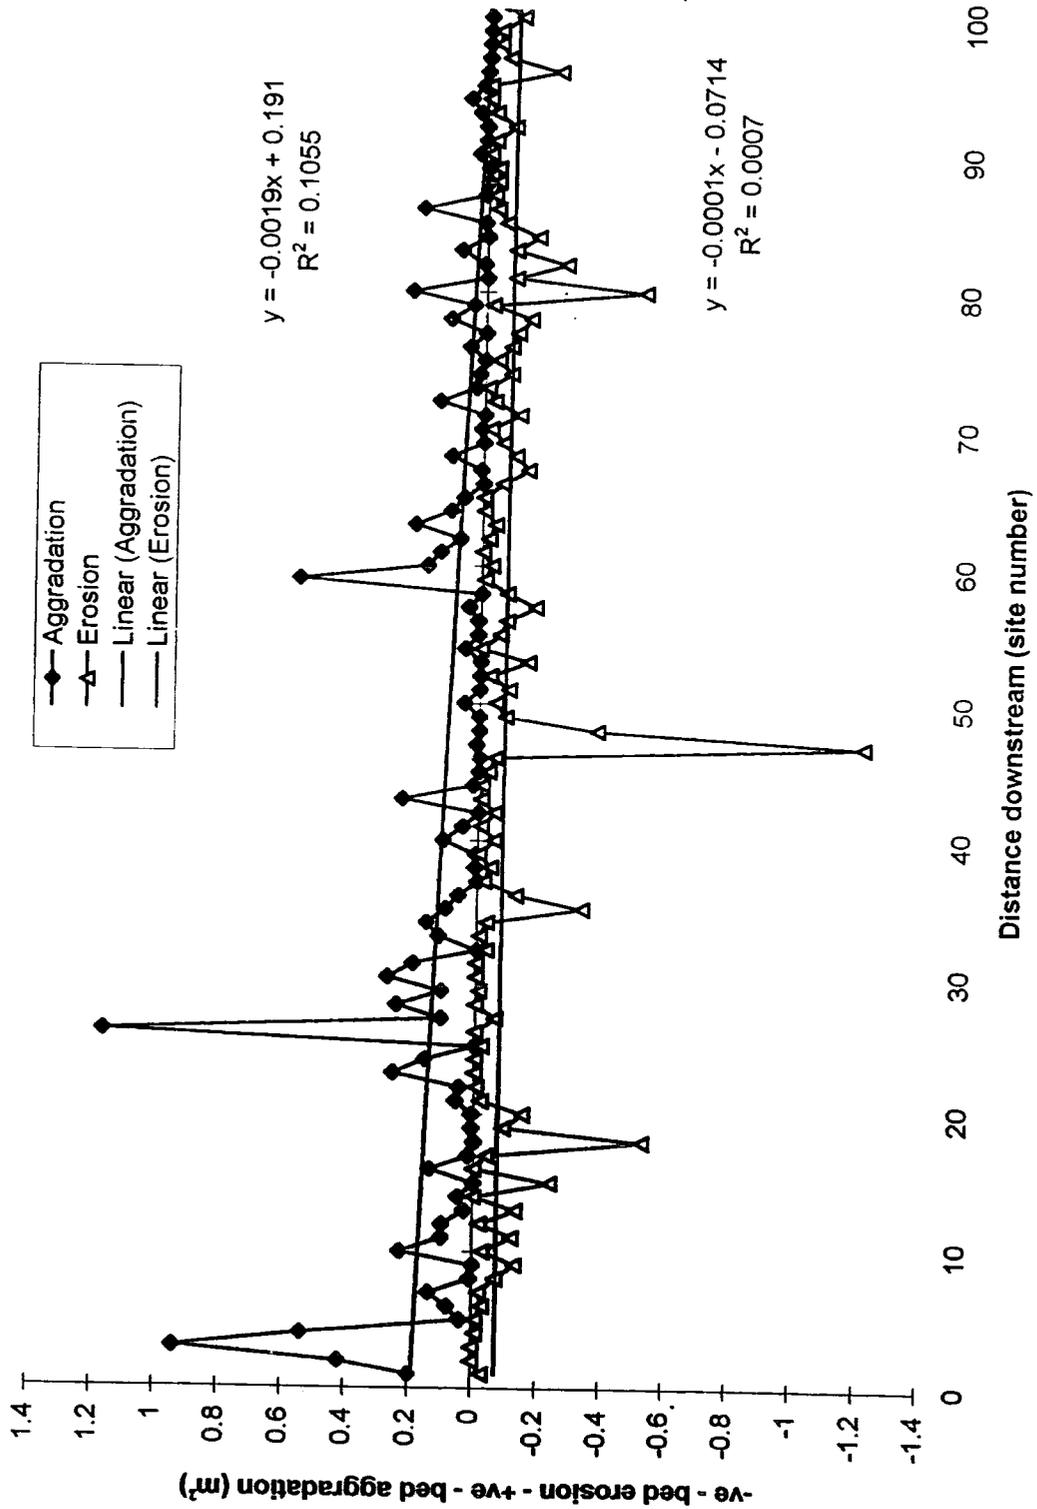
Figure 6.16 Downstream changes in total area bed erosion and bed aggradation

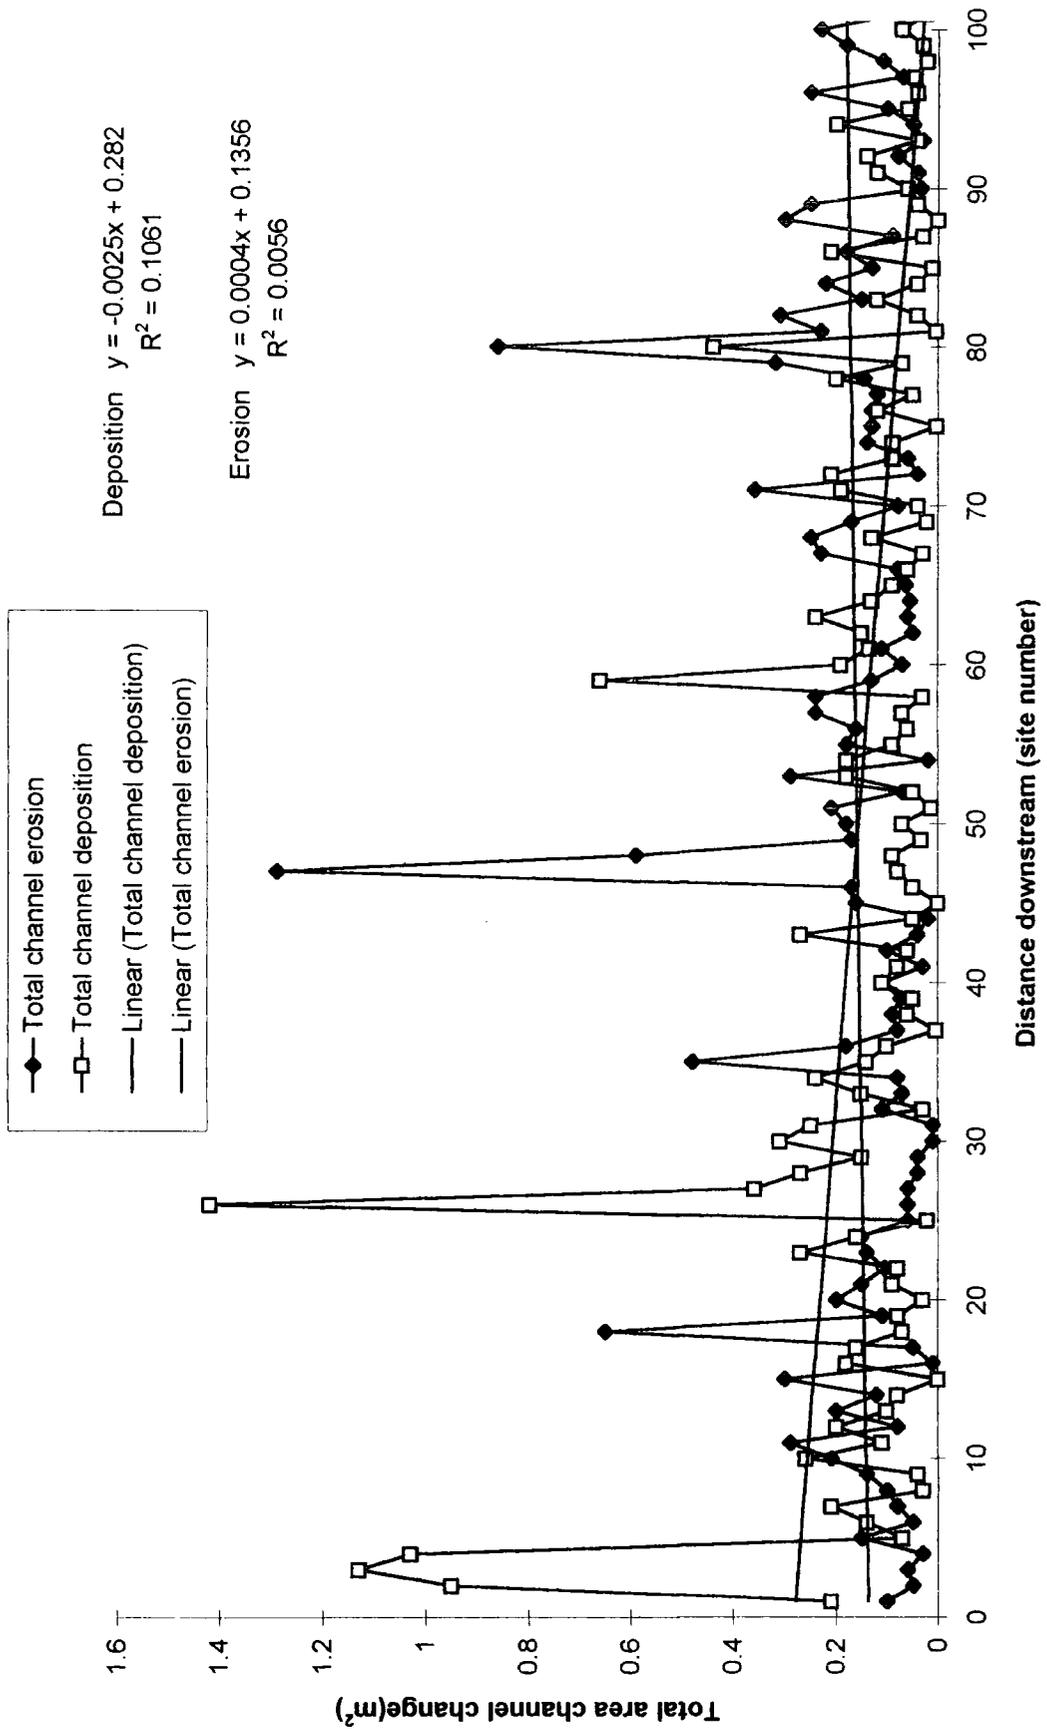
Figure 6.17 Downstream variations in total area channel erosion and deposition

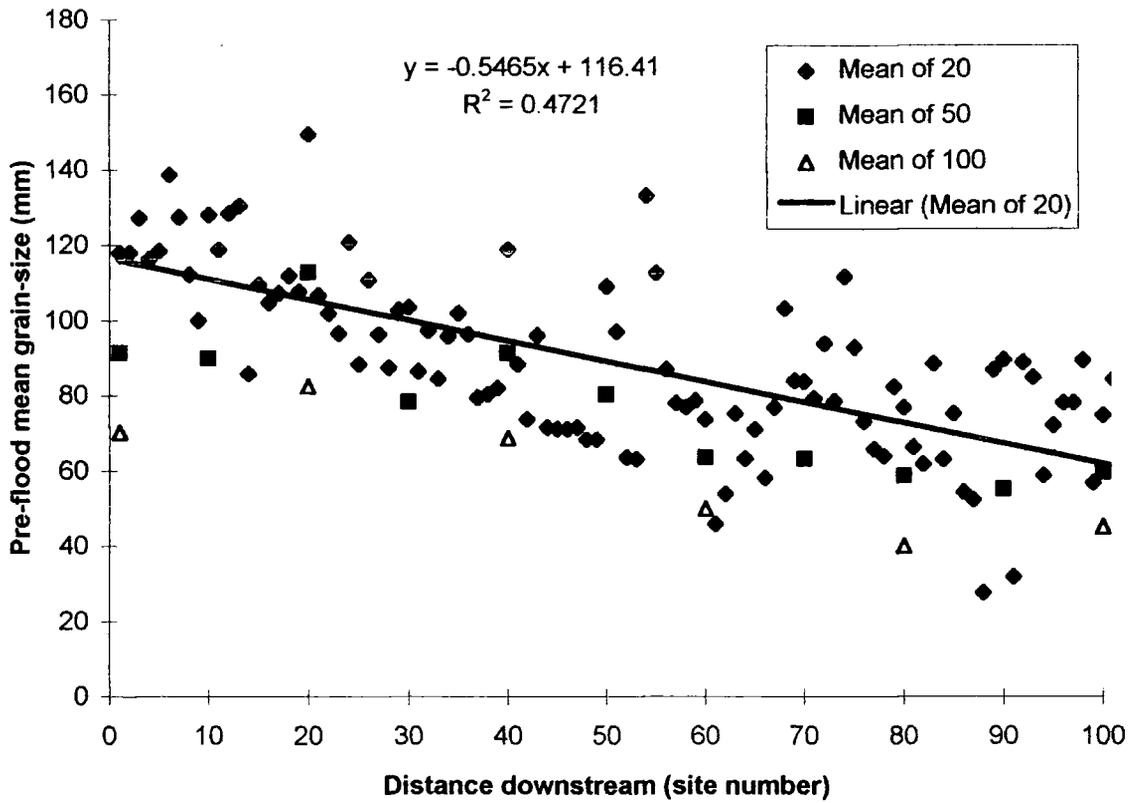
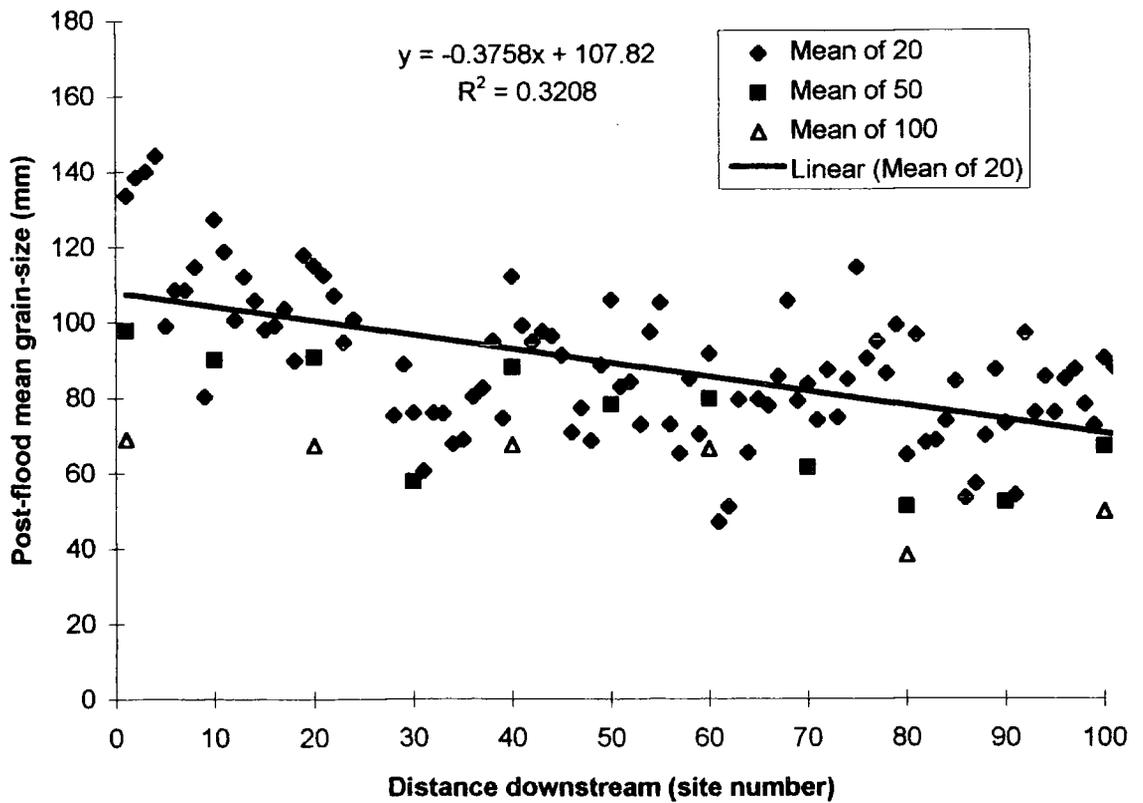
Figure 6.18 Mean grain-size of the 20 largest surface particles, measured at the 101 cross-sections, before and after the February, 1997 flood

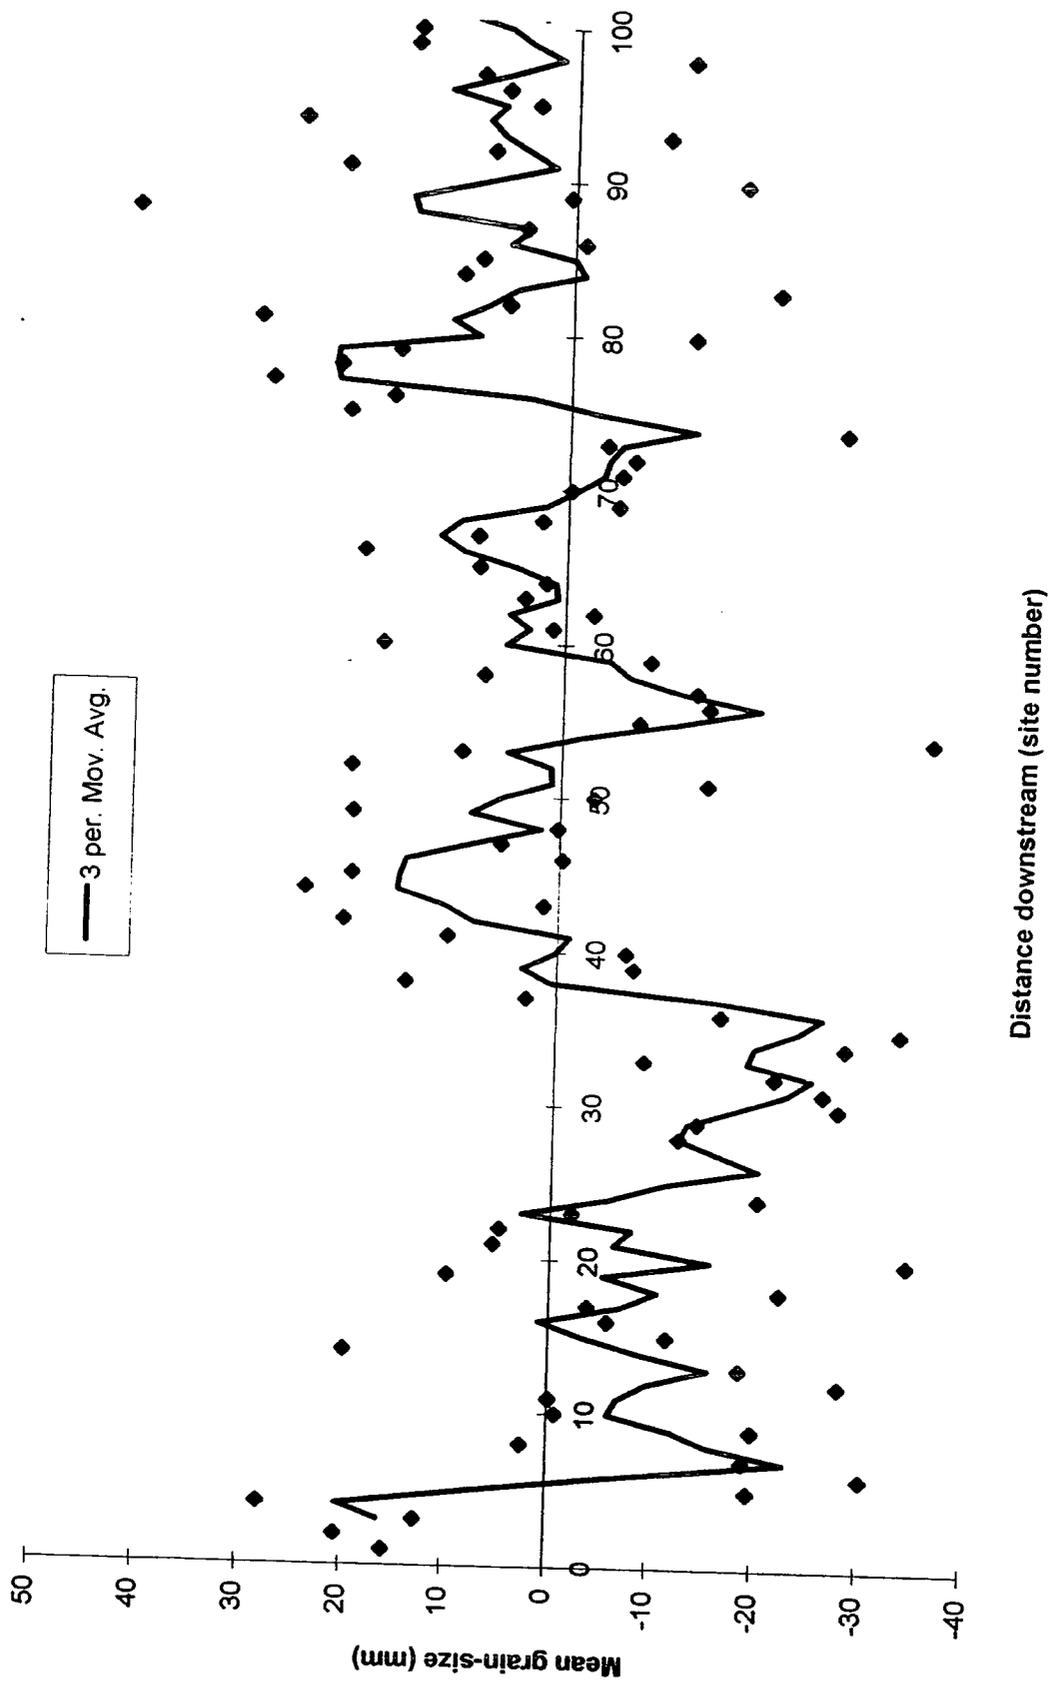
Figure 6.19 Post-flood mean grain-size minus pre-flood mean grain-size

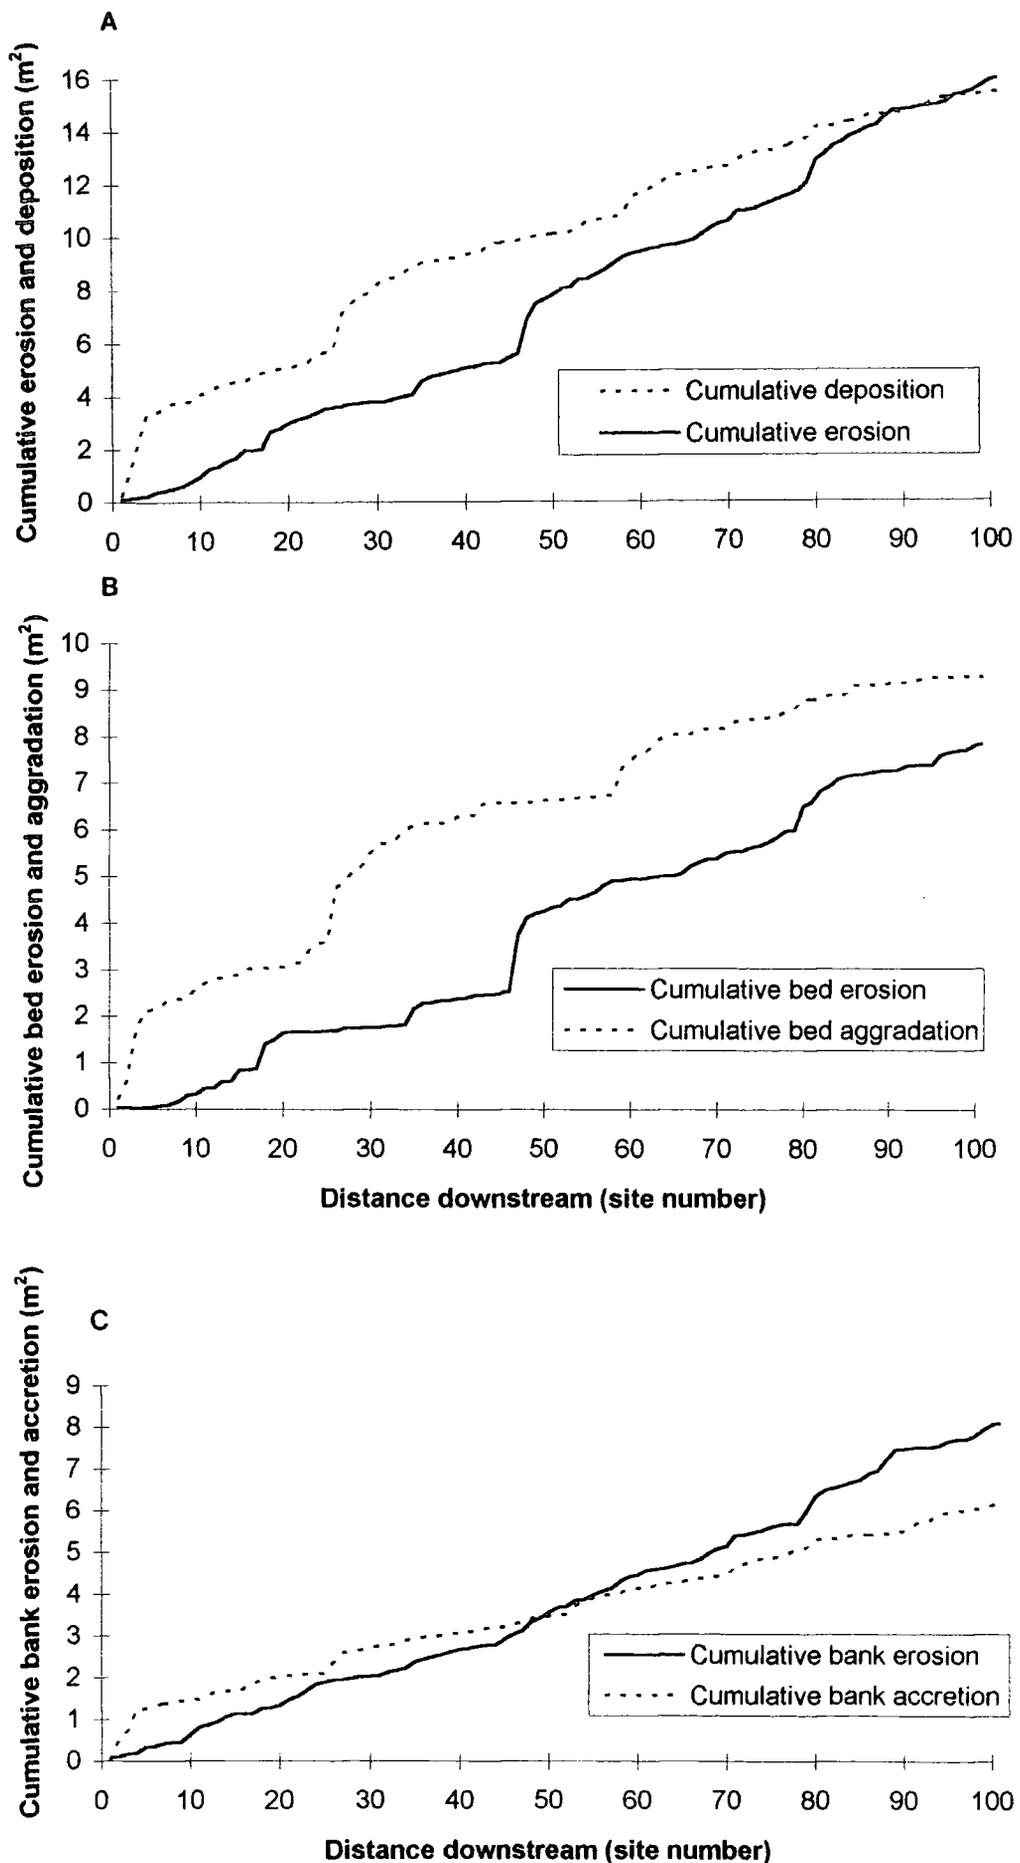
Figure 6.20 Cumulative channel erosion and deposition along the study reach

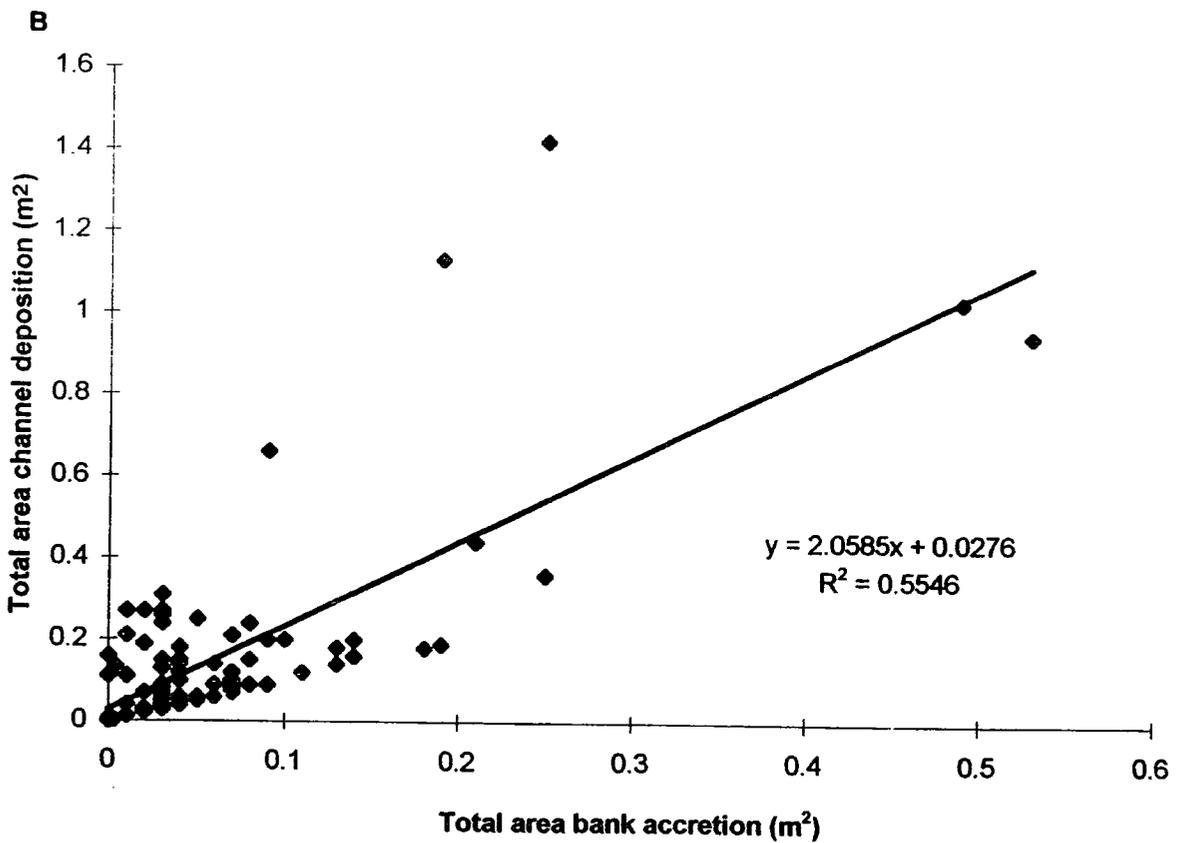
Figure 6.22 Total area of bed (a) and bank (b) deposition in relation to total channel deposition

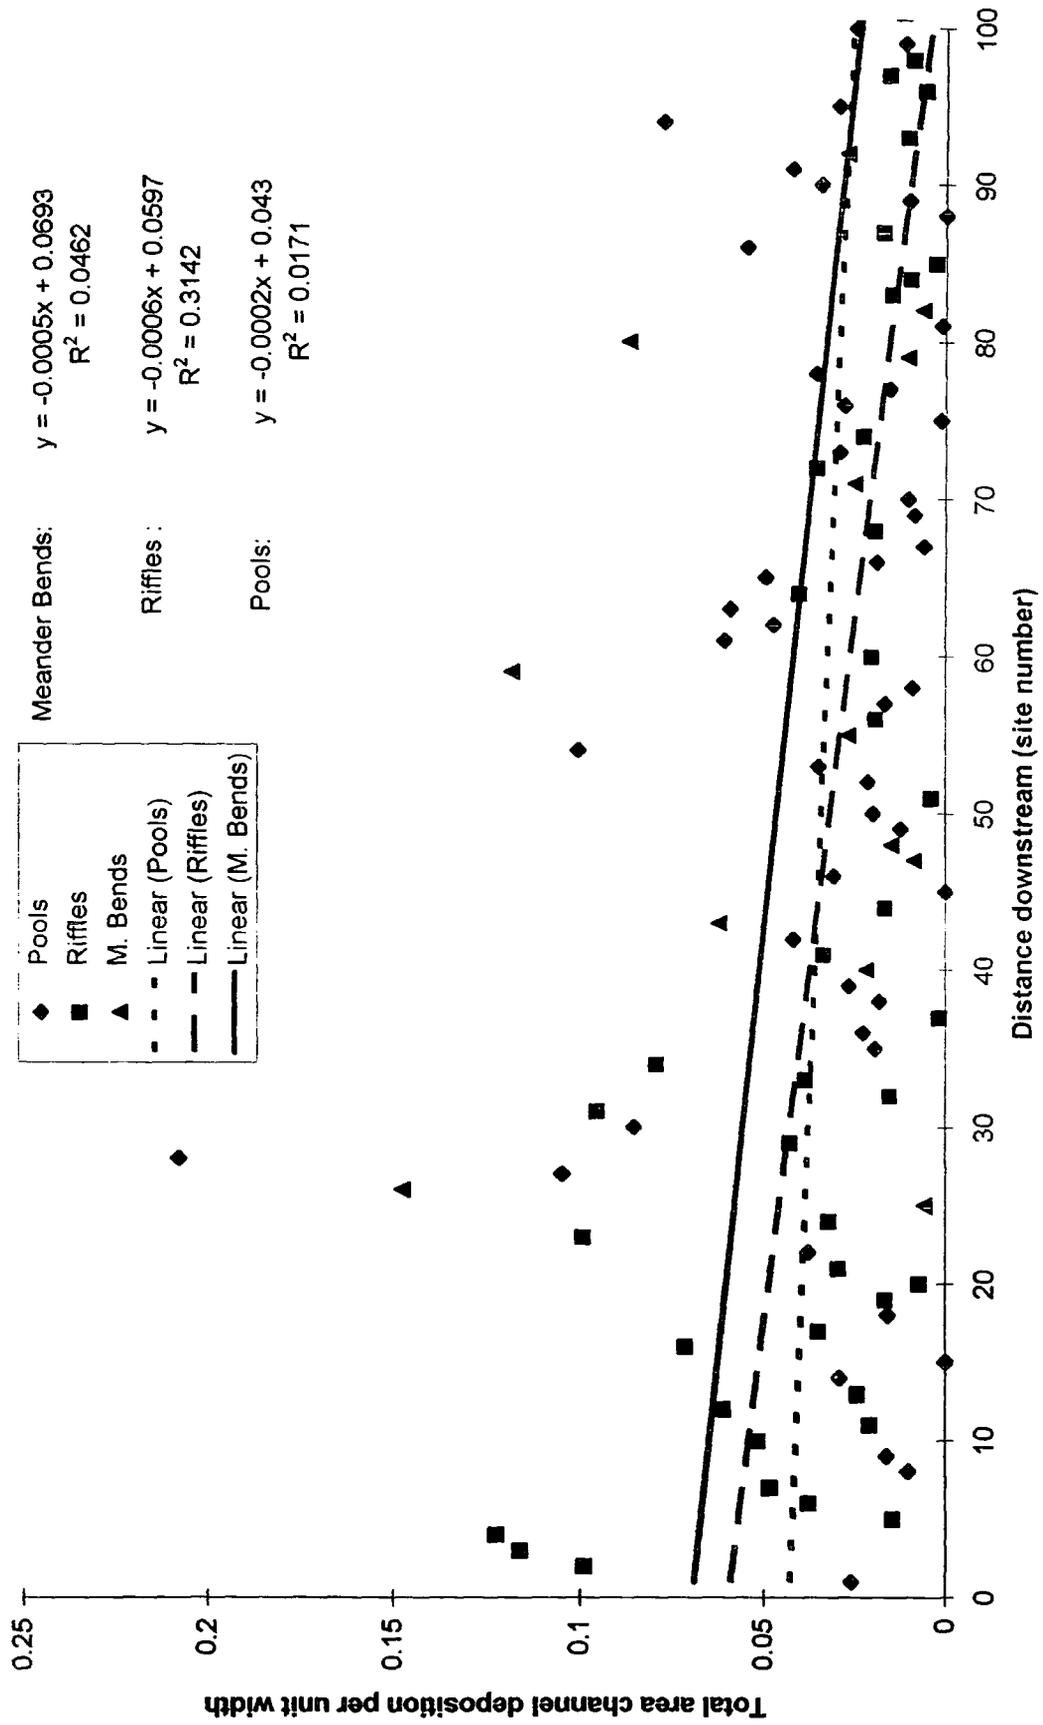
Figure 6.24 Downstream changes in total area of channel deposition/unit width in relation to the pool-riffle, bend sequence

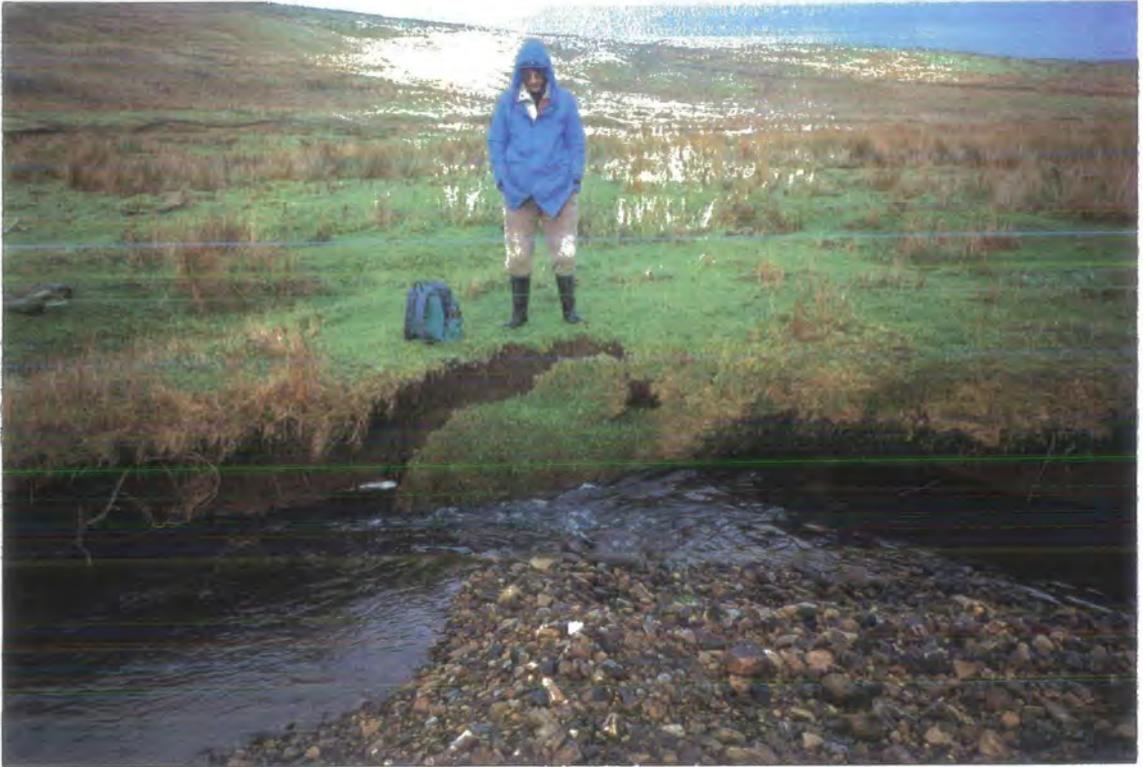
Figure 6.26 Example of flow being directed away from a bar surface towards the opposite bank causing bank undercutting and failure

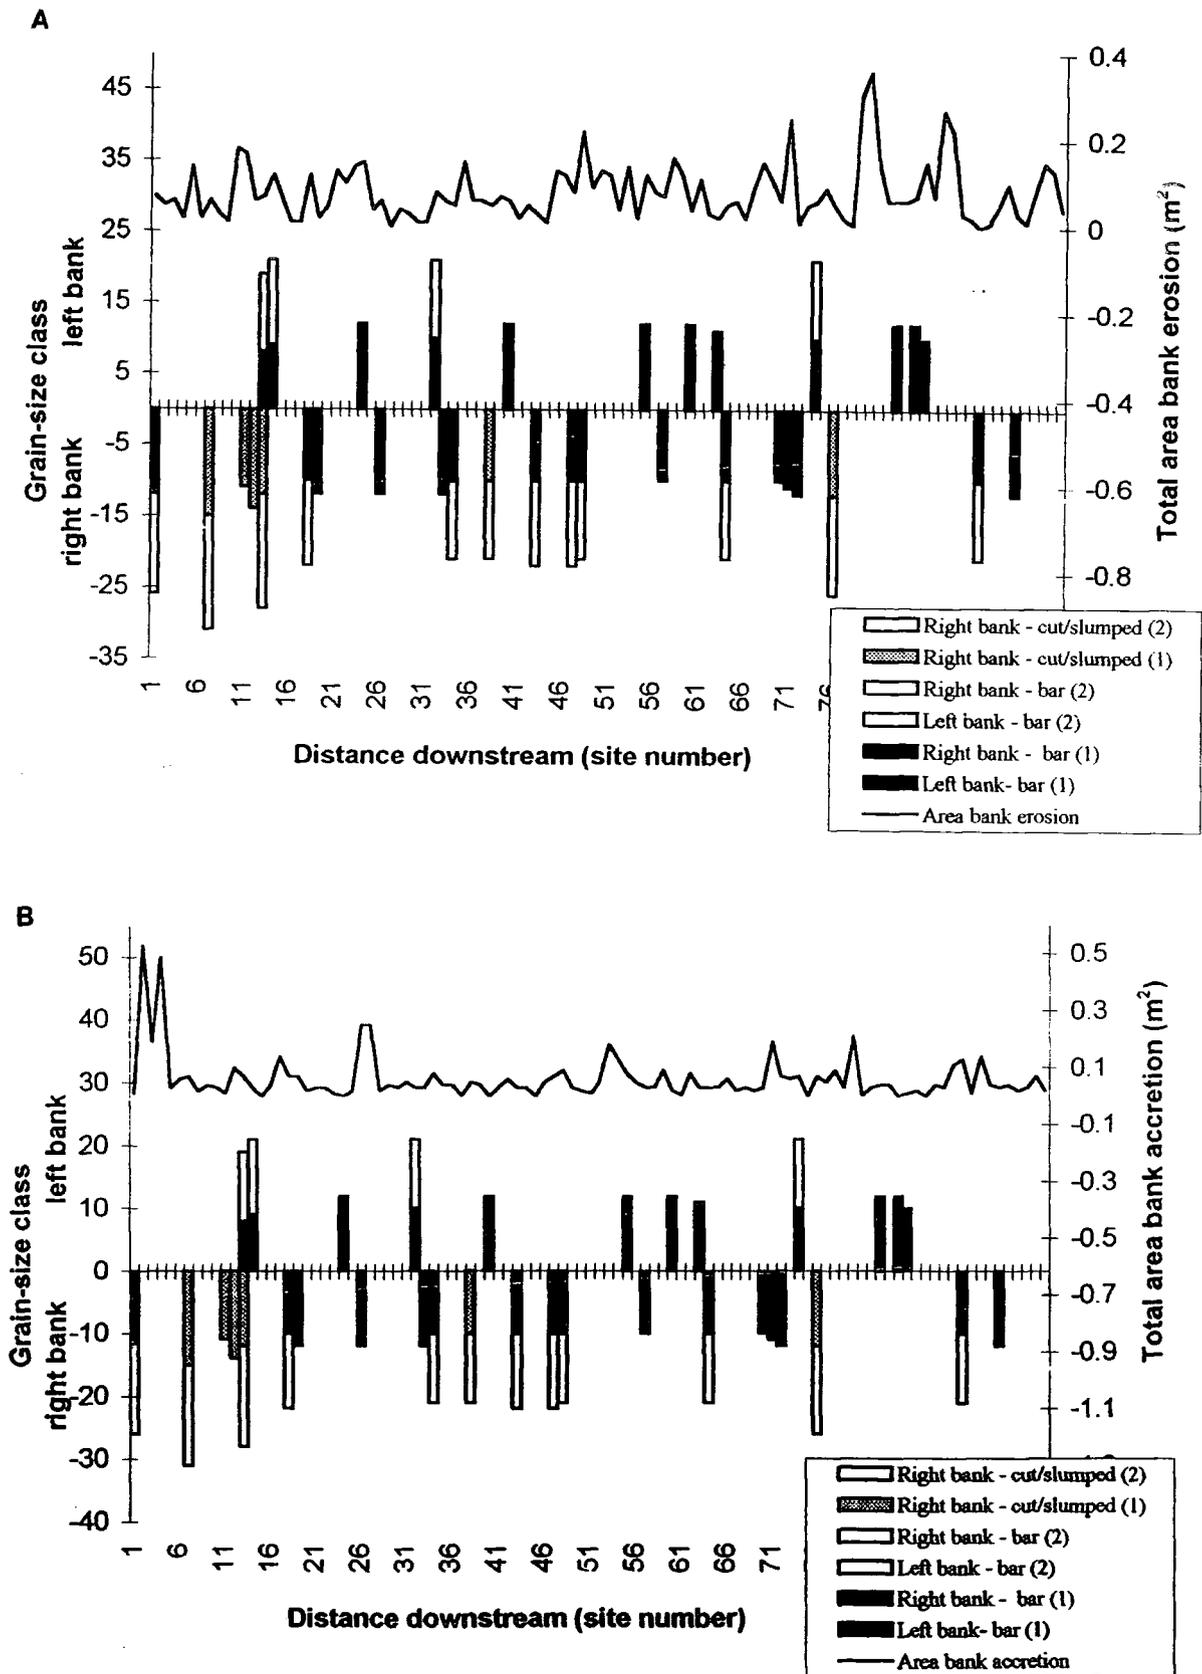
Figure 6.27 Downstream changes in bank erosion and bank accretion in relation to the presence of bars and cut-banks

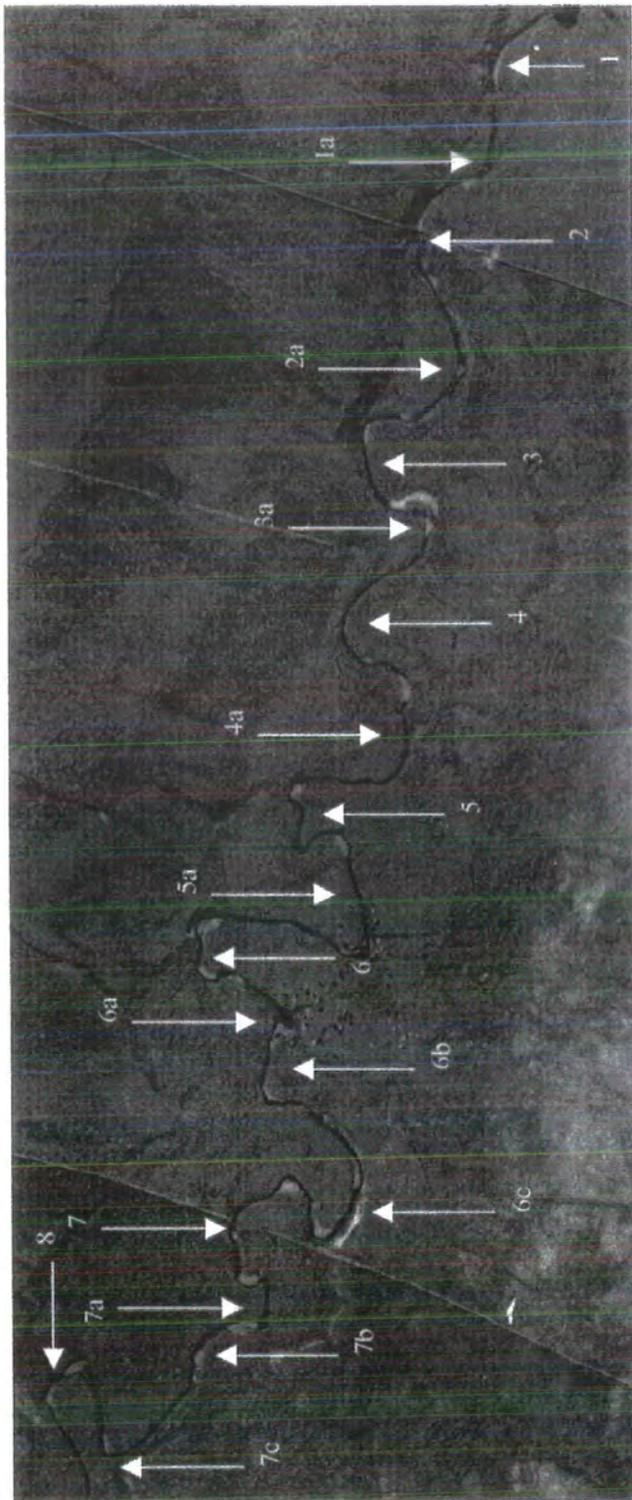
Figure 6.29 Location map of bends along the study reach of Swinhope Burn (Air photograph courtesy of Aerofilms and Durham County Council).

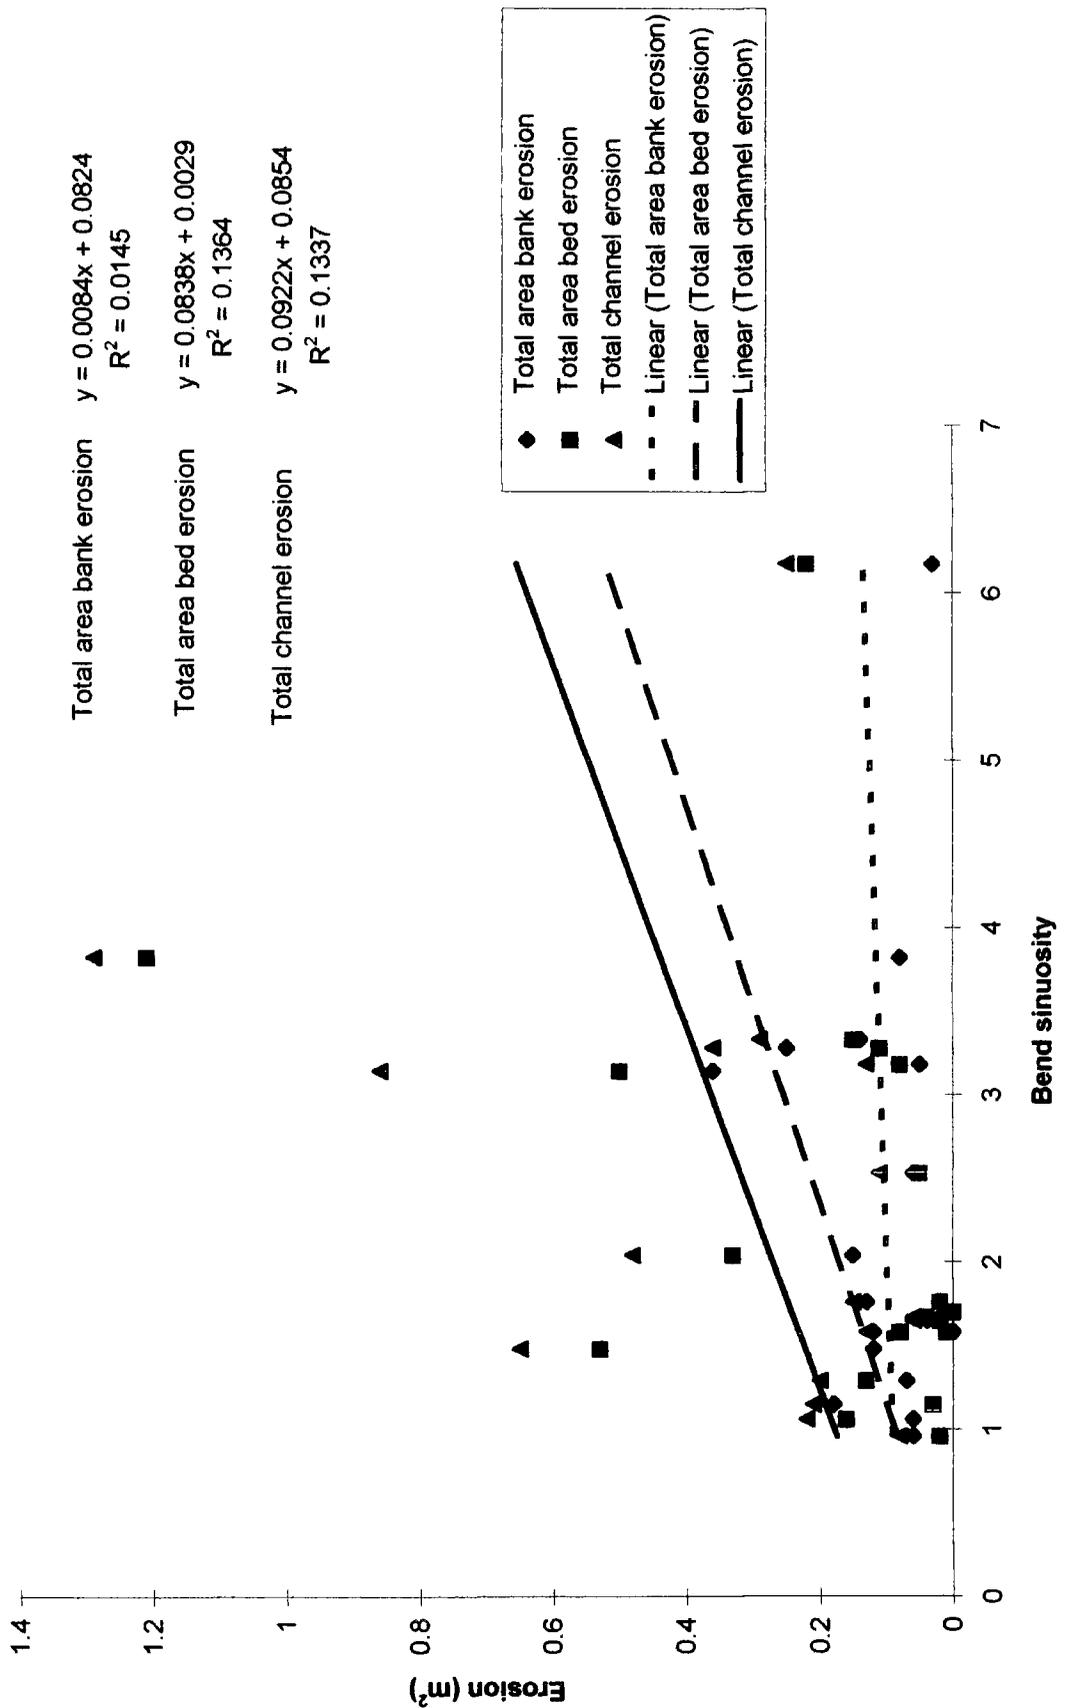
Figure 6.30 Relationship between bend sinuosity and channel erosion at the bend apex

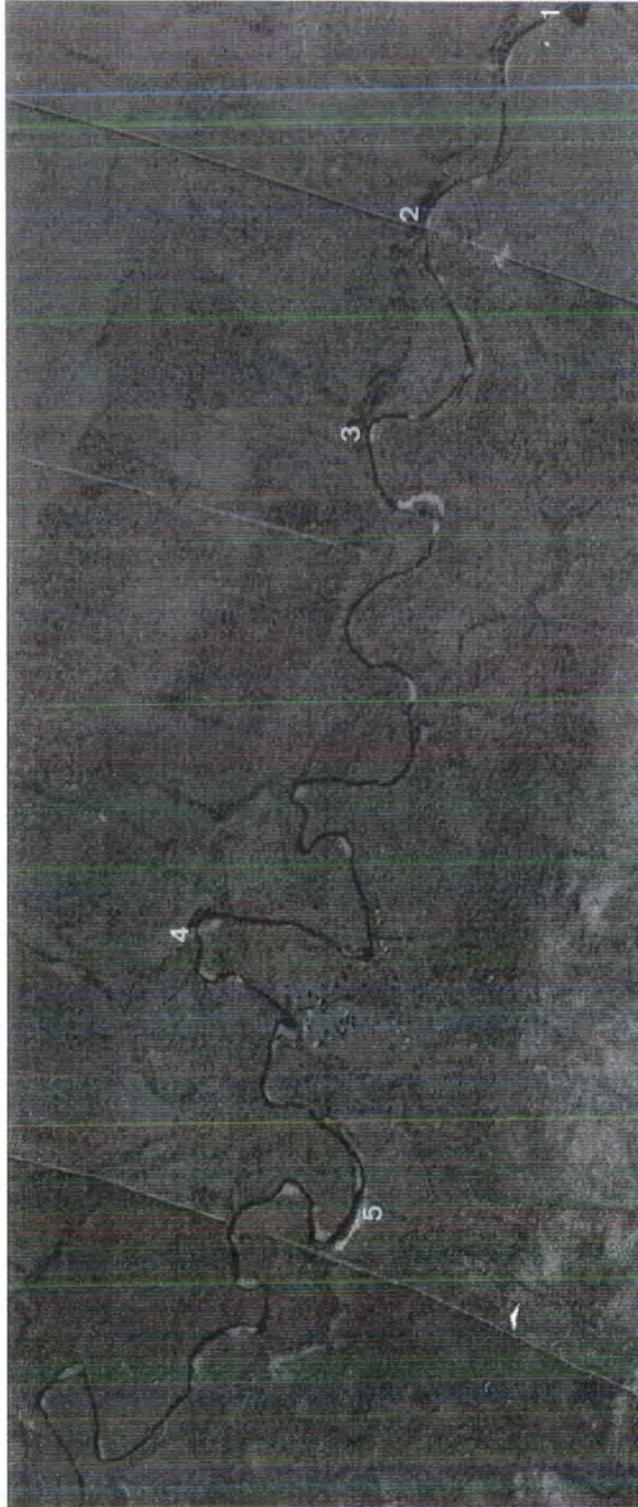
Figure 7.3 Channel planform of Swinhope Burn showing bluffs and tracer input sites

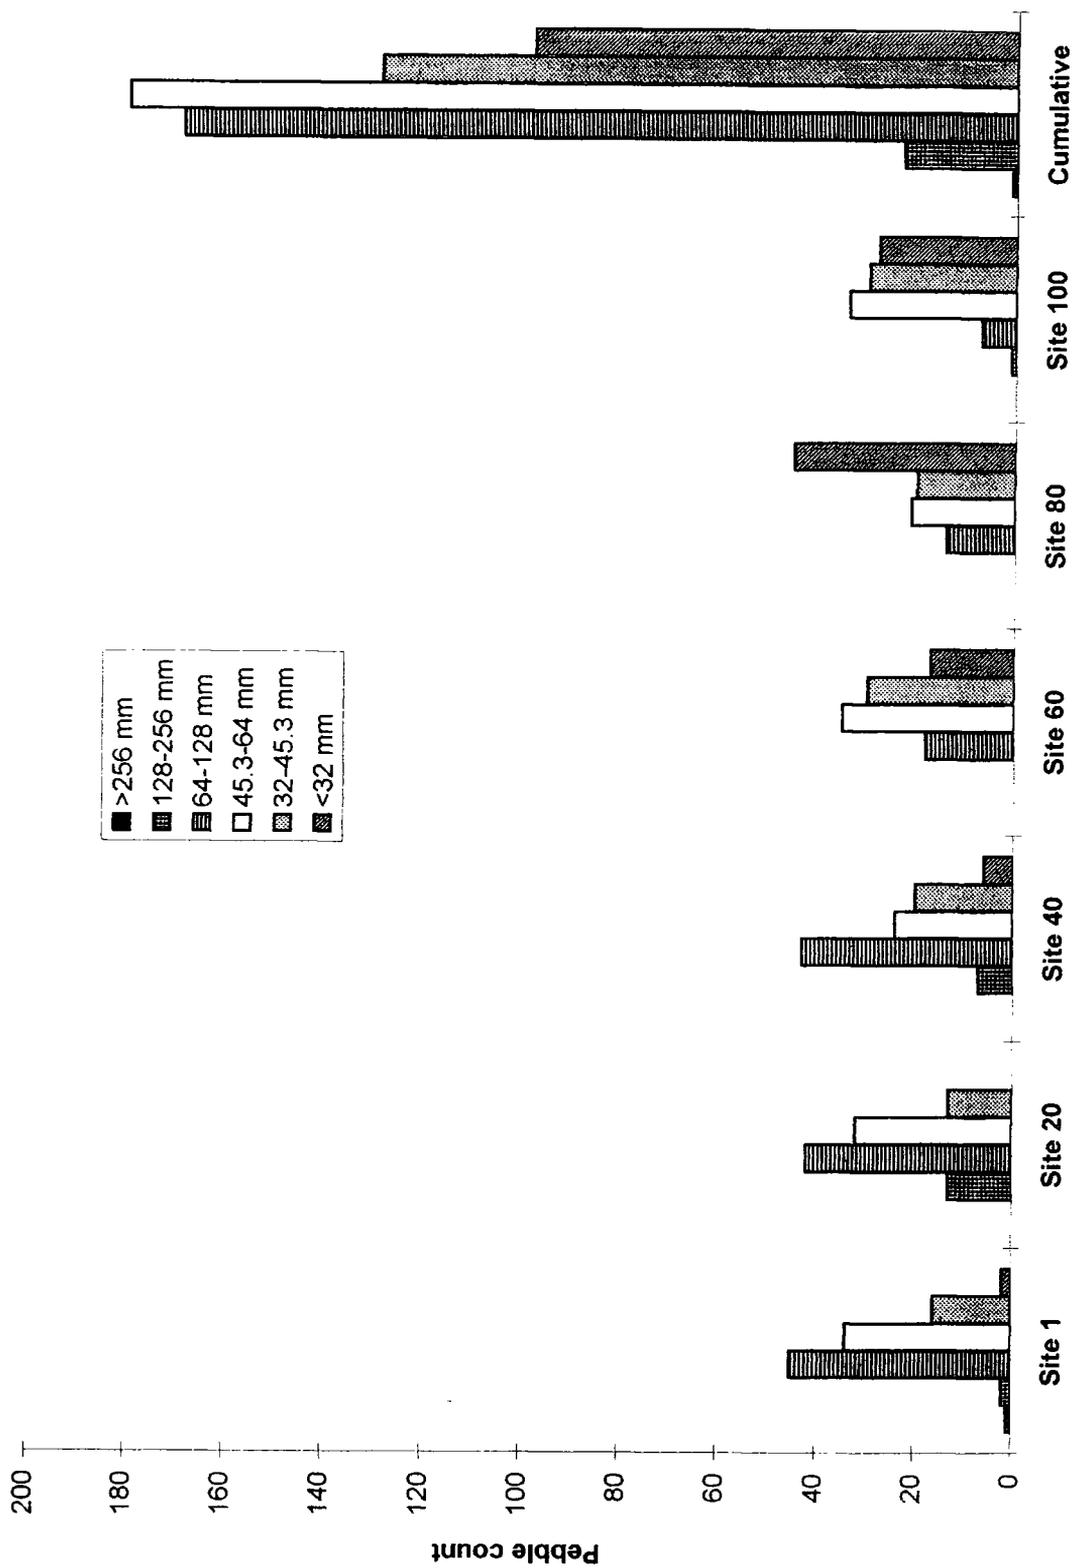
Figure 7.4 Histogram of main grain-size groups of bed material at Swinhope Burn
