Contemporary and historic river channel change at Swinhope bum, Weardale: a study of river response to flood events in an upland, gravel-bed stream

Danks, Melanie (1998) Contemporary and historic river channel change at Swinhope bum, Weardale: a study of river response to flood events in an upland, gravel-bed stream. Masters thesis, Durham University.

MSc Thesis, 1998

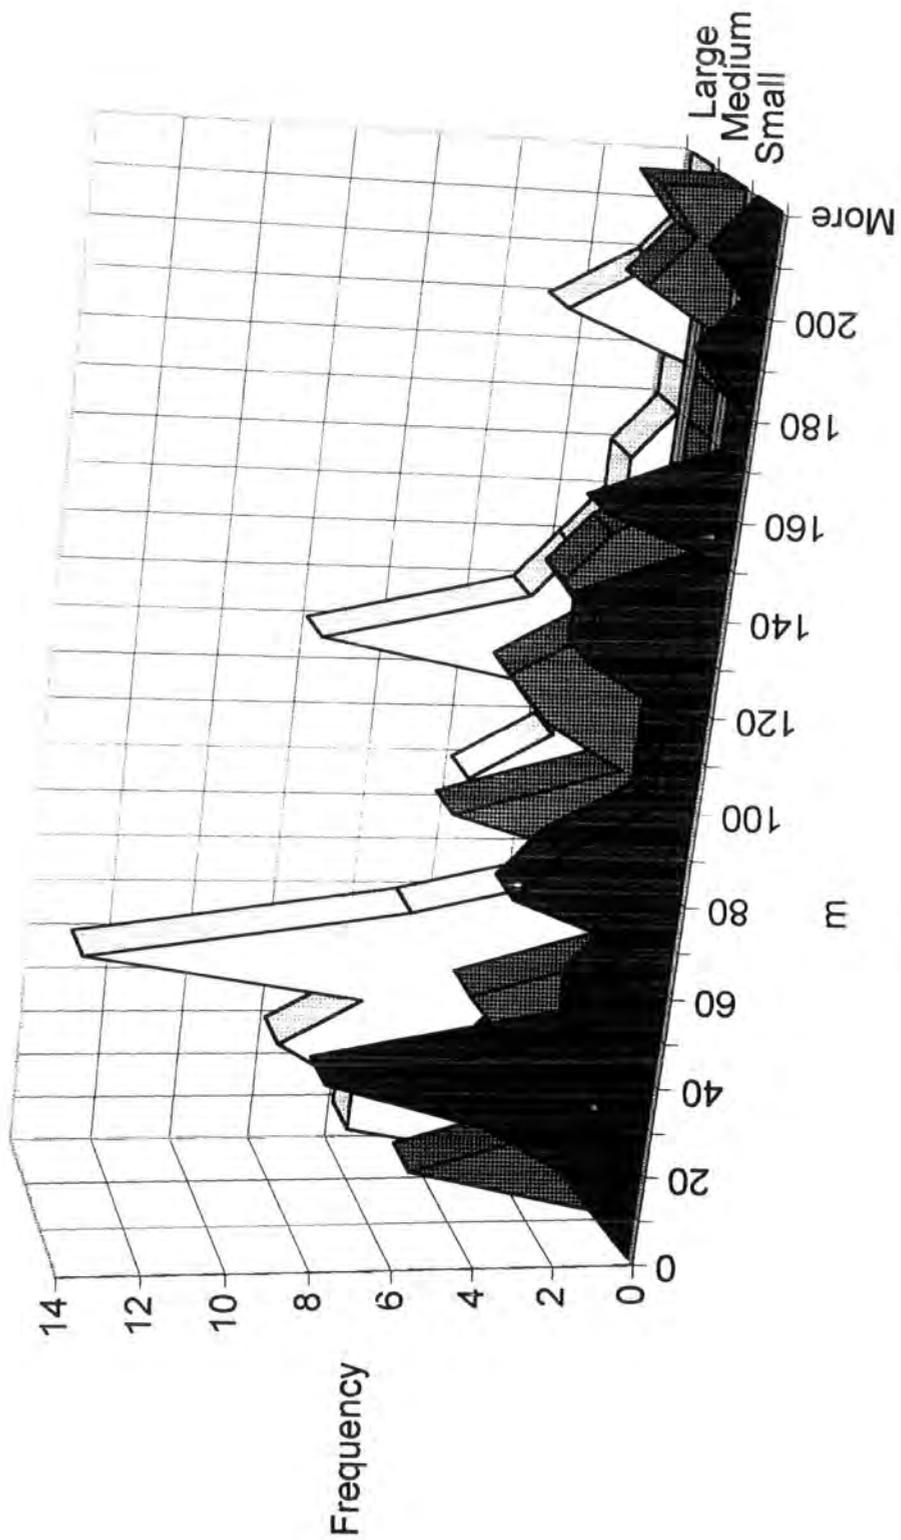
Figure 7.5 Dispersal of within-channel tracers in relation to pebble size following the January, 1998 flood

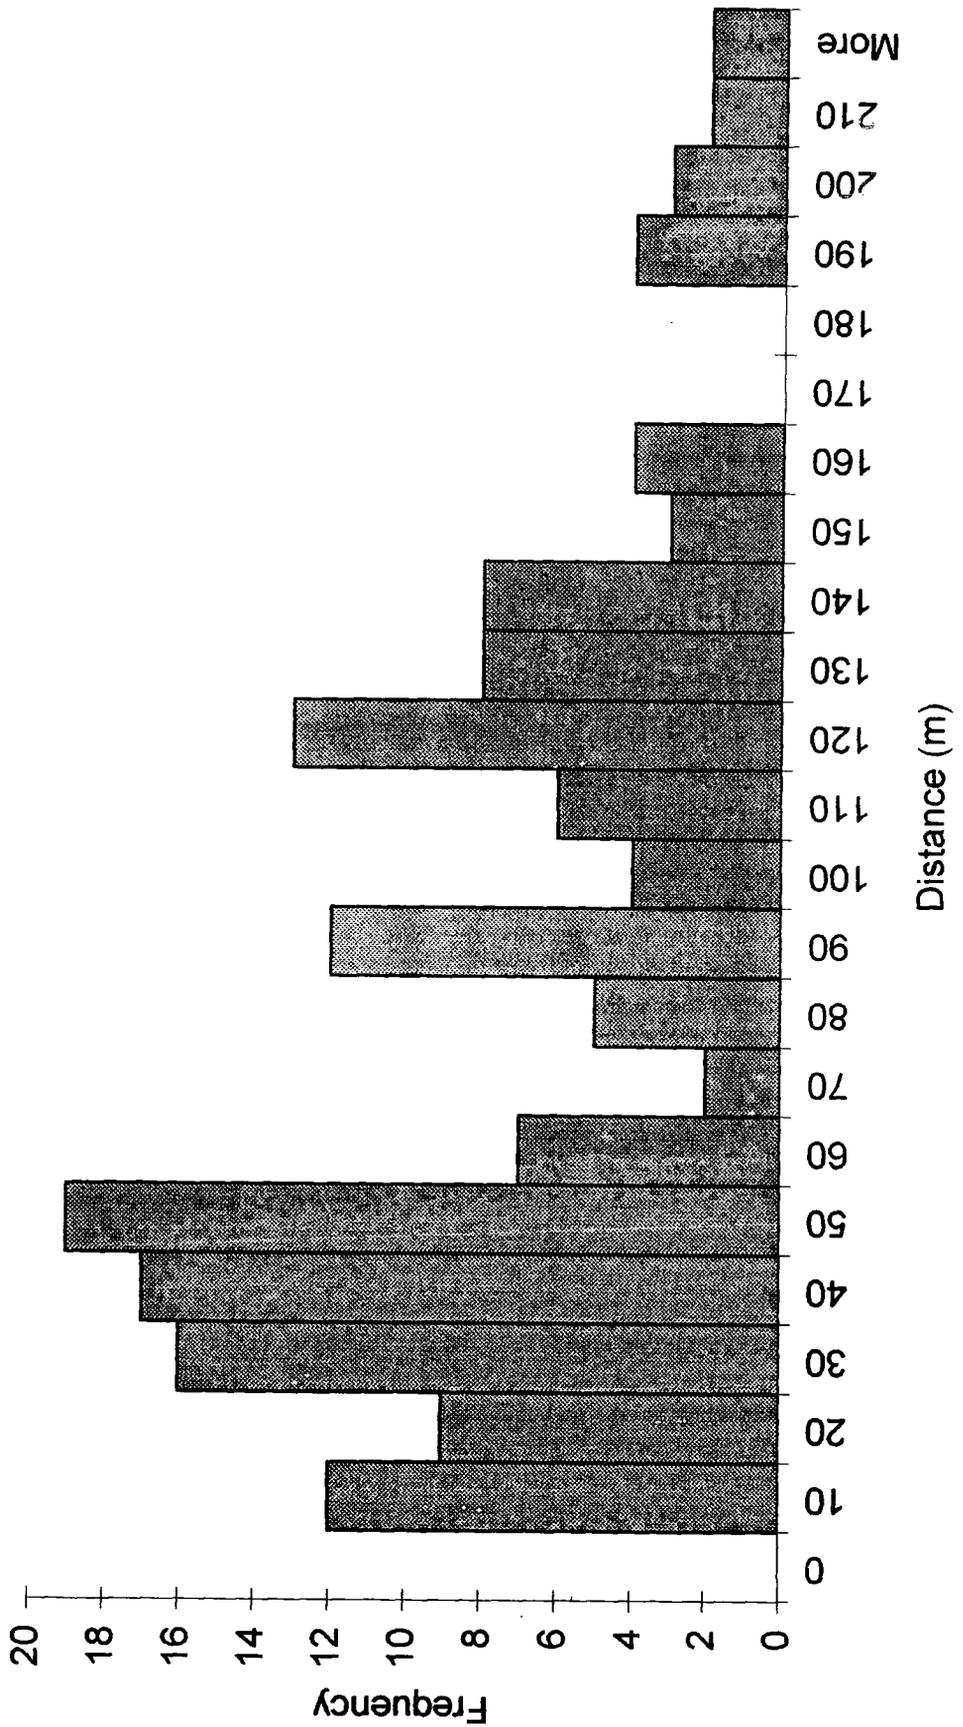
Figure 7.6 Dispersal of within-channel tracers for all grain-size classes following the January, 1998 flood

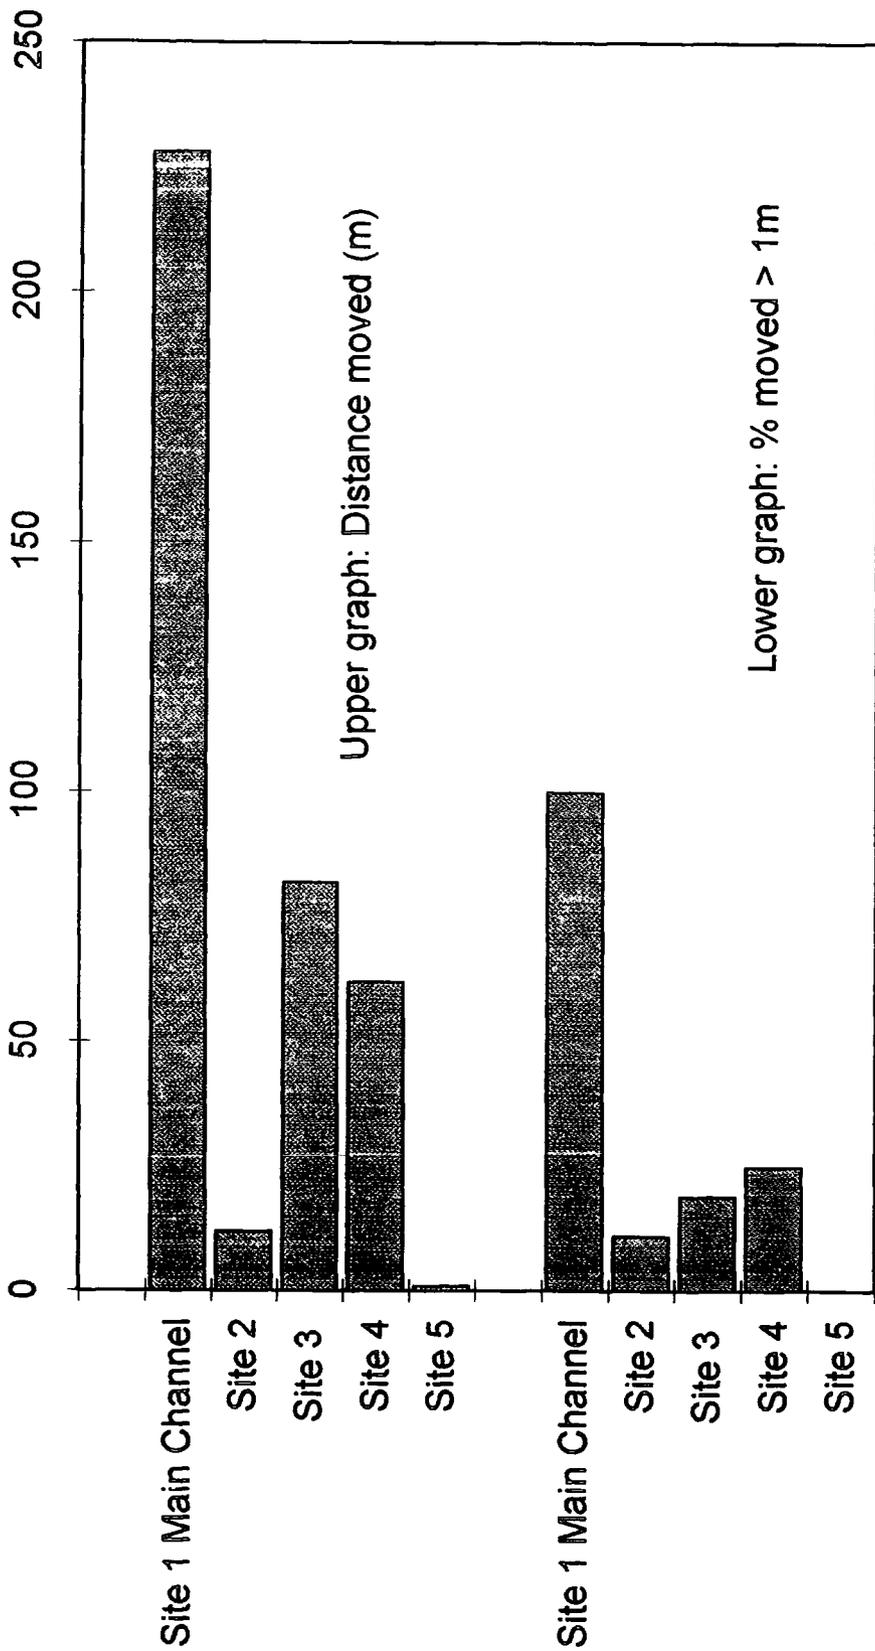
Figure 7.7 The percentage and distance of tracers moved in the main channel compared with lateral sediment inputs following the January, 1998 flood
