Weathering and brittleness in shale fill dams and embankments

**WEATHERING AND BRITTLENESS
IN SHALE FILL
DAMS AND EMBANKMENTS.**

A thesis presented for the degree of Master of Science
in the University of Durham.

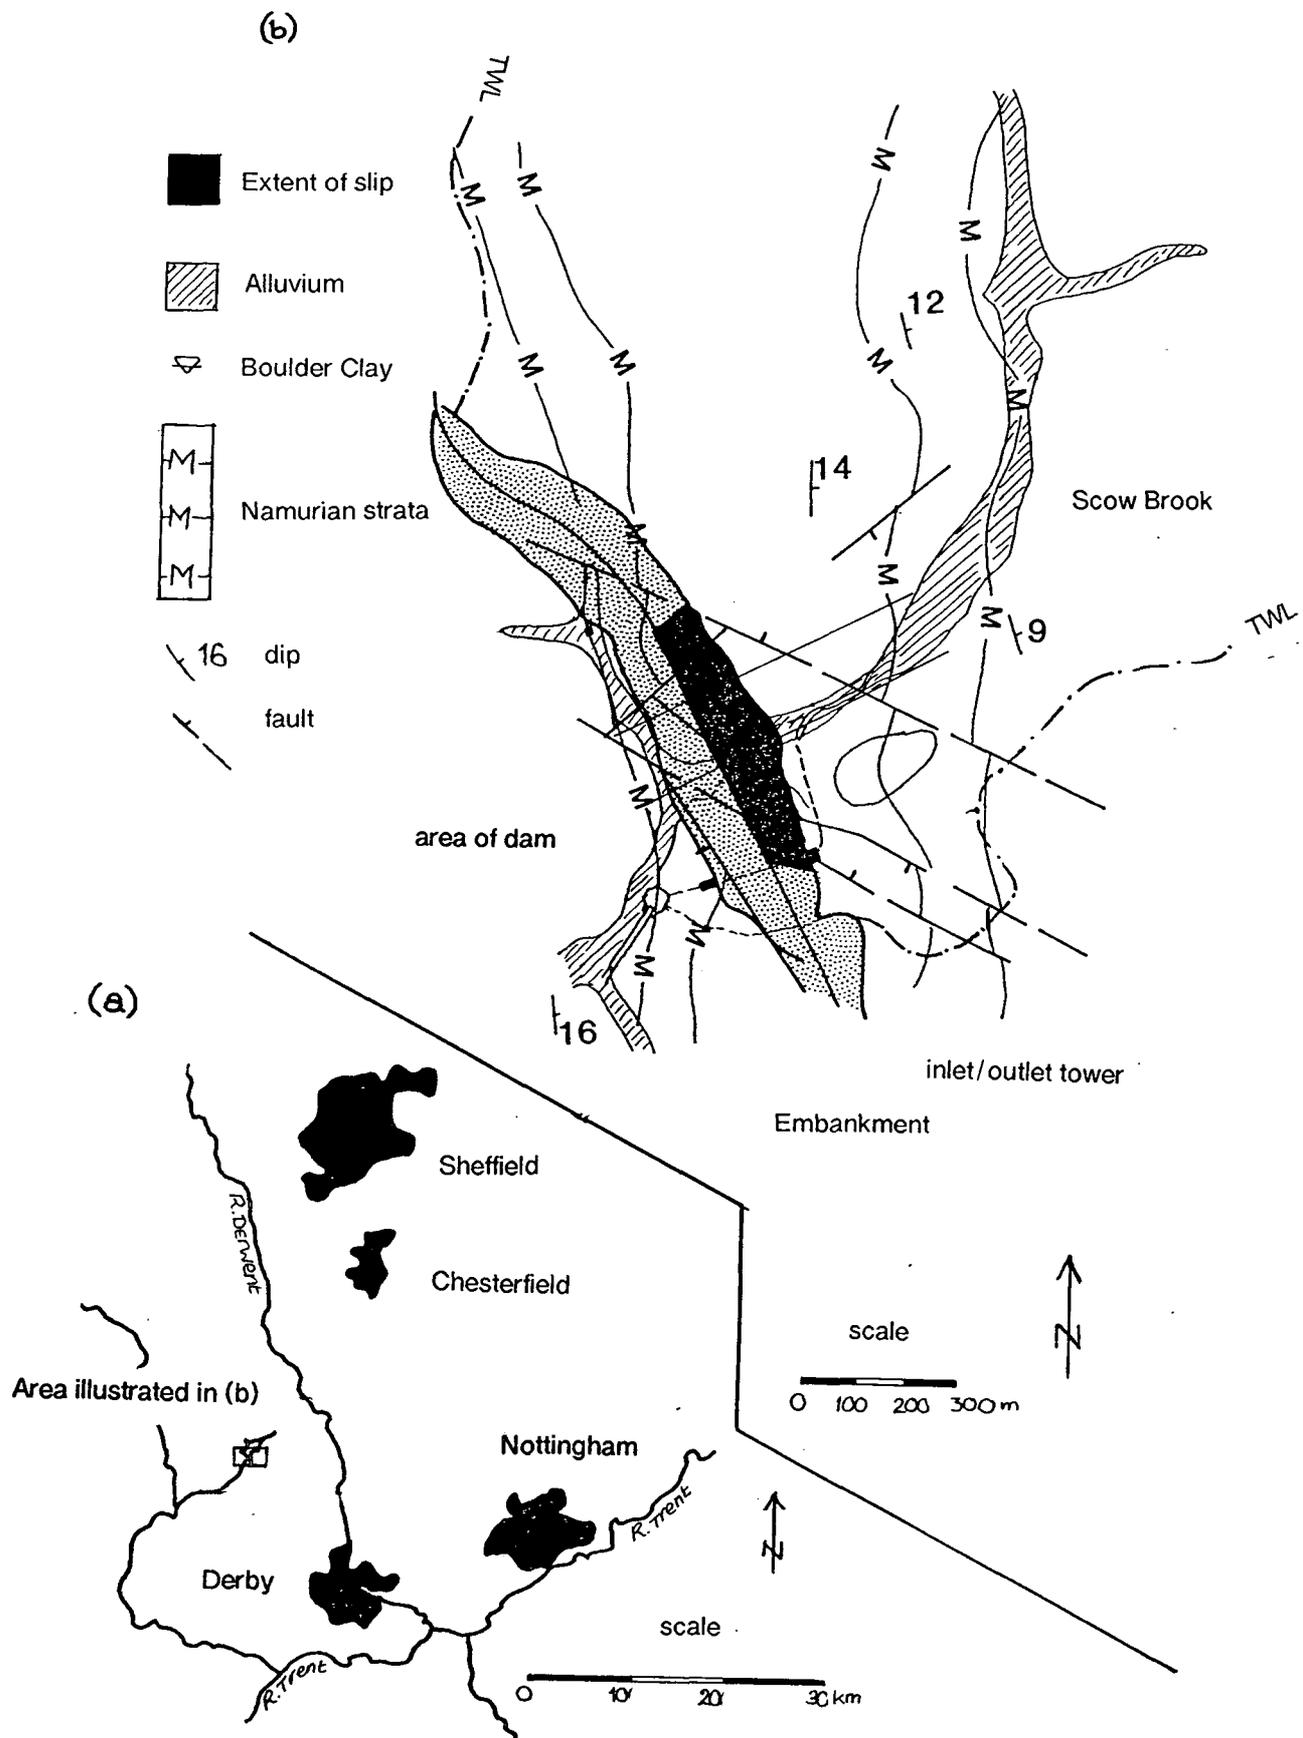
Figure 1.2 Carsington Dam: (a) Location plan, and, (b) plan of reservoir and dam area showing local geology and extent of slip.

Figure 1.2 shows the general geology in the area of Carsington Dam. The bedrock comprises Upper Carboniferous mudrocks which were found to be glacially brecciated, crumpled and weathered to a depth of several metres. This upper layer of weathered mudstone plus the head (*that is* solifluction deposits) which together became known as the 'Yellow Clay' contained many shear surfaces, some up to several metres in length. Prior to construction, alluvial deposits along with top and sub-soil were removed so that the dam was founded either directly on the weathered mudstone as in the valley floor in the area of chainage 850m * , or elsewhere on the Yellow Clay, for example, at chainage 725m. Local materials were used in the construction of the dam which began in July 1982. The rolled central

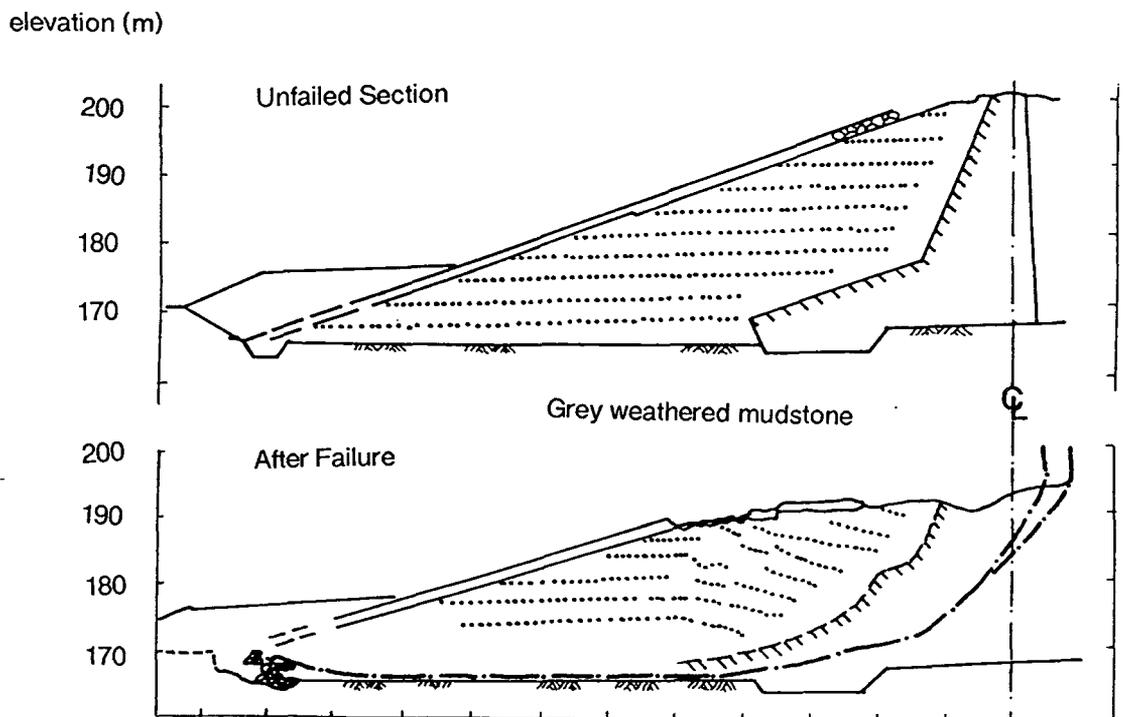
SECTION AT CHAINAGE 725m

SECTION AT CHAINAGE 850m

Figure 1.3 Cross sections of Carsington Dam at chainage 725m and 850m before and after failure (based on Coxon, 1986).

core with its boot-shaped upstream extension was constructed from weathered clay as shown in the cross sections in Figure 1.3, and the shoulders from blocky and brecciated mudstones compacted at their optimum moisture content with the finer grained material being used for the inner Zone I, and coarser material for the outer parts of the shoulders *that is*: Zone II.

Early observations in the area where first movement had occurred showed the position of the slip surface running through the core and boot, then through the Yellow Clay and thrust over the small rock fill toe. In the flood plain area at chainage 850m, where the Yellow Clay was absent, the slip passed through the Zone II fill. The dam itself was left with a near vertical backscarp approximately 10m deep at the crest and large blocks of the upstream face back rotated as thrust – graben features formed in the tension zone above the failure plane (Coxon, 1986). Figure 1.3 shows the cross section at two points (chainage 725 and 850m), before and after the failure.

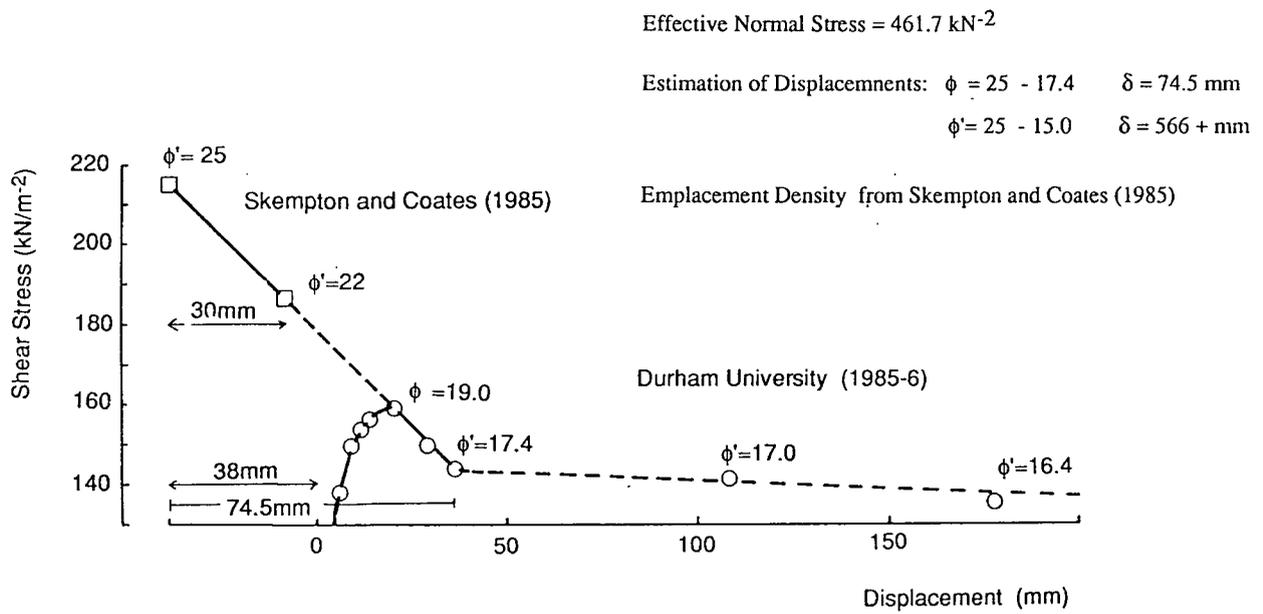
Figure 1.4 Shear stress - displacement curve for post-failure shear box tests on material from Carsington Dam, using data from Skempton and Coates (1985) and University of Durham (1985 and 1986, unpublished). For explanation see Section 1.3.1.c.

3. Further Large Shear Box Tests on a remoulded sample of fill from Carsington Dam, originally dug from near the dam's surface and remoulded at natural moisture content yielded peak shear strength parameters of $c_p = 0$, $\phi_p = 22^\circ$ and residual parameters of $c_p = 0$, $\phi_p = 16.5 - 17^\circ$. However, Skempton and Coats (1985) quote peak values of $\phi_p = 28^\circ$ in freshly compacted shale and $\phi_p = 25^\circ$ for shale in the dam. This drop of 3° was thought to be an indication that additional processes were acting on the outer zones of the embankment which had the overall effect of reducing shear strength. The Durham sample reached a residual strength after a smaller than expected displacement. This was attributed to weathering and degradation of the sample during placement and exposure. Considerable amounts of sulphate were observed on the shear plane after only 48 hours exposure in the laboratory at 20°C , which demonstrates the rapid nature of these weathering processes (Taylor, in Coxon 1986). These results are summarized in Figure 1.4.

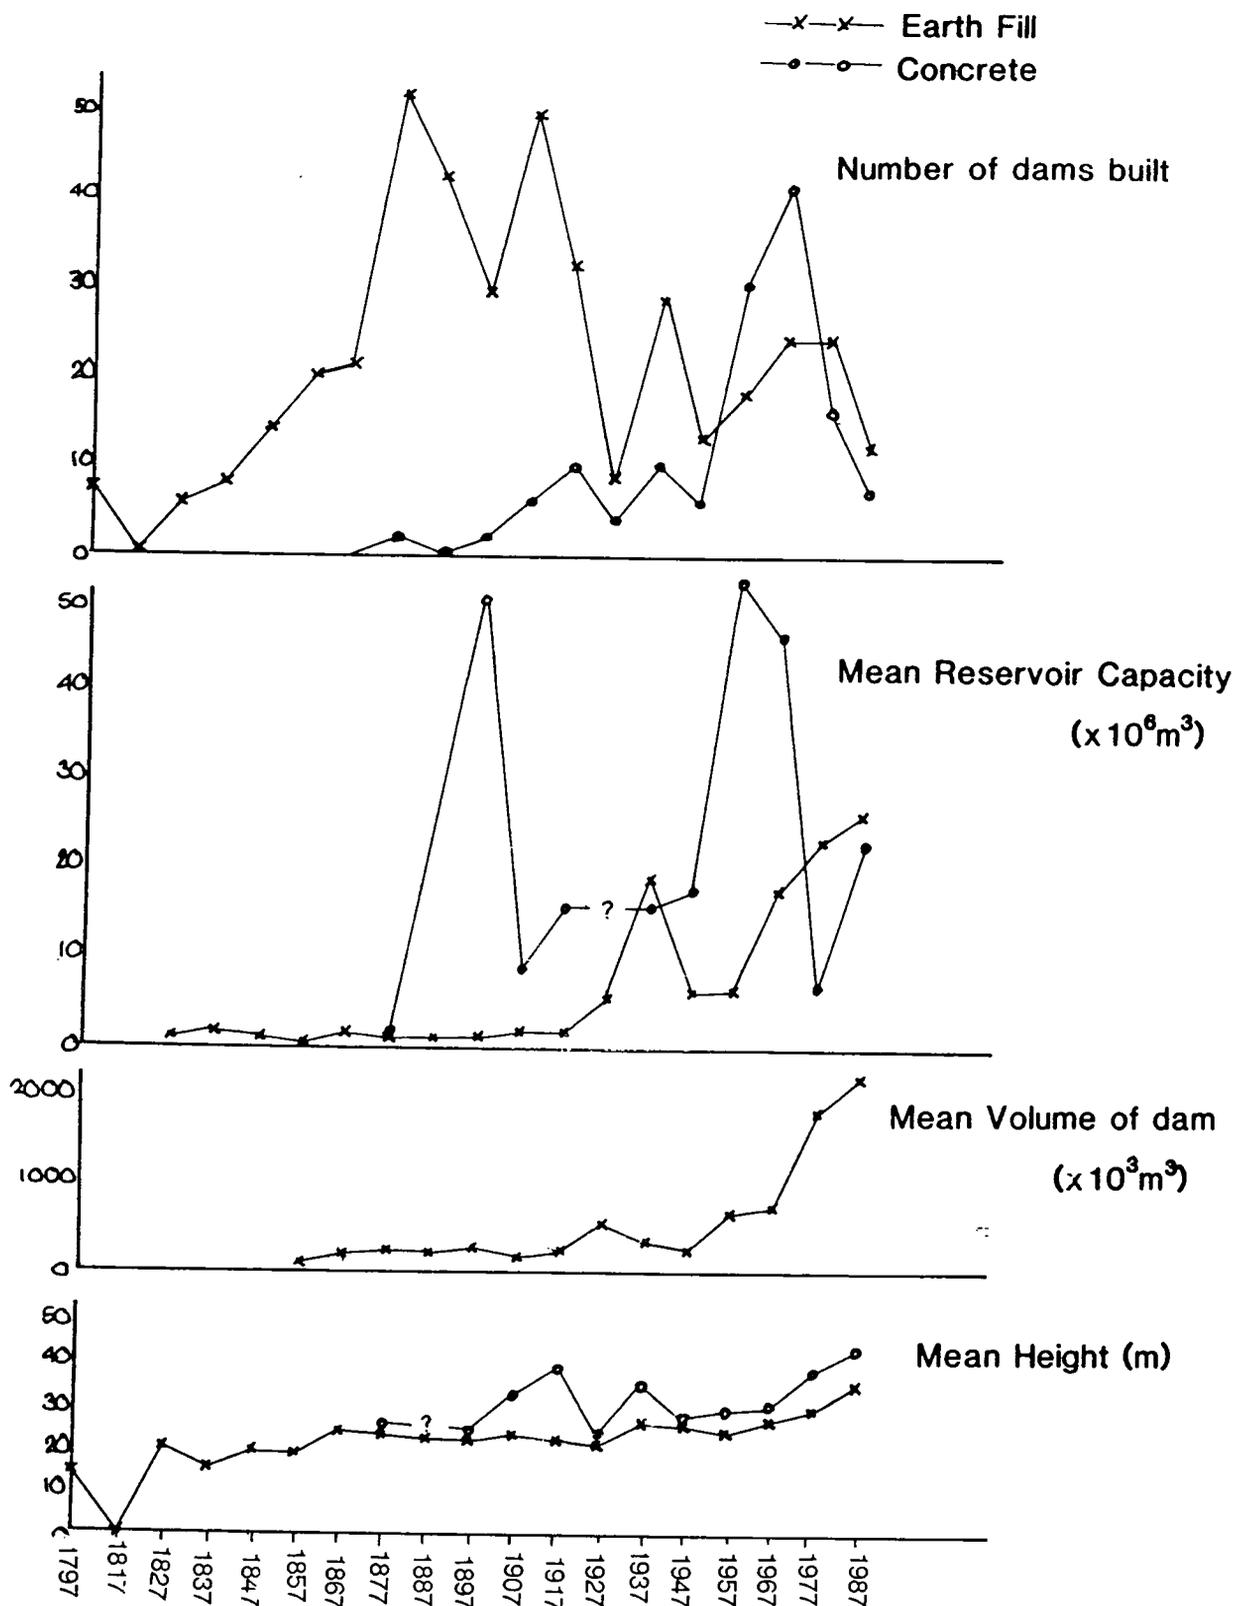
Figure 2.2 Change in dimensions of earth fill and concrete dams with time.

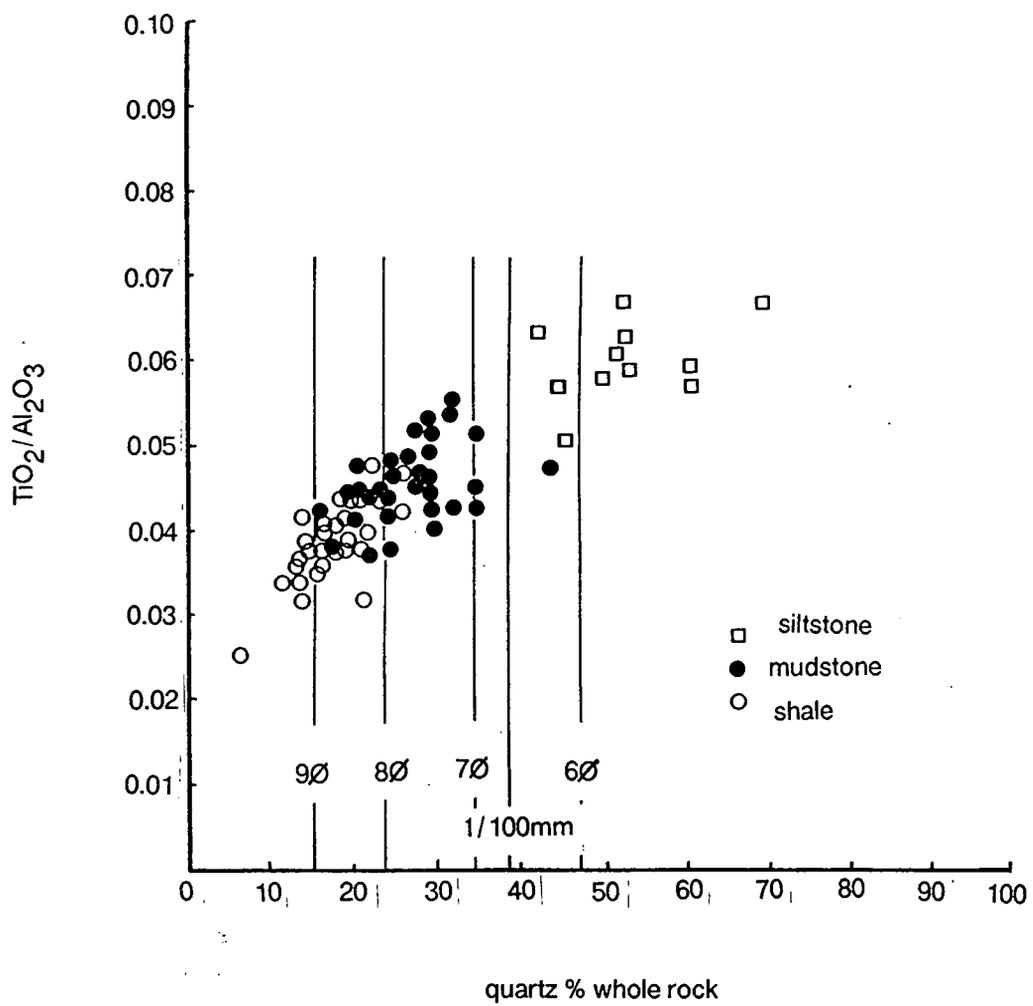
Figure 3.1 Relationship between grain size and clay mineral/quartz content (after Spears, 1980)

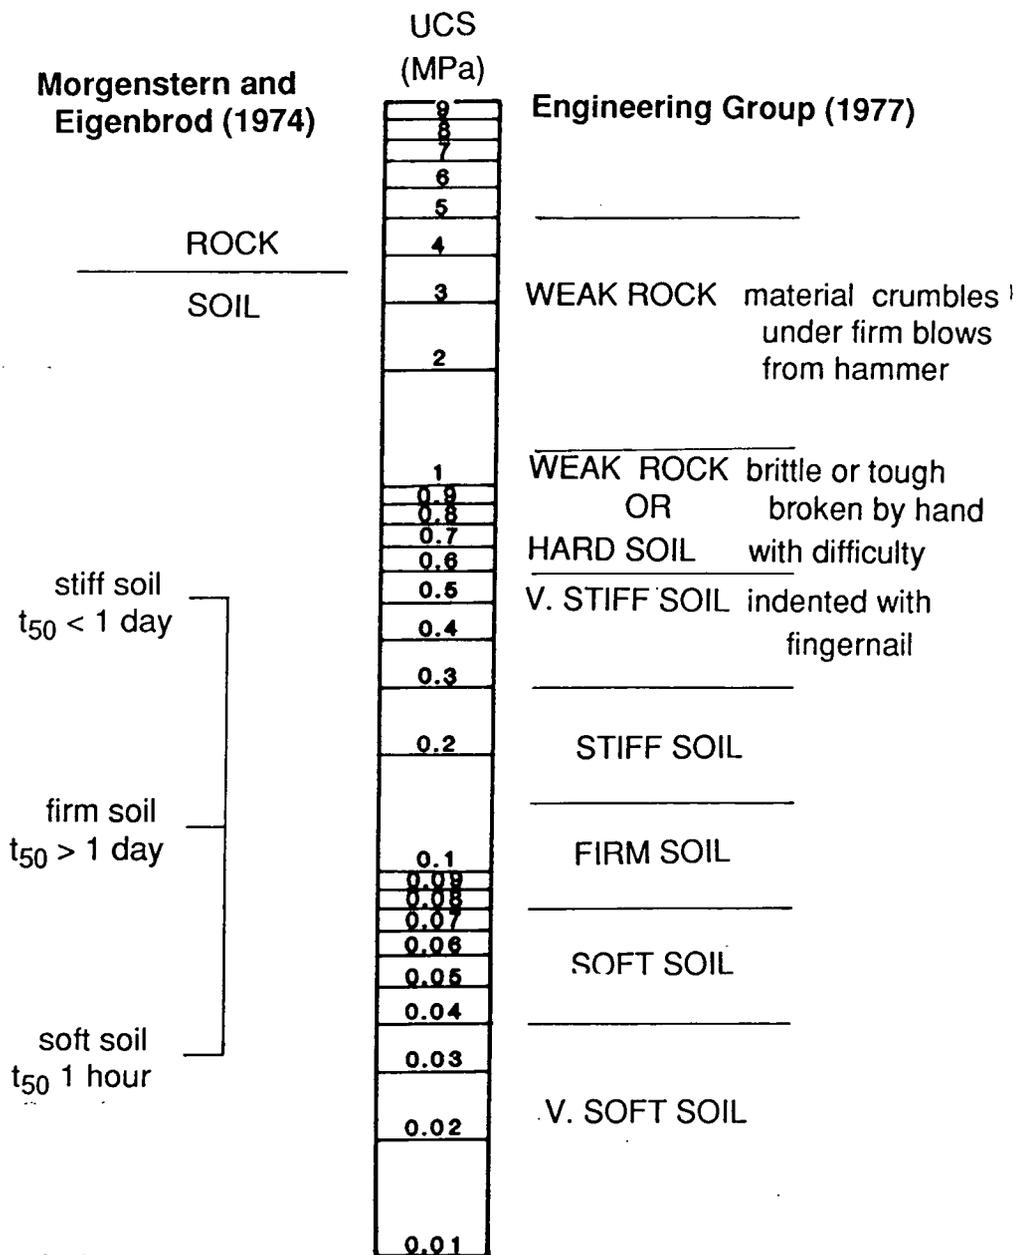
t_{50} = soaking time required for reduction of 50% in UCS.

Figure 3.2 Strength (UCS) classification of mudrocks and muds according to Morgenstern and Eigenbrod (1974) and the Engineering Group (1977).

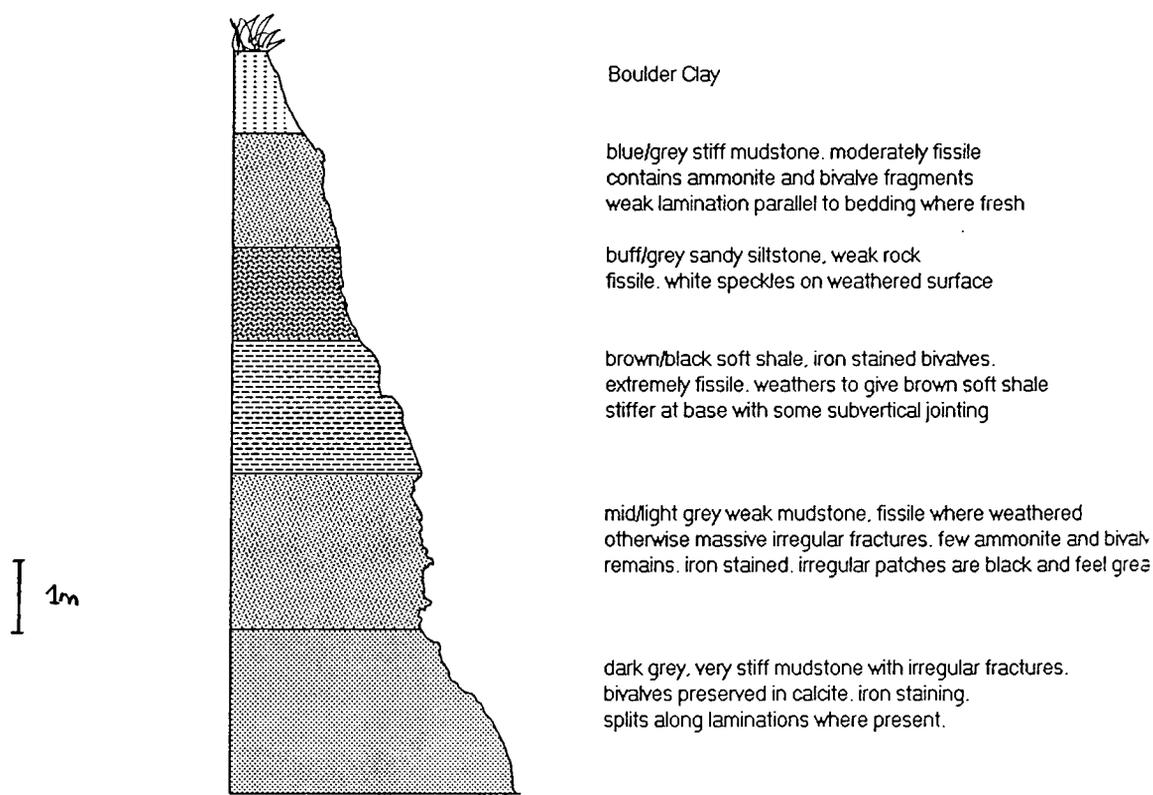
Figure 3.10 Quarry wall section in Kimmeridge Clay at Foxholes Quarry.

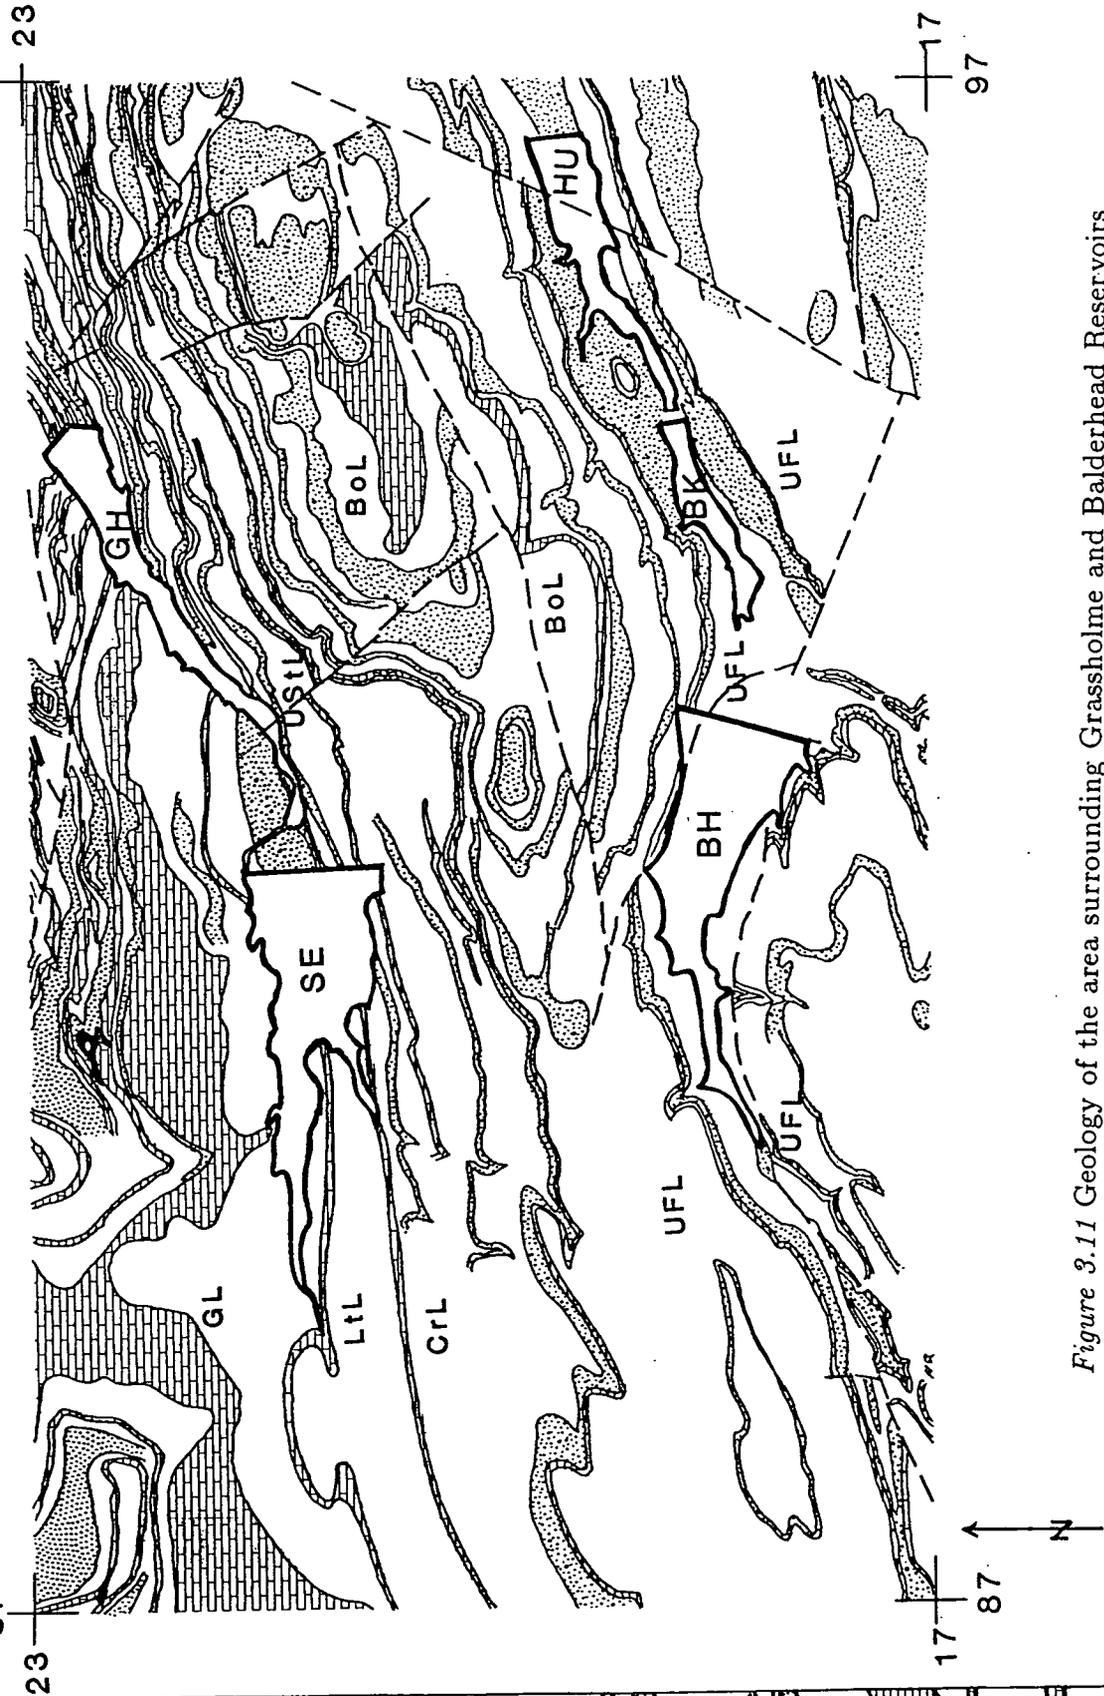
Figure 3.11 Geology of the area surrounding Grassholme and Balderhead Reservoirs

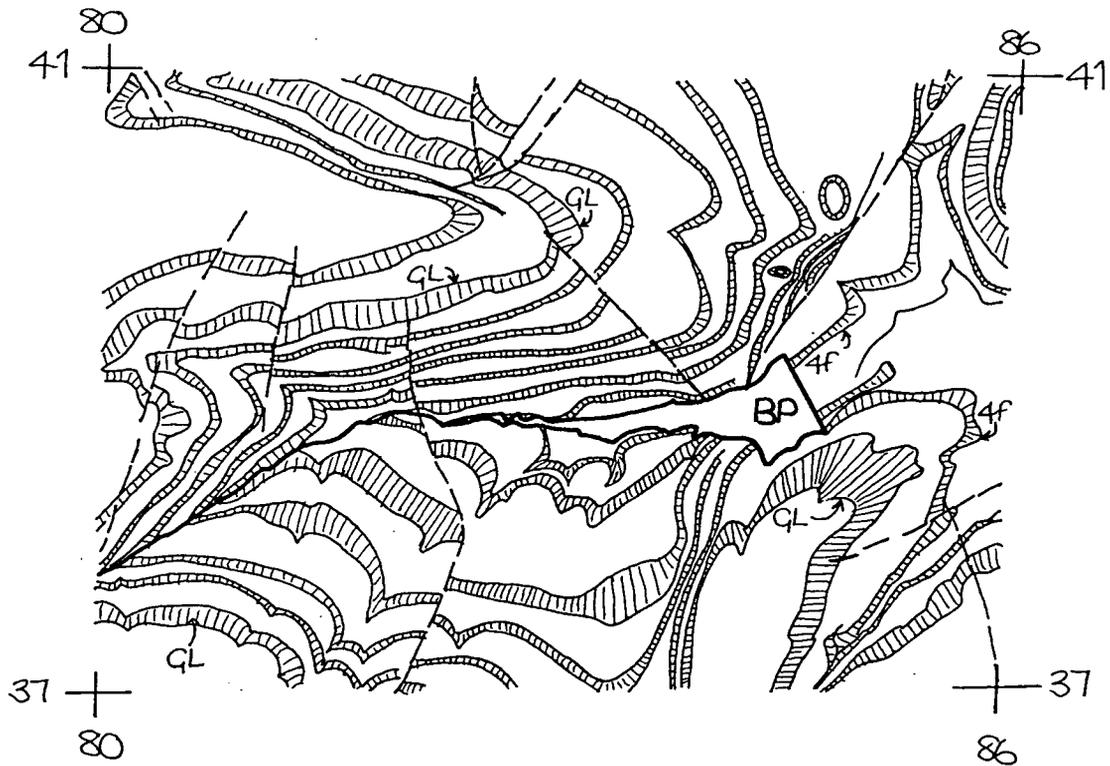
Figure 3.12 Geology of the area surrounding Burnhope reservoir.

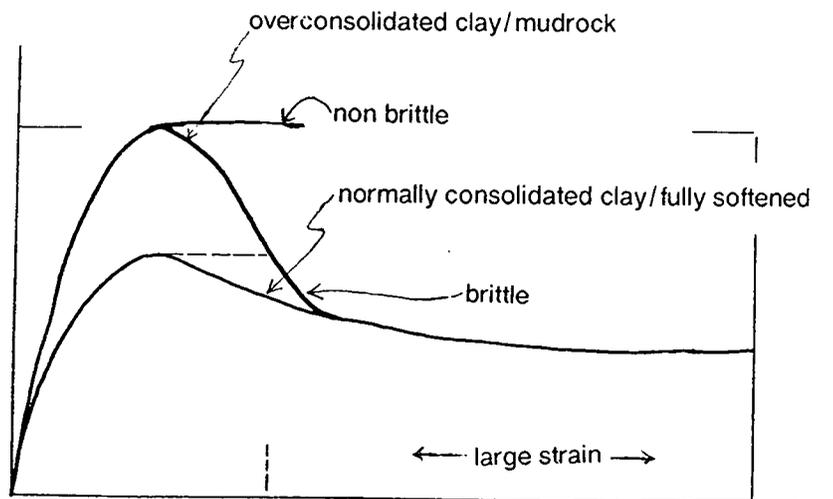
Figure 4.1 Effective peak and residual shear strength parameters for progressively weathered mudrocks.

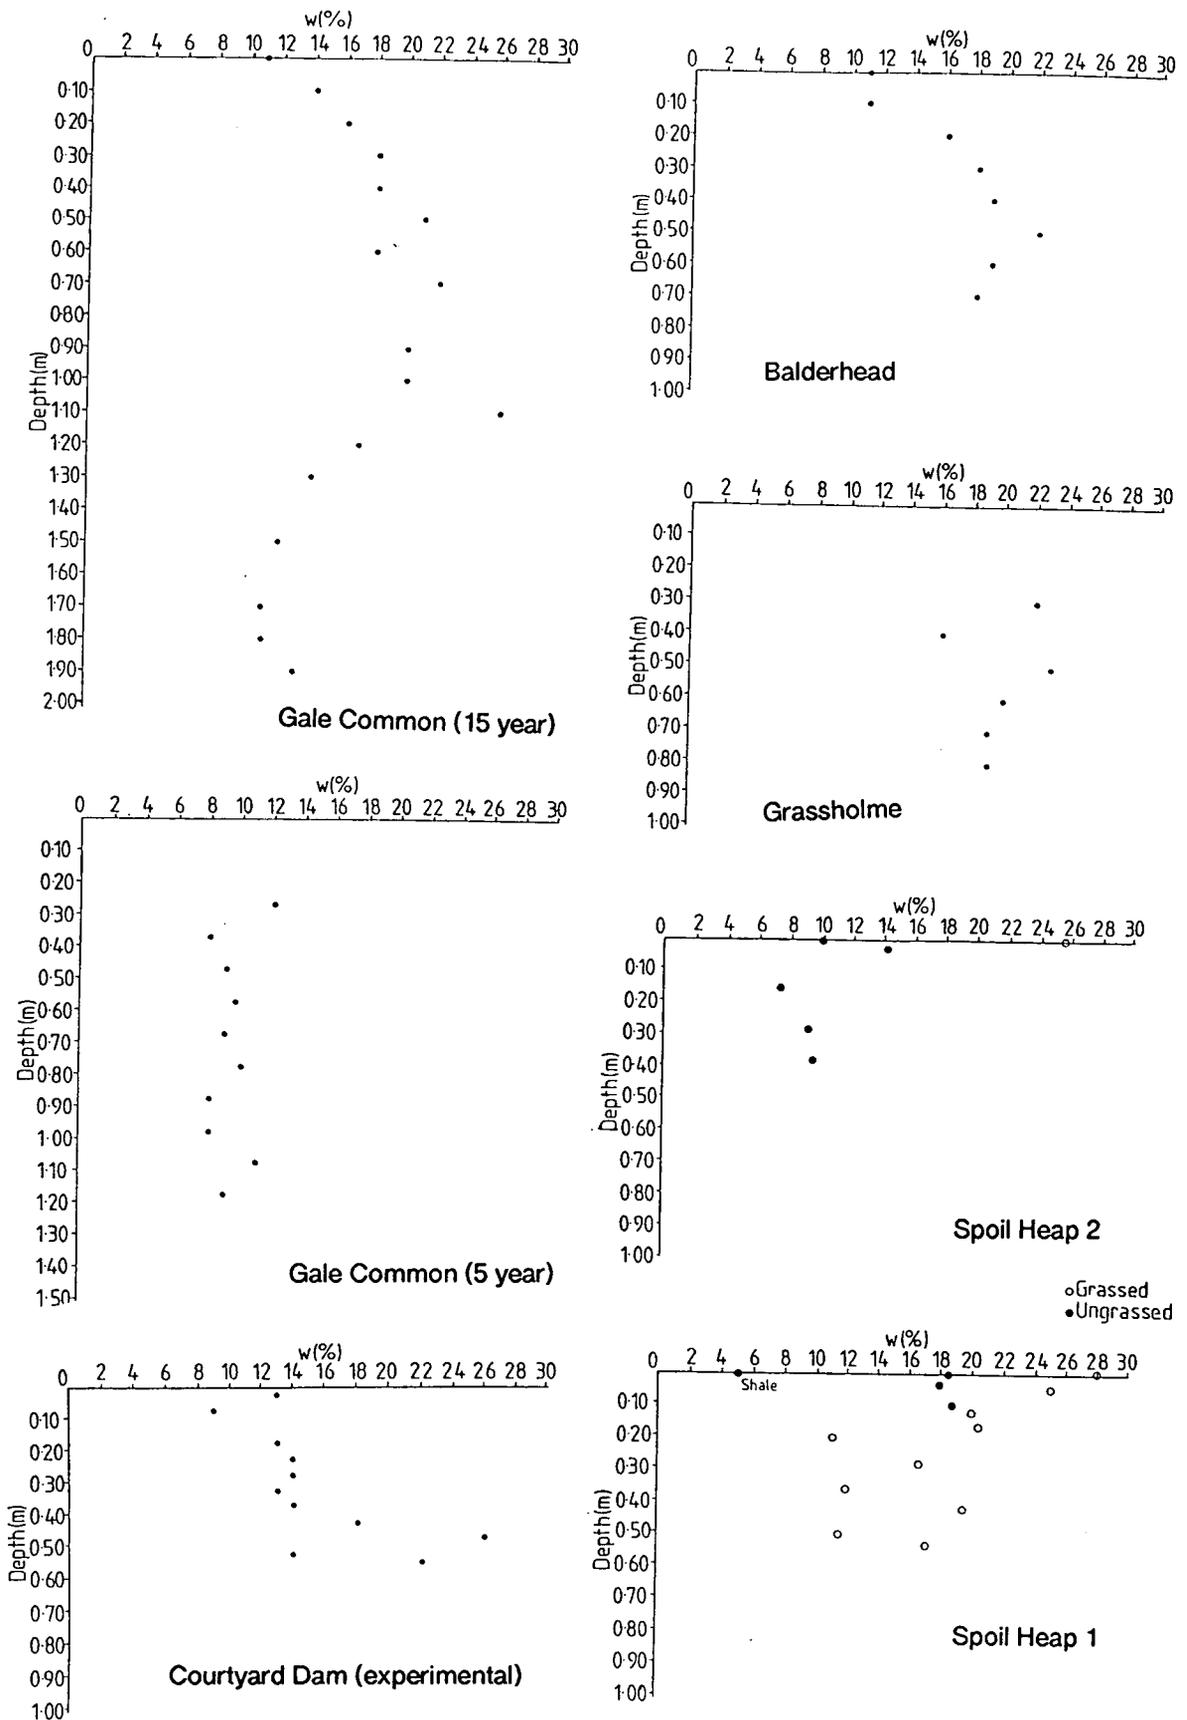
Figure 4.3 Moisture content – depth relationships.

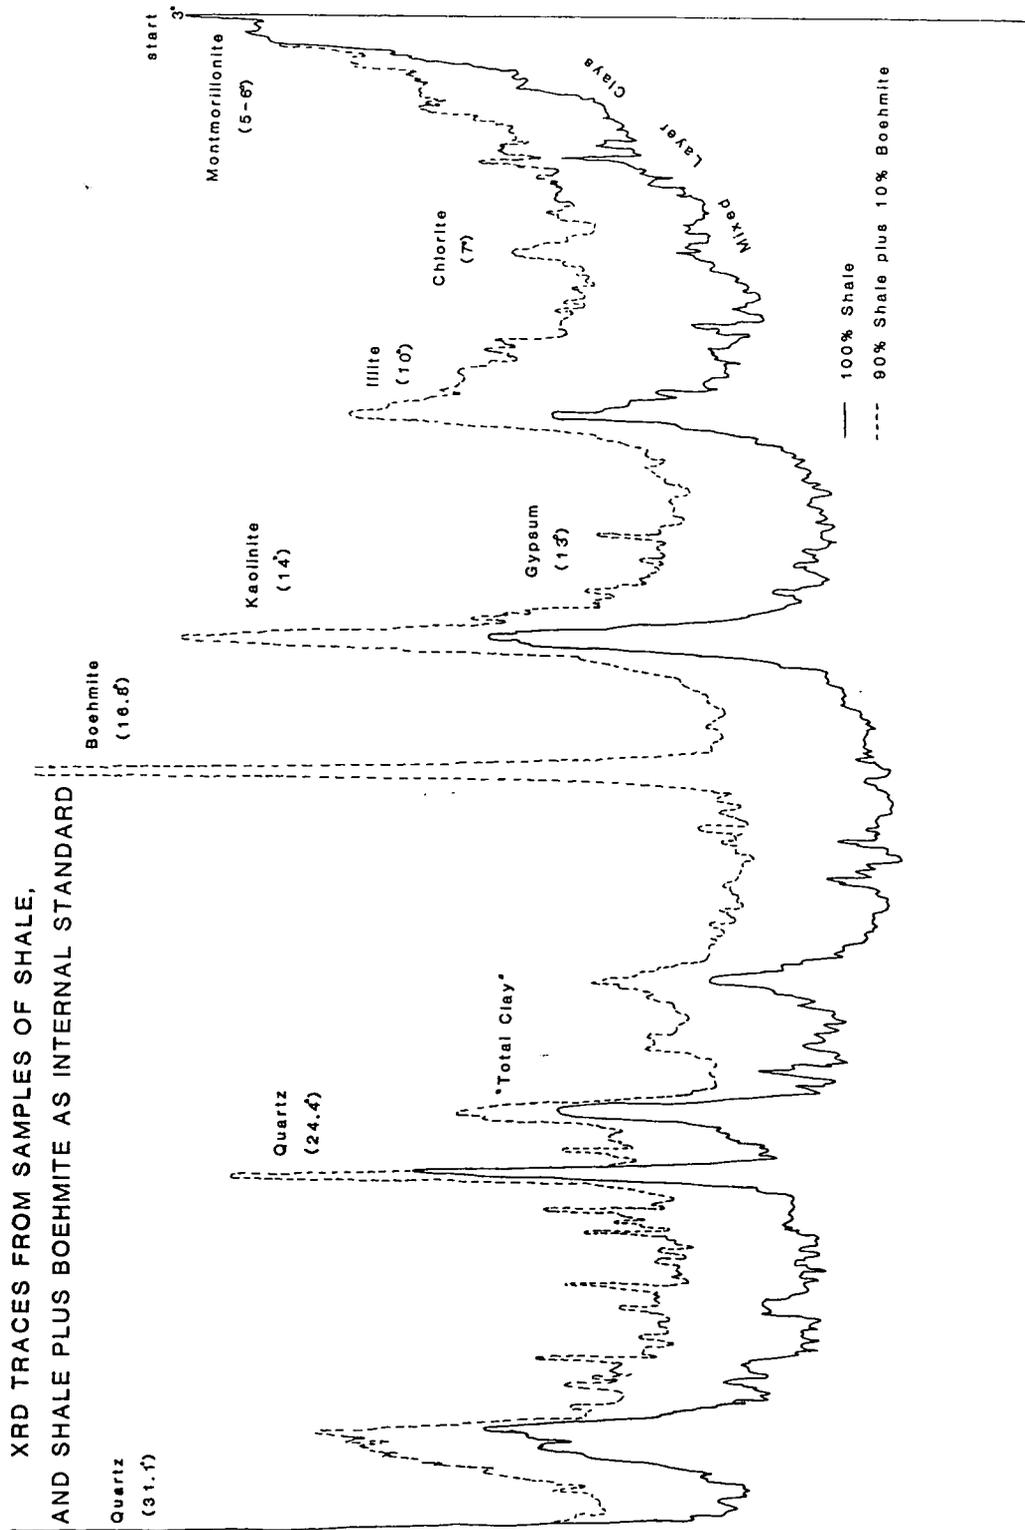
Figure 4.5 X-Ray diffractogram for Carboniferous shale with and without the addition of 10% boehmite.

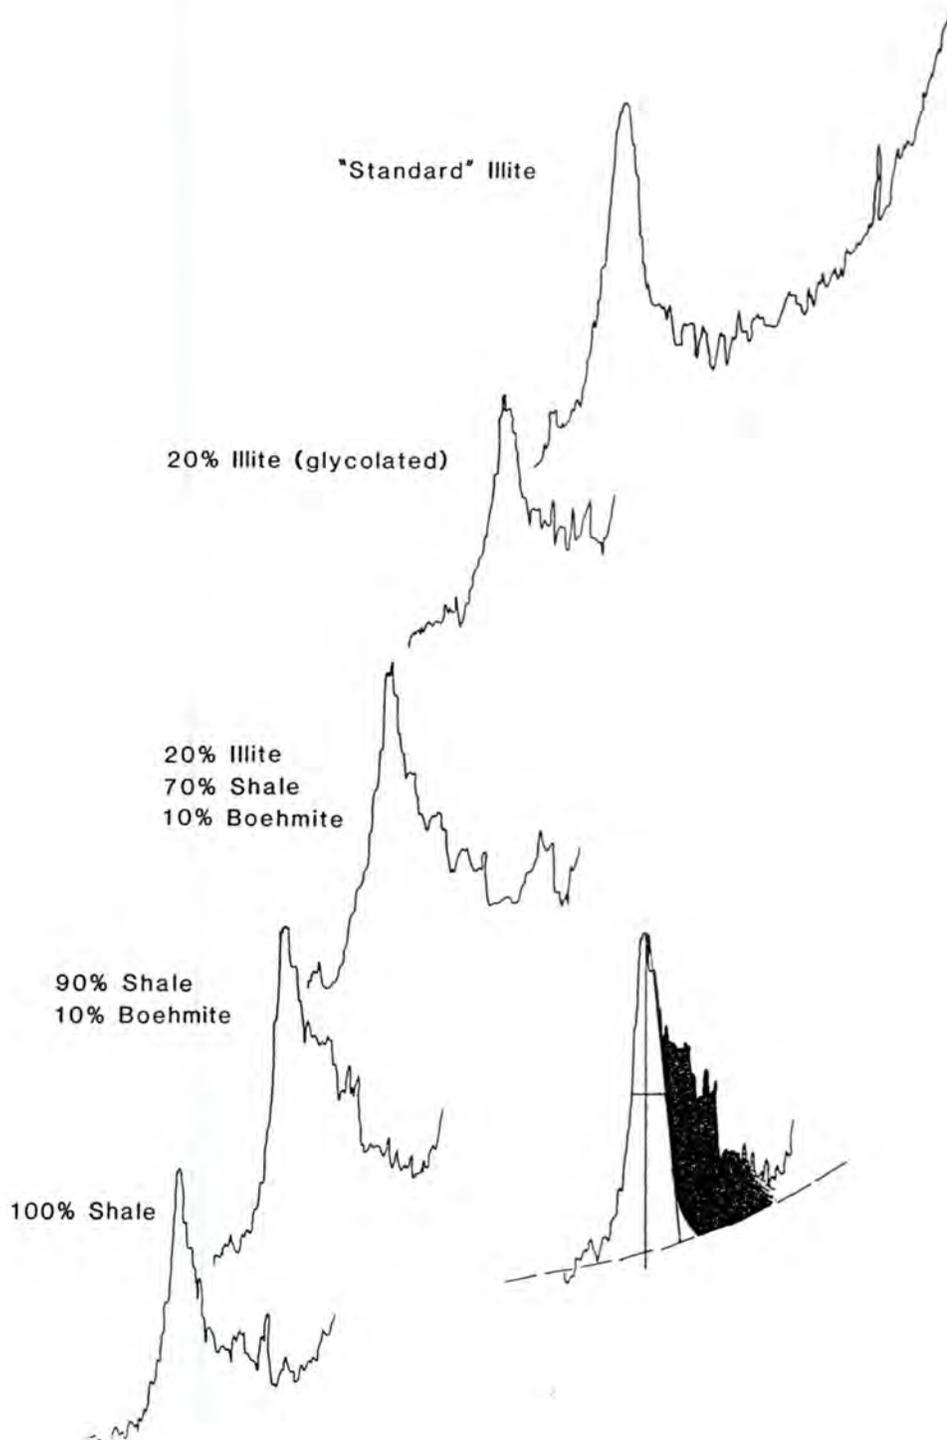
Figure 4.6 Illite Crystallinity (not to scale - diagrammatic representation of change in shape only)

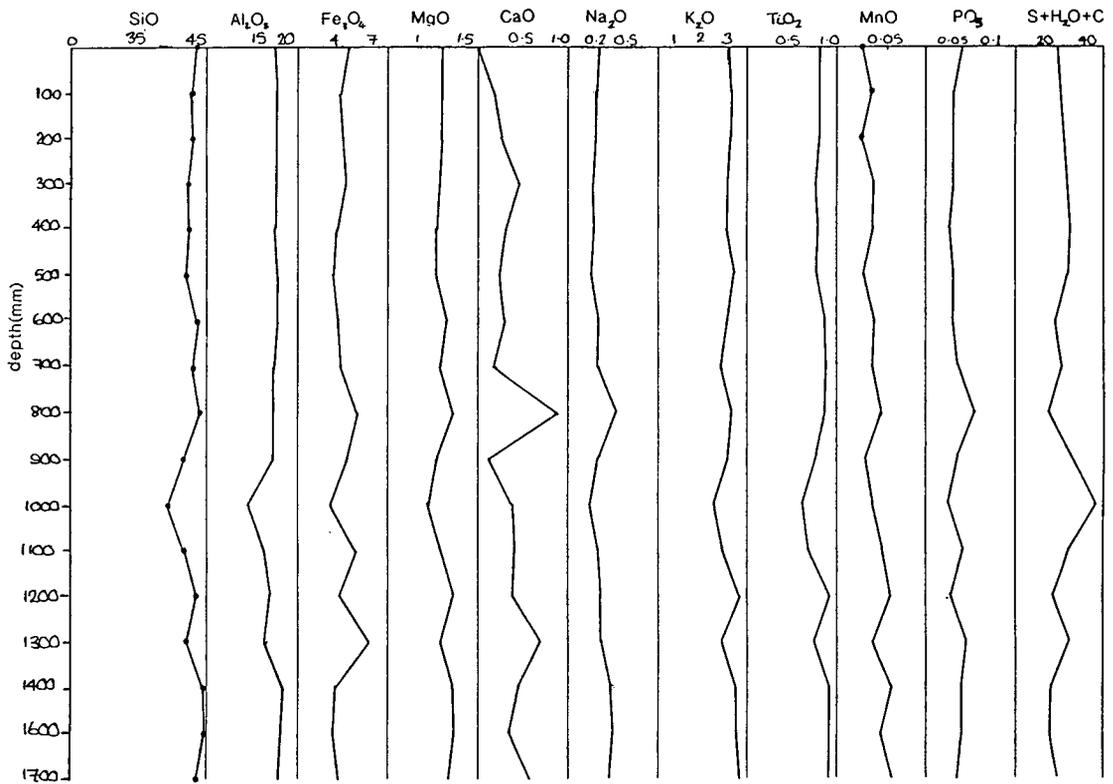
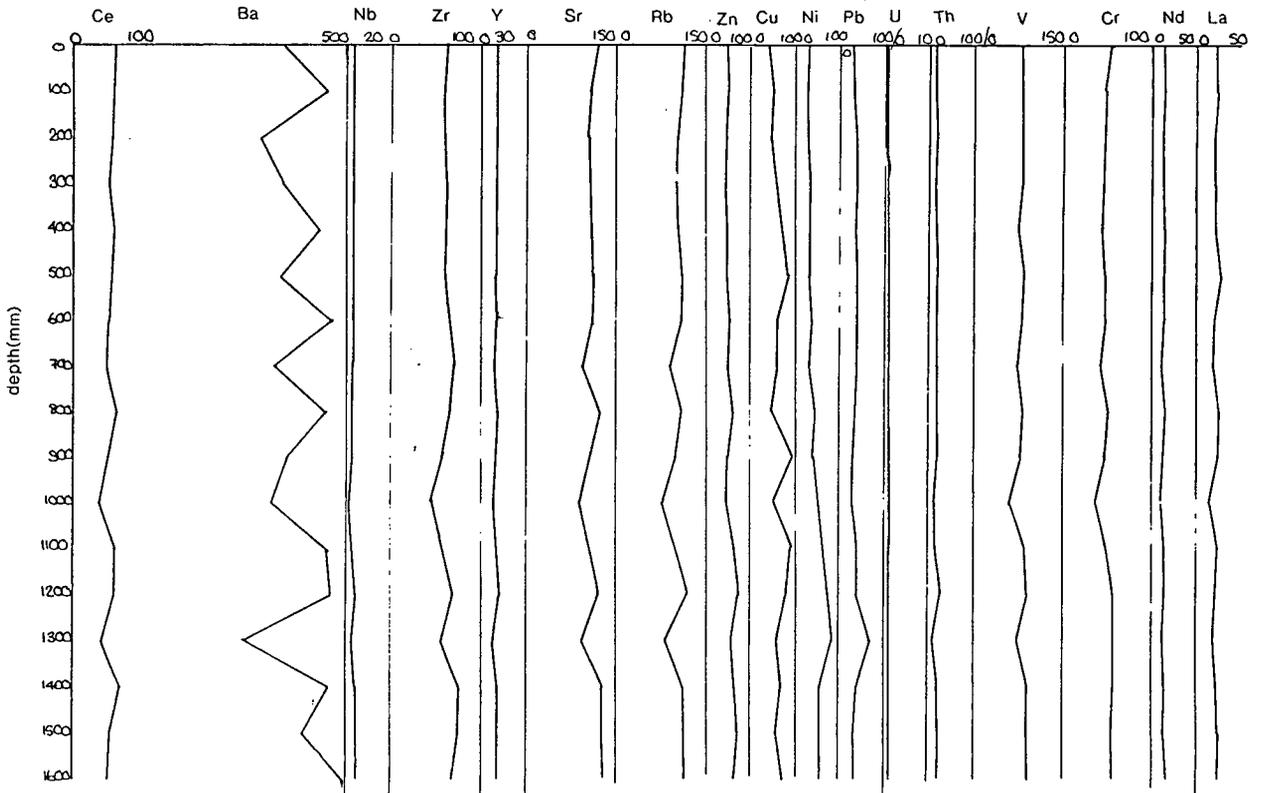
Figure 4.7 Mineral content, major element and trace element – depth: Gale Common five year weathered.

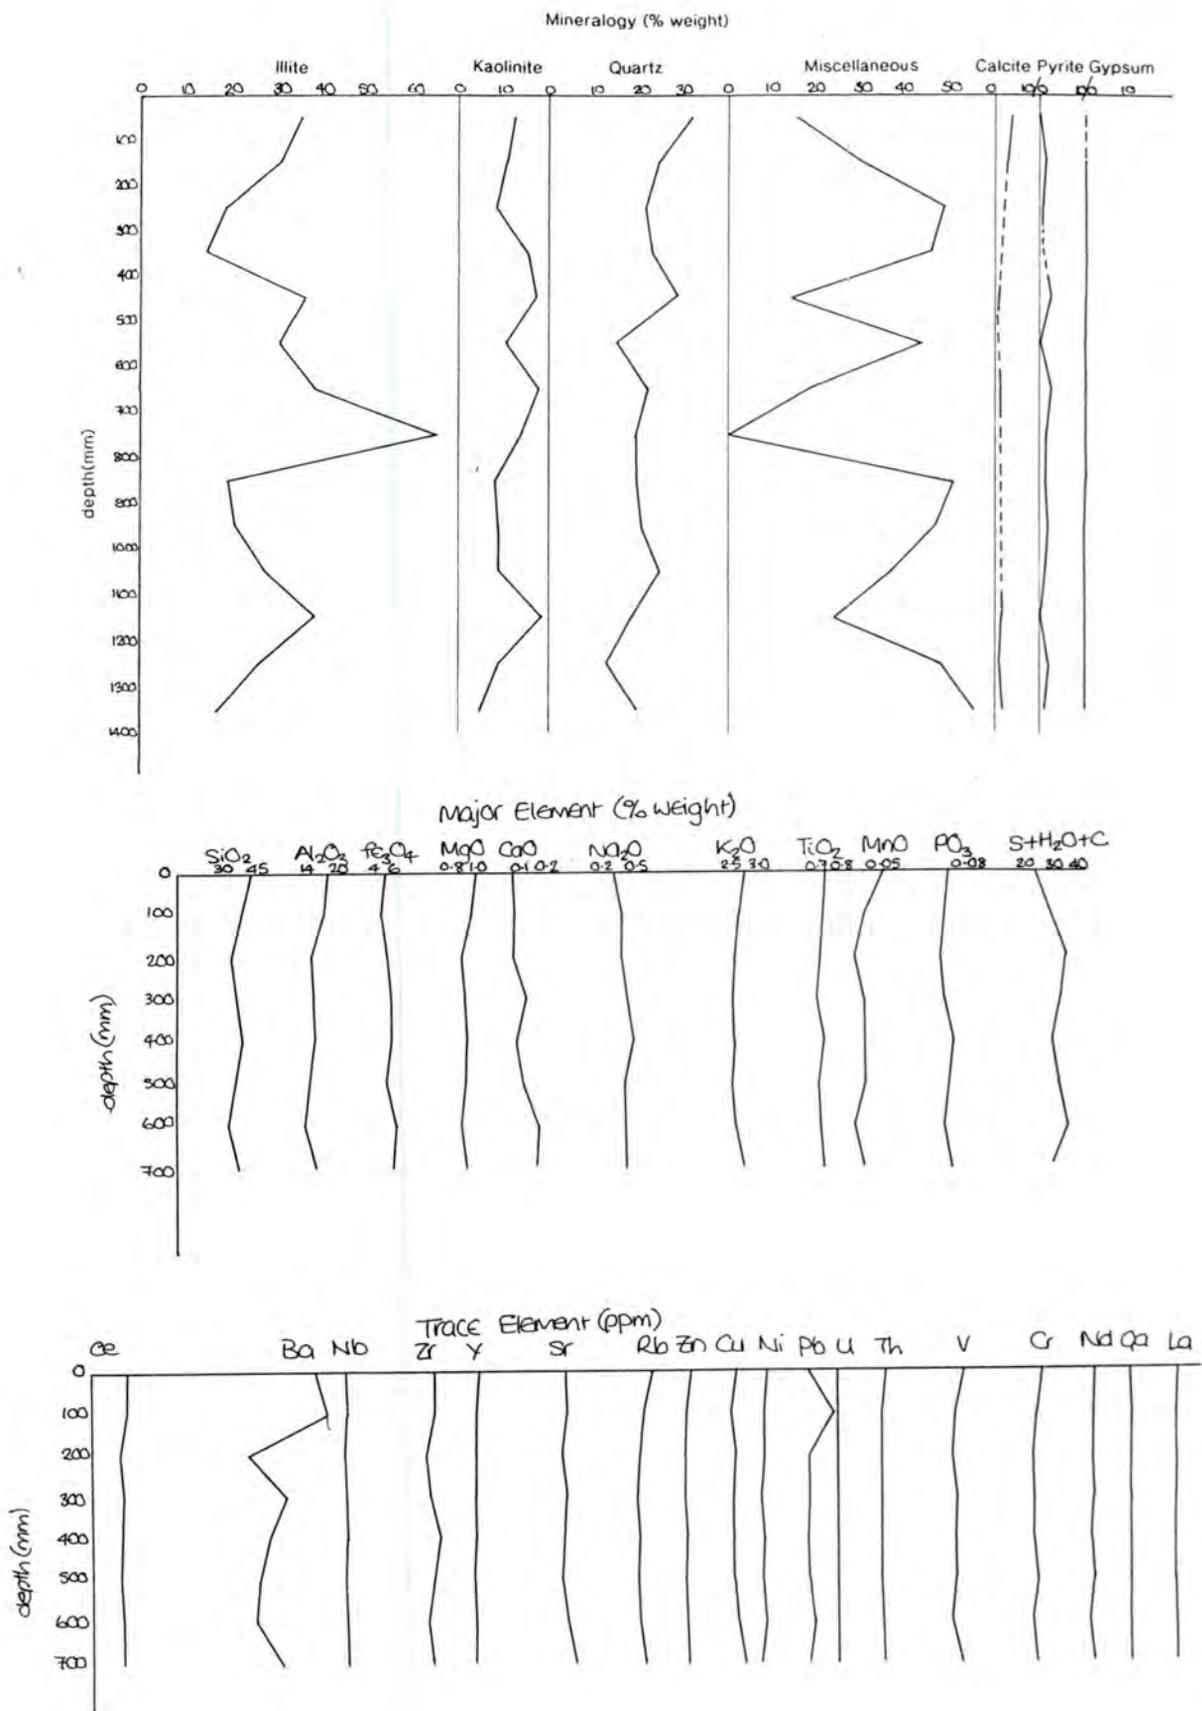
Figure 4.8 Mineral content, major element and trace element – depth: Gale Common fifteen year weathered.
