Weathering and brittleness in shale fill dams and embankments

**WEATHERING AND BRITTLENESS
IN SHALE FILL
DAMS AND EMBANKMENTS.**

A thesis presented for the degree of Master of Science
in the University of Durham.

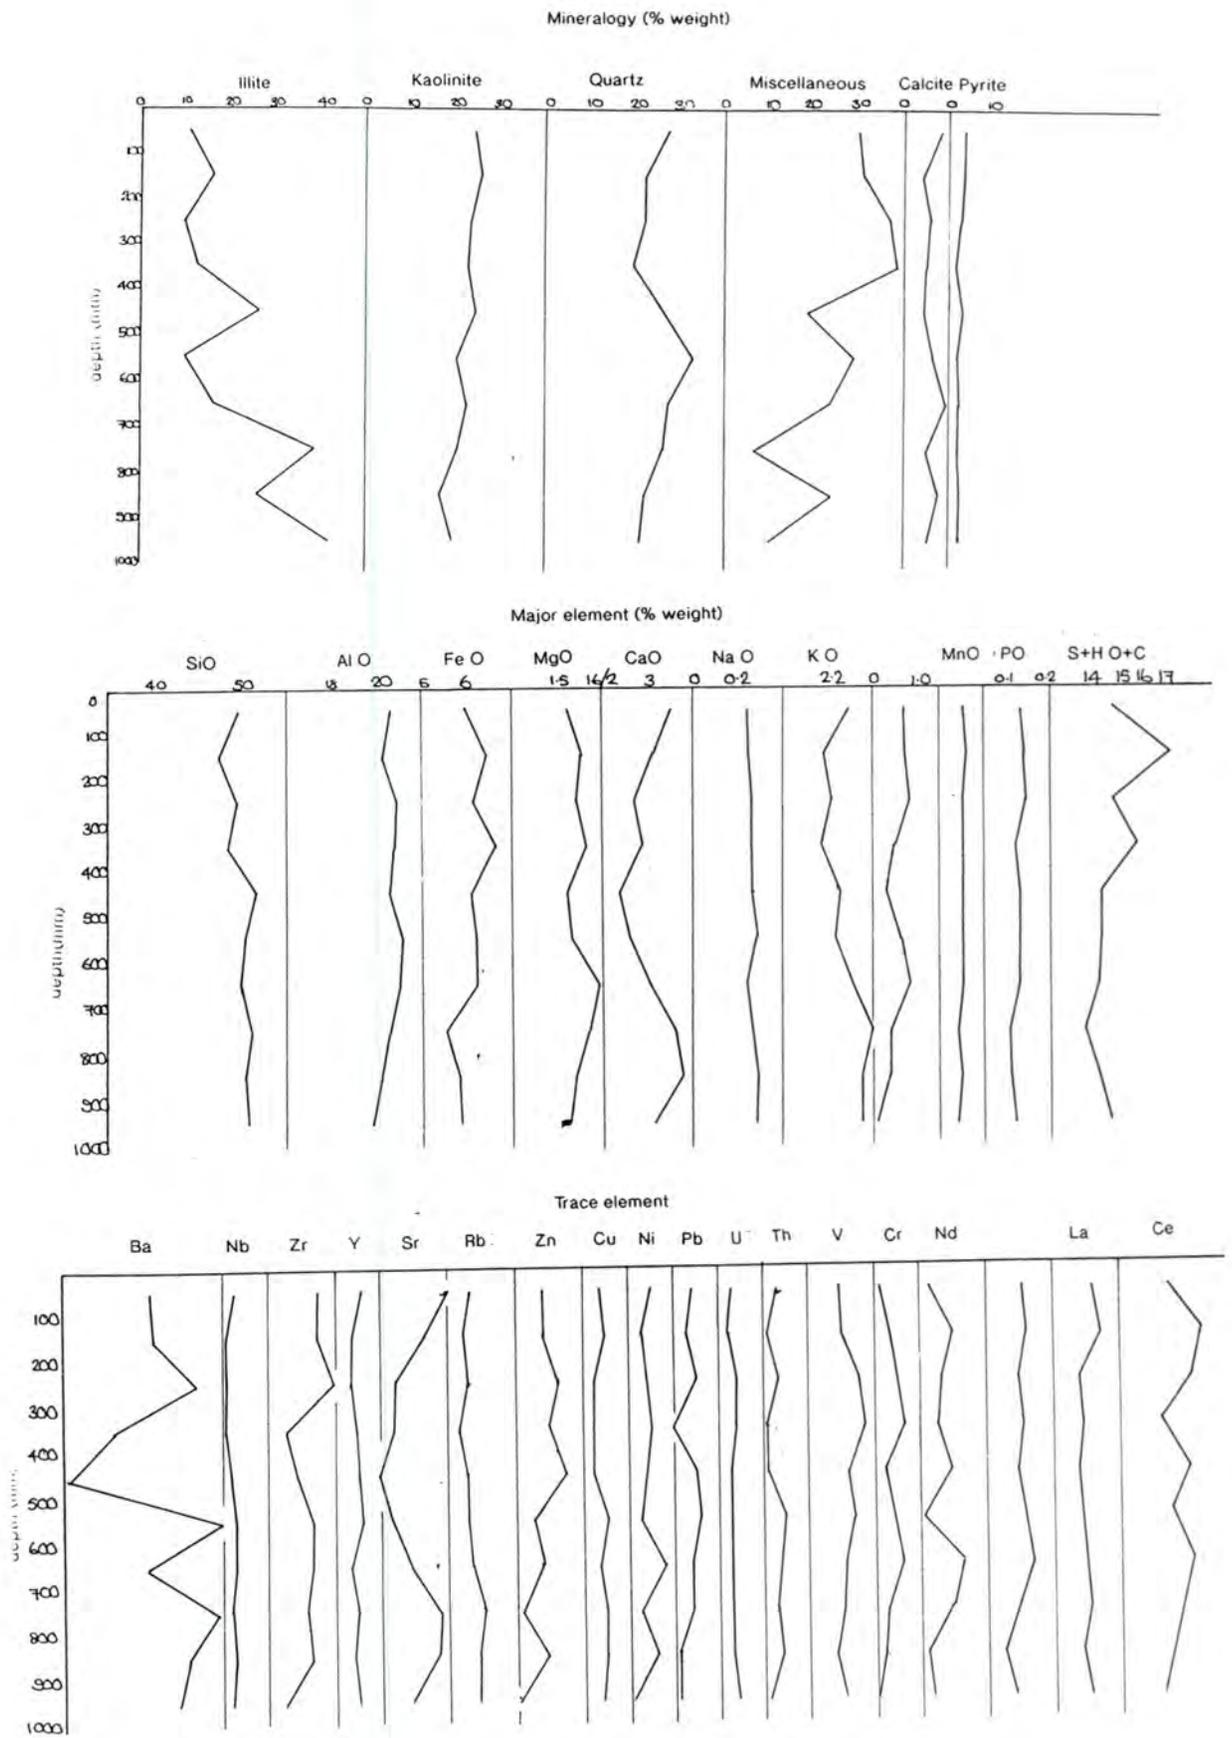
Figure 4.9 Mineral content, major element and trace element – depth: Balderhead Dam.

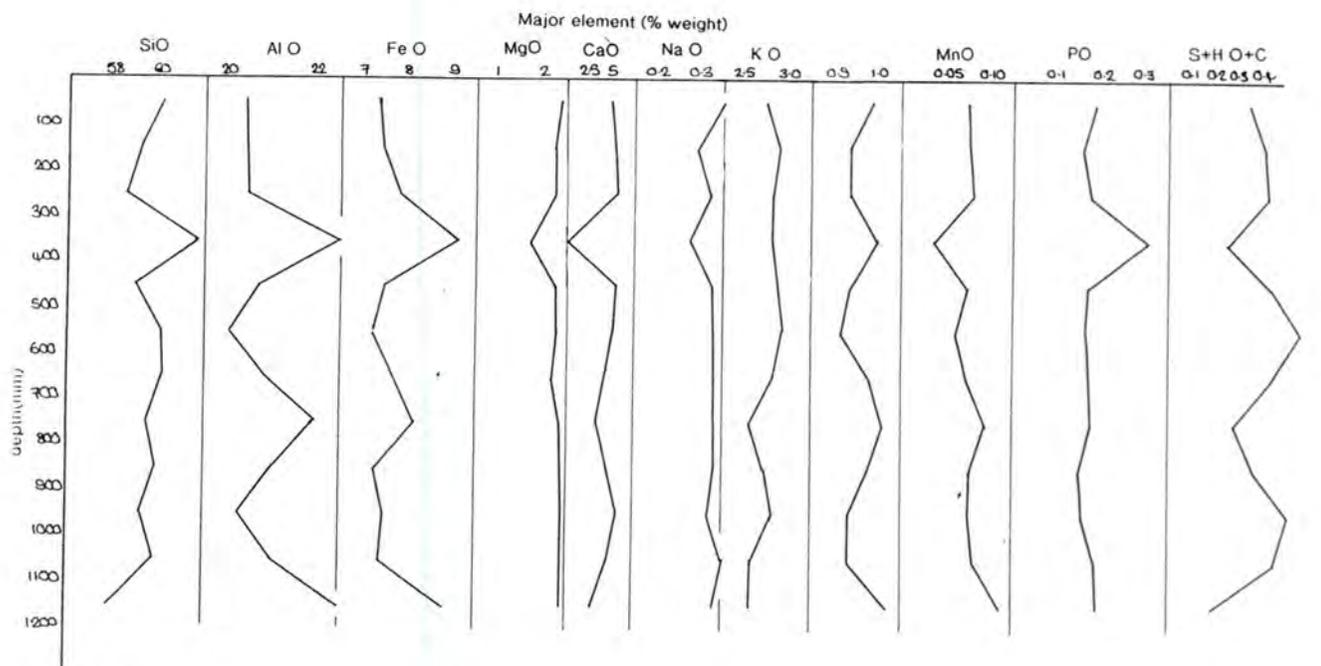
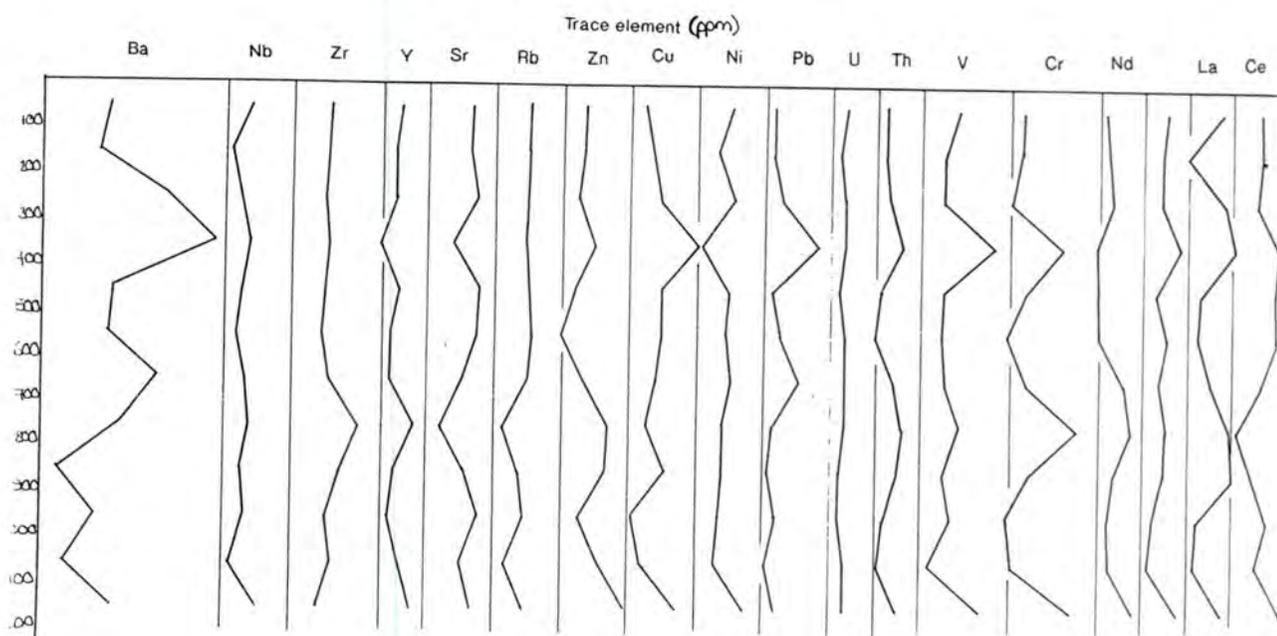
Figure 4.11 Mineral content, major element and trace element – depth: Grassholme Hury tunnel spoil heap

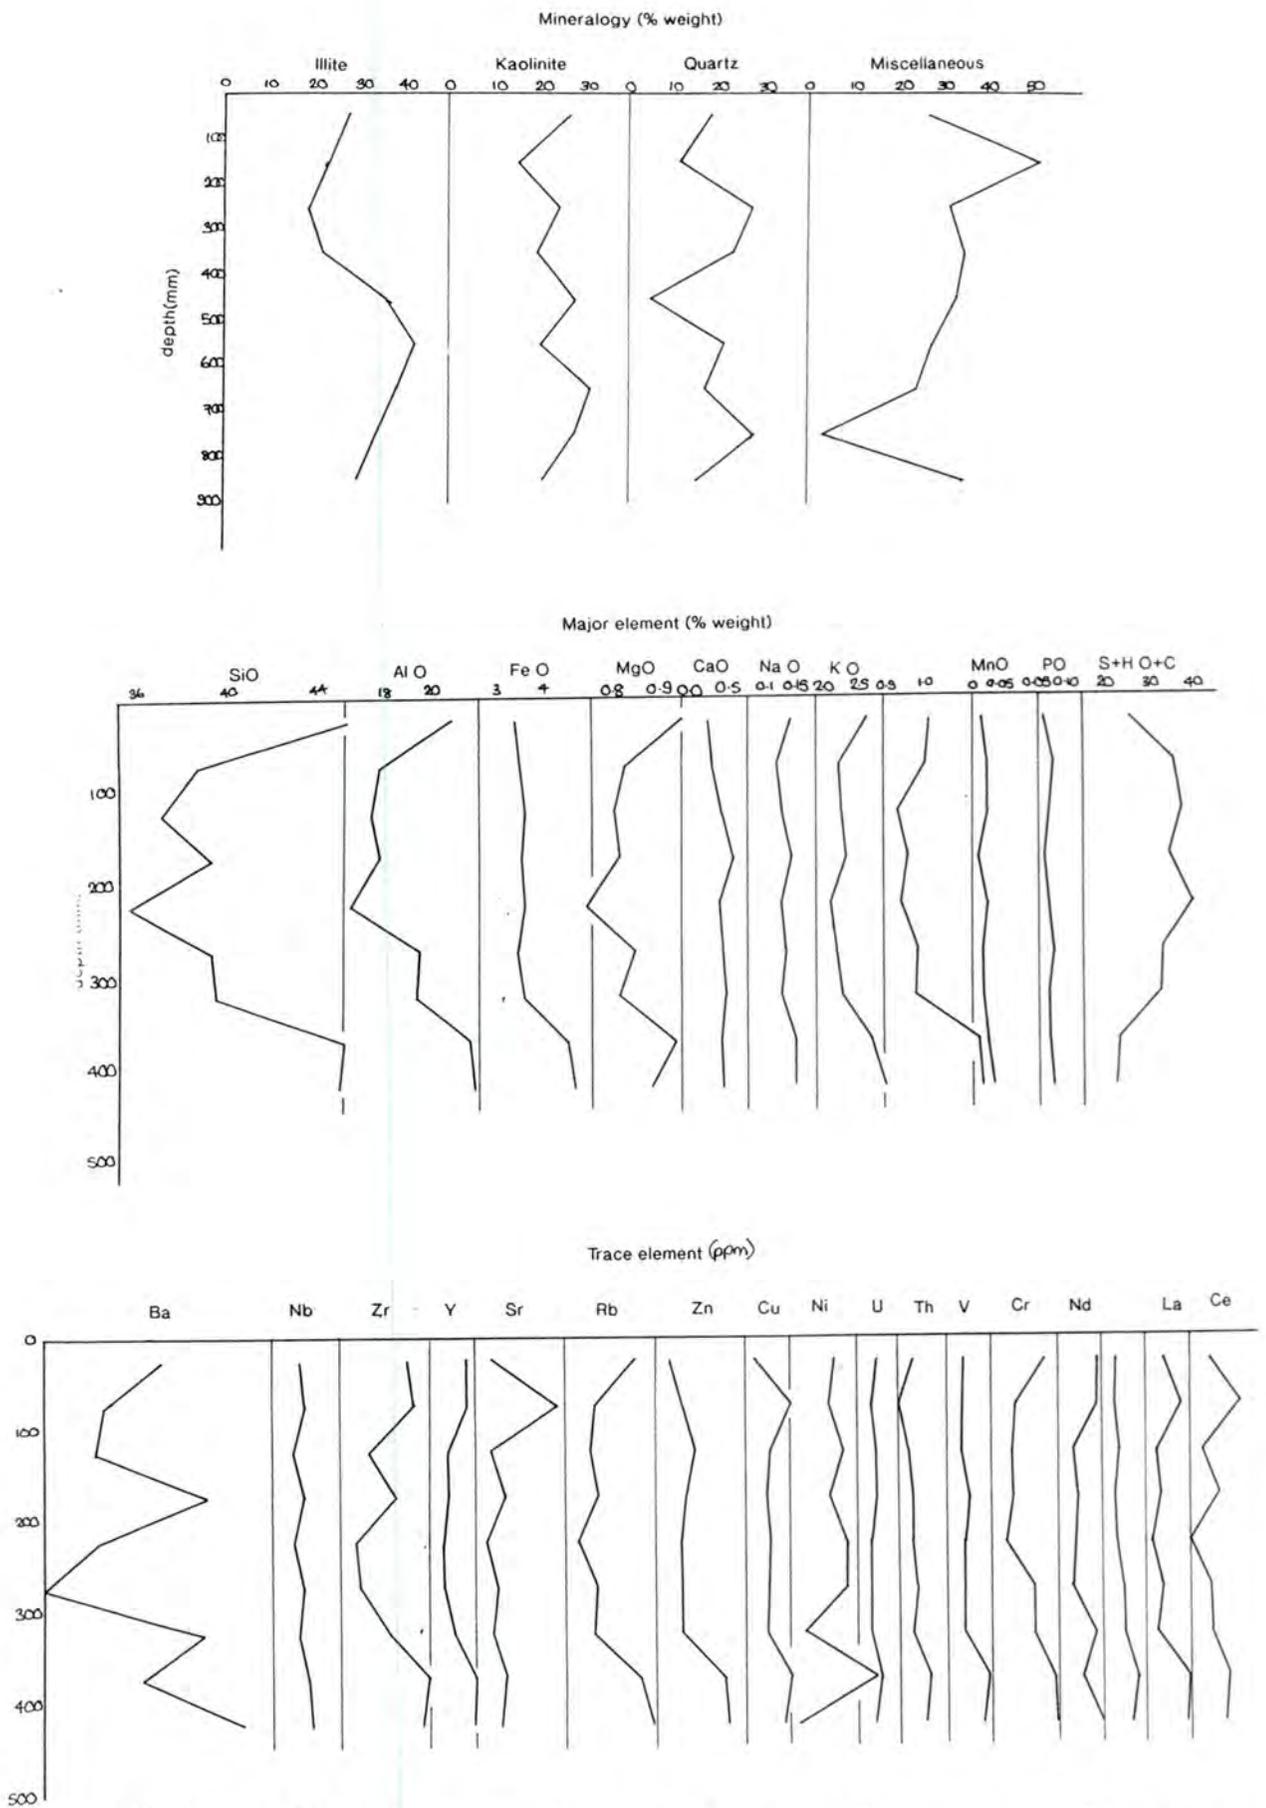
Figure 4.12 Mineral content, major element and trace element – depth: Courtyard model dam.

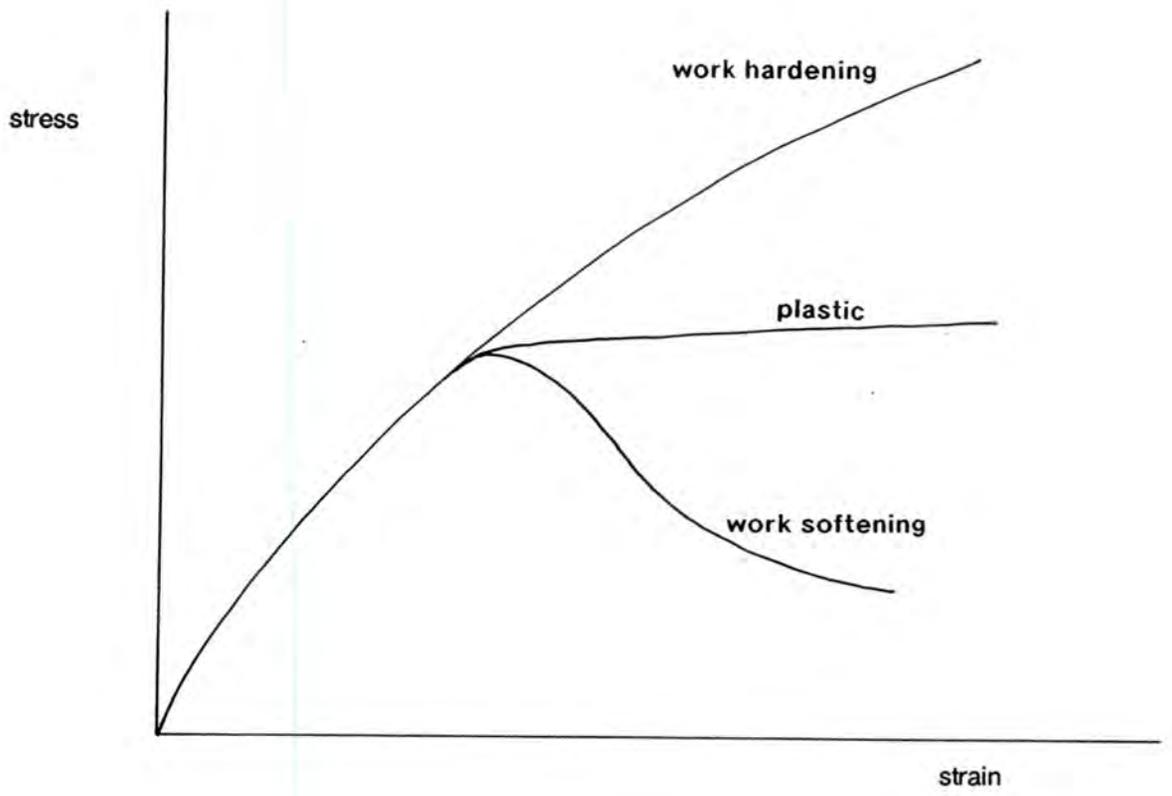
Figure 5.1 Summary of post failure behaviour observed in different materials.

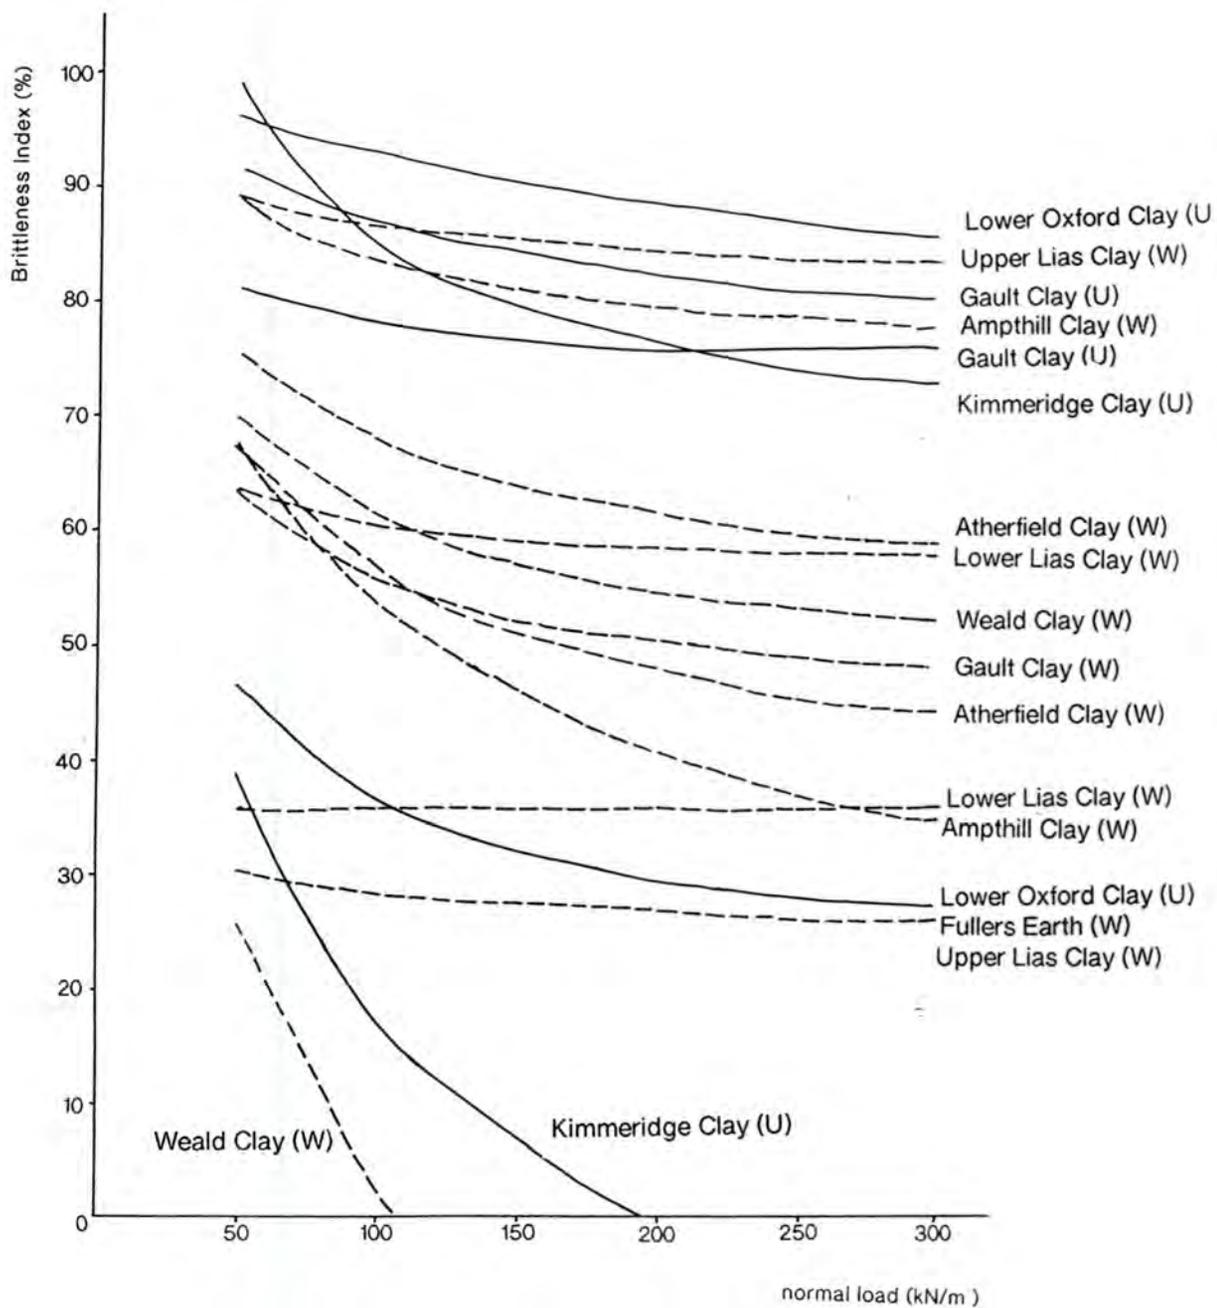
Figure 5.2 Brittleness index – normal load in Mesozoic overconsolidated clays and mudrocks.

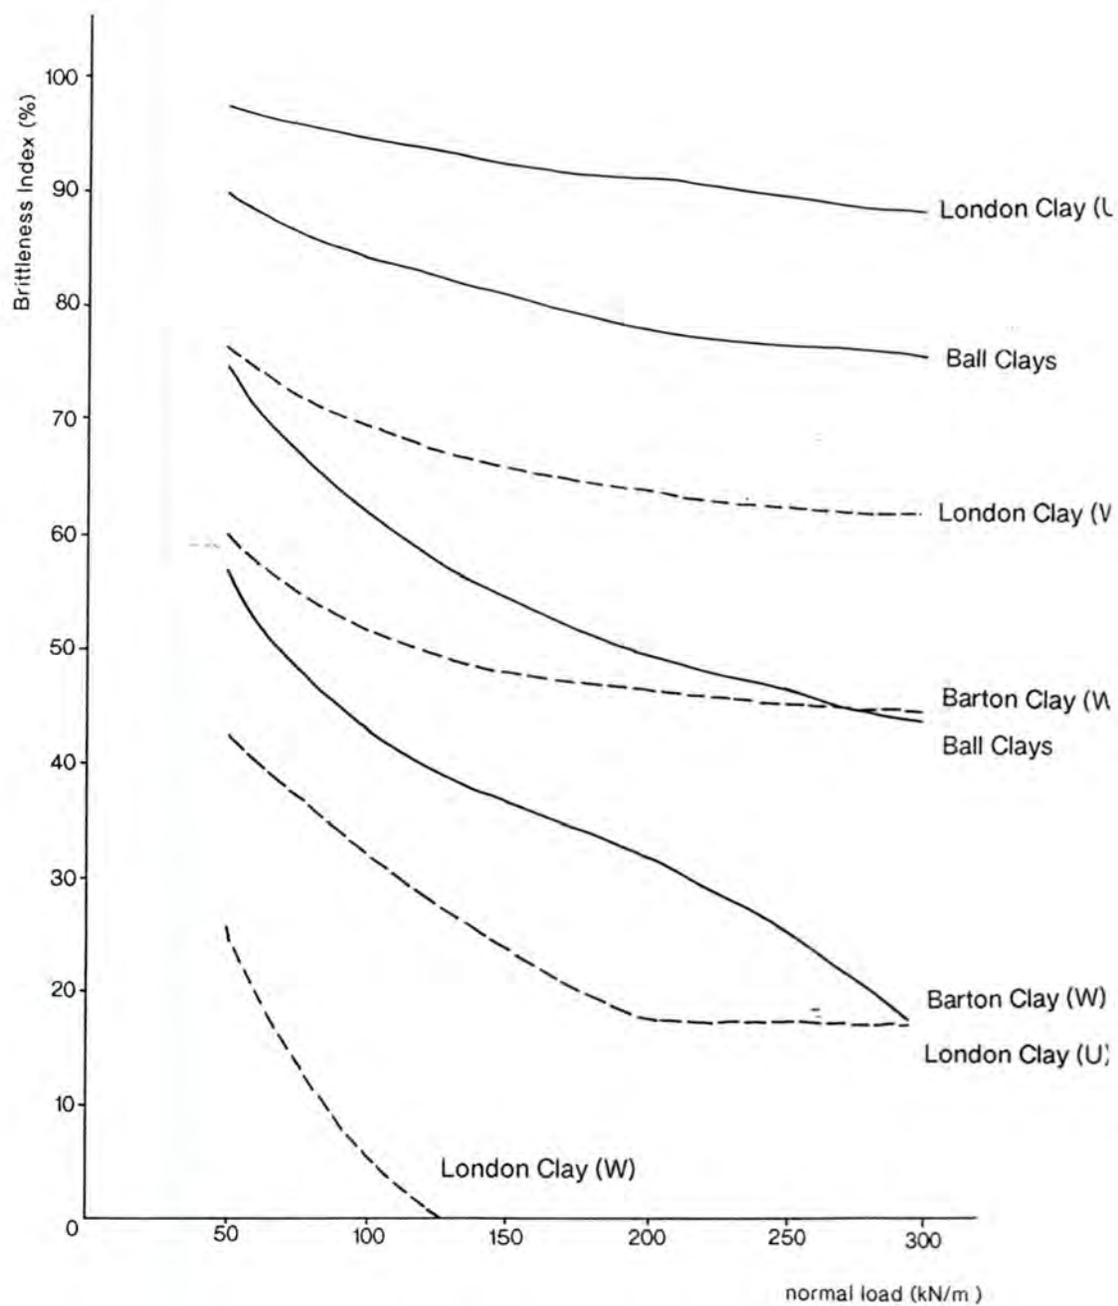
Figure 5.3 Brittleness index – normal load in Tertiary overconsolidated clays and mudrocks.

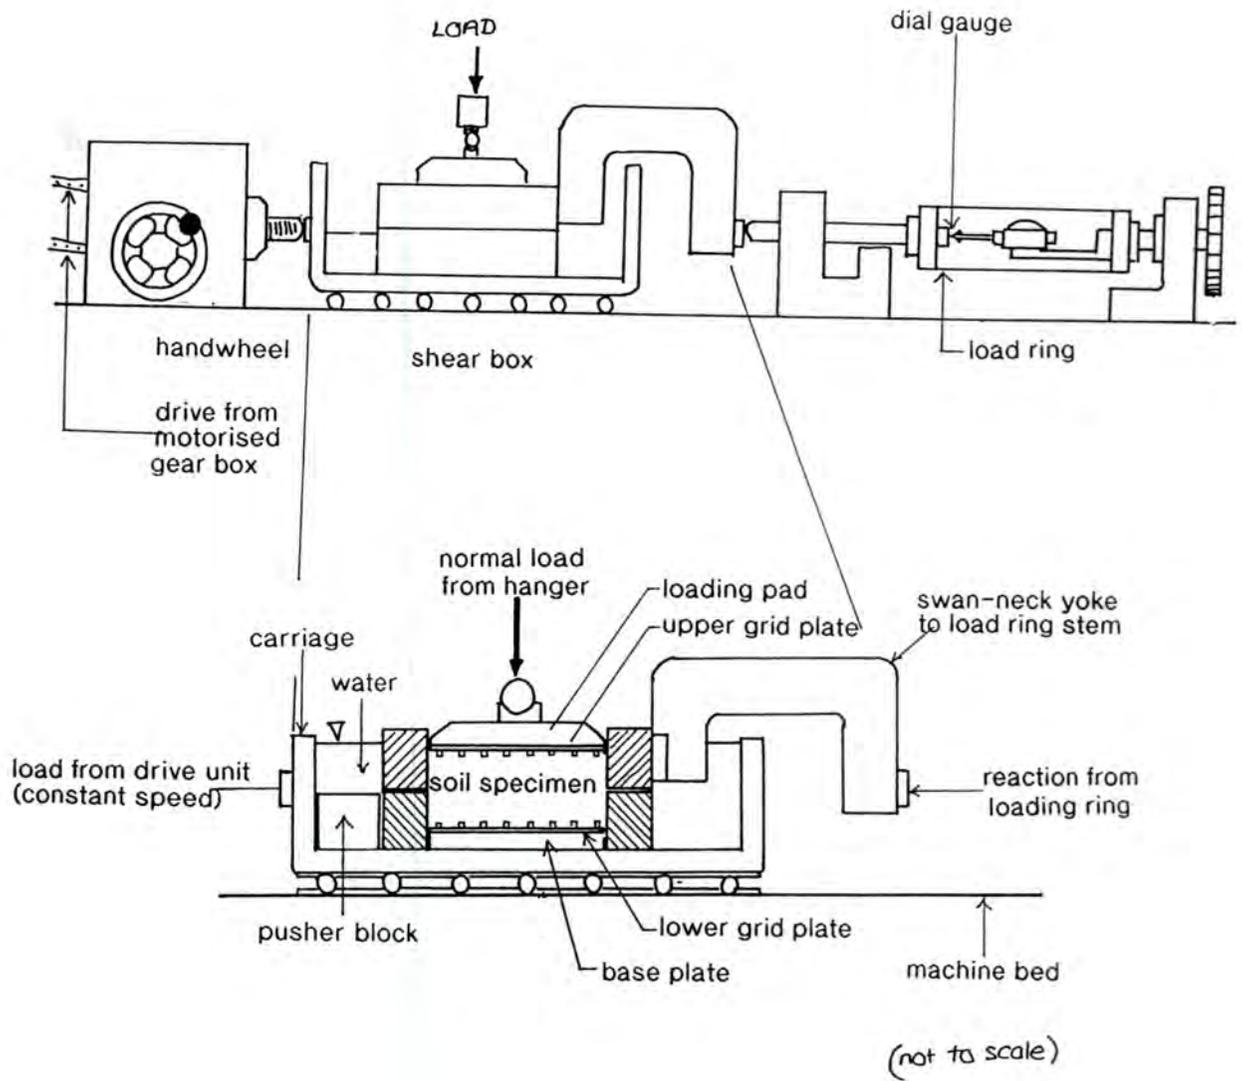
Figure 6.1: Basic design of shear strength apparatus

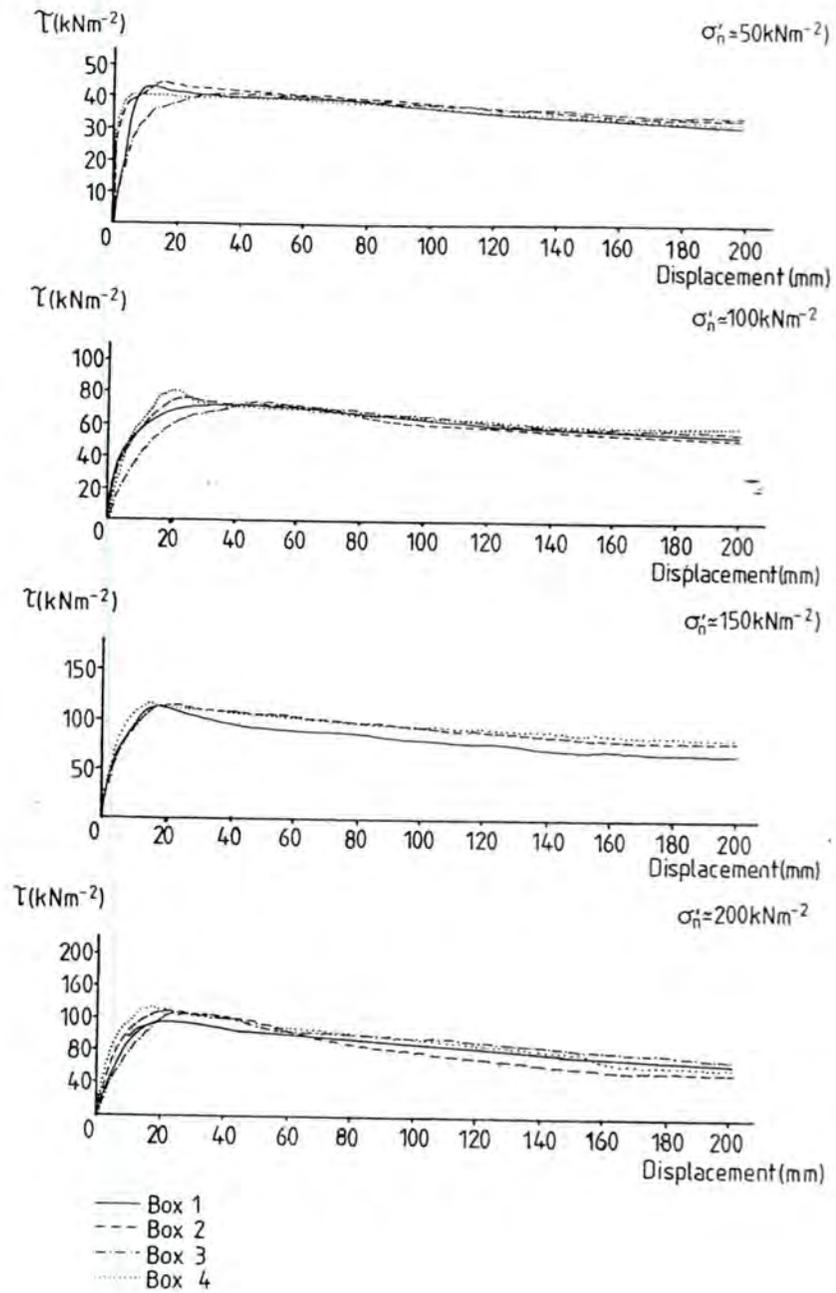
Figure 6.3 a - d: Shear stress - displacement curves: Coal Measures shale passing 2mm, at different normal loads. Tests to check precision of small shear boxes.

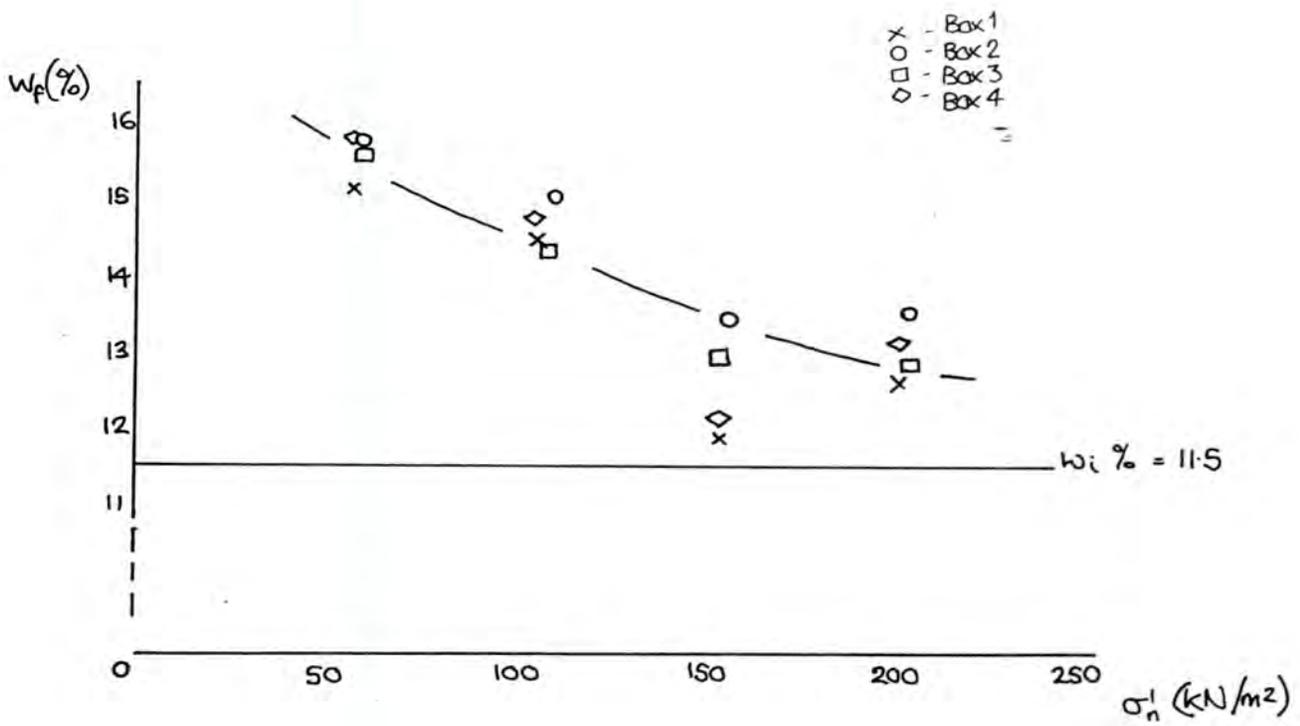
Figure 6.5: Initial and final moisture content: Coal Measures shale passing 2mm. Tests to check precision of small shear boxes.

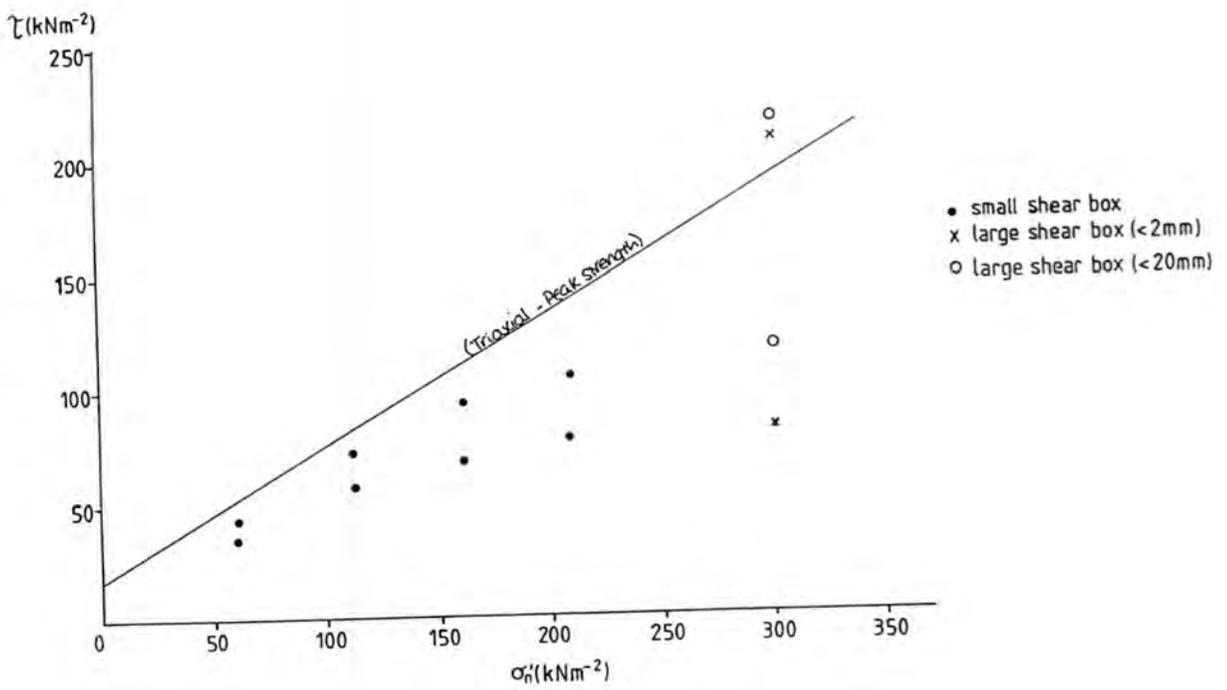
Figure 6.6: Shear strength – normal load: Coal Measures shale.

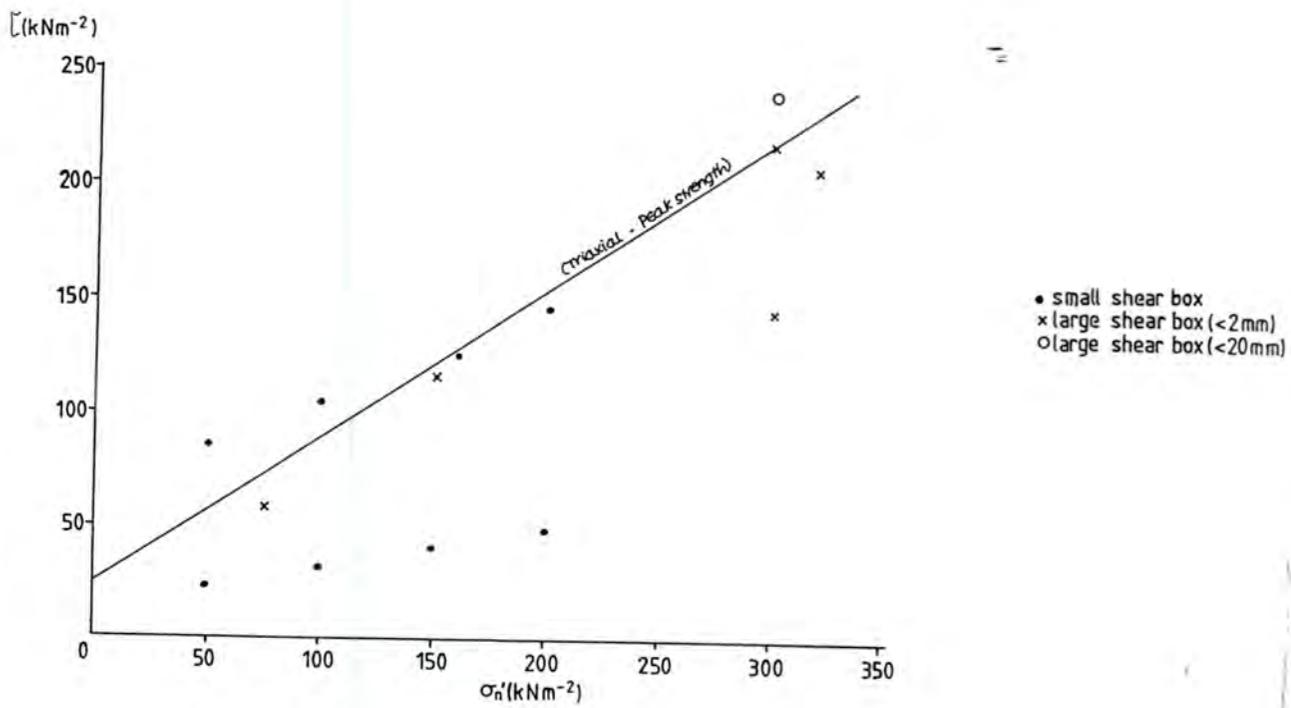
Figure 6.7: Shear strength – normal load: Kimmeridge Clay.

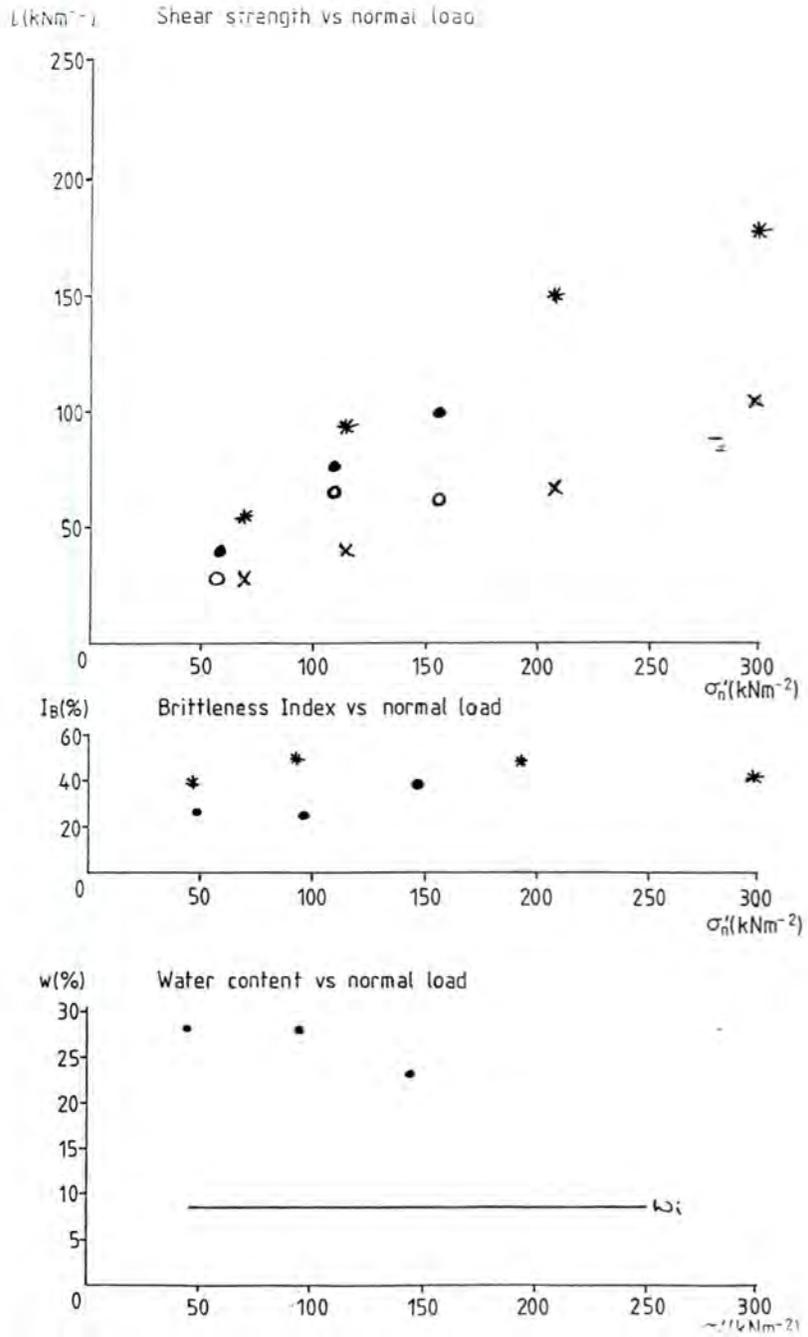
Figure 6.11: Shear stress – normal load, brittleness index – normal load and moisture content – normal load: Gale Common fresh shale.

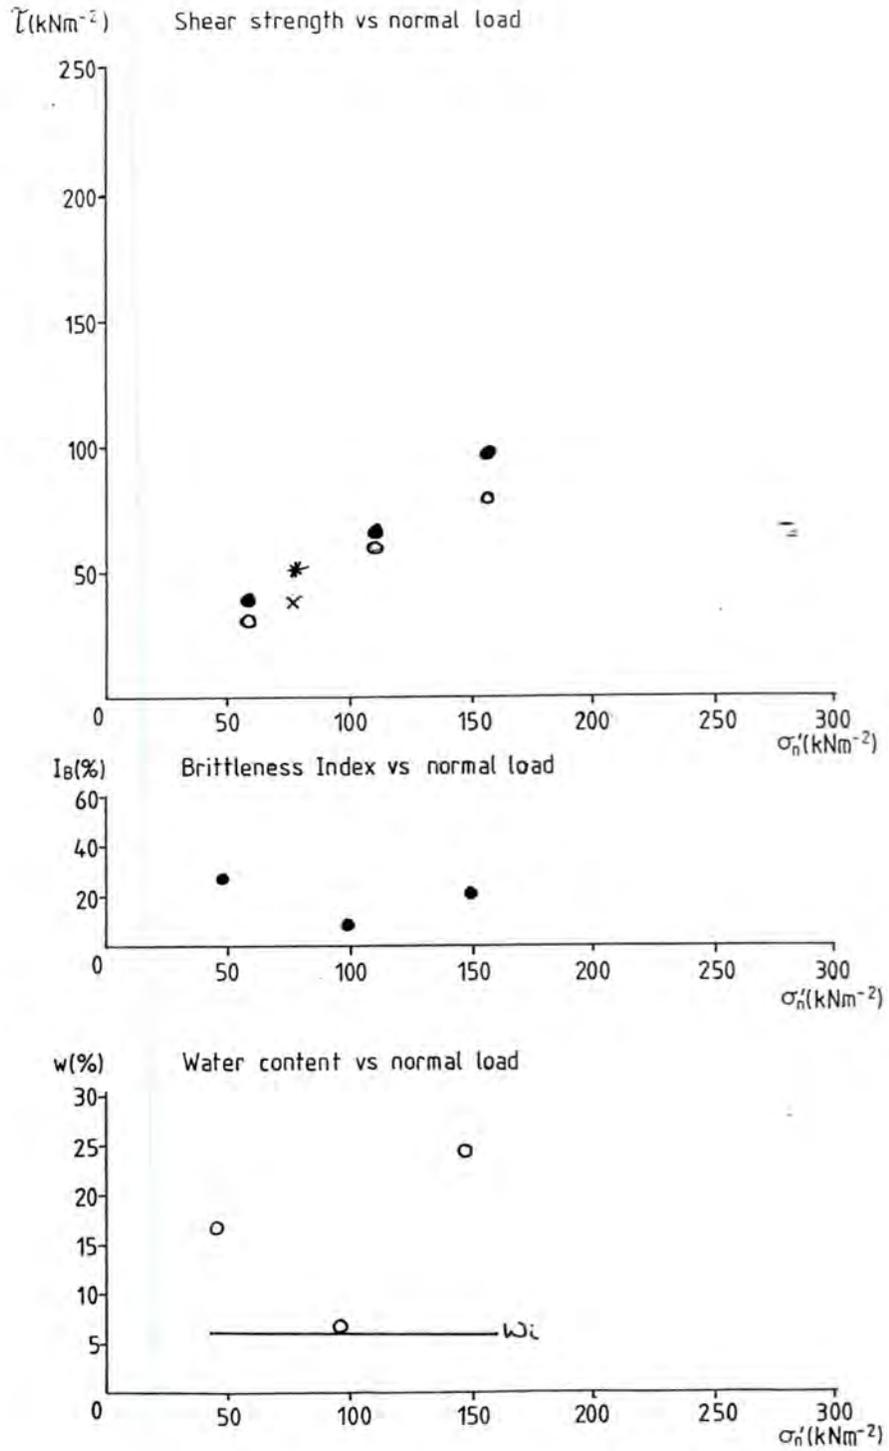
Figure 6.12: Shear stress - normal load, brittleness index - normal load and moisture content - normal load: Gale Common stockpiled shale.

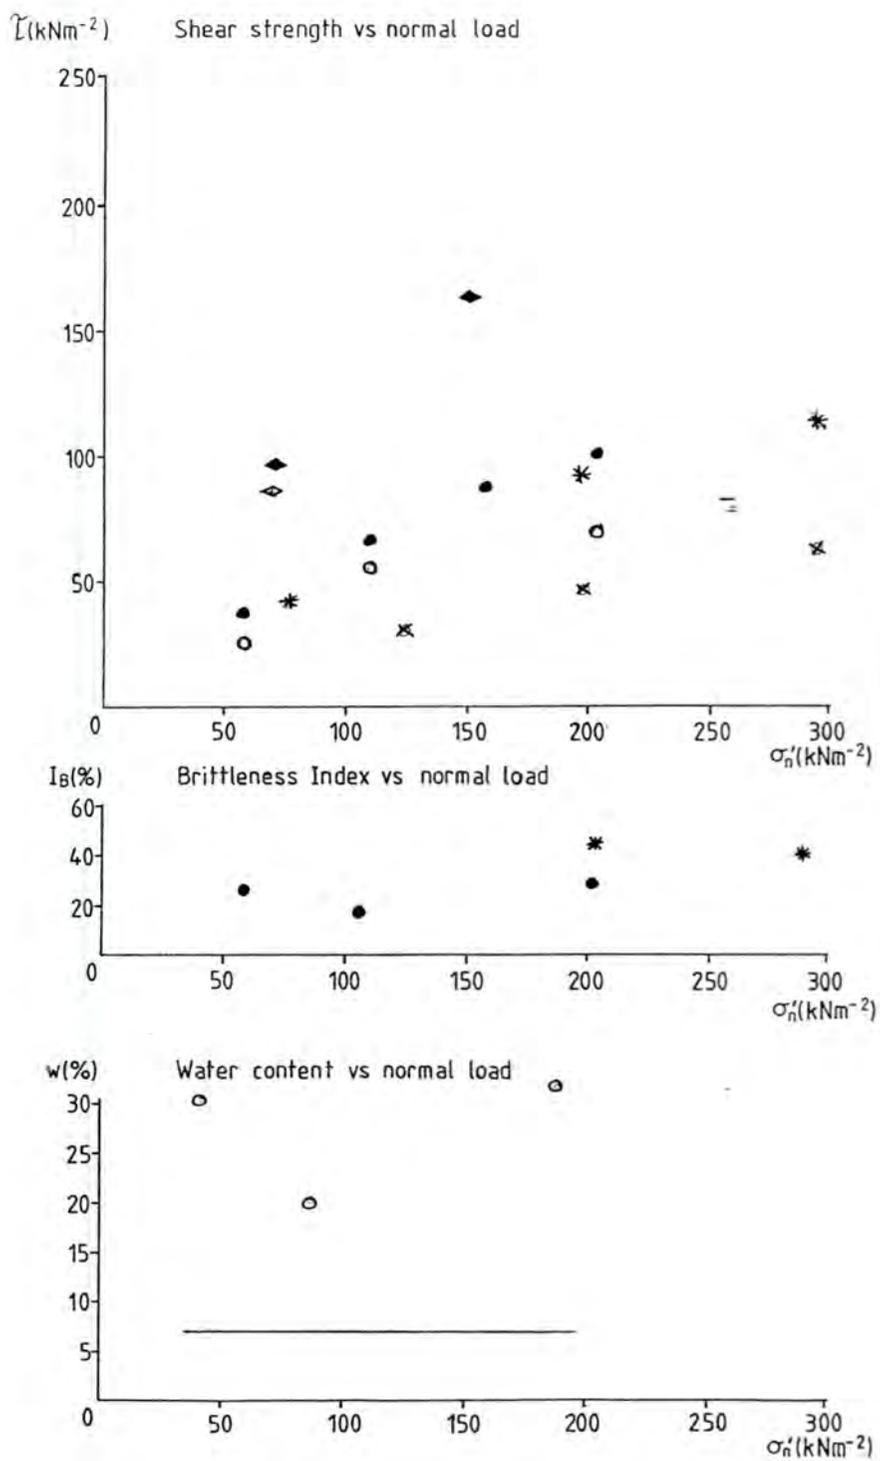
Figure 6.13: Shear stress – normal load, brittleness index – normal load and moisture content – normal load: Gale Common five year weathered shale.

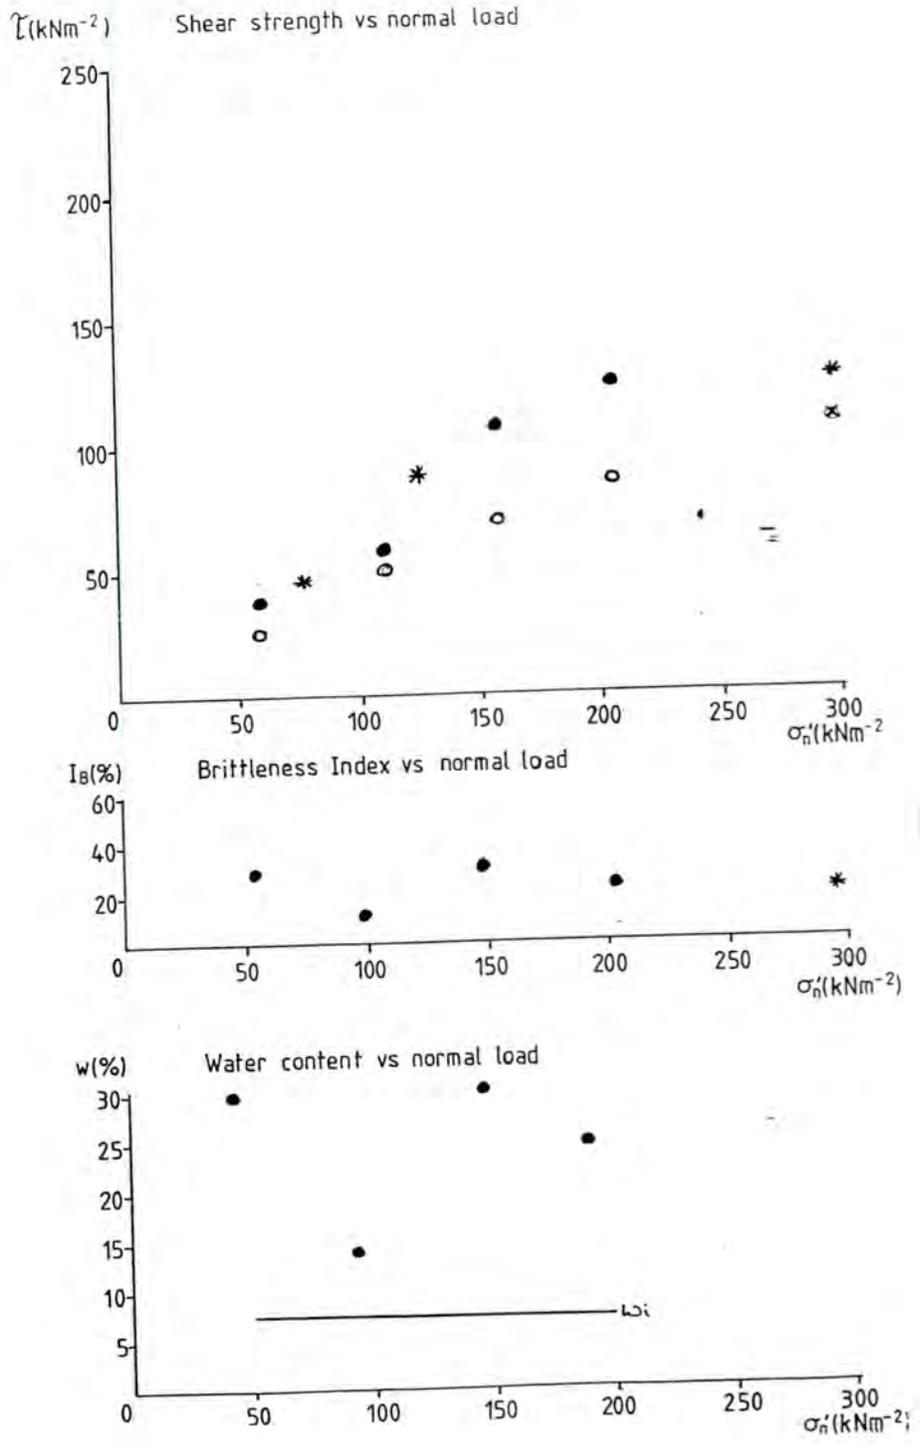
Figure 6.14: Shear stress – normal load, brittleness index – normal load and moisture content – normal load: Gale Common fifteen year weathered shale.

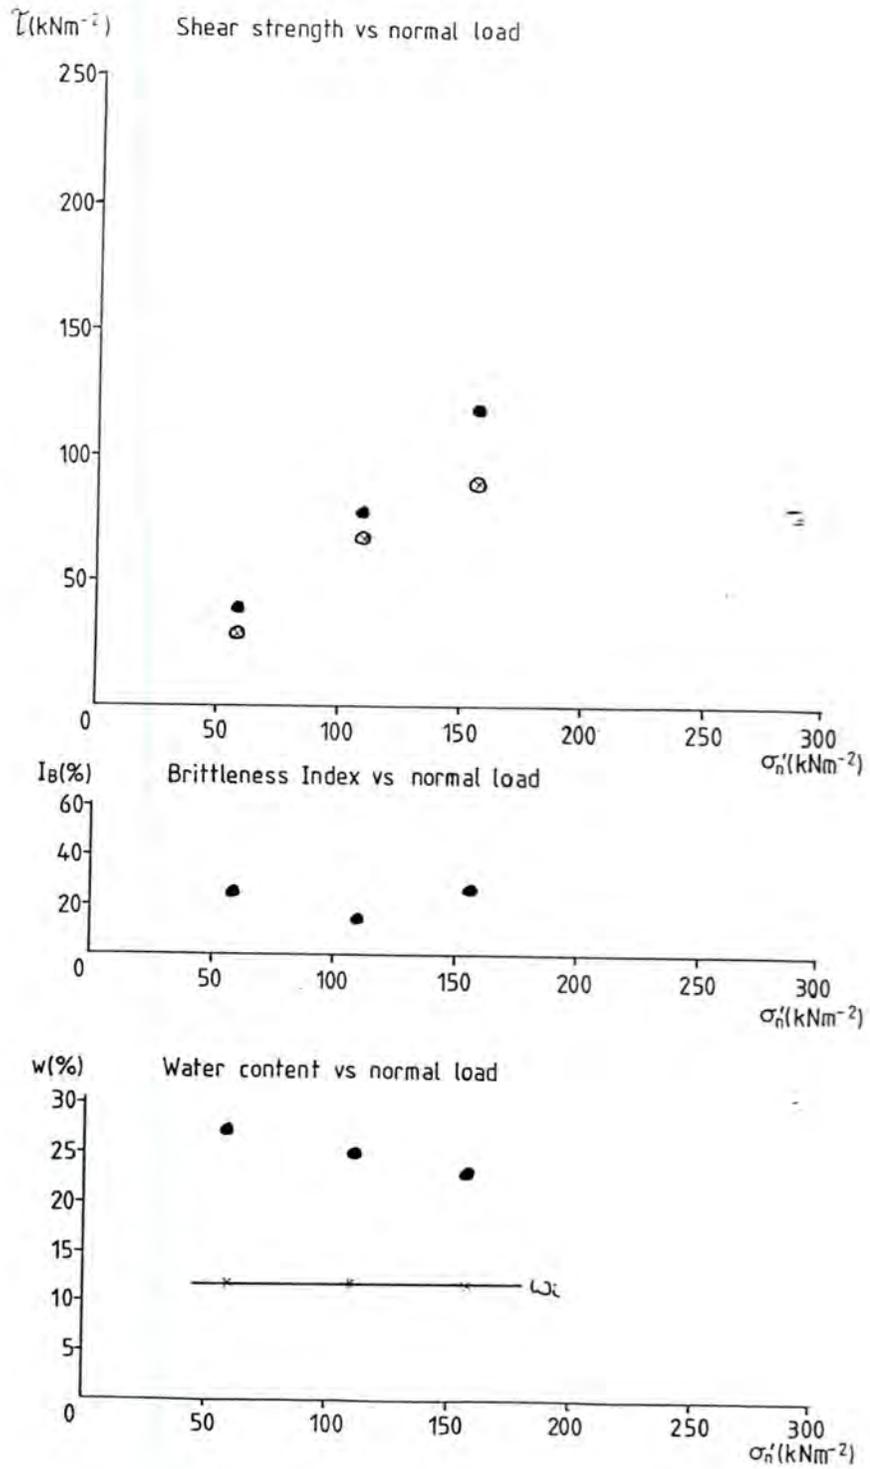
Figure 6.15: Shear stress – normal load, brittleness index – normal load and moisture content – normal load: Grassholme Dam.

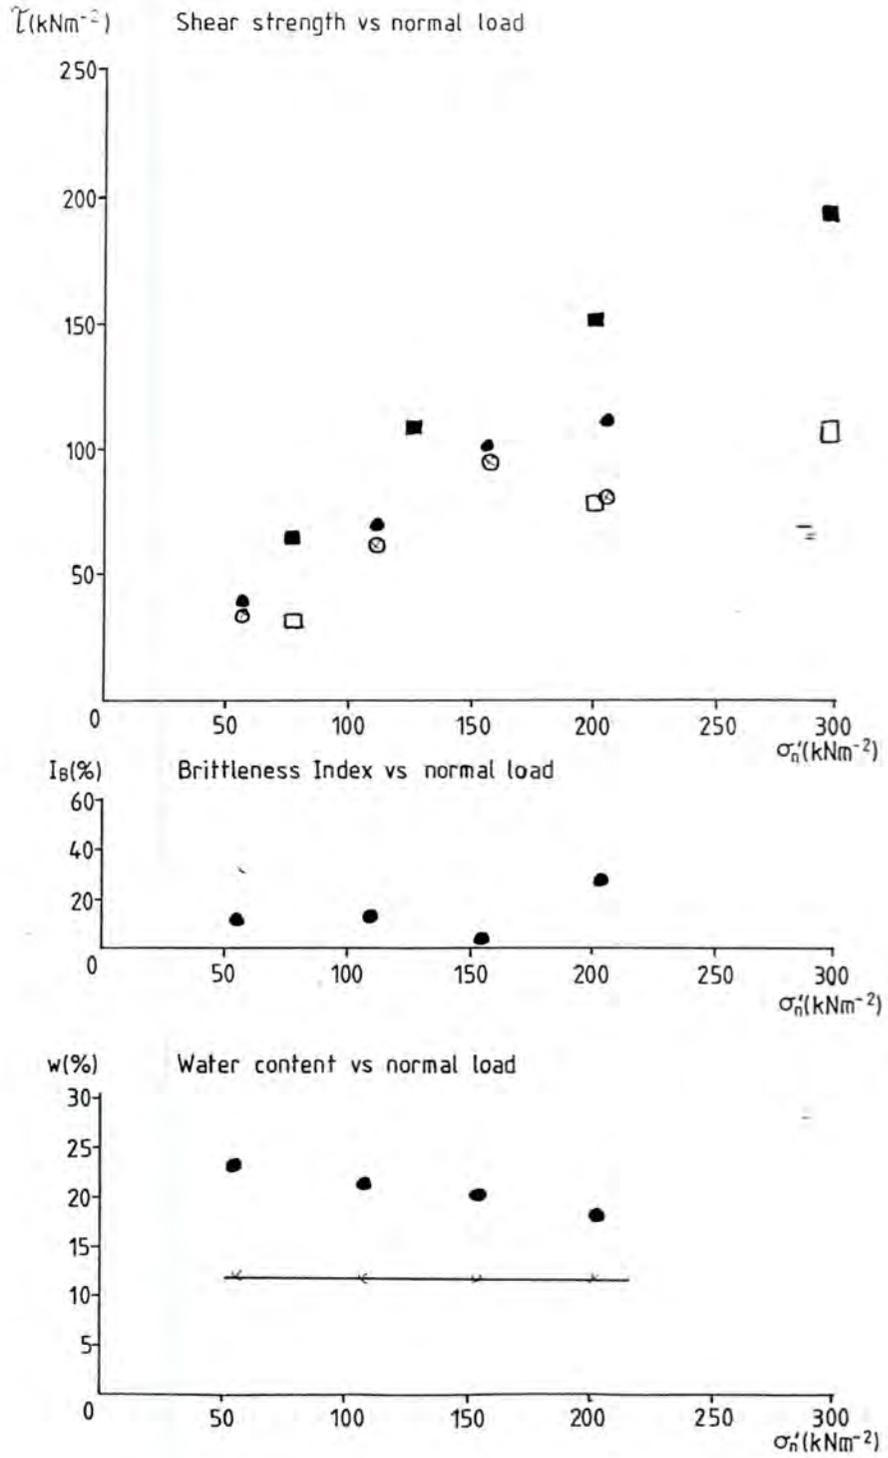
Figure 6.16: Shear stress – normal load, brittleness index – normal load and moisture content – normal load: Balderhead Dam.
