Weathering and brittleness in shale fill dams and embankments

**WEATHERING AND BRITTLENESS
IN SHALE FILL
DAMS AND EMBANKMENTS.**

A thesis presented for the degree of Master of Science
in the University of Durham.

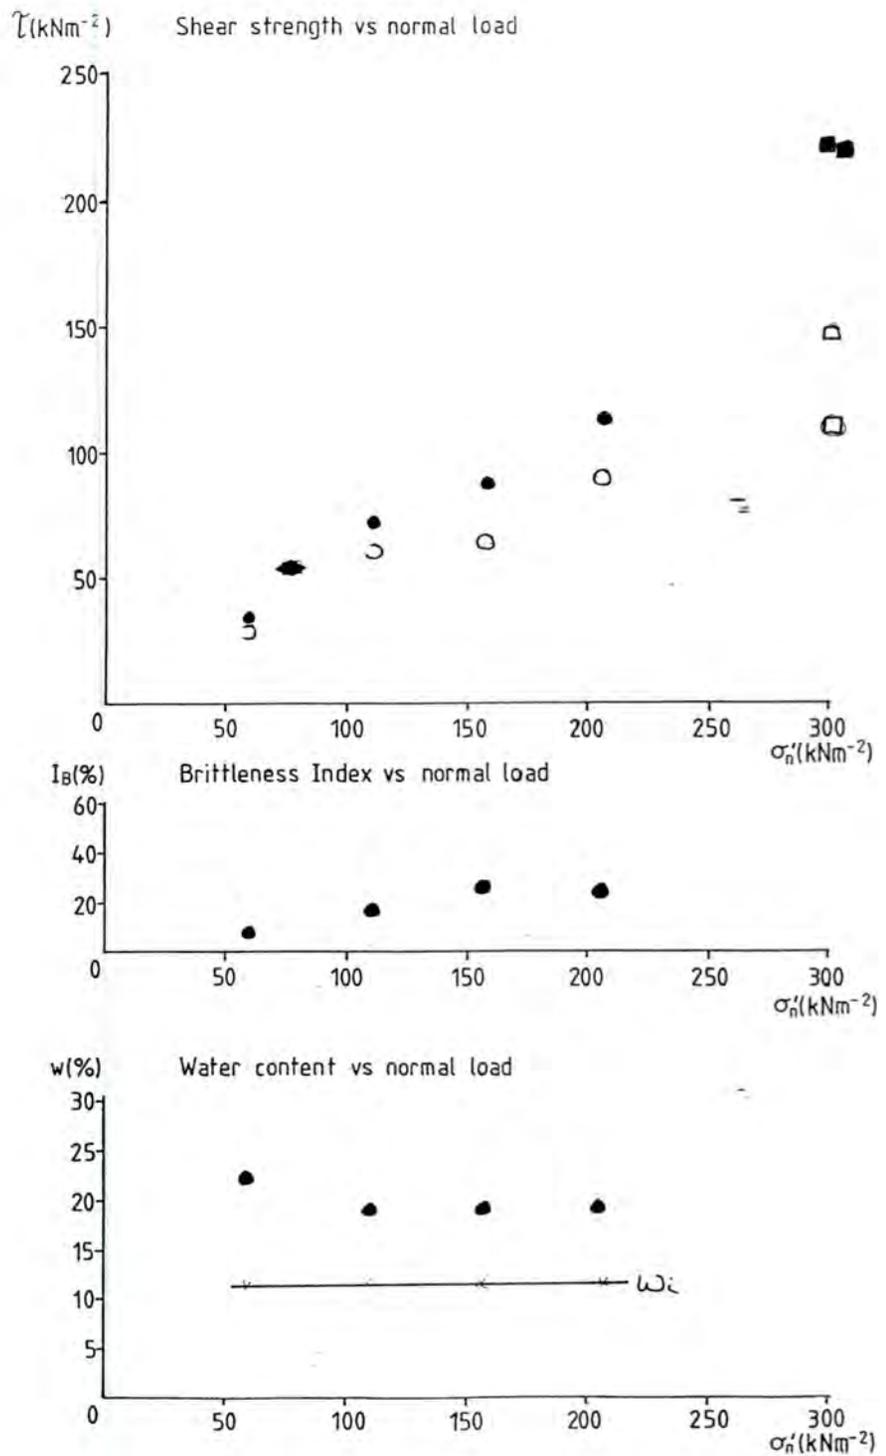
Figure 6.17: Shear stress – normal load, brittleness index – normal load and moisture content – normal load: Grassholme – Hury tunnel spoil heaps.

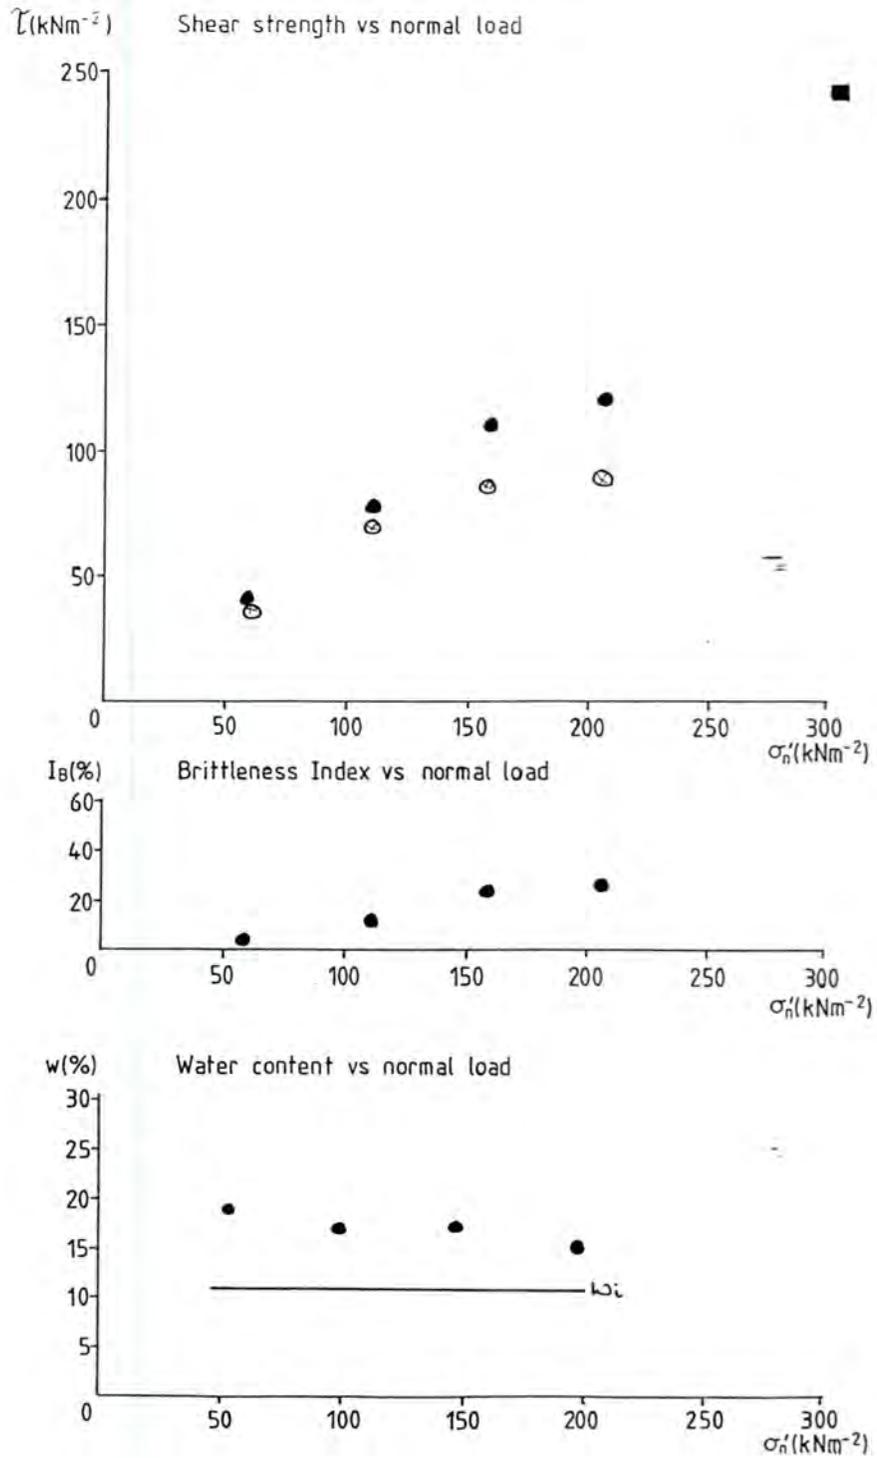
Figure 6.18: Shear stress - normal load, brittleness index - normal load and moisture content - normal load: Burnhope Dam

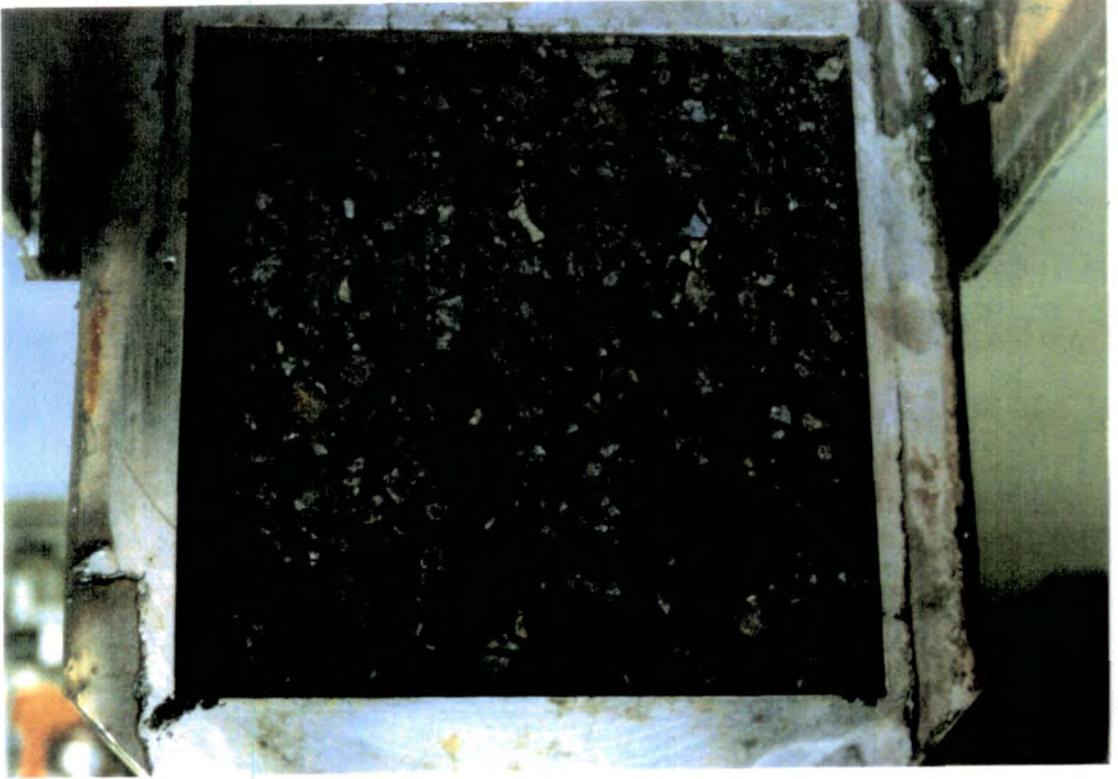
Plate 6.1: Clast size range used in large shear box test

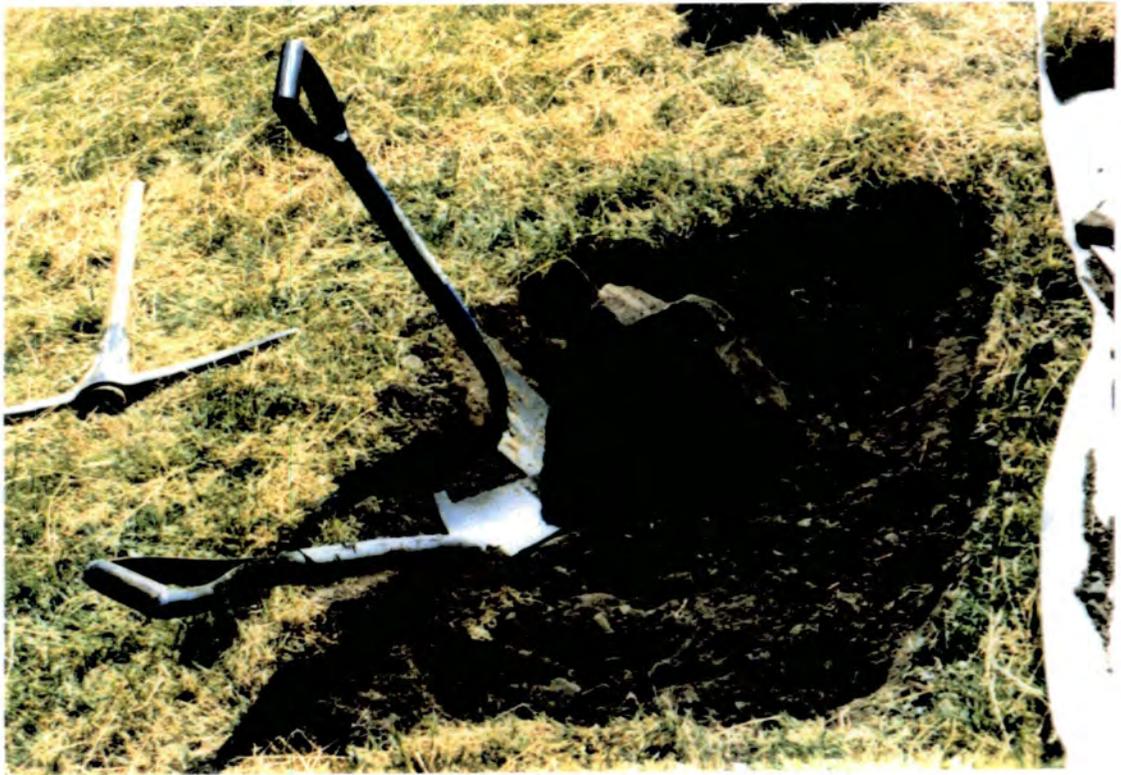
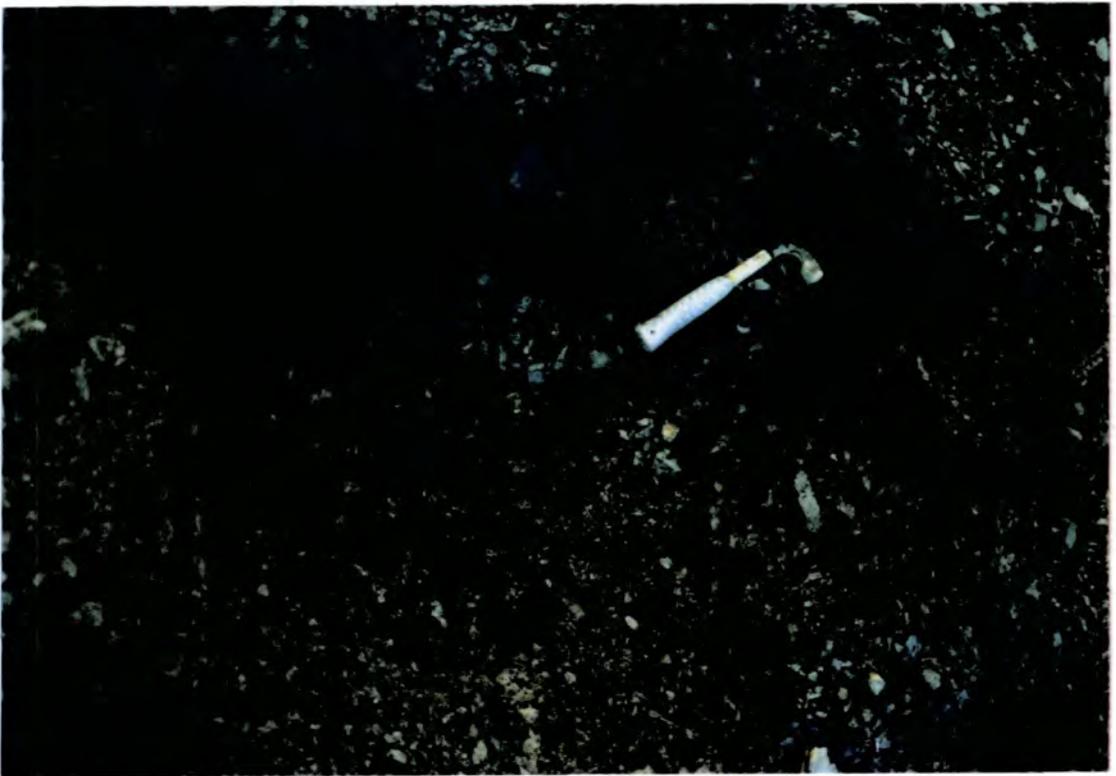
Plate 6.2: Clast size range used in typical pits dug in shale fill dams.

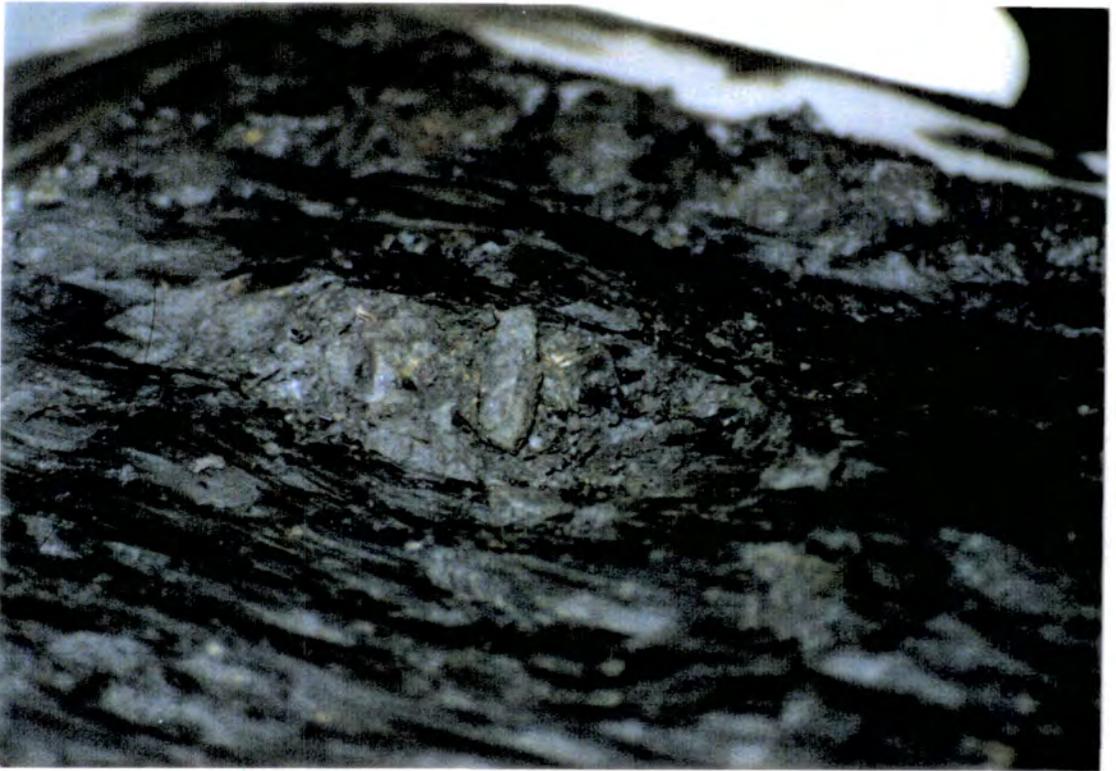
Plate 6.3: Interruption of shear plane by large clast in shear box test (undisturbed sample, Gale Common 5 year weathered shale)

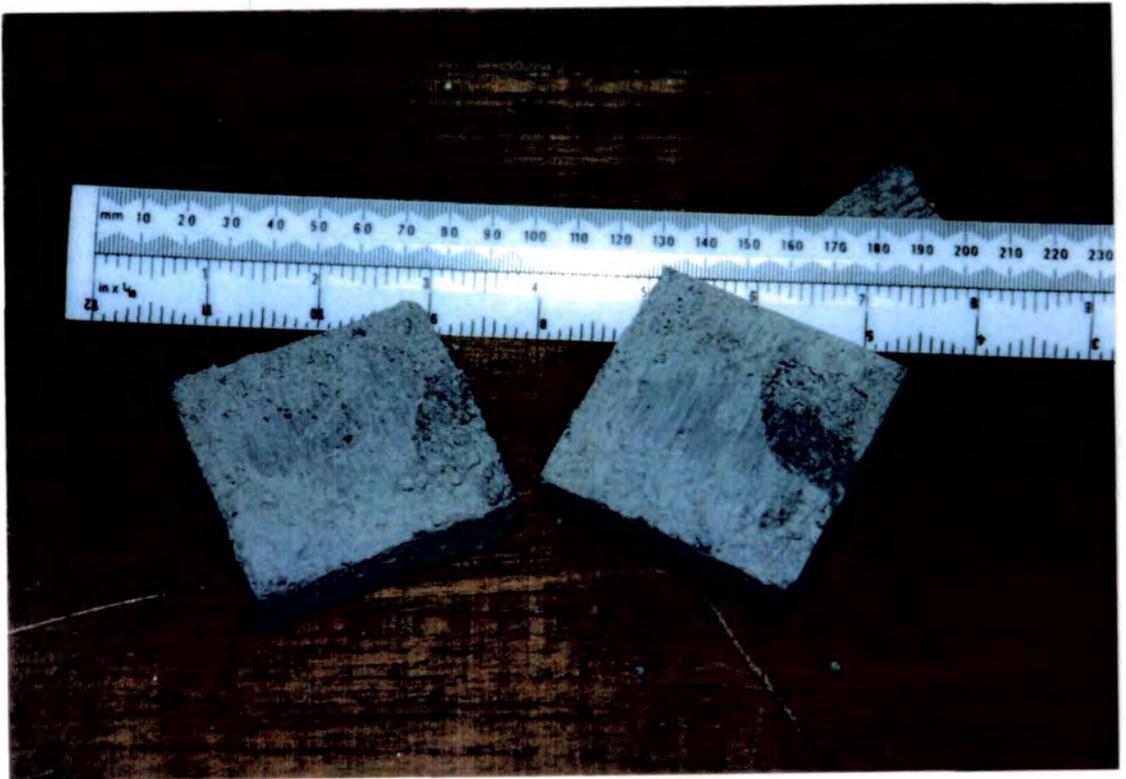
Plate 6.4: Sample from small shear box split after testing to reveal shear plane (Coal Measures shale passing 2mm sieve).

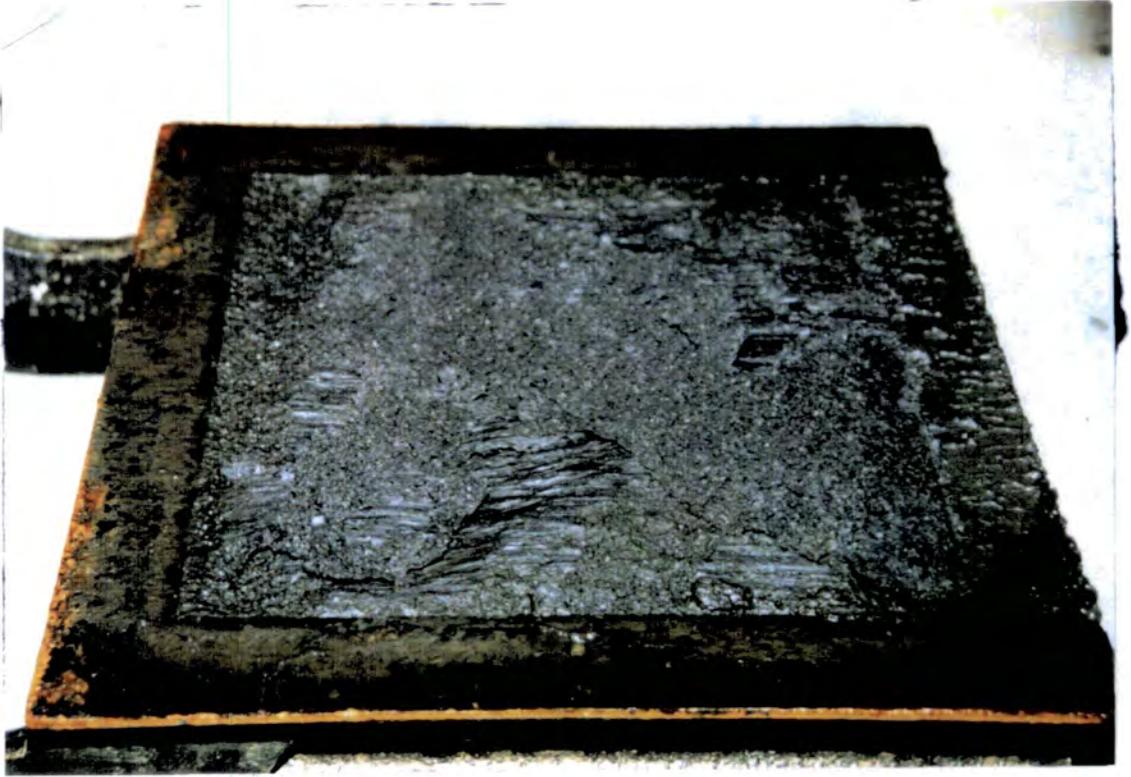
Plate 6.5: Shear plane from large shear box test (fresh Coal Measures shale passing 2mm sieve).

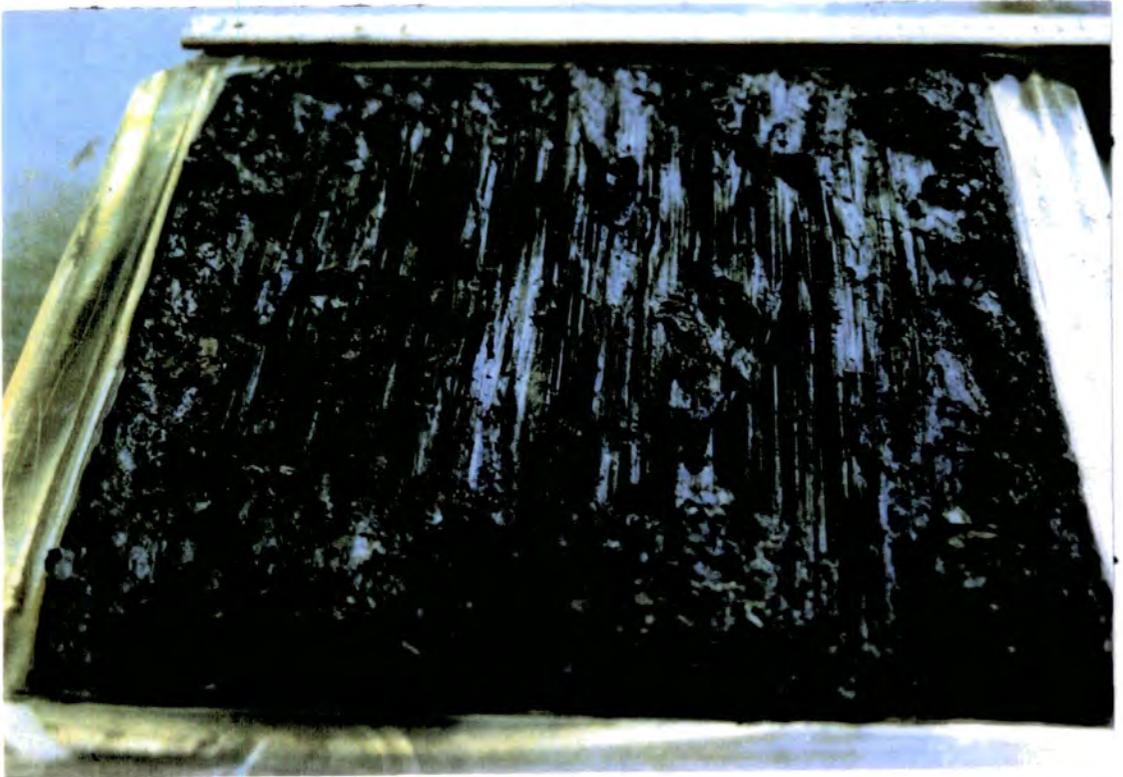
Plate 6.6: Shear plane from large shear box test (Gale Common 15 year weathered shale passing 20mm sieve)

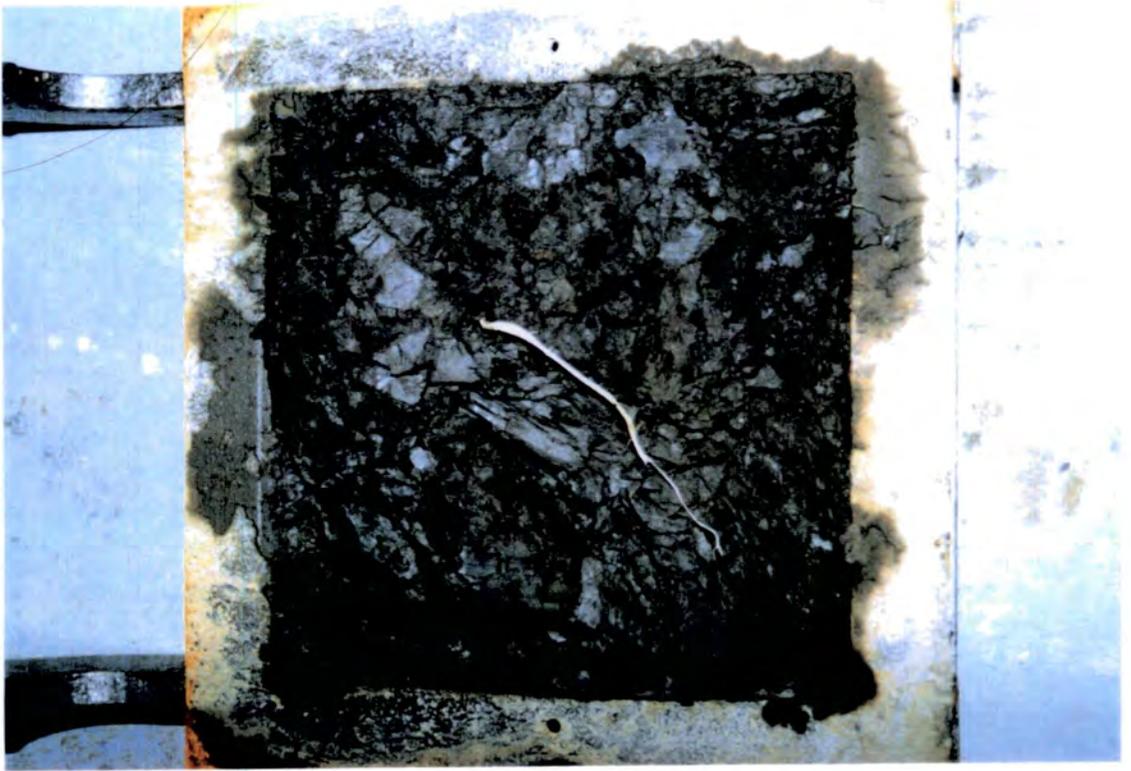
Plate 6.7: Shear plane from large shear box test (undisturbed Namurian shale from Grassholme Hury tunnel spoil heap).

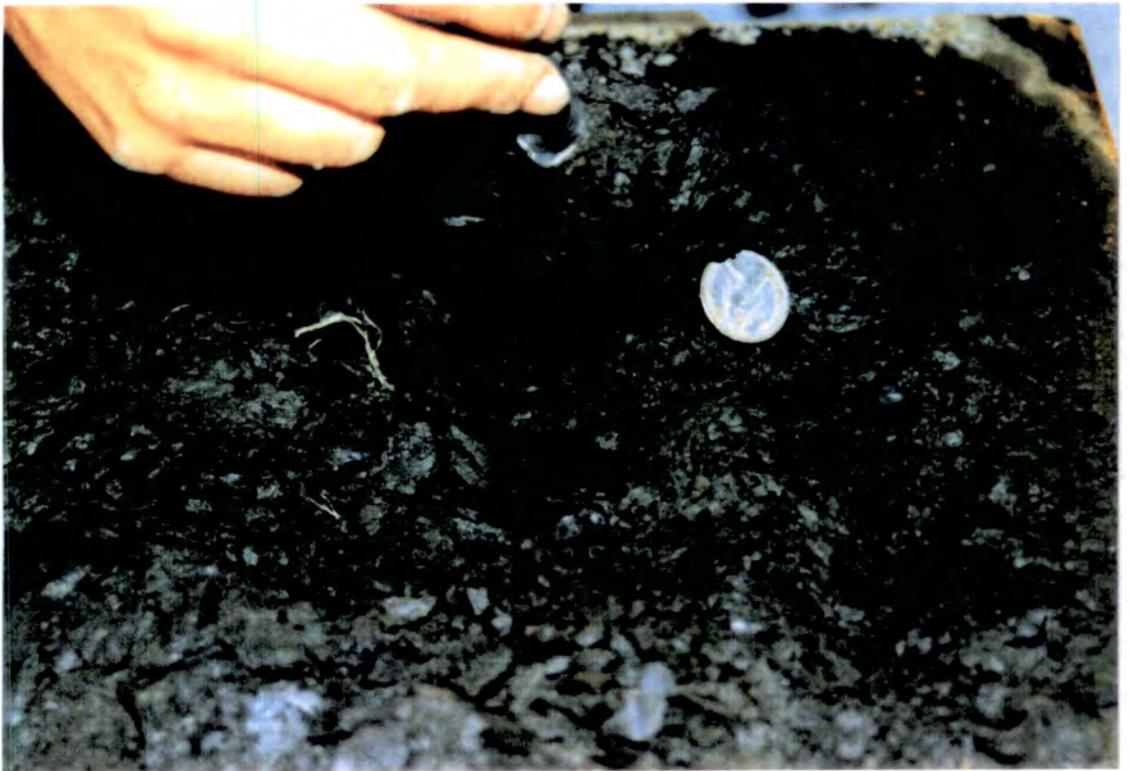
Plate 6.8: Close up of shear plane from Plate 6.7.

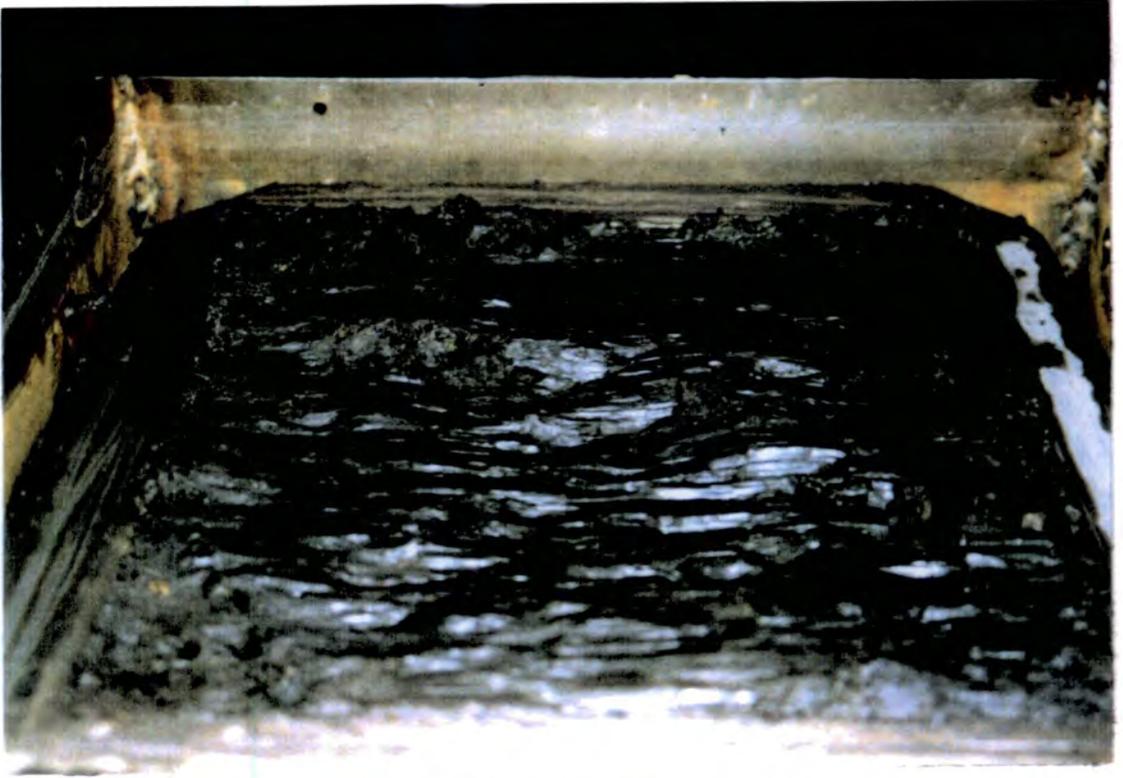
Plate 6.9: Shear plane in undisturbed sample of Namurian shale showing distortion of plane by large clasts.

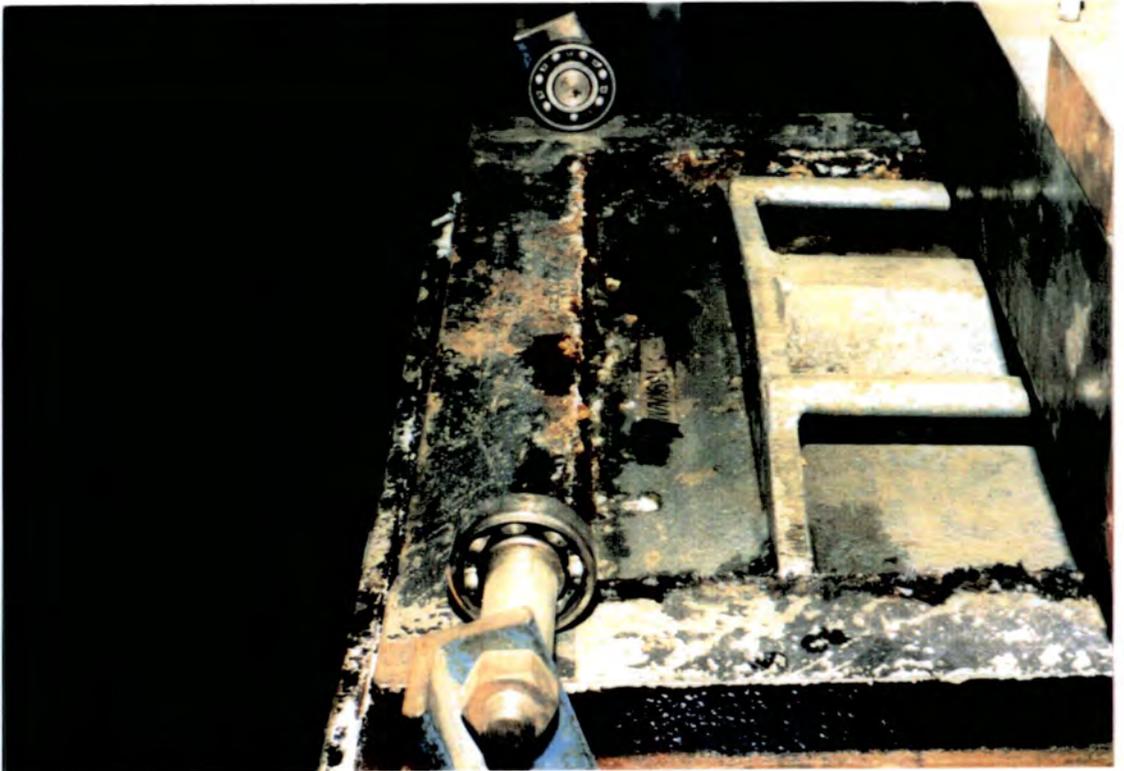
Plate 6.10: Crystalline growths around box lid observed during large shear box test (Gale Common 5 year weathered shale).

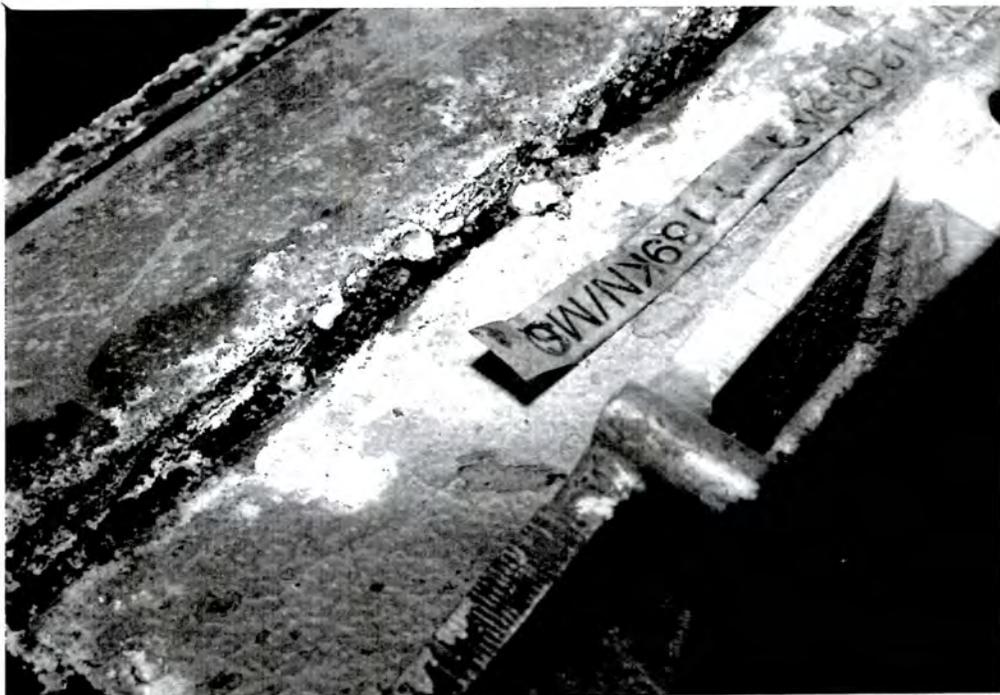
Plate 6.11: Close up of crystalline growth shown in Plate 6.10.

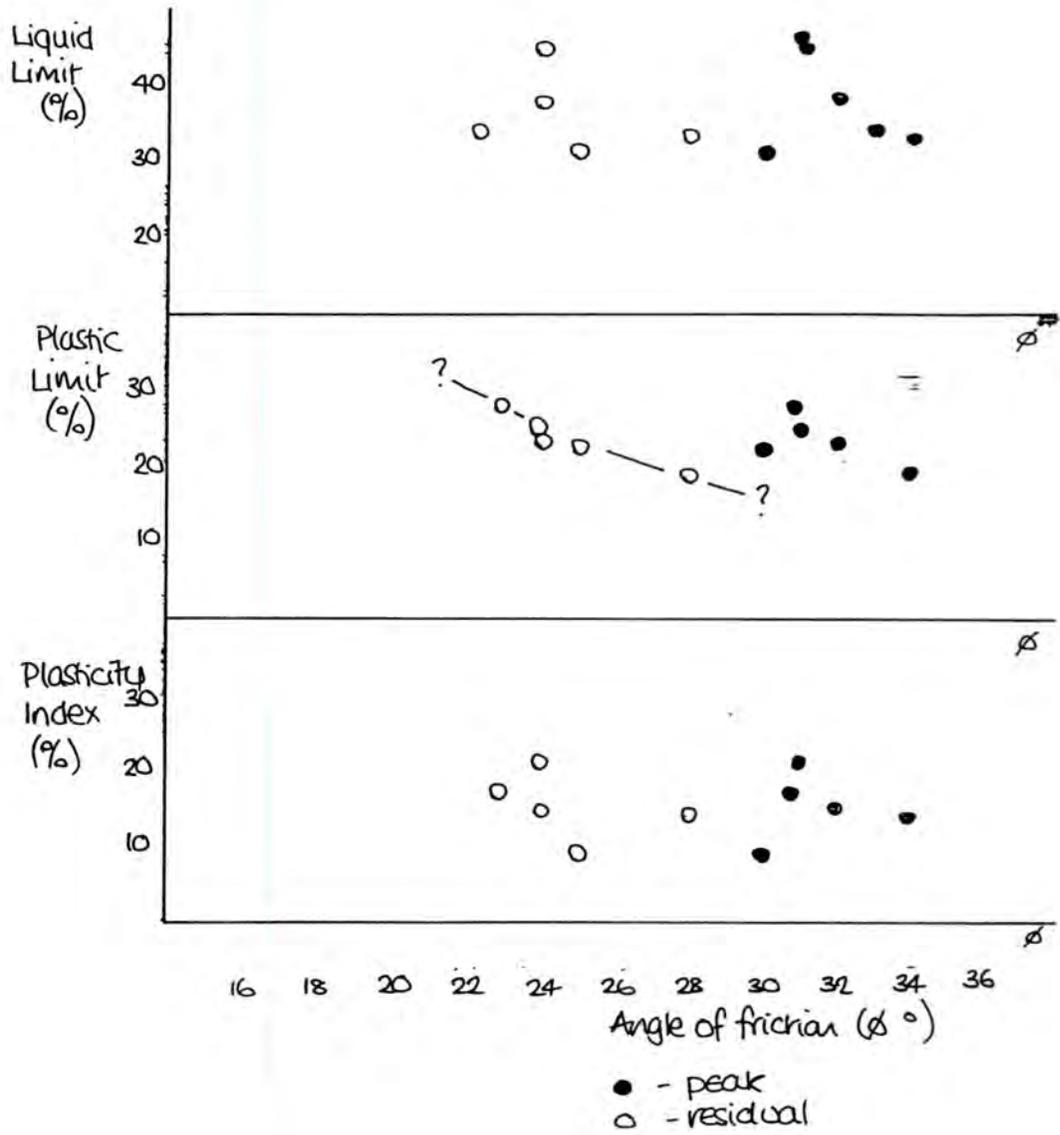
Figure 7.1 : Relationship between shear strength and other geotechnical data.

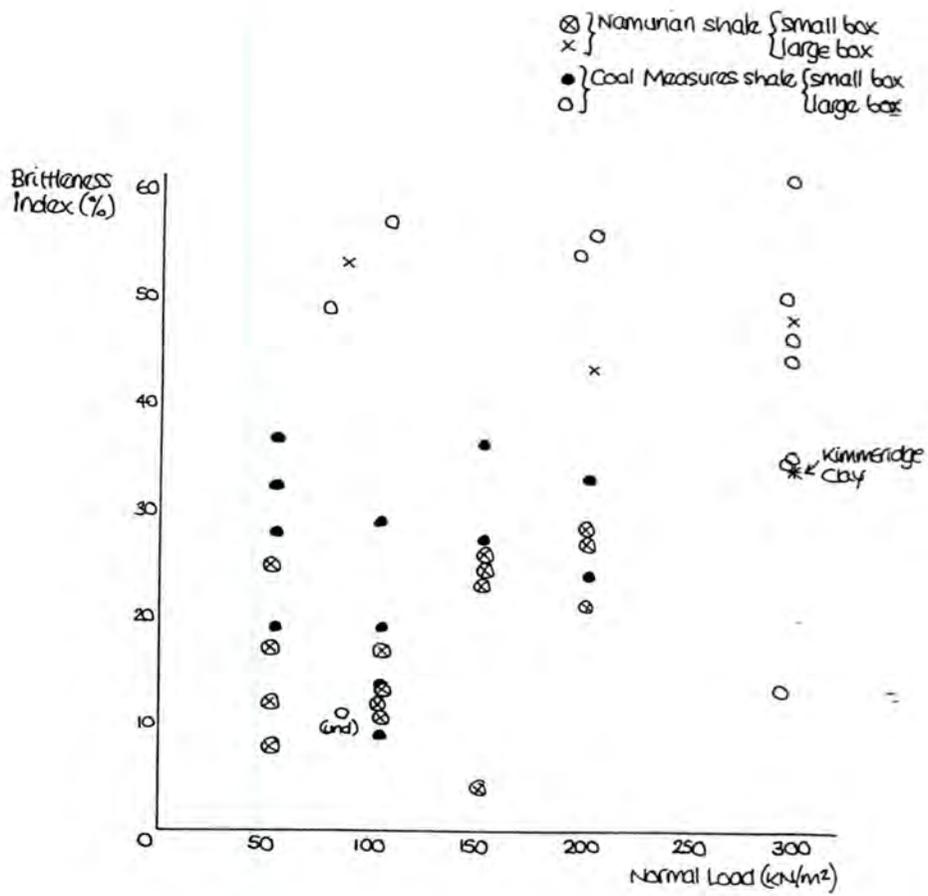
Figure 7.4 : Summary of brittleness data for all samples tested.
